| PROJECT | SMP - St Mary's CE Primary School |
| TITLE | Elevation EE - Demolition & Repairs |
| NUMBER | SMP-SEV-XX-XX-DR-A-03014 |

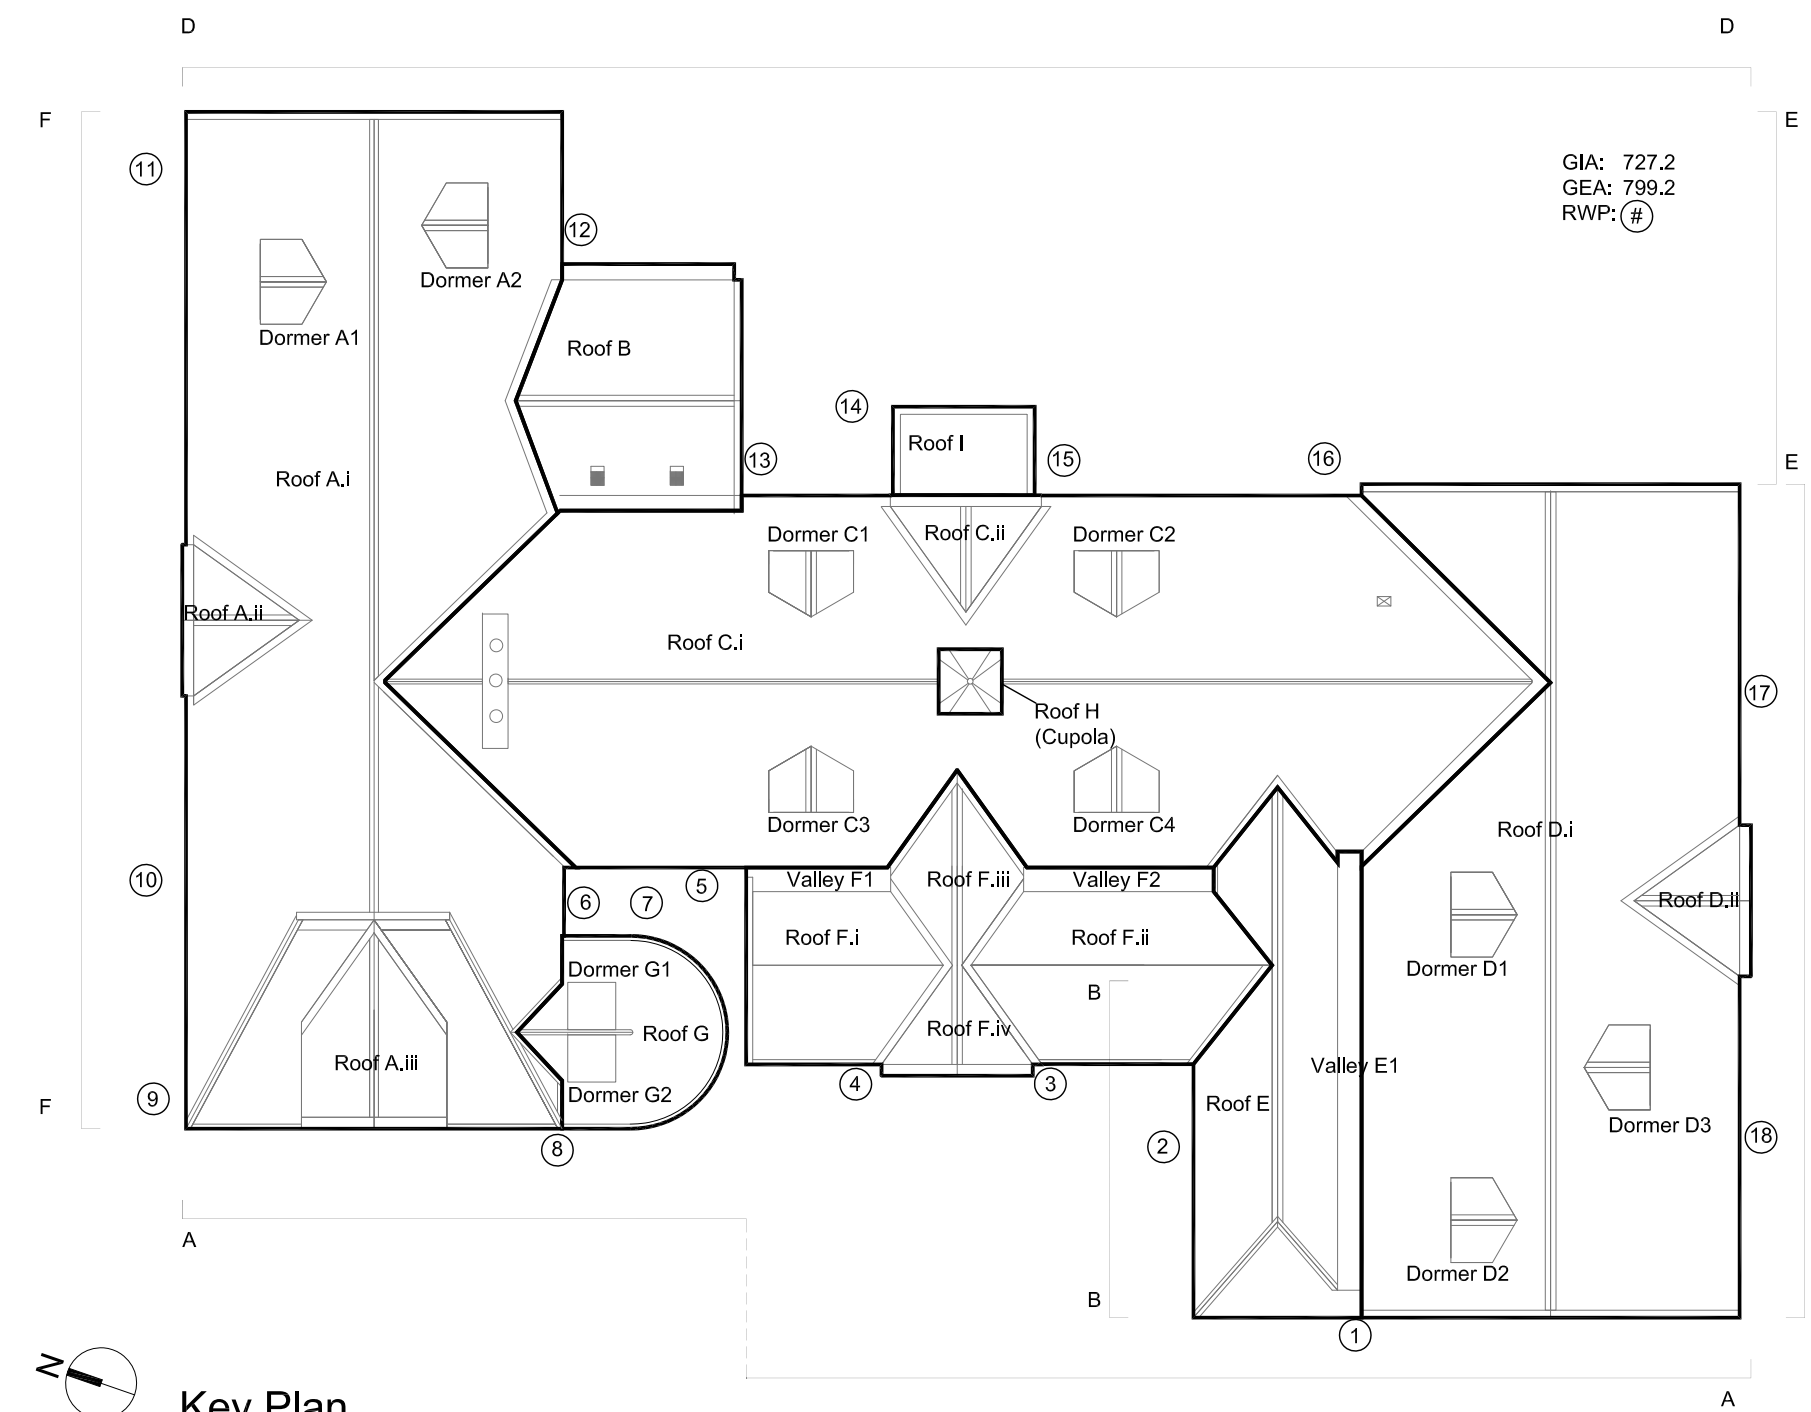
A2 Dormer wood paintwork worn; requires further inspection

Downpipe rusted; requires sanding down & repainting

- Dormer Window: 09 no.  
Splice in new timbers where appropriate. Access to be provided for detailed inspection and methodology agreed. Carefully sand down and repaint in appropriate materials as per the specification. Roofing section per detail F-F in drawing SMP-SEV-XX-XX-DR-A-03105 (Typical Dormer Window)

- Rainwater Goods: 18 no.  
Down-pipe to be removed and replaced with cast-iron rainwater goods allowing for increased diameter (8 inch) to mitigate increased rainfall. Existing cast-iron hoppers to be retained & refurbished where possible. Guttering per detail B-B in drawing SMP-SEV-XX-XX-DR-A-03100 (Typical External Gutter)
