| PROJECT | SMP - St Mary's CE Primary School |
| TITLE | Elevation AA - Demolition & Repairs |
| NUMBER | SMP-SEV-XX-XX-DR-A-03010 |

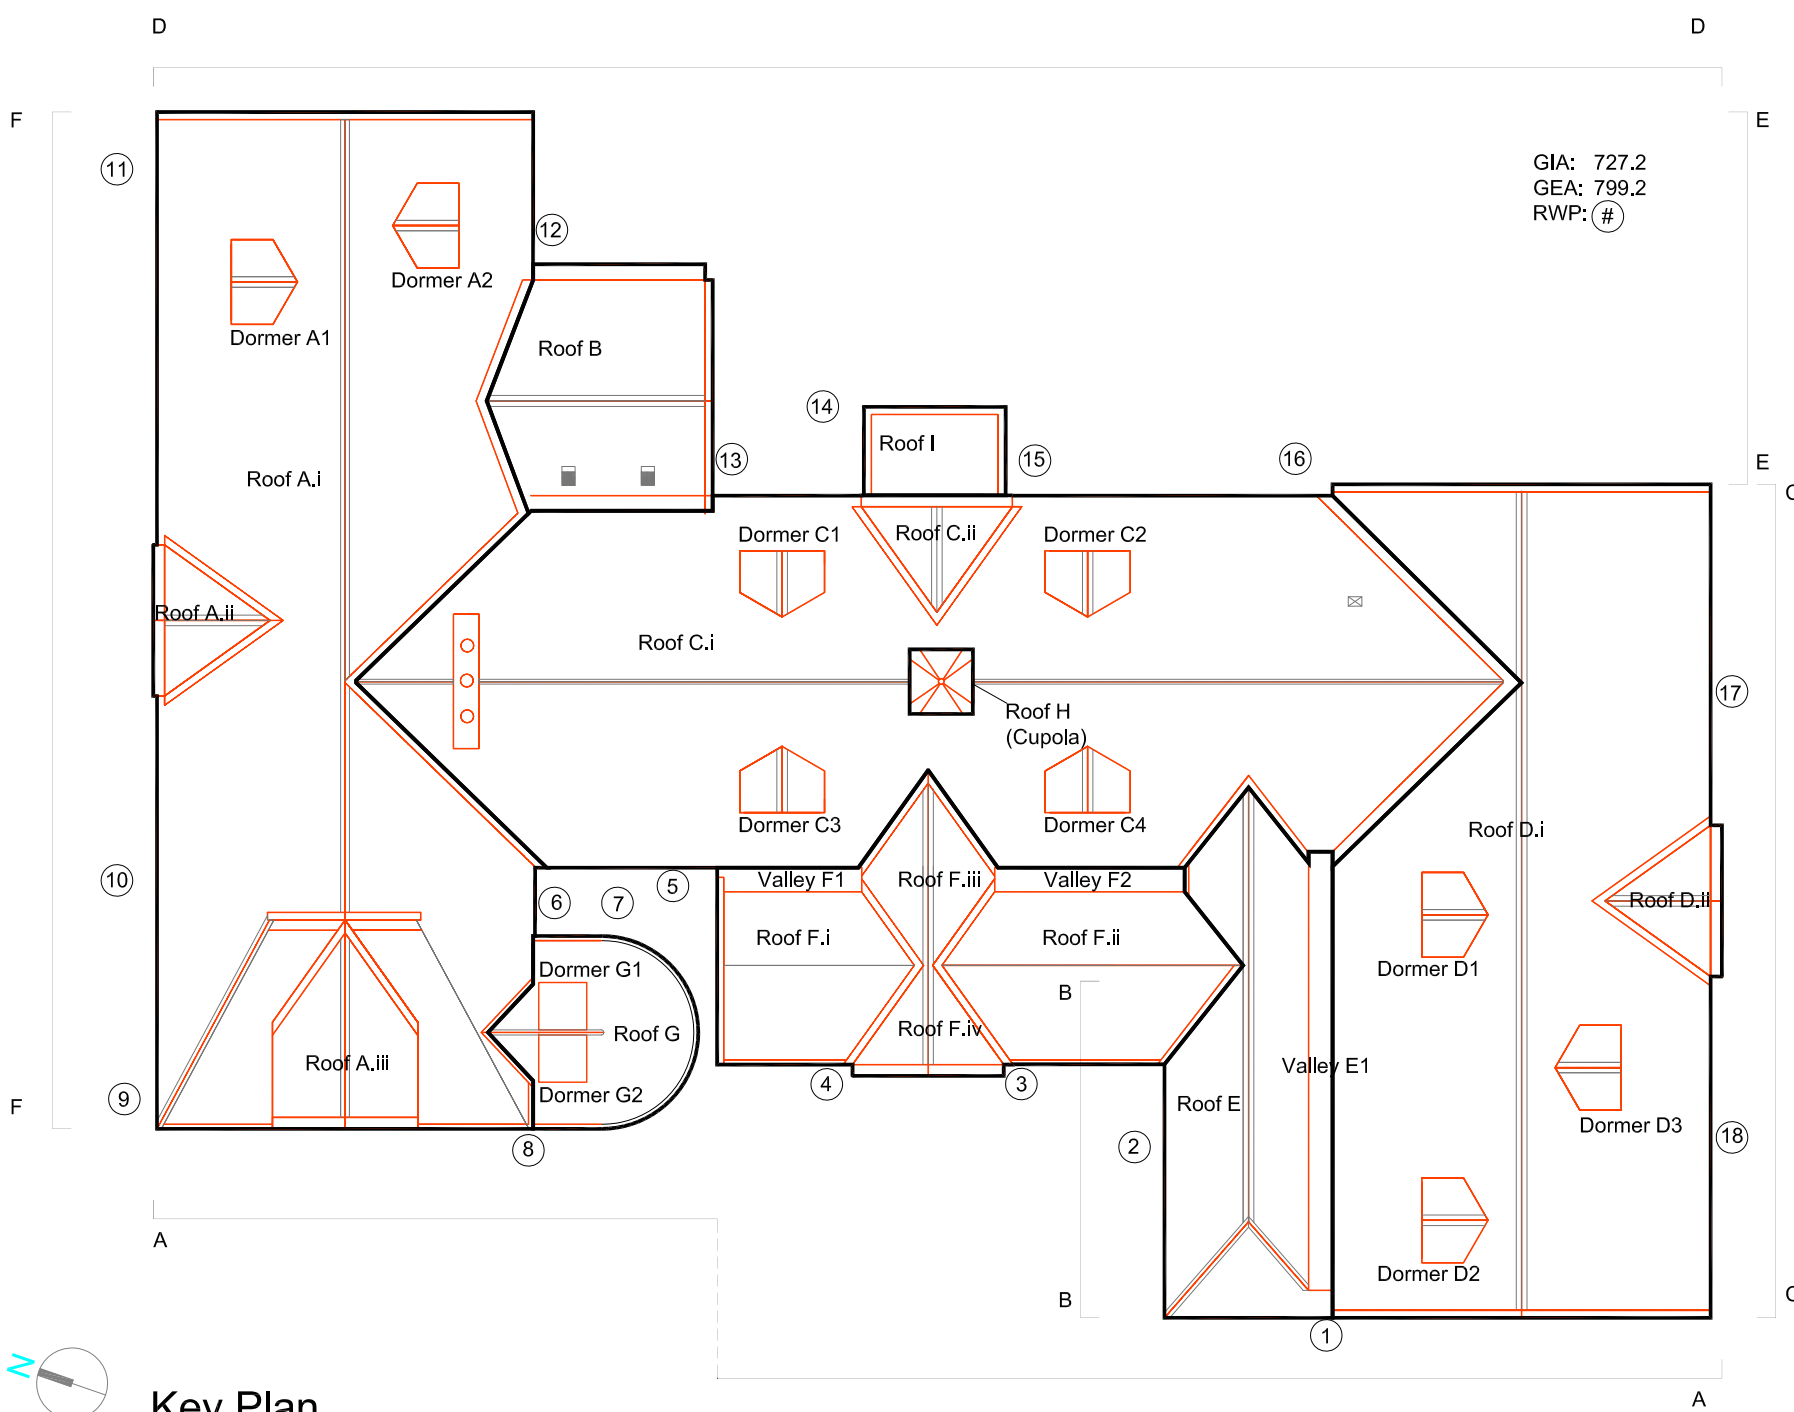
Elevation AA

Soil Vent Pipe

Gutter on opposite side (under Dormer G1) sagging, downpipe rusted

Lead Flashing under Ridge Tiles

Gutter Sagging

Missing tile covered with lead flashing; replace Tile.

Valley Gutter

- Rainwater Goods: 18 no.  
Down-pipe to be removed and replaced with cast-iron rainwater goods allowing for increased diameter (6 inch) to mitigate increased rainfall.  
Guttering per detail B-B in drawing SMP-SEV-XX-XX-DR-A-03100 (Typical External Gutter)

- Lead Flashing: 75 Lm  
Replace with new lead flashing where appropriate.  
Access to be provided for detailed inspection and methodology agreed.
- Ridge Tiles: 105 Lm  
Ridge tiles to be removed and set aside with salvaged tiles for re-use.  
Replace damaged tiles as per the existing style. Ridge ventilation provided with new linear vent.  
Ridge venting per detail F-F in drawing SMP-SEV-XX-XX-DR-A-03105 (Typical Dormer Window)

- Ridge Tiles: 50 Lm  
Ridge tiles to be removed and set aside with salvaged tiles for re-use.  
Replace damaged tiles like-for-like.
- Bat Slate: [Dashed Hatch Approx. Location, Solid Hatch Exact Location]  
Integrated Bat access slate: metal vent to allow access for bats into roof void, with sufficient gap cut into roof structure underneath. Fitted within a hole cut to slate which is placed over the vent to reduce visual impact. 1no. Bat Slate located in area of observed bat emergence (west wing of the building, facing north, adjacent to Dormer D2) and then 3no. supplementary 'enhancement slates' along remaining wings (north, east, south).
