| PROJECT | SMP - St Mary's CE Primary School |
| TITLE | Elevation DD - Demolition & Repairs |
| NUMBER | SMP-SEV-XX-XX-DR-A-03013 |

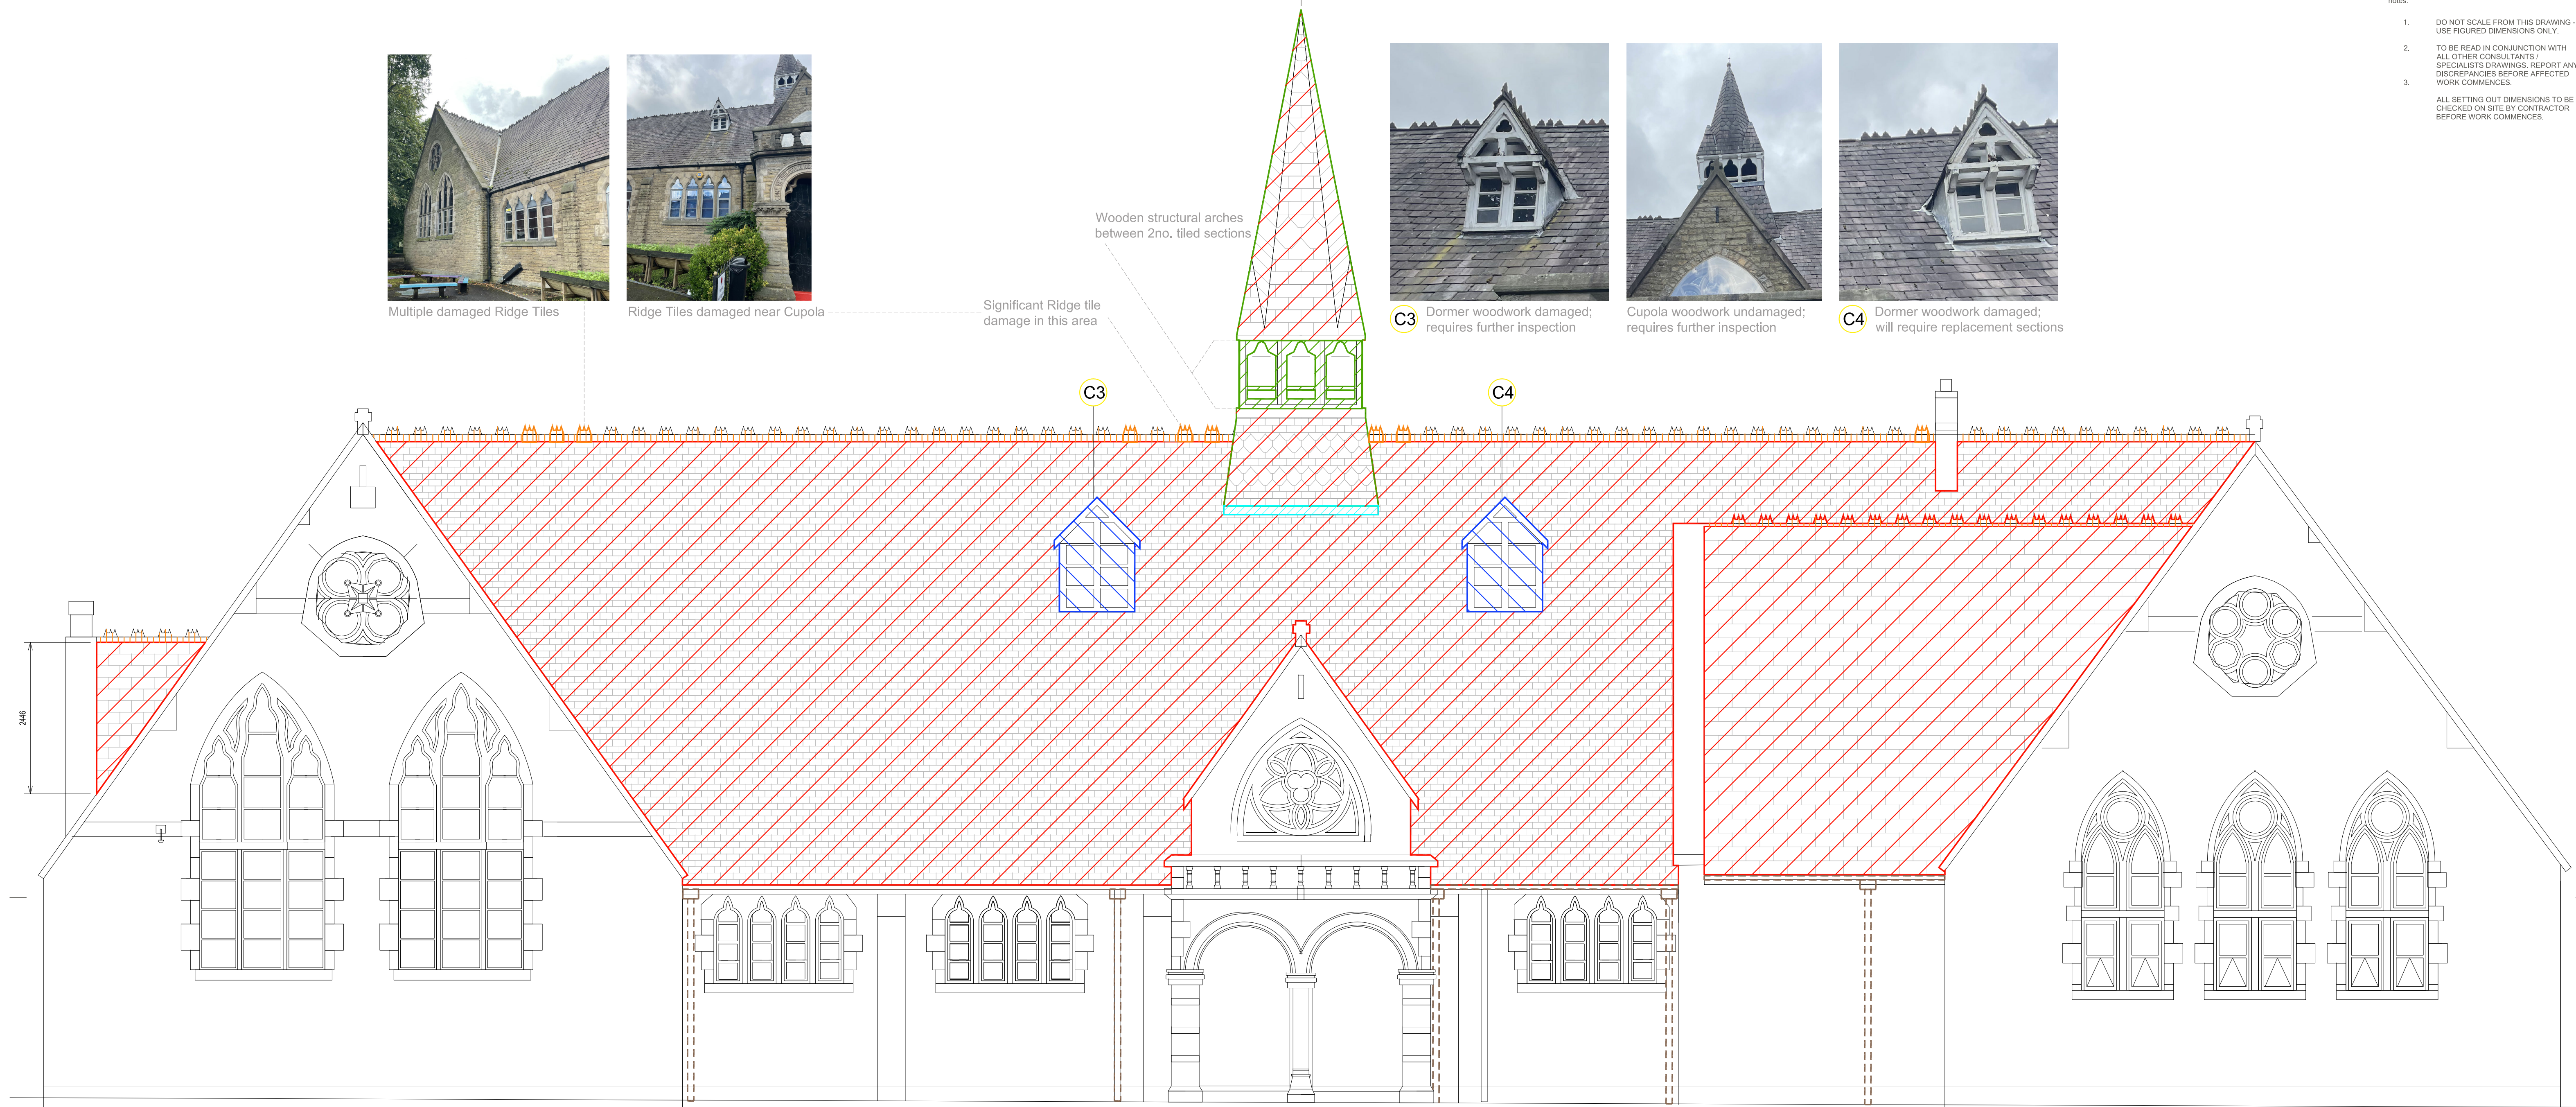
Elevation DD

C4 Dormer wooden structure damaged; will require replacement sections

- Dormer Window: 09 no.  
Splice in new timbers where appropriate. Access to be provided for detailed inspection and methodology agreed. Carefully sand down and repaint in appropriate materials as per the specification. Roofing section per detail F-F in drawing SMP-SEV-XX-XX-DR-A-03105 (Typical Dormer Window)

- Ridge Tiles: 50 Lm  
Ridge tiles to be removed and set aside with salvaged tiles for re-use.  
Replace damaged tiles like-for-like.
