**ENGINEERING REPORT 9179**

**ROBINSONS EQUESTRIAN CENTRE  
HARWOOD FIELD FARM  
CASTLE HILL ROAD  
BURY  
BL9 6UL**

**CLIENT: STEPHEN ROBINSON**

**24.11.2023 MP/CH**

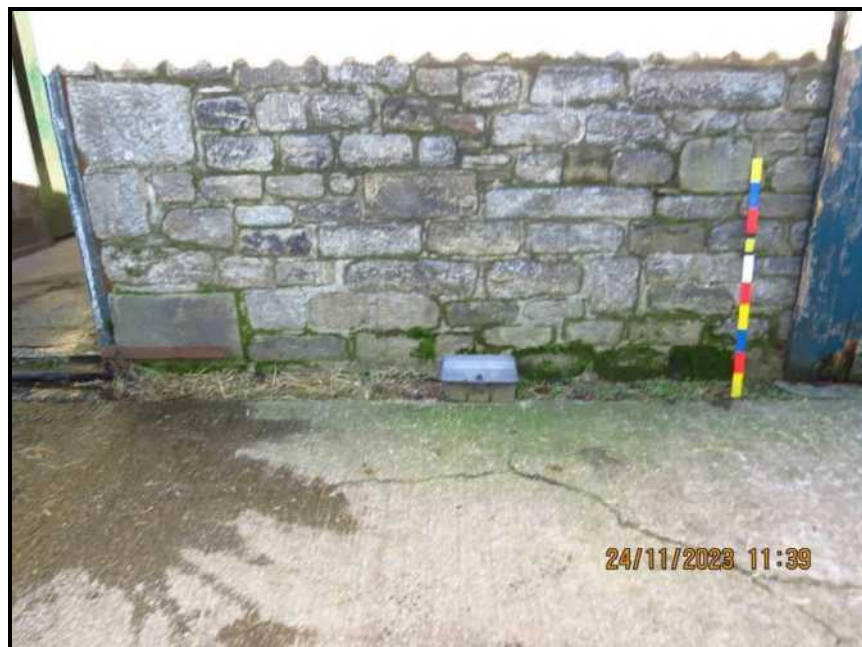
**Photograph 032 Plinth wall, chainage 10 – 7 metres**

- 3.5 The vertical alignment of the right hand door reveal (chainage 1.5 metres) is satisfactory. (Photograph 038).
- 3.6 The sliding door covers the main wall section between chainage 4 – 5 metres but overall vertical profile on either side of the doorway is satisfactory with good vertical alignment and satisfactory horizontal coursing. (Photographs 036, 037).
- 3.7 The adjoining stone panel (chainage 8 – 10 metres) is well pointing with satisfactory vertical alignment. (Photographs 032, 033, 034, 035).

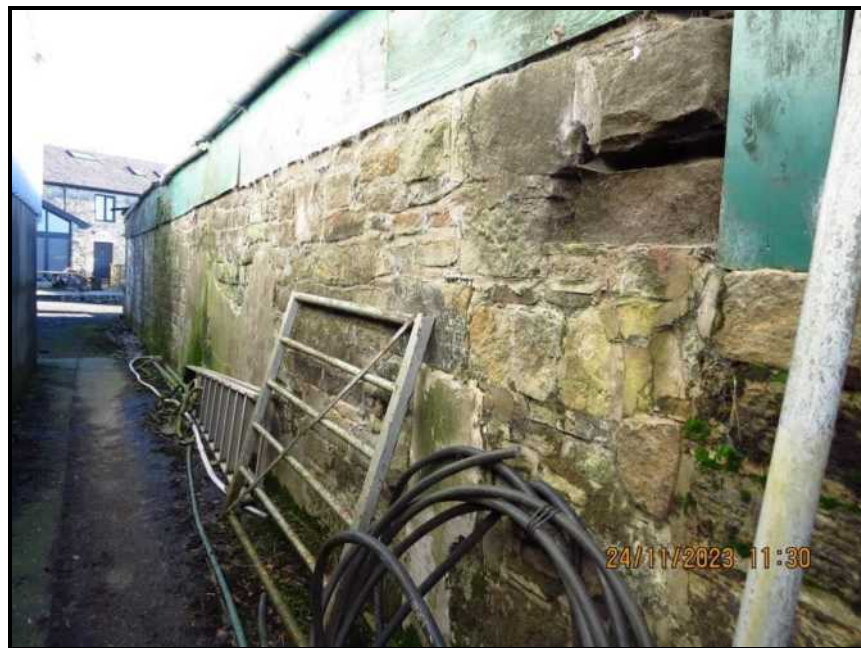
**Photograph 020 Rear elevation looking South East**

- 5.1 The North Eastern elevation extends for a length in the order of 15 metres in regular stone course of solid wall construction, a height in the order of 3 – 3.2 metres. (Photographs 012, 013, 014, 020).

- 5.3 The vertical alignment at chainage 7 metres is good with irregularities in the order of 7mm per metre.
- 5.4 The rear wall terminates with a vertical joint between the North Eastern section and the North Western section. (Photographs 019, 020).
- 5.5 Between chainage 8 – 12 metres the wall is completed with a 25mm rendered panel extending for a height between 1 – 1.2 metres and the rendering is generally in a satisfactory sound condition with good vertical alignment. (Photographs 015, 017, 018).

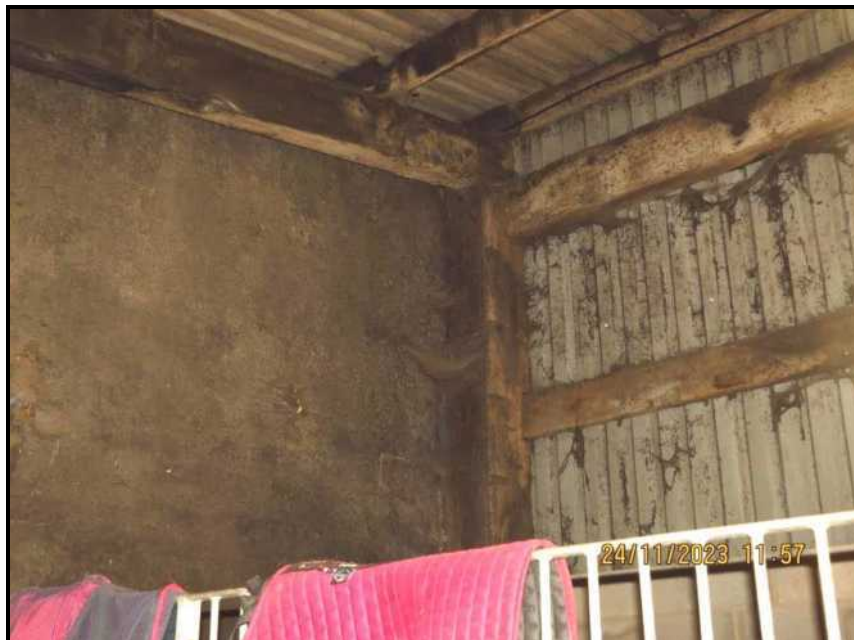
**Photograph 093 Outside of West wall**

- 6.1 The North Western half gabled wall currently acts as an internal party wall between stable units 1 and 2 to the East, and stable units 5 to 4 in the Western section (to be demolished).
- 6.2 The inspection of the Western outside face of the proposed gable elevation is limited with the existing usage (limited access).
- 6.3 The stone wall is completed with a flat cement render supporting the lateral purlin members, spanning from East to West towards the front elevation. (Photographs 093, 094 and photograph 090 towards the rear elevation).

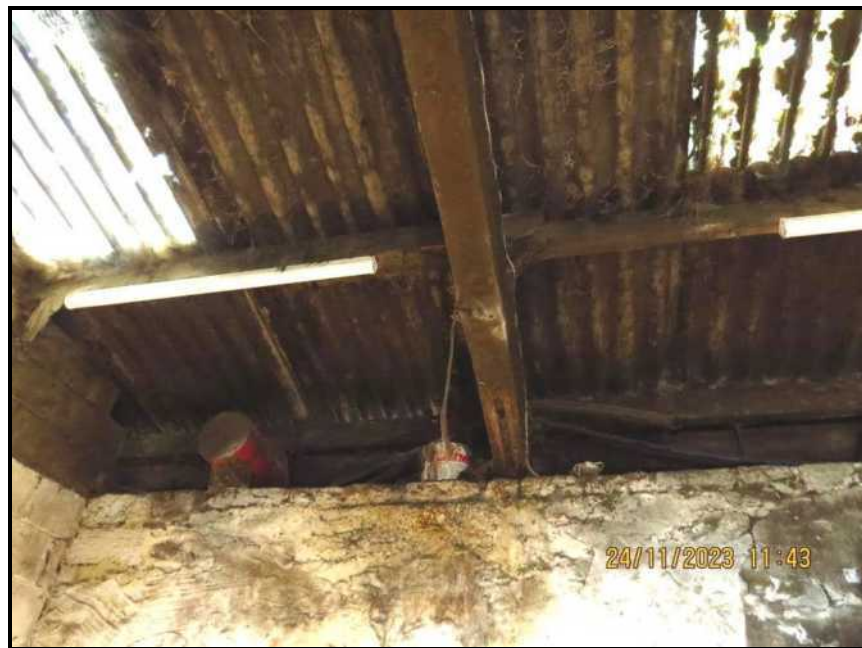
**Photograph 042 Rear wall rafter beam**

- 7.2 Stable No. 1 is sub-divided into three stalls adjoining the internal cross wall and the inside face of the Western half gable wall is completed with a random render finish. The render finish follows a satisfactory vertical profile, the wall supporting 400mm x 150mm rafters at wall plate level spanning from the rear elevation to the front elevation. The Eastern gable wall supports the lateral purlins spanning from East to West. (Photographs 040, 041, 042).

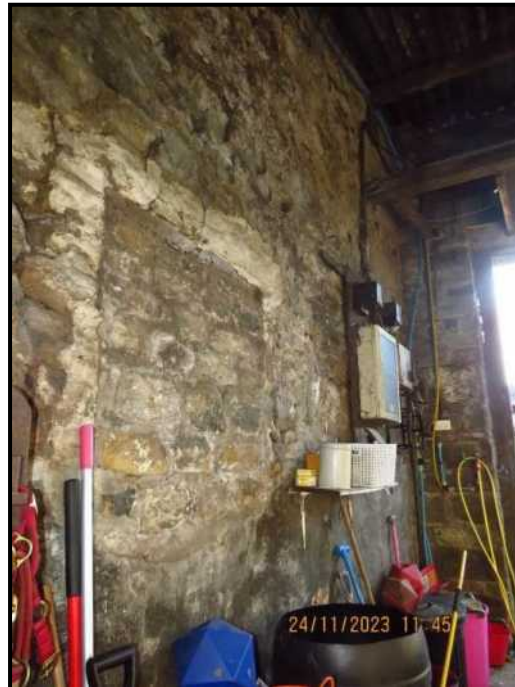
**Photograph 053 Former window, internal corner South/East**

- 7.4 On the inside face of the gable elevation the infilled window opening as identified externally can be traced in the wall finishes with no evidence of any recent movement. (Photographs 053, 054, 055).

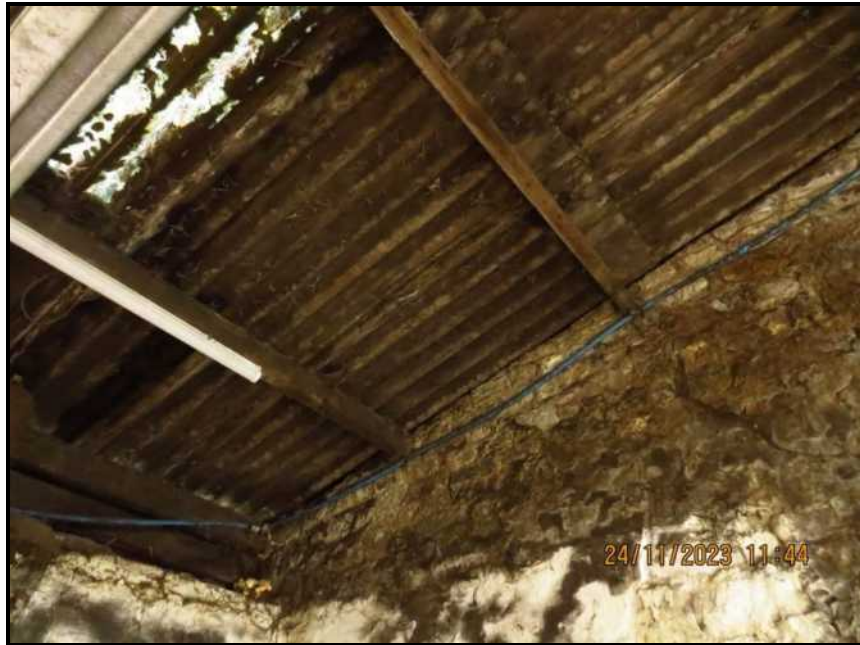
(Photograph 045 Purlin seating Eastern gable)

- 7.5 There are no signs of any separation where the purlins seat into the gable wall. (Photographs 045, 047, 50, 051).

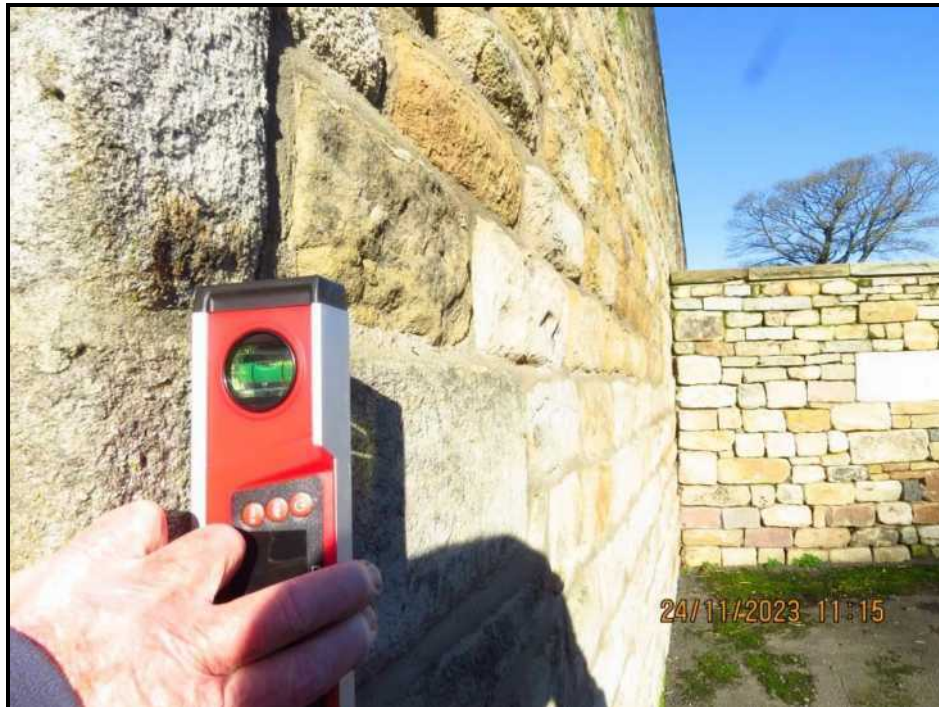
003 Satisfactory vertical alignment

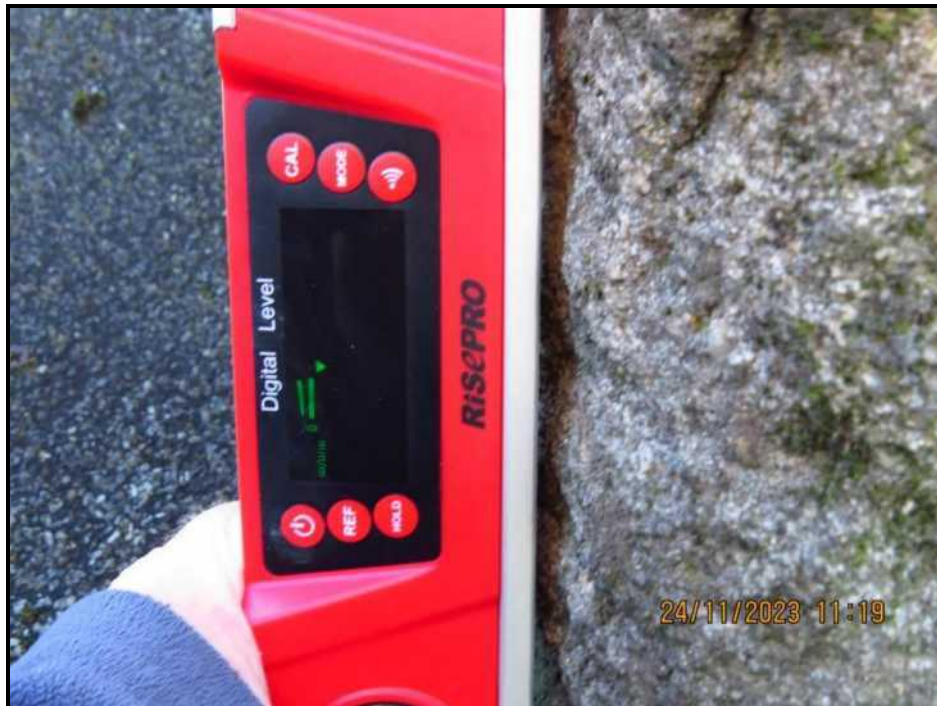
007 Satisfactory vertical alignment 5mm per metre

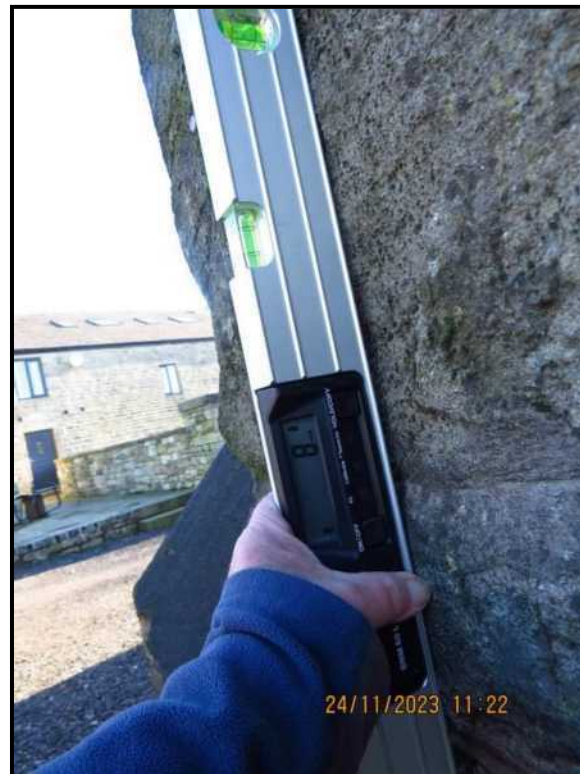
- 5.2 At chainage 0.5 metres the vertical alignment is in the order of 8mm per metre with a 7mm per metre at chainage 4 metres. (Photographs 010, 011).

010 Good vertical alignment 8mm per metre

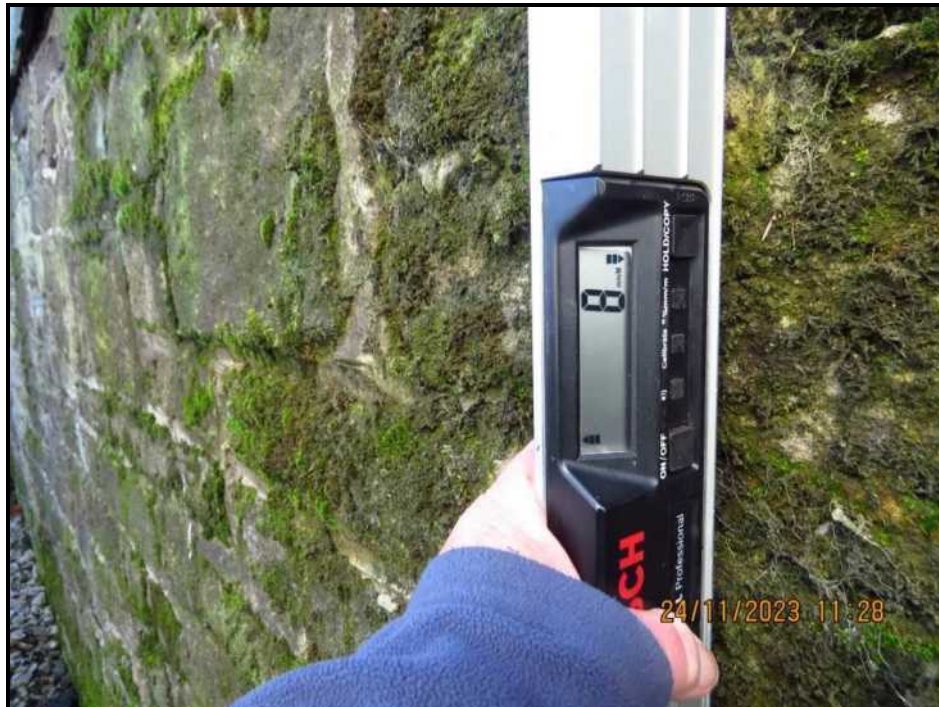
016 Satisfactory vertical alignment, chainage 12 metres

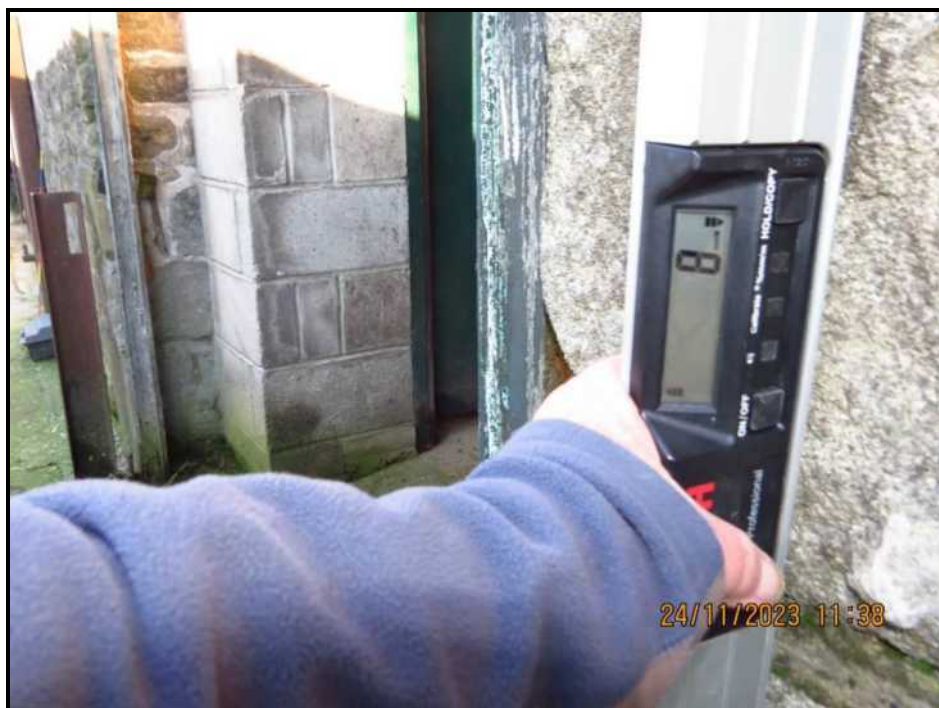
031 Good vertical alignment

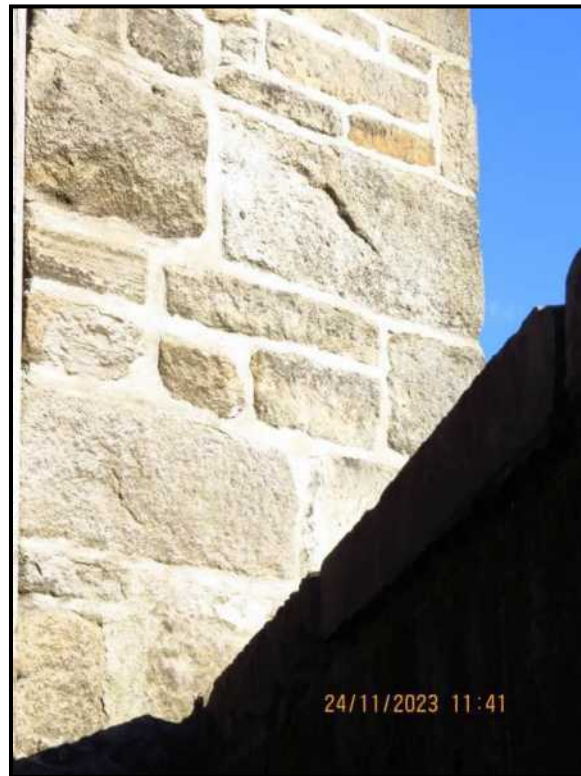
039 South Eastern corner, chainage 1.2 – 0 metres

- 3.4 On the front right hand corner of the doorway (0 – 1.5 metres) the stonework and pointing are in good order with good vertical alignment to the front face of the quoin detail with irregularities in the order of  $\pm$  5mm per metre. (Photograph 039).

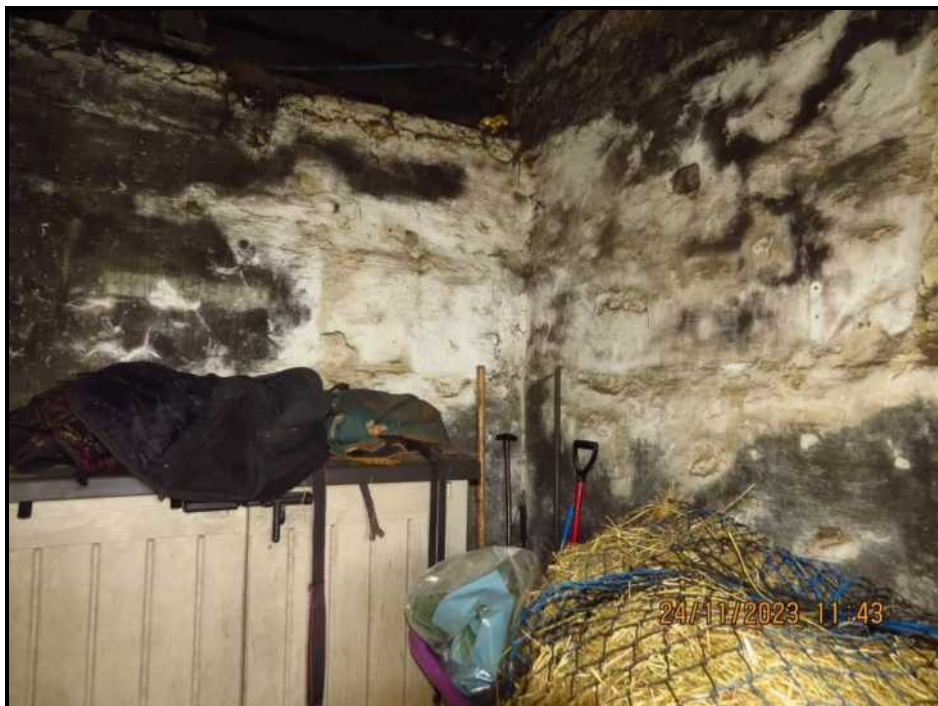
044 Lower wall, Northern corner

- 7.3 There are no signs of any separation where the rear wall adjoins the return half gable Eastern elevation. (Photographs 043, 044).

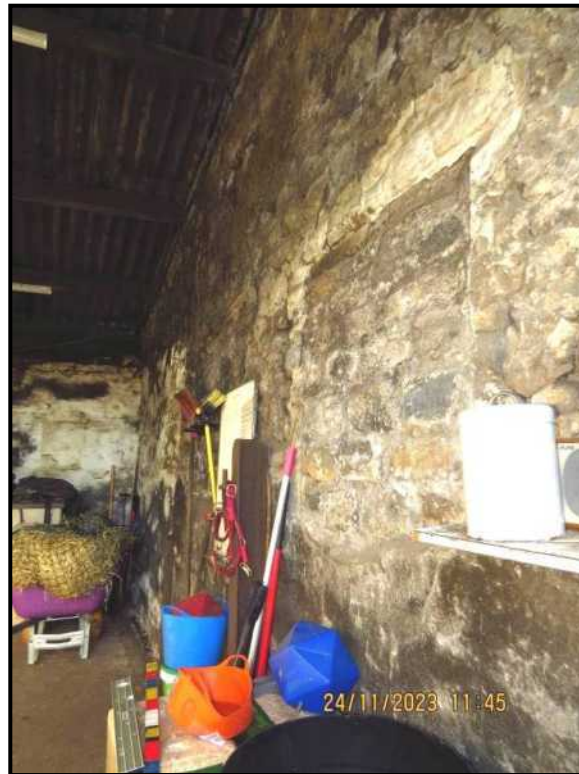
054 Gable elevation looking to rear

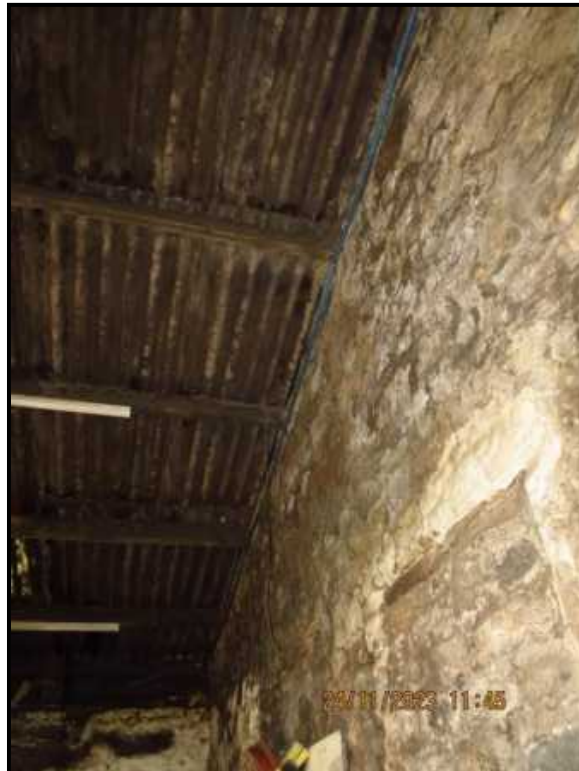
055 Gable elevation looking to rear

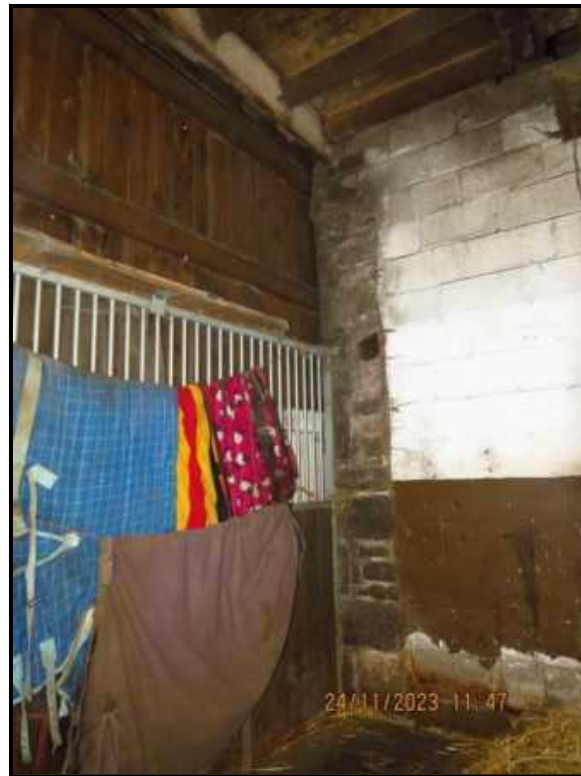
- 7.6 In the front stall the roof incorporates 300mm x 150mm joists spanning longitudinally onto a blockwork seating.
- 7.7 The vertical and horizontal alignment of the internal cross wall is good and the blockwork and pointing in very good condition.
- 7.8 Parallel to the front wall there are suspended beams supporting a timber platform between the gable and the internal cross wall. (Photographs 056, 057, 058).

058 Front elevation and internal cross wall

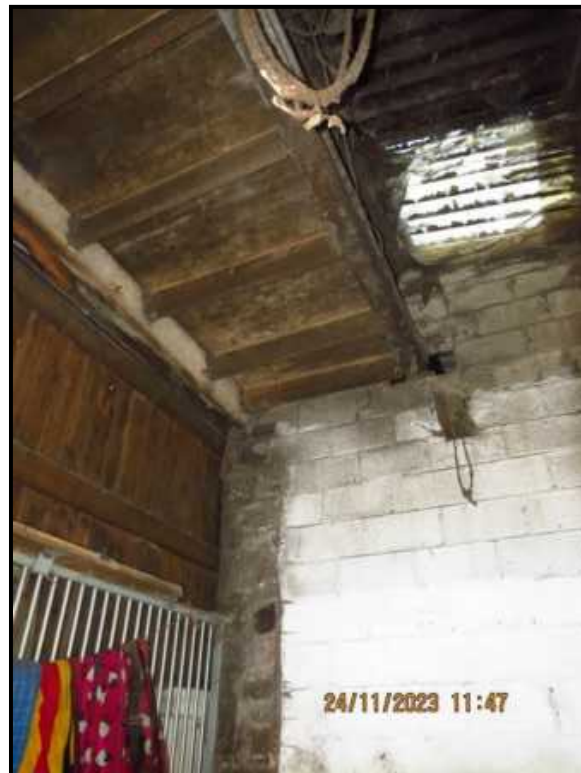
059 Front elevation, upper roof and cross wall

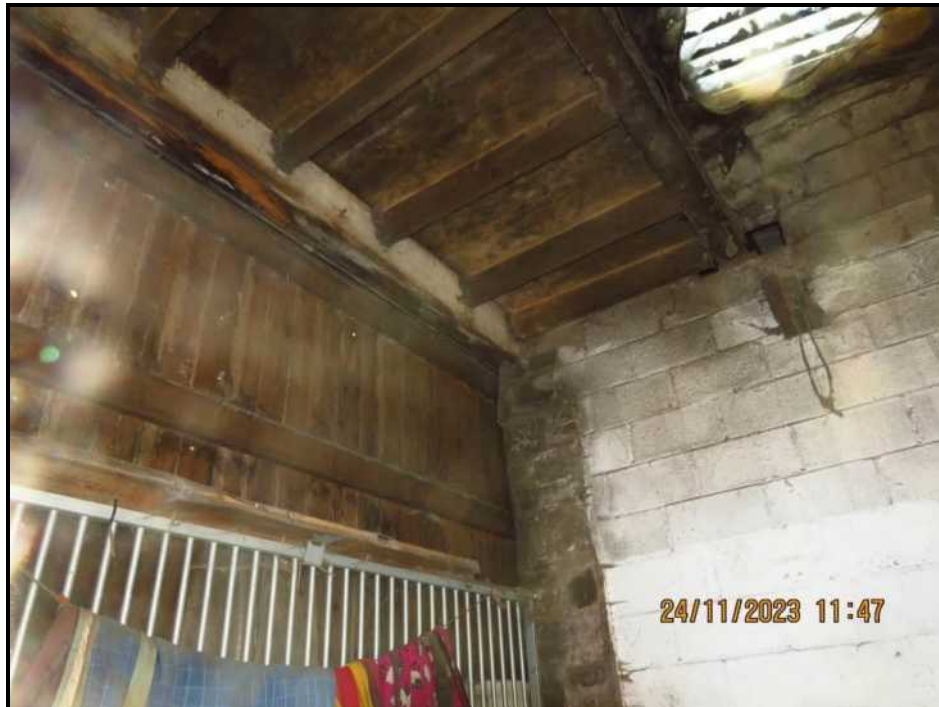
060 Front elevation, upper roof and cross wall

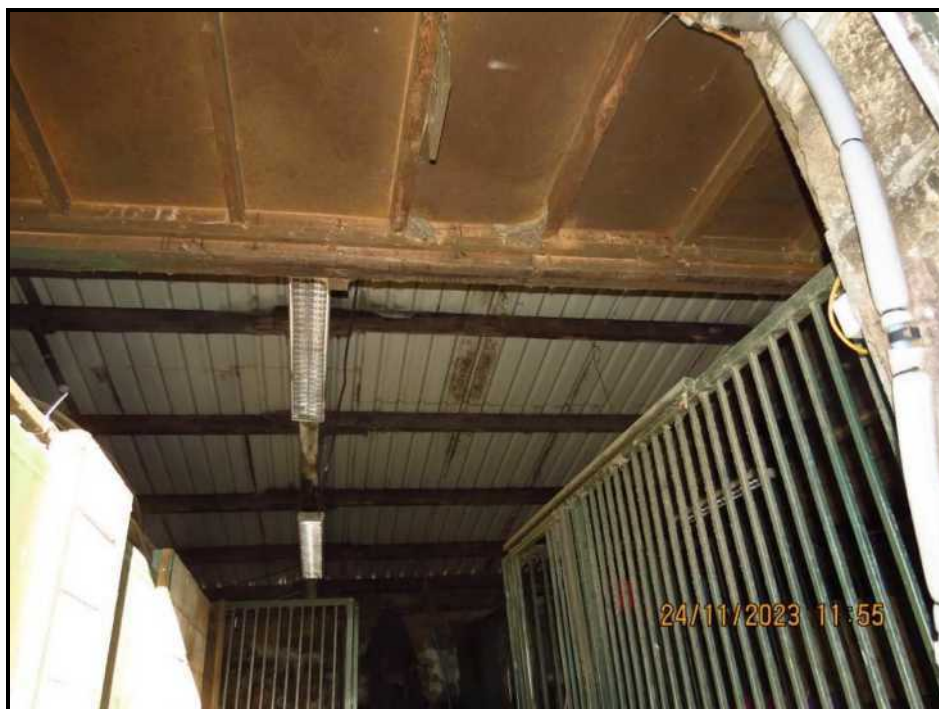
088 Roof, front elevation

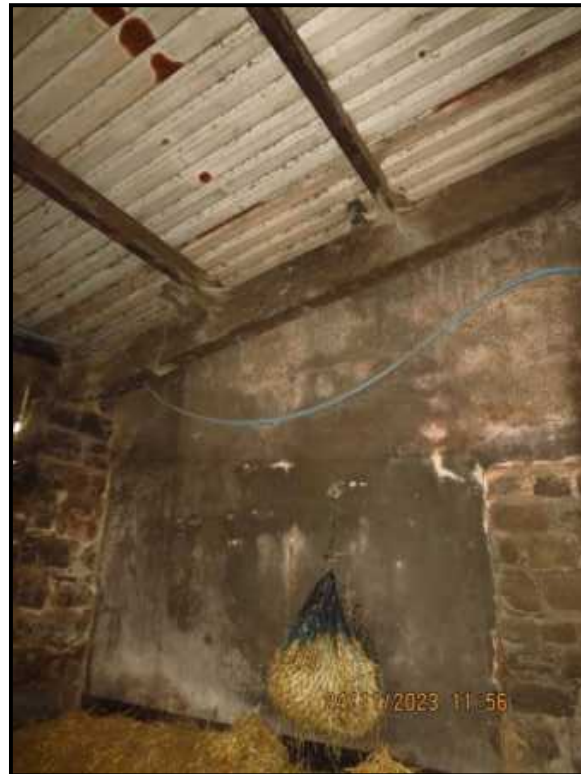
090 'Outside' of Western wall

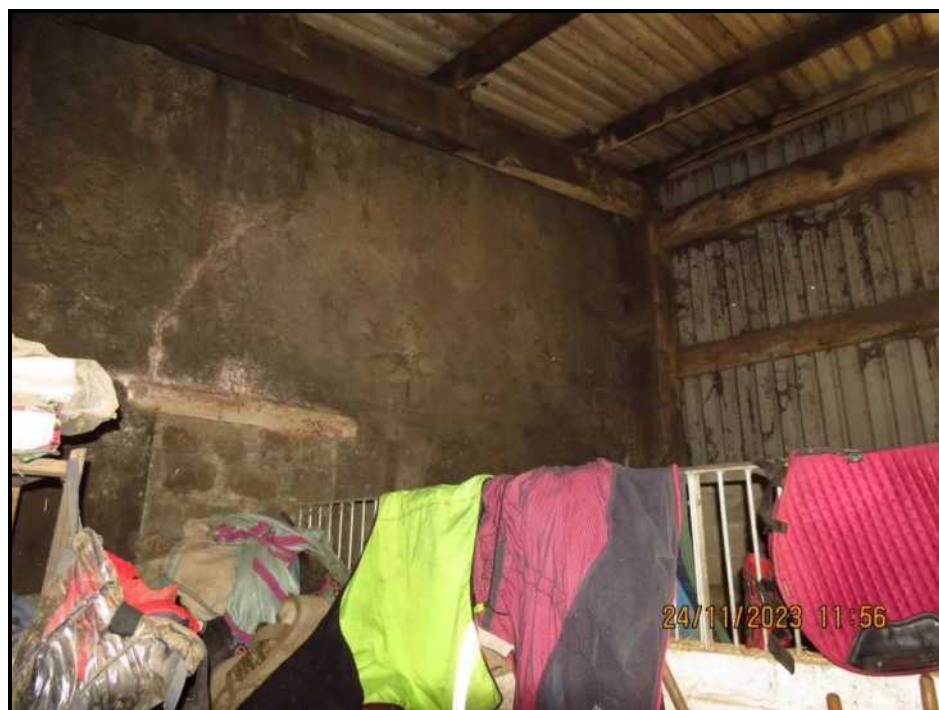
092 'Outside' of Western wall
