LAND AT GREENBOOTH ROAD  
NORDEN  
ROCHDALE

GEOENVIRONMENTAL RISK  
ASSESSMENT & REMEDIATION  
STRATEGY

**Job Number:** LKC 20 1618

**Date:** September 2020

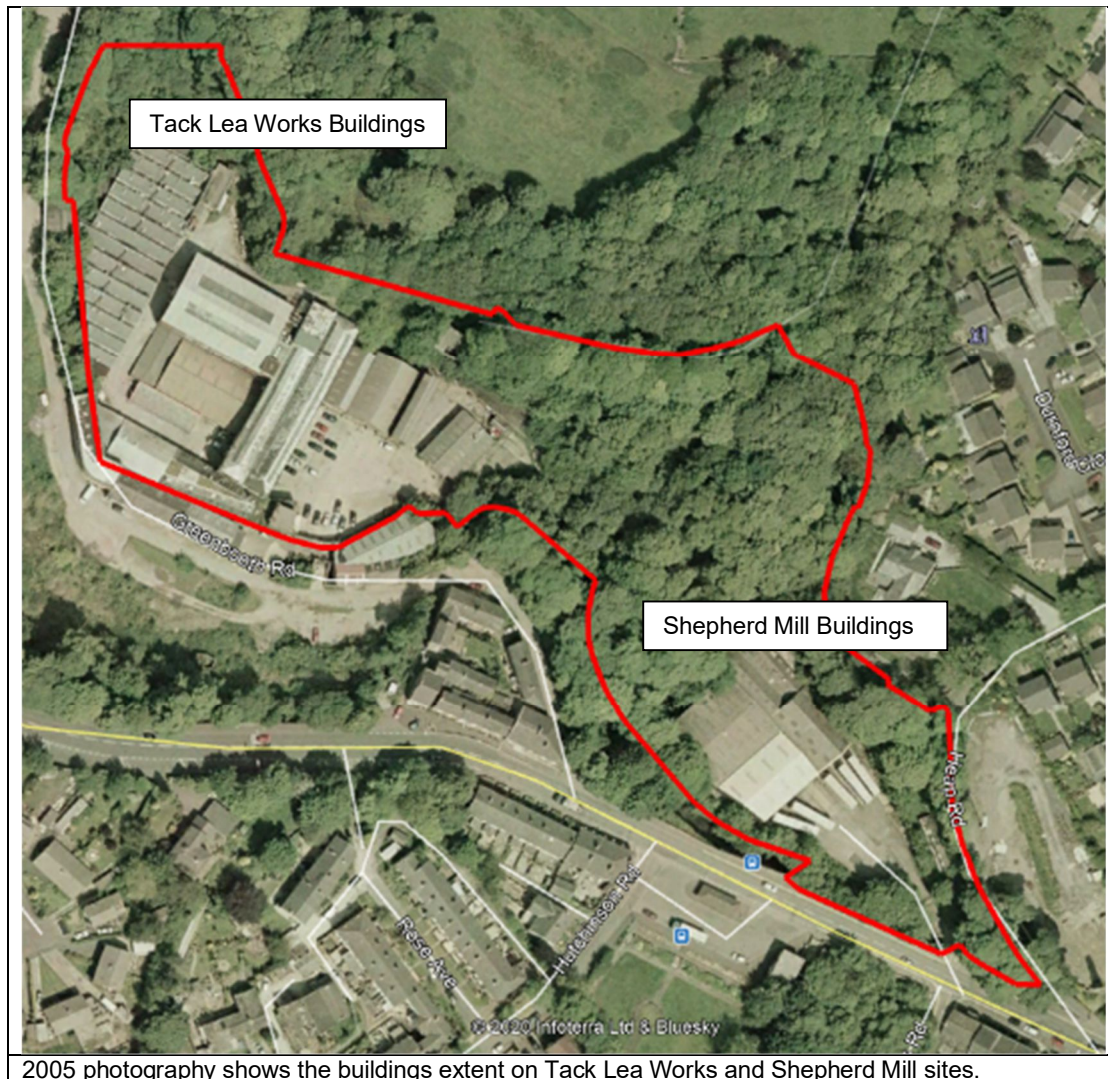
Plate 2-2: Extract from Google Earth Imagery 2005 © Google 2020

2005 photography shows the buildings extent on Tack Lea Works and Shepherd Mill sites.

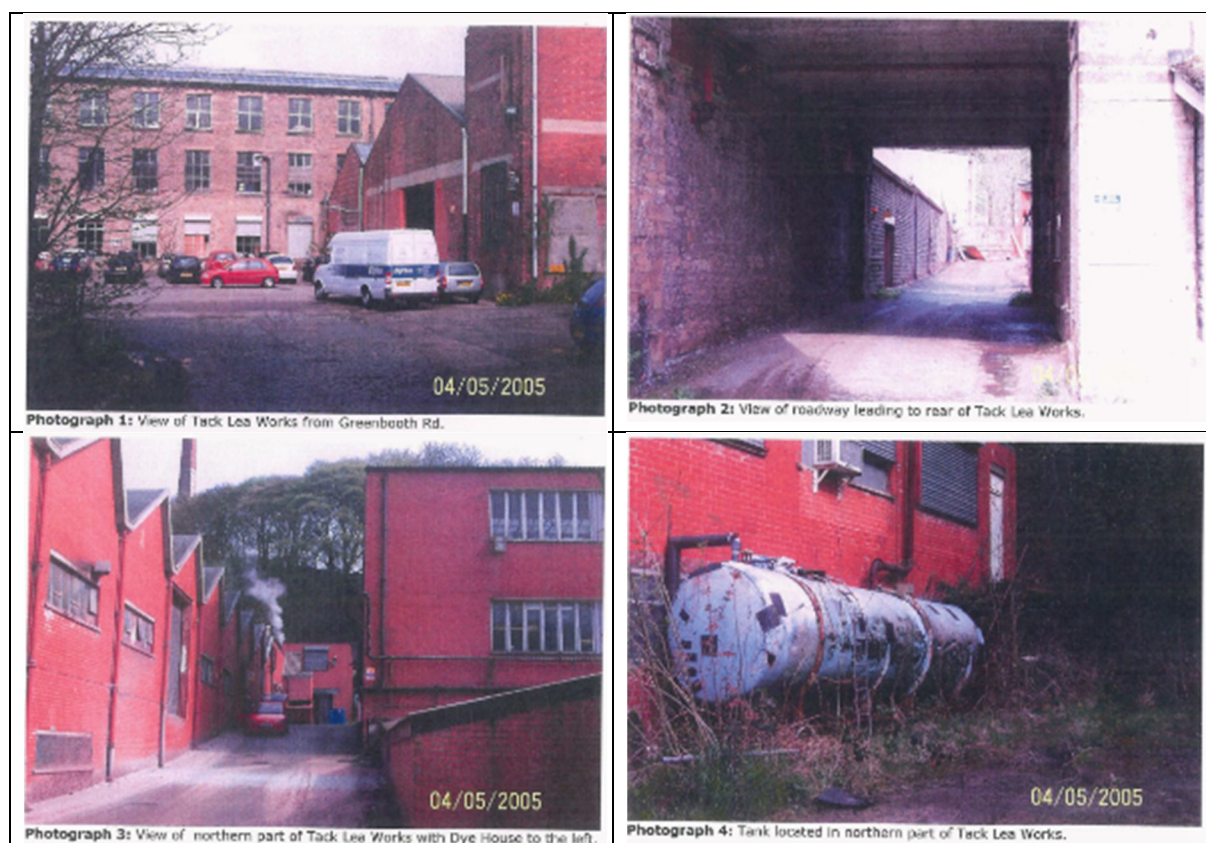
Plate 2-5: Extract from Encia report of site reconnaissance of Tack Lea Works and Shepherd Mill.

- 2.2.5 Access to the site is from Greenbooth Road located to the south east of the site. A stone bridge is present crossing the Naden Brook at the site entrance. A large concrete surfaced car park fronts the main mill building which comprises a three storey warehouse of mixed brick and stone construction with slate roofing. The dying and finishing works are located to the west of the main mill building. A narrow roadway leads to the rear of the buildings where a large storage tank and containers of dye stuffs, peroxides, antimony based chemicals and general bleaching chemicals were noted to be stored.

- 2.2.7 The northern part of the Tack Lea Works site is occupied by a steep hillside, vegetated by grass and mature trees with outcrops of sandstone and siltstone. The hillside rises up towards the north, with an approximate increase in elevation of 20m from the valley floor. A pond was previously located on the hillside. It was noted during the site walkover that the pond was dry and that the pond base had in fact been lined with concrete.

- 2.2.8 Immediately north of the mill building is a large disused coal bunker and hopper which were formerly used to supply the mill's coal fired boilers. A chimney located on the hillside approximately 50m to the north of the site boundary was used to release smoke emissions from the boilers via a 1.5m high brick constructed 'flue' which runs from the old boiler house, north over the hillside to the chimney. The flue was noted to have a large volume of ashy deposits inside.

- 2.2.9 The old boiler house, located in the eastern part of the mill building, was noted to now house an electricity sub-station and above ground fuel tank.

- 2.2.17 To the north east of the car park and industrial unit lies a steep, densely vegetated slope. There is an approximate change in elevation of 15m from the car park to the hilltop. A 2.5m high brick retaining wall is located at the base of the slope. The wall appeared to be in poor condition.

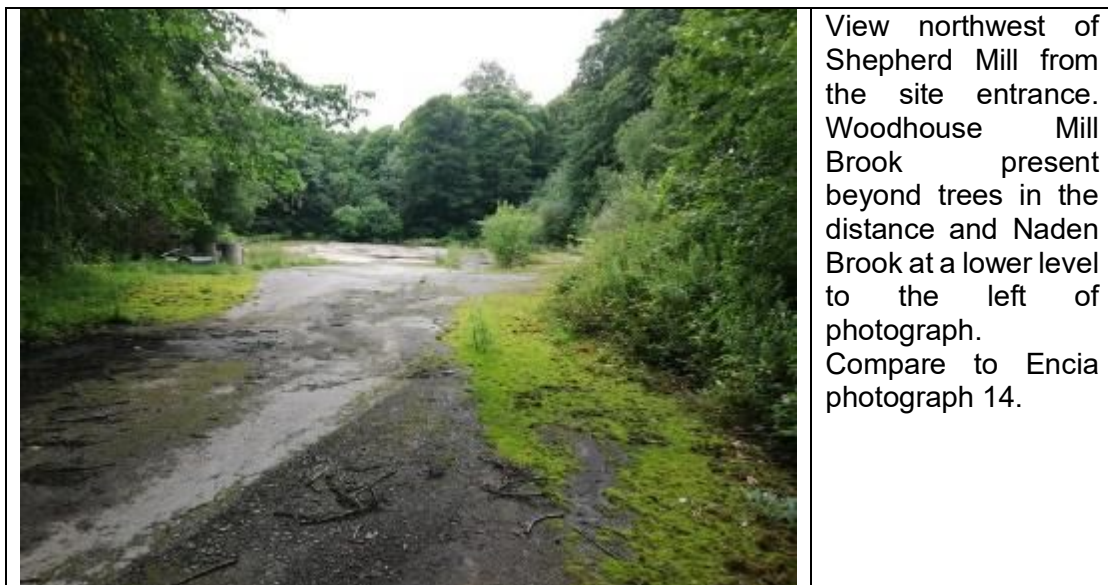
It was noted the Shepherd Mill site had been cleared of buildings. Hardstanding remained and the north eastern and western boundary (with Woodhouse Mill Brook beyond) were heavily vegetated.

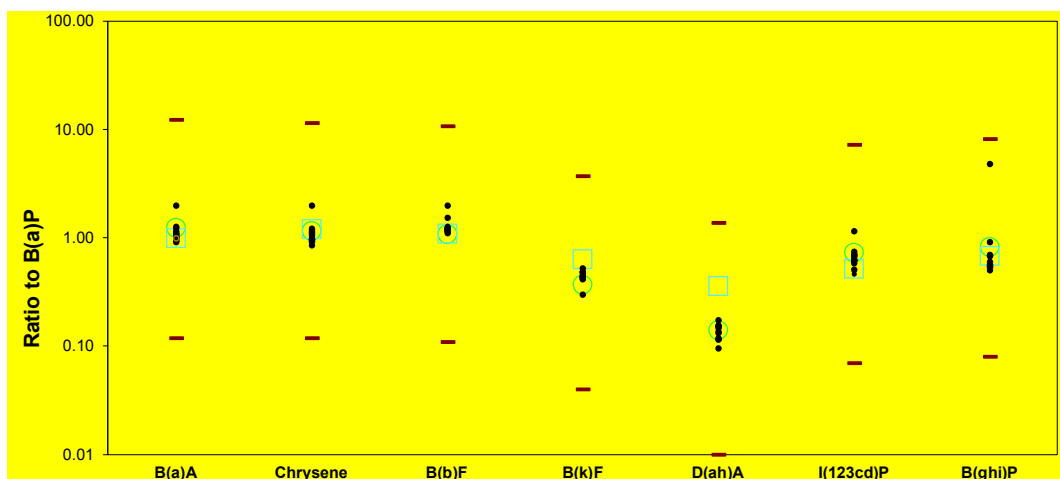
Graph 5-1: The ratio of PAH to B(a)P in soil for all available data at the site based on 15 samples (where values were >LOD to allow the calculation of a ratio).
