Validation Report  
Land off Don Street, Middleton

Reference: 14-554-R8-3  
Date: February 2025

# REMEDIATION AND ENABLING WORKS VALIDATION

Land off Don Street  
Middleton  
Greater Manchester  
M24 2DB

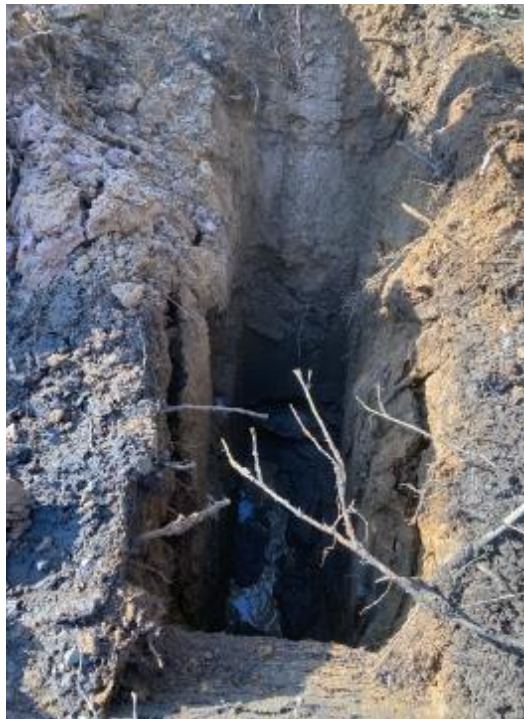
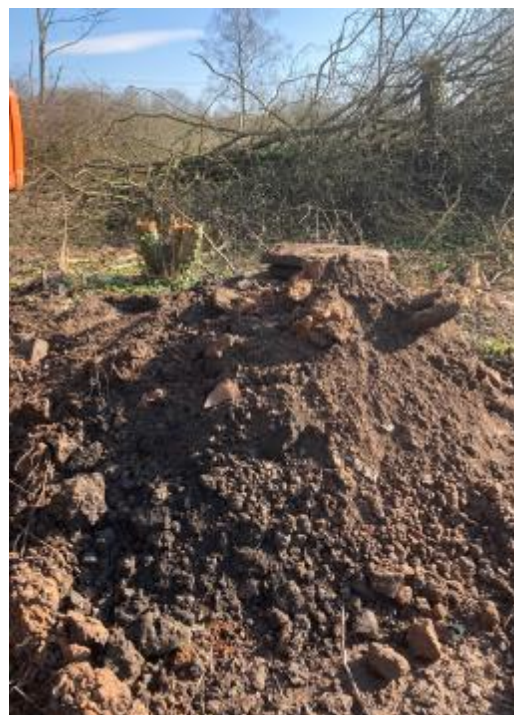
PLATE 2 SUPPLEMENTARY TRIAL PITTING PHASE 1 (AREA 2)

| Within Areas 1-4, as shown on Figure 4.1 overleaf, multiple phases of supplementary trial pitting were undertaken on the 8 <sup>th</sup> and 9 <sup>th</sup> of February 2022, 8 <sup>th</sup> of March 2022 and 10 <sup>th</sup> May 2022 to record ground conditions and obtain geotechnical and geochemical samples. Additional investigation of potential peat deposits in Area 3 (Phase 2A) were undertaken within these phases of supplementary trial pitting. The further investigation did not identify any true peat deposits, only very soft to soft clays with a shear strength value (Cu) of less than 30 kN/m <sup>2</sup> , the material is not suitable for vibro stone columns and requires removal with granular replacement during remedial works in this area. |

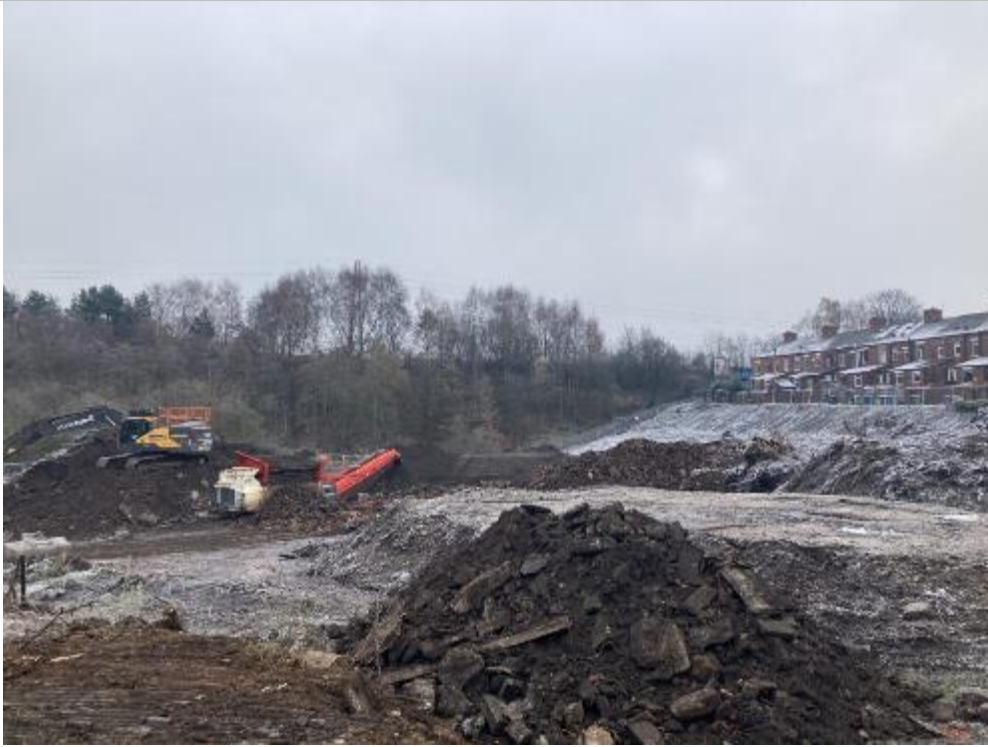
PLATE 31 PROCESSING OF MADE GROUND PHASE 3 (AREA 5)

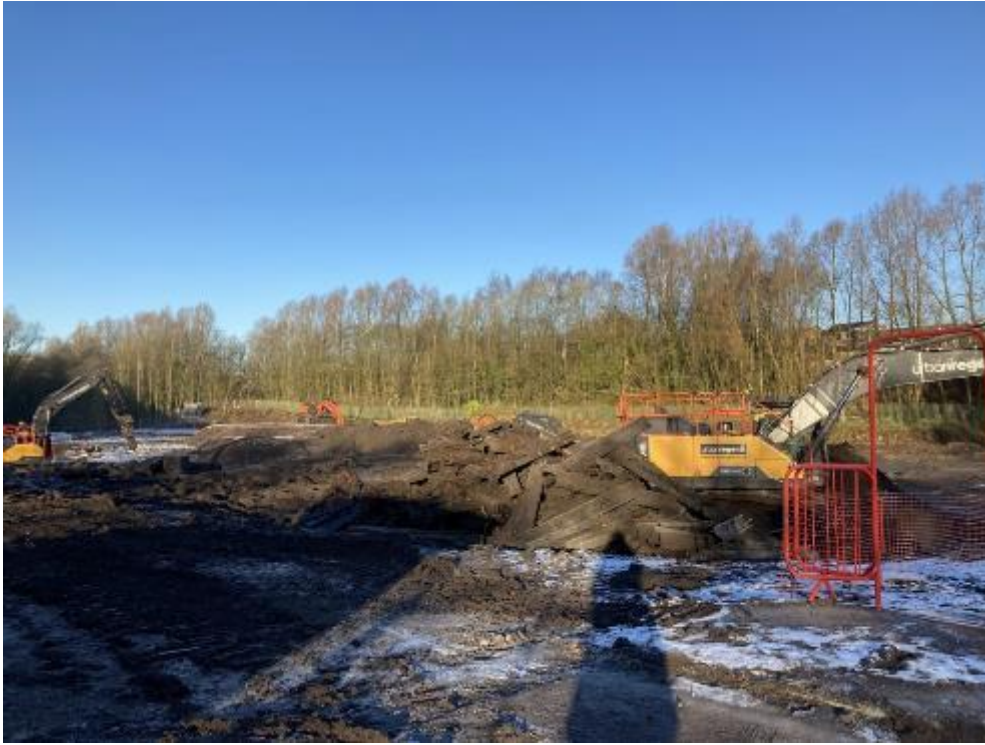
PLATE 33      BREAKING AND PROCESSING OF ABOVE AND BELOW GROUND STRUCTURES  
PHASE 1 (AREA 1)

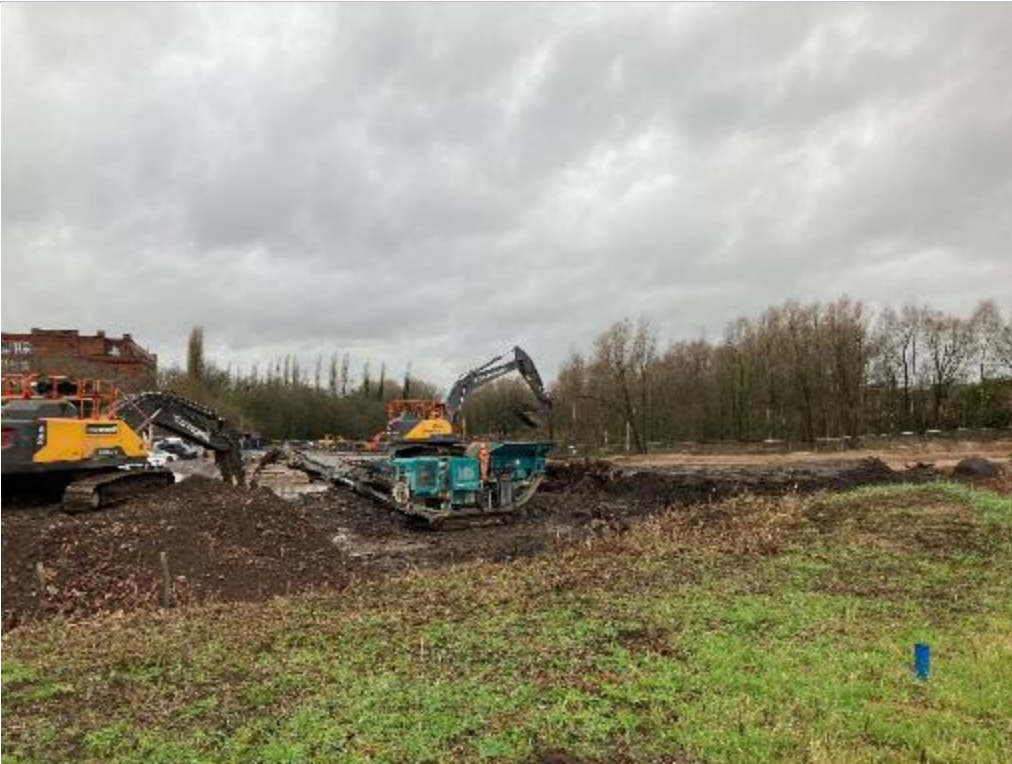
PLATE 34      PROCESSING OF MADE GROUND (AREA 2A)

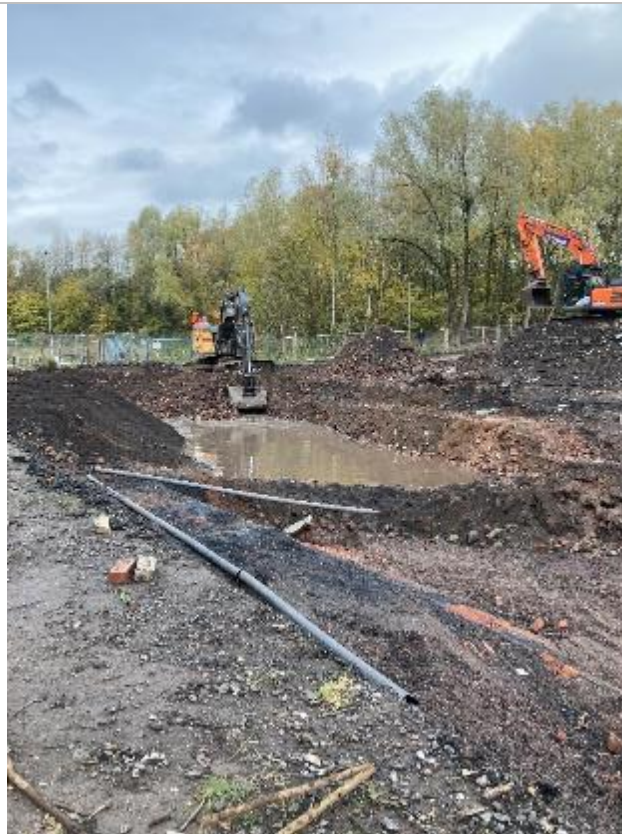
PLATE 35      BREAKING AND PROCESSING OF ABOVE AND BELOW GROUND STRUCTURES  
PHASE 1 (AREA 2A)

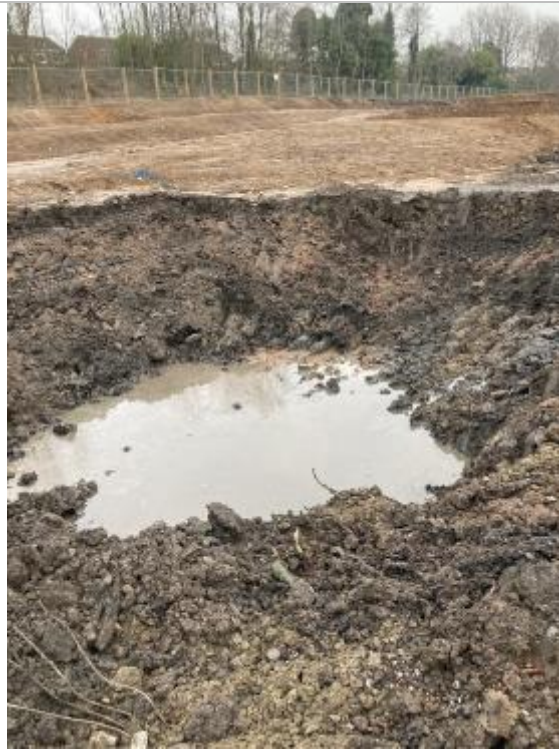
PLATE 37      SUPPLEMENTARY TRIAL PITTING OF IMPACTED SOILS

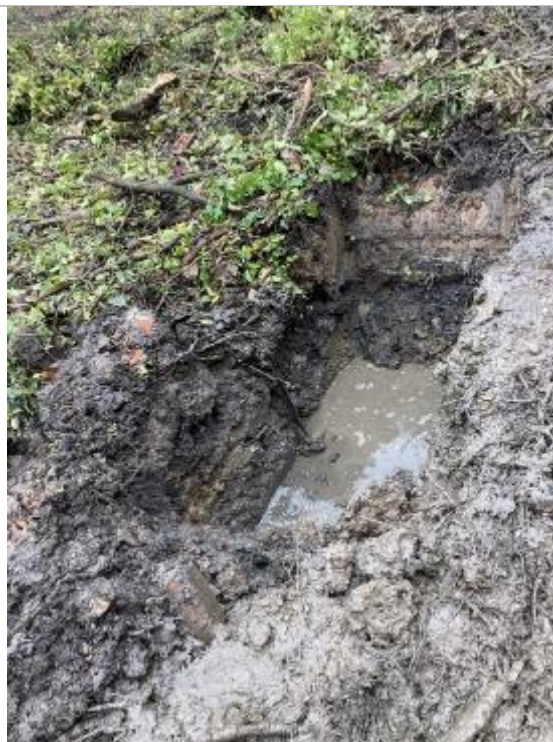
PLATE 38      SUPPLEMENTARY TRIAL PITTING OF IMPACTED SOILS

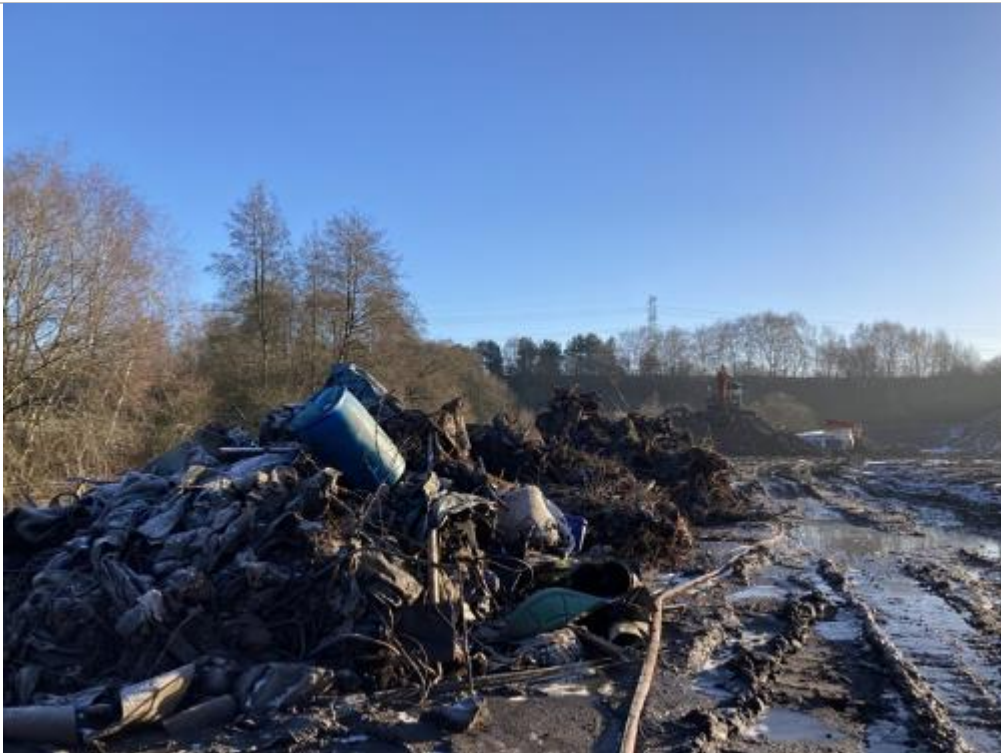
PLATE 44 REMOVAL AND SEGREGATION OF WASTE

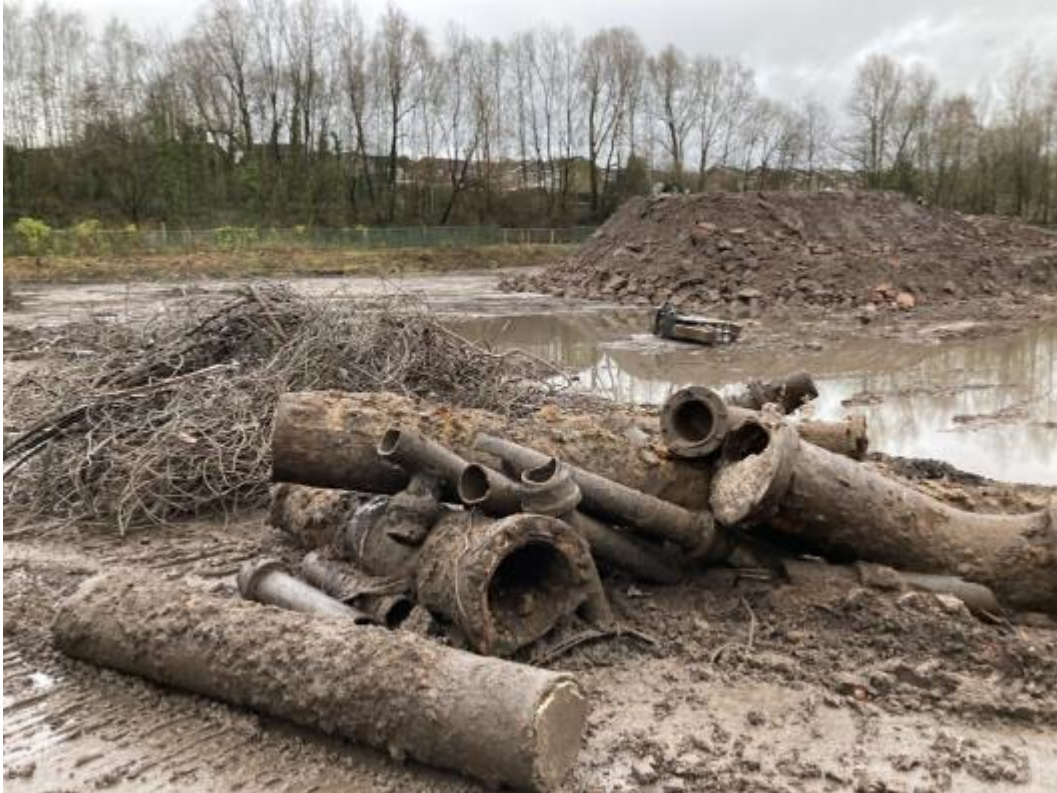
PLATE 45      REMOVAL AND SEGREGATION OF WASTE

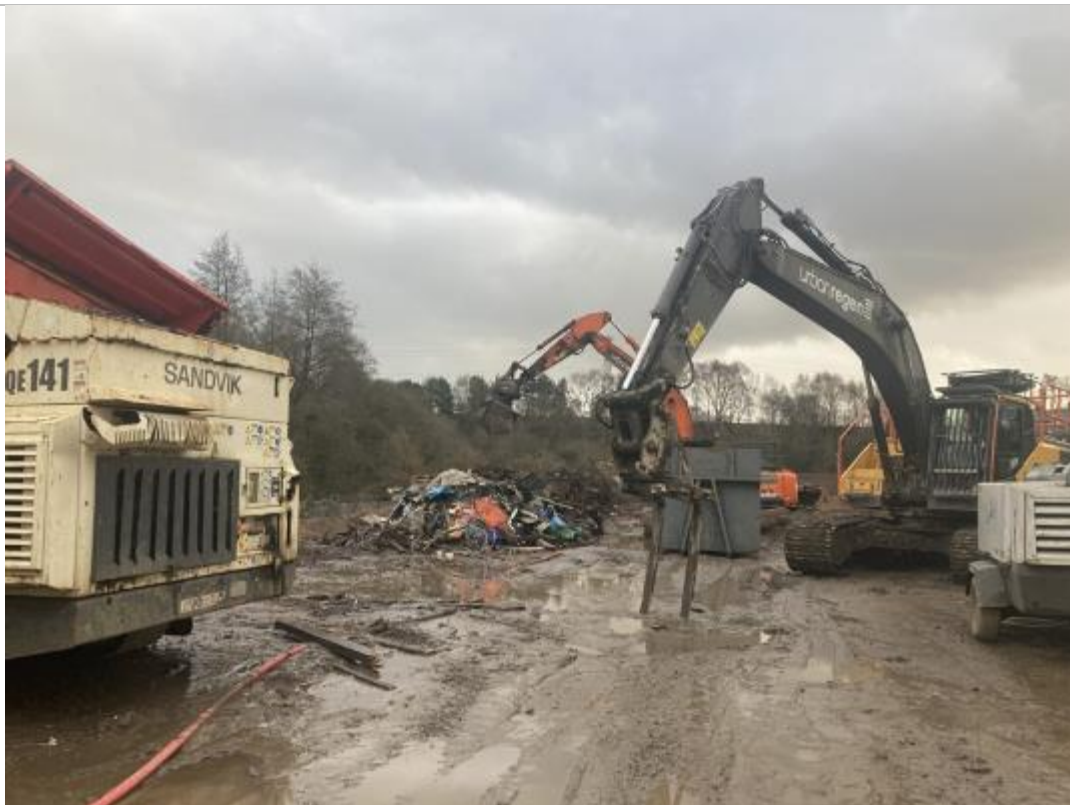
PLATE 46      REMOVAL AND SEGREGATION OF WASTE

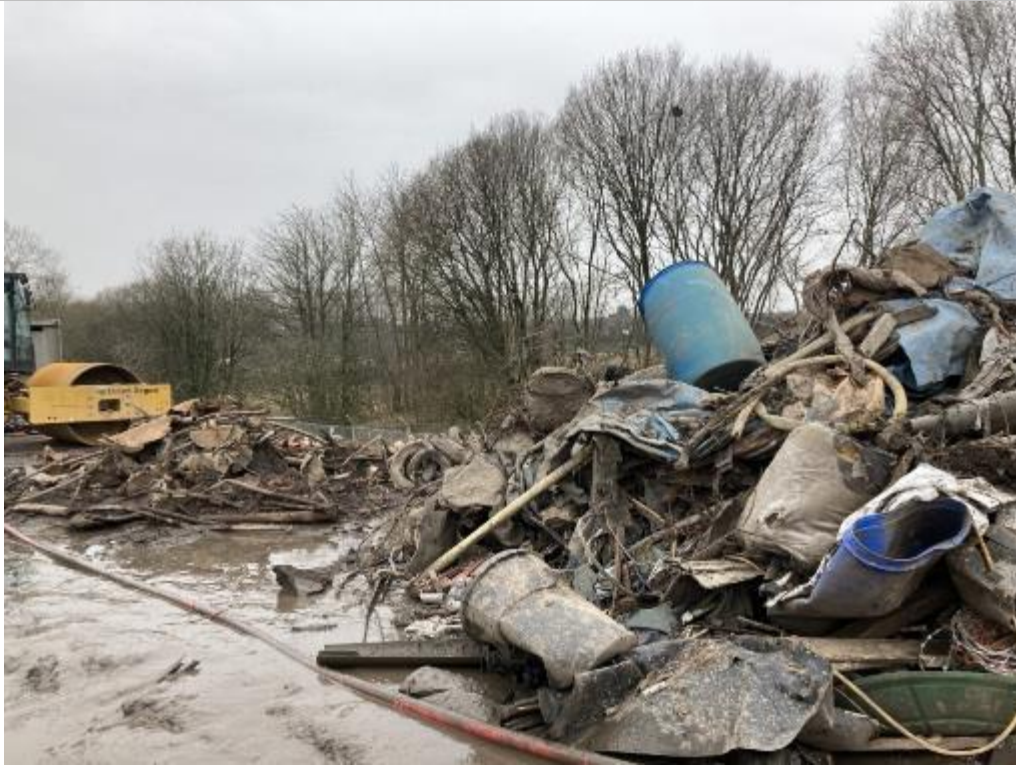
PLATE 47 REMOVAL AND SEGREGATION OF WASTE

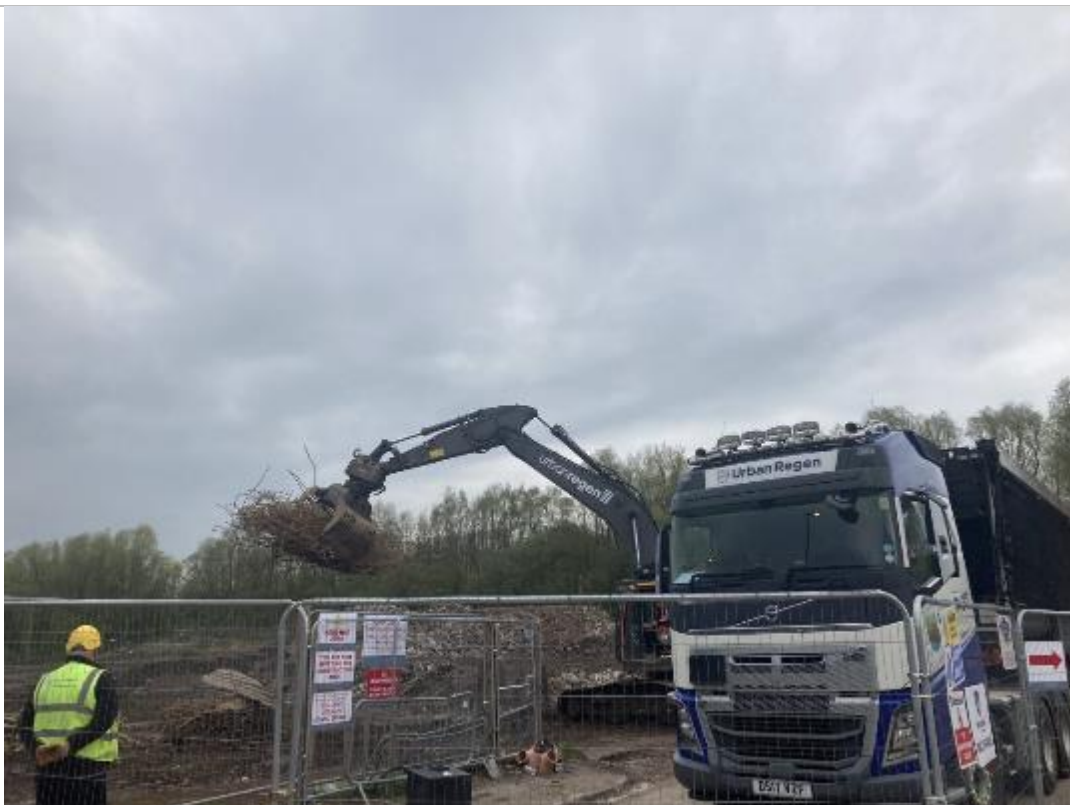
PLATE 48 REMOVAL AND SEGREGATION OF WASTE

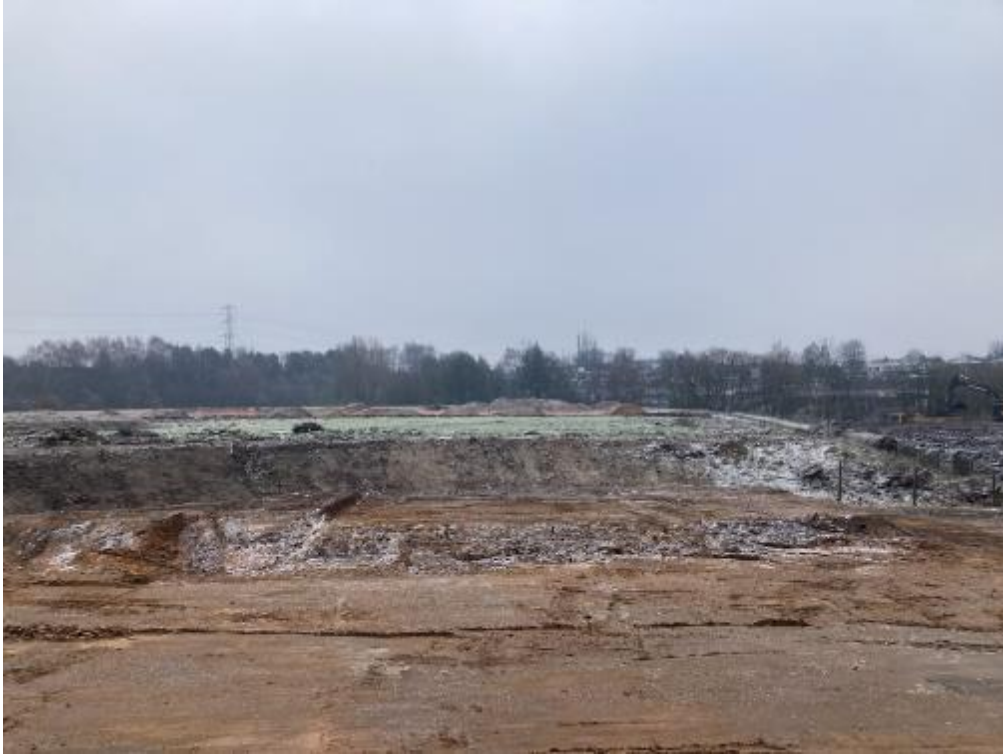
PLATE 49

SUPPLEMENTARY TRIAL PITTING PHASE 3 (AREA 5)

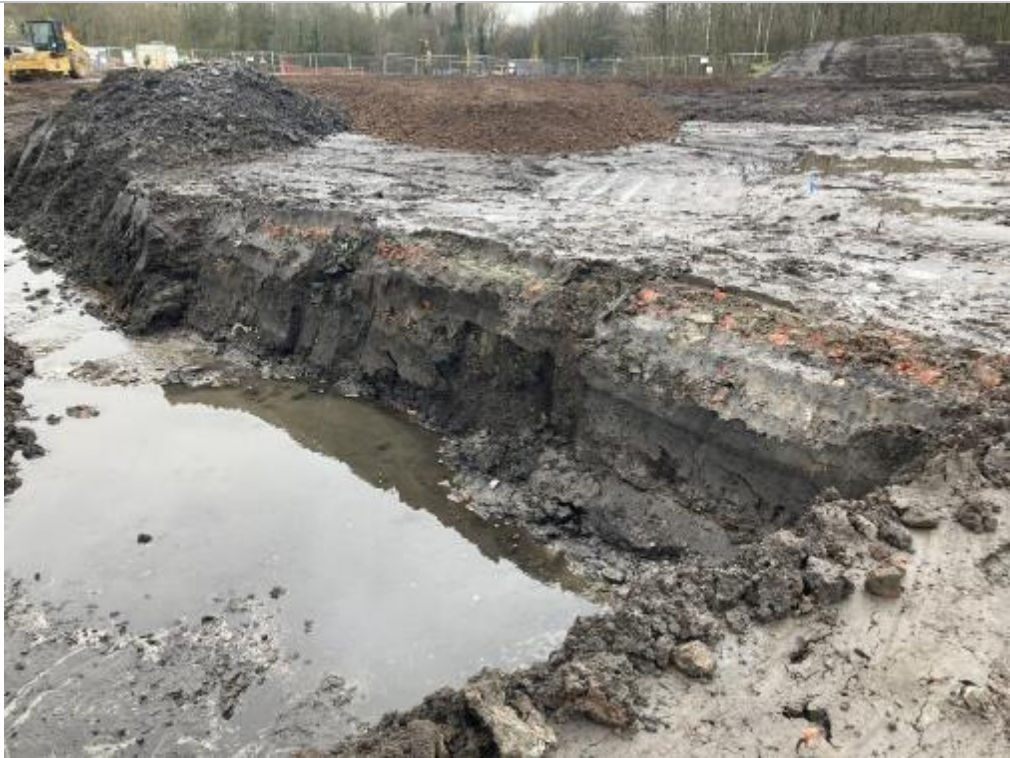
PLATE 51 CUT AND FILL (AREA 2A)

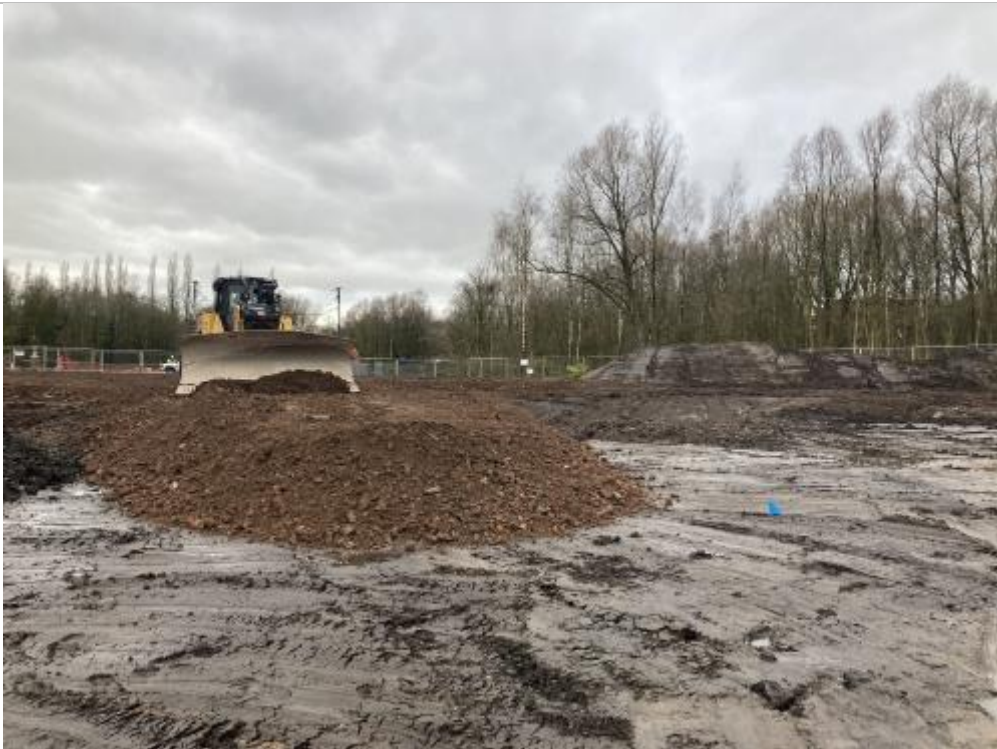
PLATE 52 CUT AND FILL (AREA 2A)

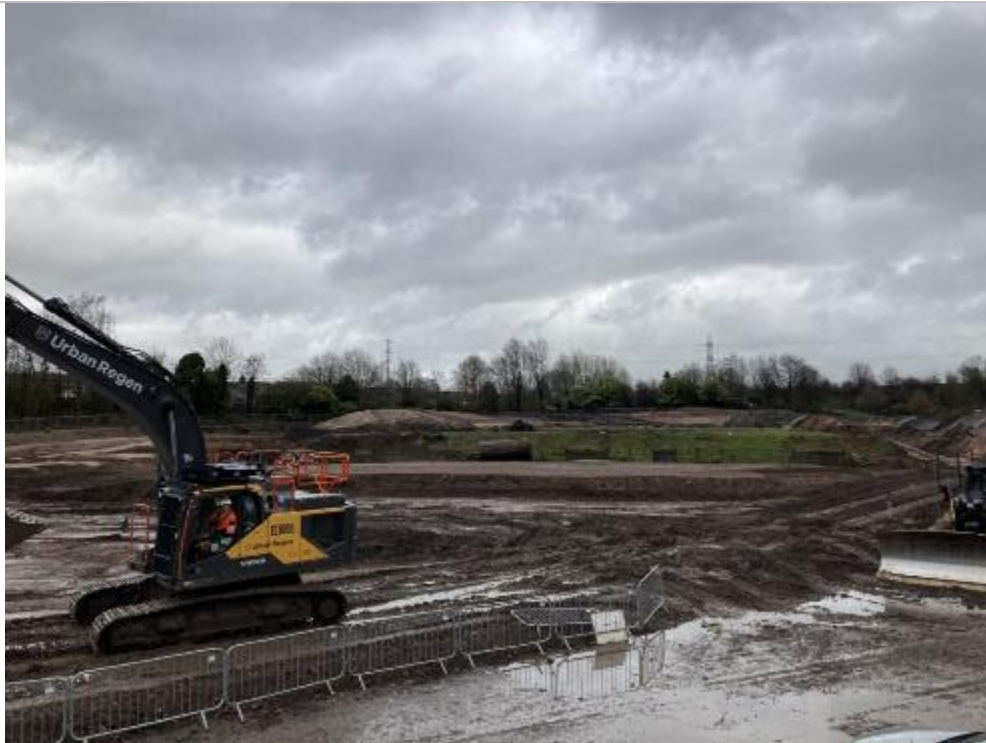
PLATE 53 CUT AND FILL (AREA 2A)

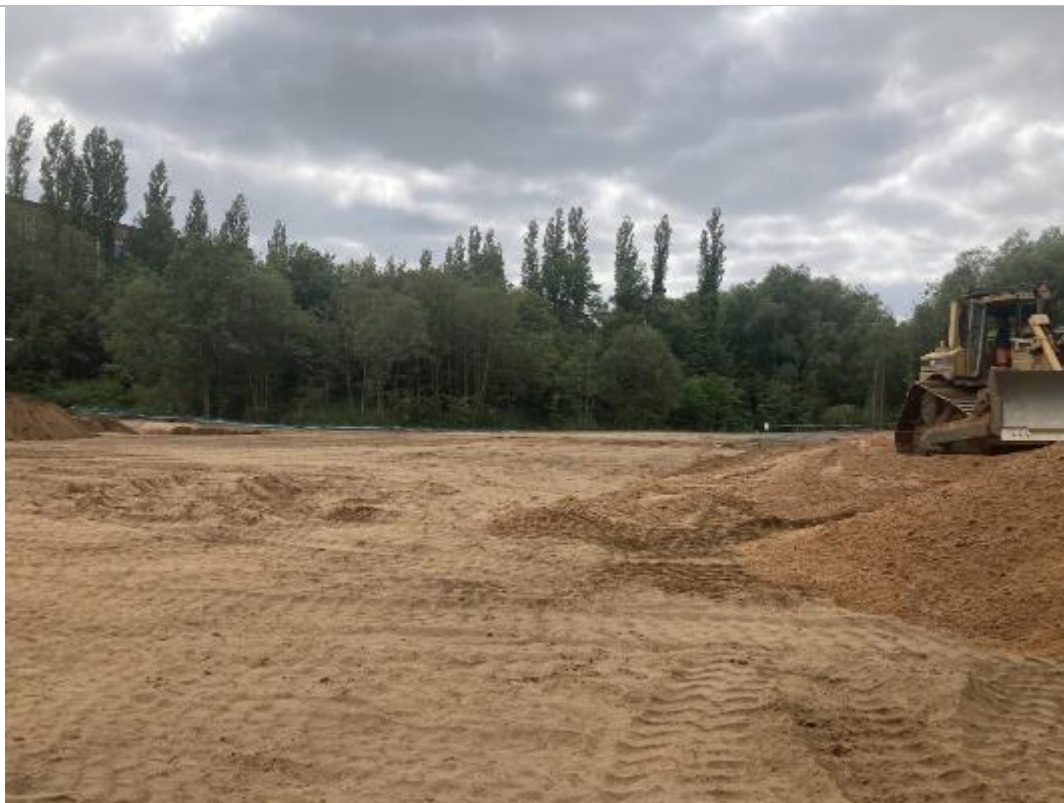
PLATE 54 FILLING OPERATIONS IN PHASE 1 (AREA 1)

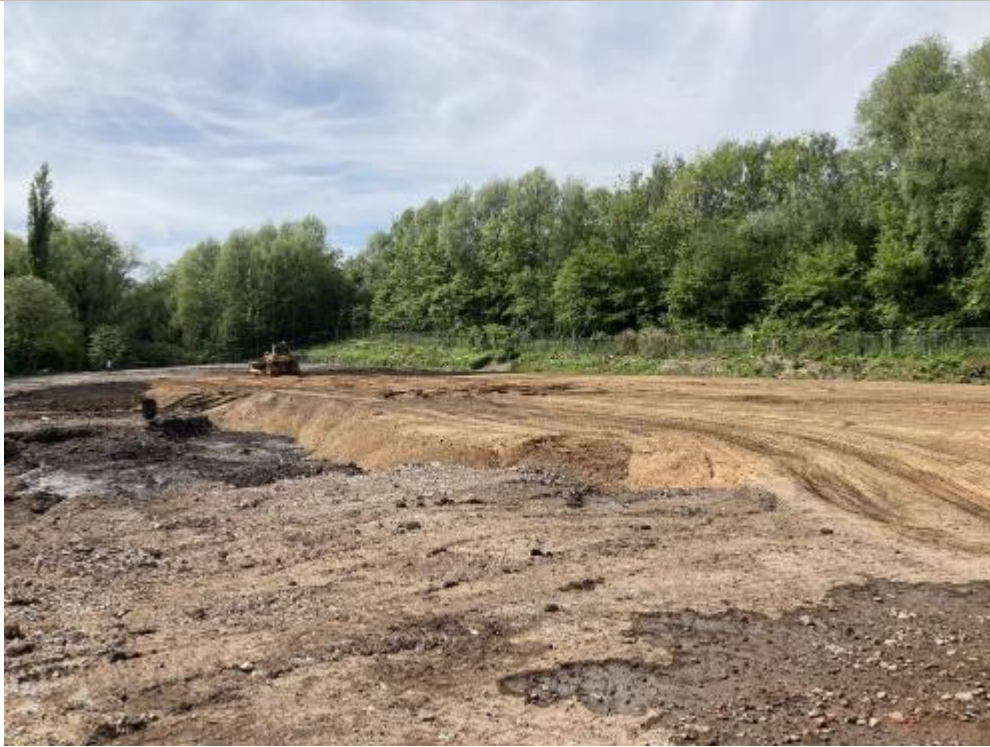
PLATE 55 FILLING OPERATIONS IN PHASE 1 (AREA 1)

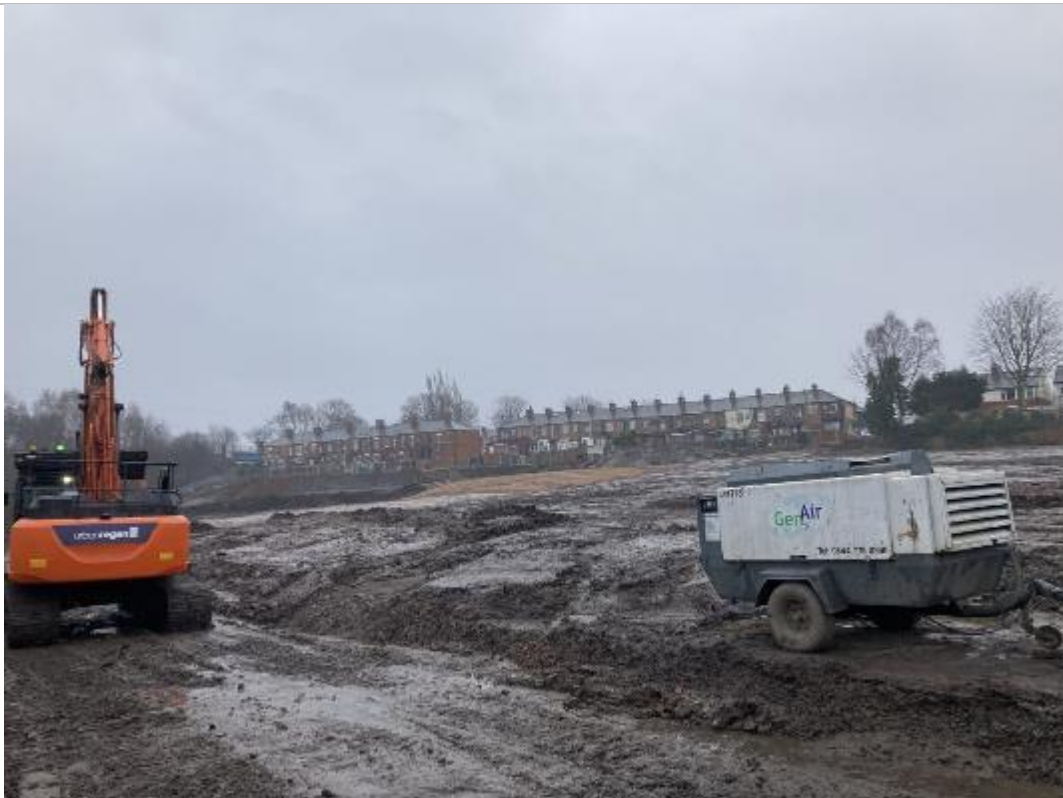
PLATE 56 CUT AND FILL WORKS (AREA 5)

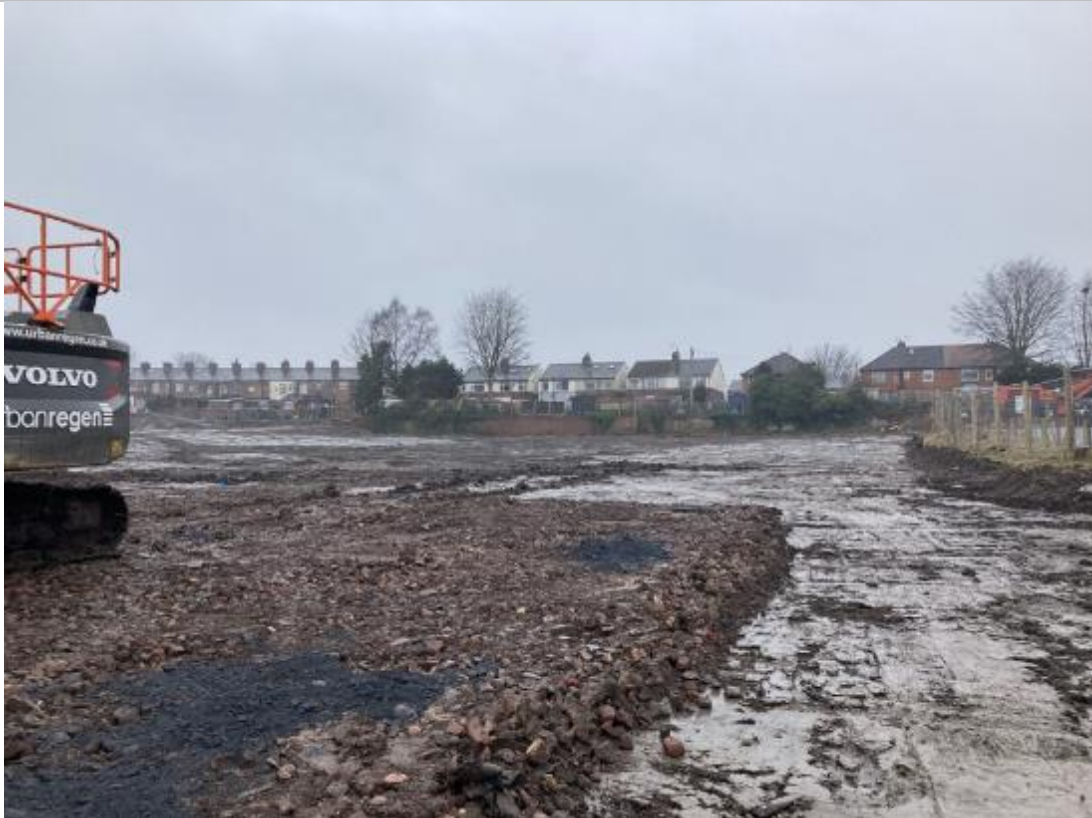
PLATE 57

CONSTRUCTION OF TEMPORARY WORKING PLATFORM PHASE 3 (AREA 5)

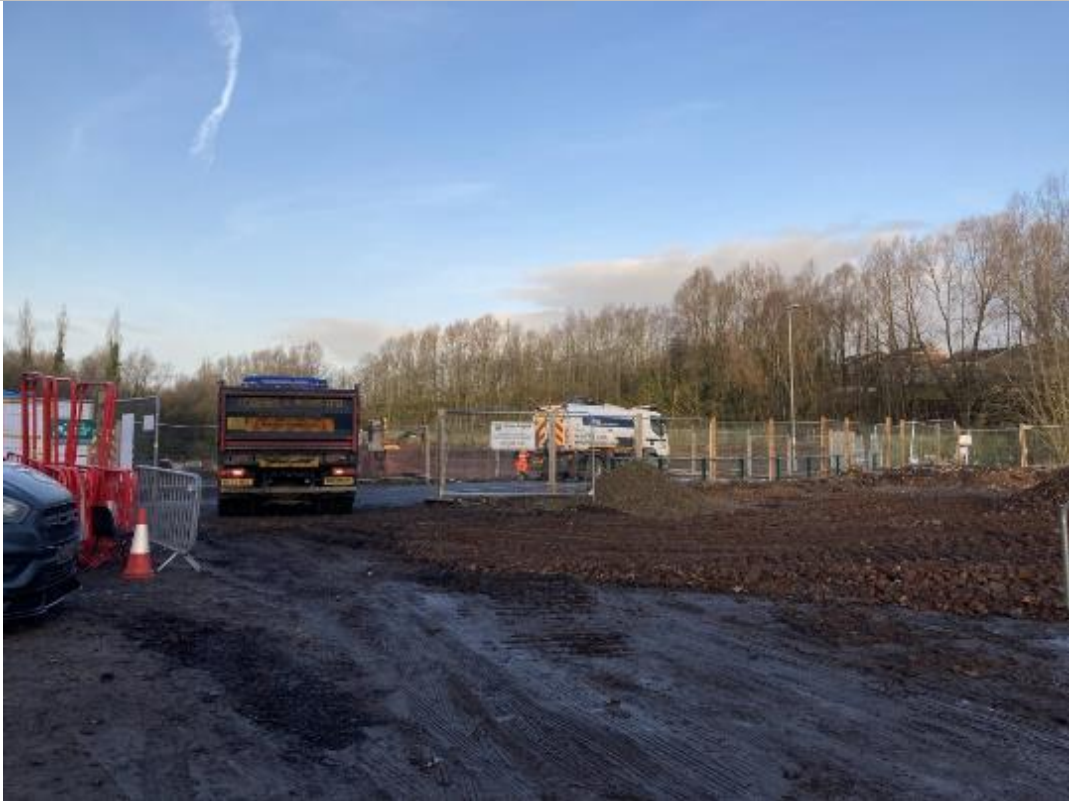
Phase 2A has been turned over and upfilled with site won made ground soils and imported 6F5 material to raise levels within Parcel C. All import material is compliant with the remediation target values for human health stated in the Remediation Strategy. Within Phase 2 site levels have changed in line with FFLs given on Coopers Foundation Zoning Plan 5639/Fd/02 (March 2022) and a series of window samples were undertaken at FFL to obtain samples at pipeline depth in April 2023 (i2 Analytical - 23-28846-1, 23-26301-1, 23-19920-1, 23-15243-1 & 23-14763-1). A UKWIR assessment (14-554 - UURA - Don Street, Phase 2A – May 2023) was undertaken by E3P and recommended barrier pipe was used within Phase 2A of the development due to the presence of TPH above PE thresholds in the existing soils and imported soils that have been re-used across Phase 2A.

PLATE 59 IMPORTATION OF BULK FILL TO PHASE 2A
