# Drainage Report

**Morris Construction Ltd**  
**Moorgate Far East Farm**  
**Burnedge**  
**Rochdale**  
**OL16 4QL**

## Moorgate Farm - CCTV Survey Report : 10/10/23

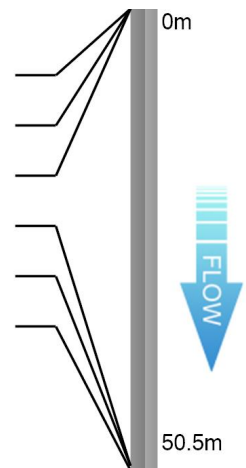
| Position | Code | Description | CD | Pic | Video Ref | |
|---|---|---|---|---|---|--|
| 50.00m | REM | General remark | | 0_3 | 0:00:00 | |
| 50.50m | OFF | Finish node type, outfall | | 0_99 | | |

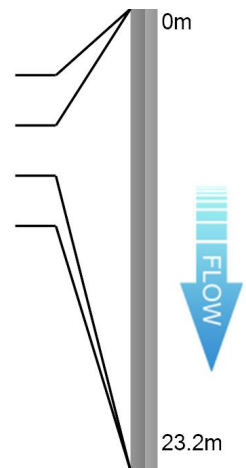
| Position | Code | Description | CD | Pic | Video Ref | |
|---|---|---|---|---|---|--|
| 23.20m | REM | General remark | | 1_2 | 0:01:20 | |
| 23.20m | BRF | Finish node type, major connection without | | 1_99 | | |

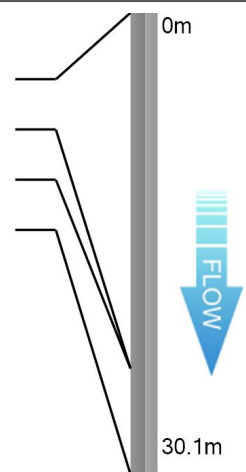
| Position | Code | Description | CD | Pic | Video Ref |
|---|---|---|---|---|---|
| 23.20m | REM | General remark | | 2_2 | 0:01:30 |
| 30.10m | SA | Survey abandoned | | 2_99 | |
