# Heritage Statement

## Silverhill Farm, Rochdale

July 2022

### SILVERHILL FARM AND BARN ROCHDALE

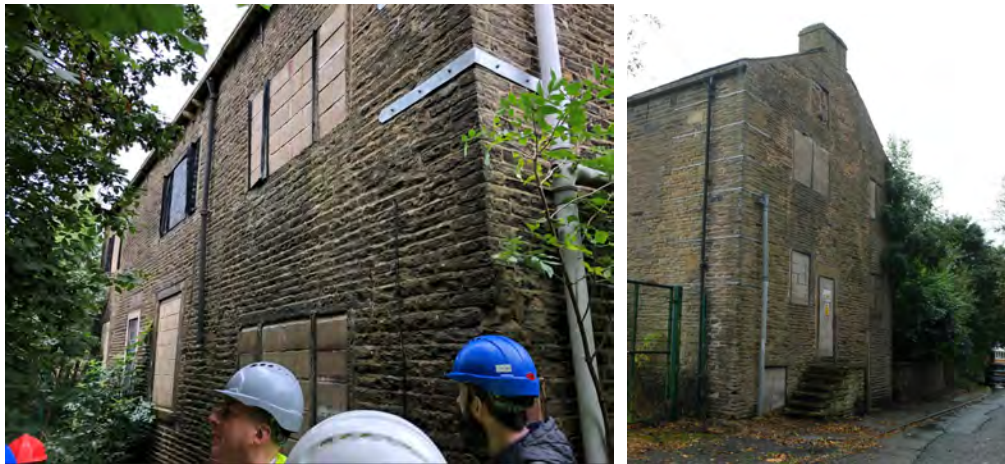
- 3.15 As previously identified, the House is in a poor and deteriorating condition and a number of key architectural features have been lost. All windows including the frames and external doors have been removed and blocked up and two of the three chimneys have been rebuilt in a mix of blue/black and red brick. Structural ties have been added to seek to address movement and substantial areas of the stonework are heavily eroded.

**Figure 3.2: Principal elevation (left) and north west elevation to Lower Lane (right)**

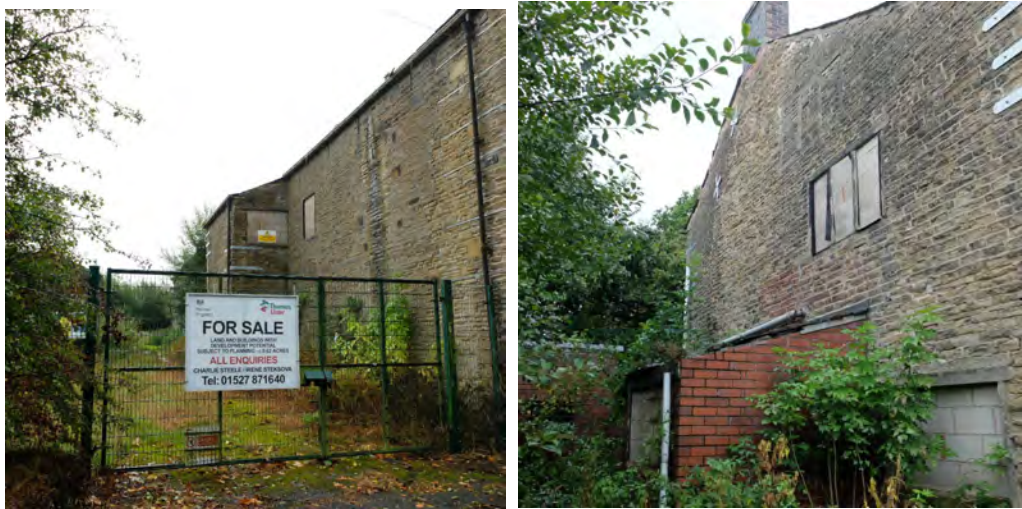
**Figure 3.3: Rear (north east) elevation (left) and south east elevation (right)**

- 3.19 The south east elevation is the return elevation of the later extension and fully obscures the original elevation of the farmhouse. A brick lean-to porch added in the late 19<sup>th</sup> or early 20<sup>th</sup> century is in a poor condition and detracts from the historic vernacular character and appearance of the elevation. The presence of weavers' windows on this elevation (and also potentially in the attic on the north west elevation) indicate the property was used in the cottage textile industry and is a key feature in understanding the history of the building and the regional textile industry.

- 4.15 The late brick porch, which is of low-quality construction and has a detrimental impact on the architectural and aesthetic value of the south east elevation will be removed. It will be replaced with a lean-to garage constructed of stone to match the House and will have a more harmonious visual relationship with the House. It will be set back from the north west elevation and along with its simple, functional design will ensure the garage is a discrete addition.

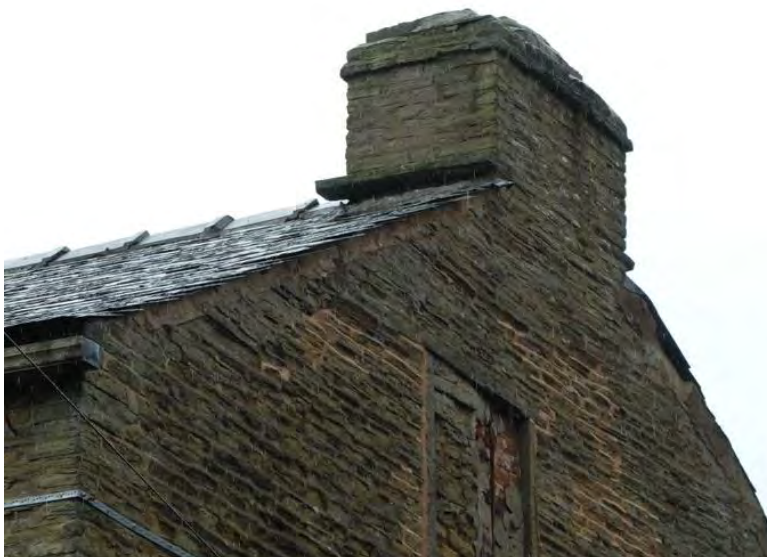
Photo Stone Chimney with weathering course to left gable.

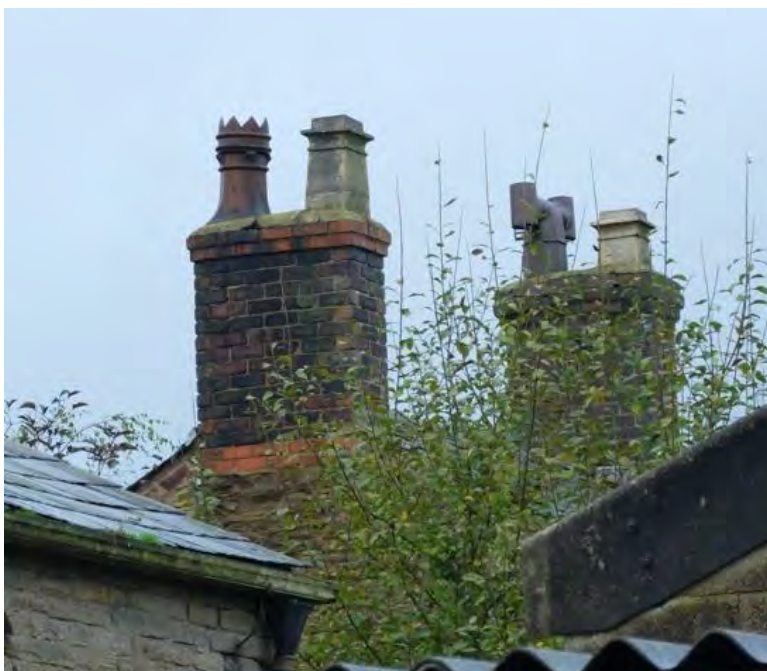
Photo Brick chimneys to farmhouse

The stone chimney appears to have no pots. There are two pots each to the brick chimneys.

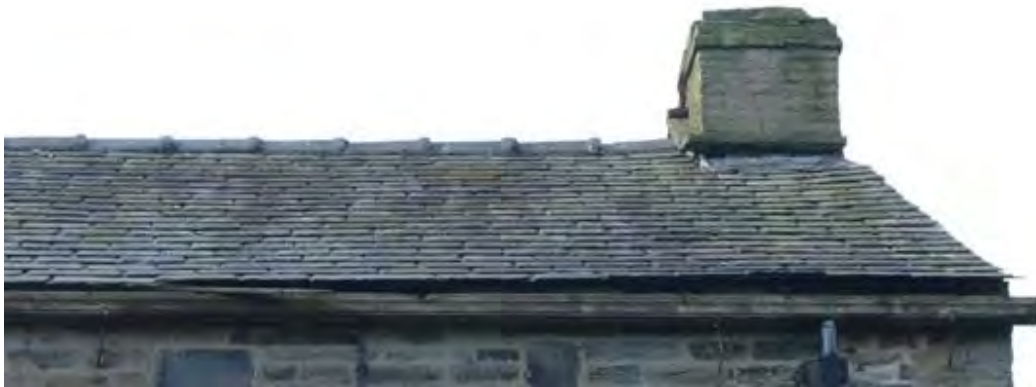
Photo. Diminishing coursed slate roof to farmhouse

At the verges the slates extend over the face of the stonework the infill verge detail is untidy and has been done using a hard cementitious mortar. This has become loose in places and will require complete renewal.

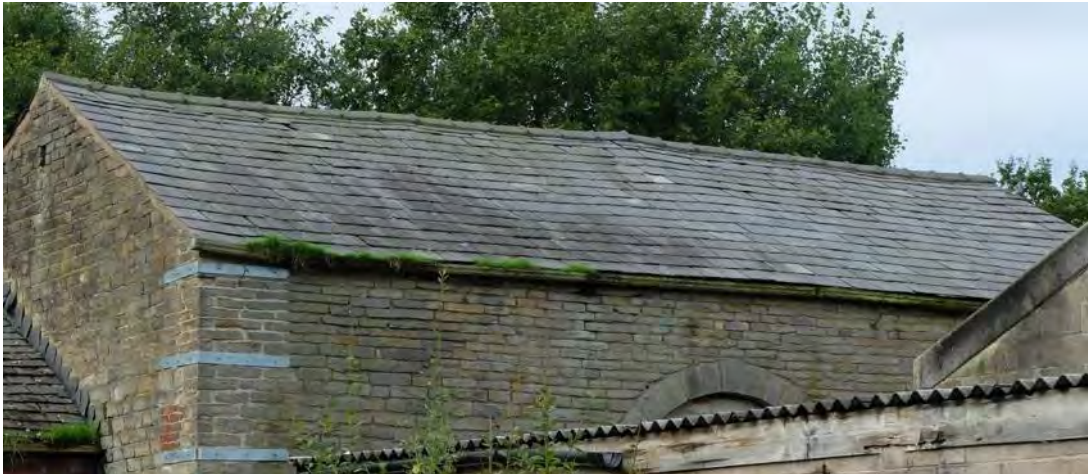
Photo. diminishing coursed slate roof over barn

At the verges the slates extend over the face of the stonework the infill verge detail is untidy and has been done using a hard cementitious mortar. This has become loose in places and will require complete renewal.

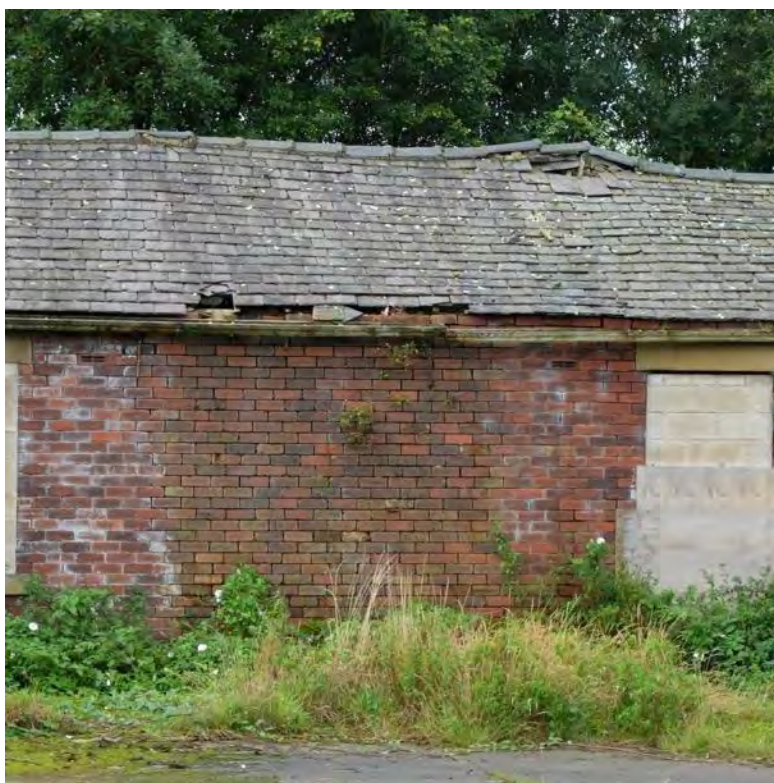
The roofs to the outbuildings are pitched and slated. The roof over the cowshed to the East elevation of the barn has been slated with an excellent quality wash 20 x 12" blue slate which should be salvaged for reuse.

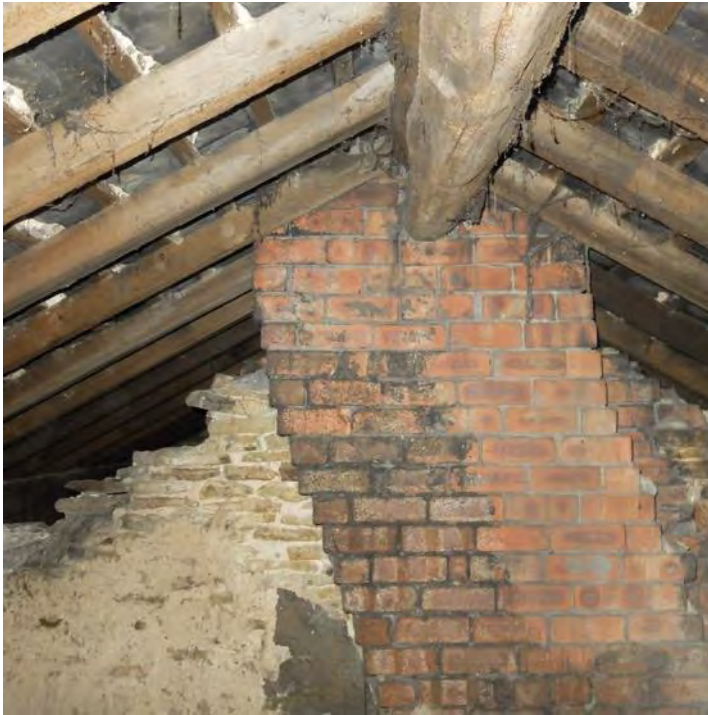
The roof is supported on an original oak log ridge which is the only remaining section of what is considered to be the original roof structure and then a later softwood 350 x 125mm purlin at mid span of each roof slope. There were signs of common furniture beetle emergence holes from the sapwood sections of the timber.

Photo. Newer brick chimney to Space R2, log ridge, which is original roof structure, note old plaster to walls

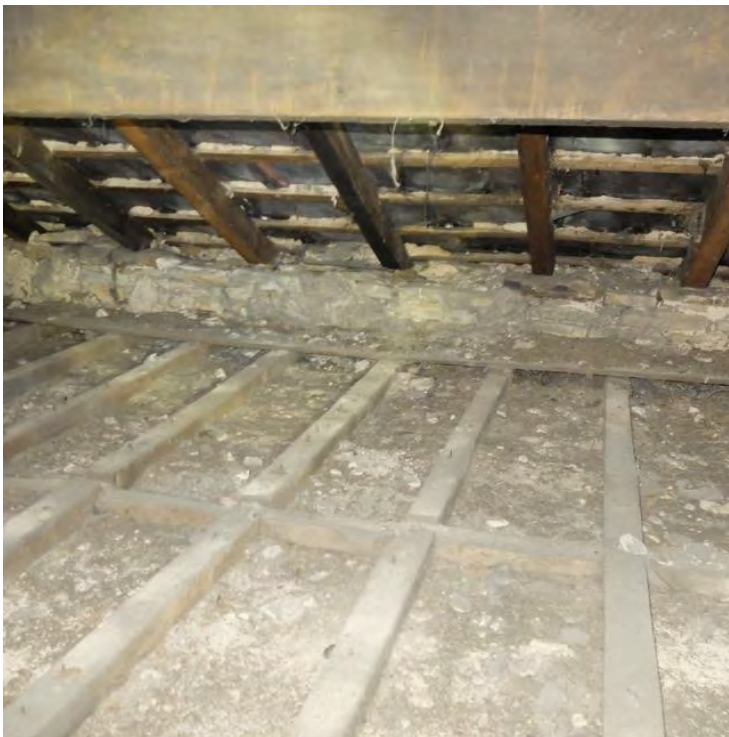
The feet of the rafters sit directly onto the stone external walls where they are packed on small sections of stone. There is no evidence of any head fixing or wall plate to the external walls.

The ceiling joists which enter the front and rear walls are located approximately 400 mm lower than the intersection of the rafters and therefore there is limited triangulation of the roof structure.

Photo. Rafters sit direct on wall head with no fixing down

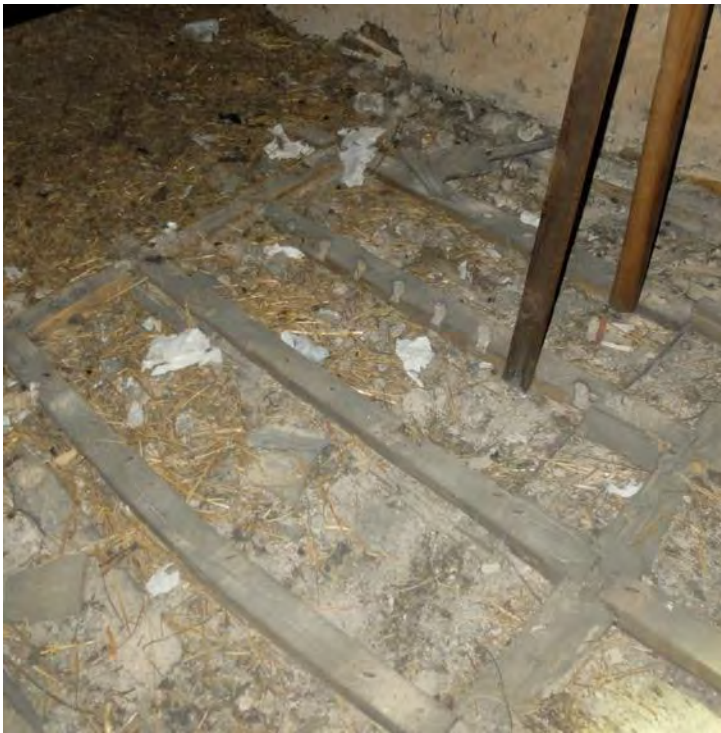
There is evidence of a large ceiling trap opening to the left-hand section of the ceiling joists which would have supported a timber stair and provide better access into this area.

Photo. Old ceiling trap in location of hangers above room F.04

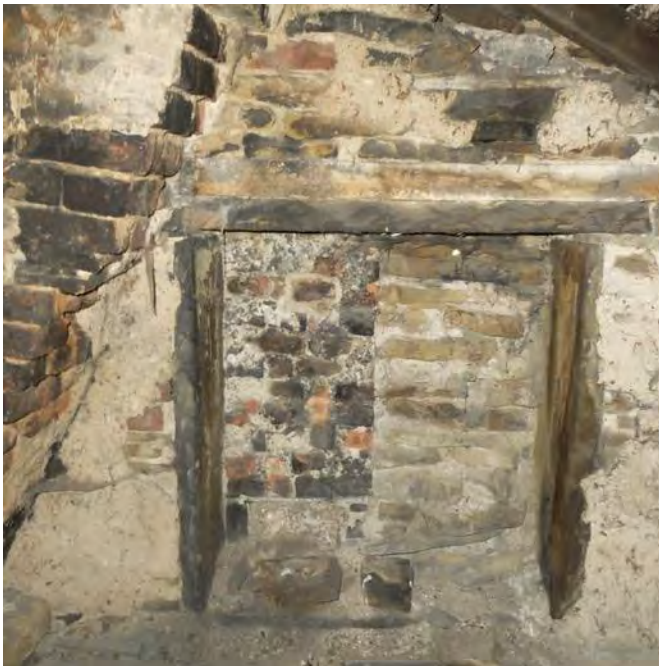
Photo. Old window infilled with masonry.

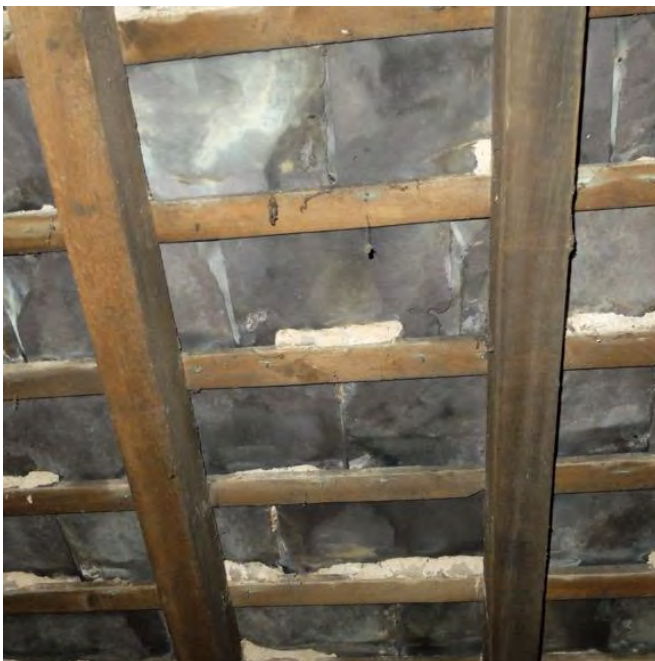
Photo. Slate fixings no underfelt. See original parging which has mostly fallen away.

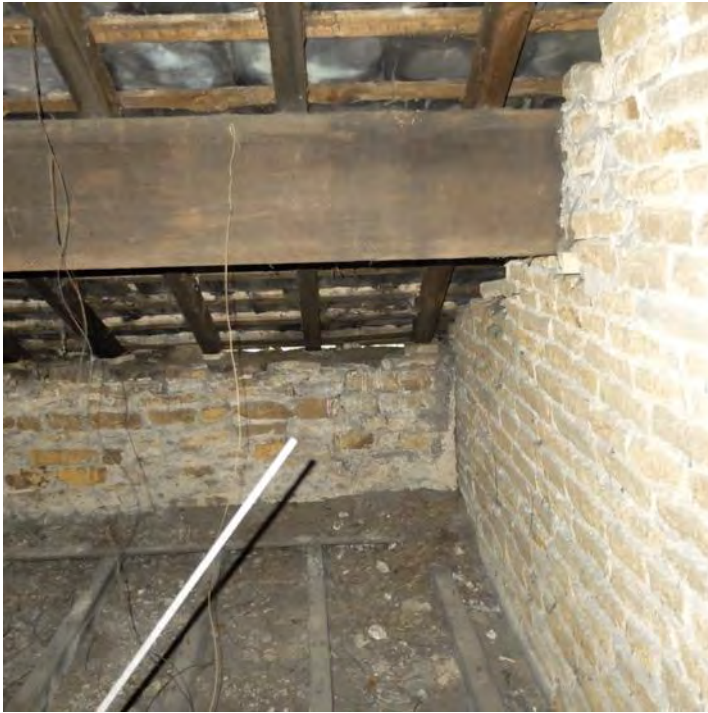
The feet of the rafters sit directly onto the stone external walls where they are packed on small sections of stone. There is no evidence of any head fixing or wall plate to the external walls.

The ceiling joists which enter the front and rear walls are located approximately 600 mm lower than the intersection of the rafters and therefore there is limited triangulation of the roof structure.

Photo. Rafters sit on wall head no fixing.

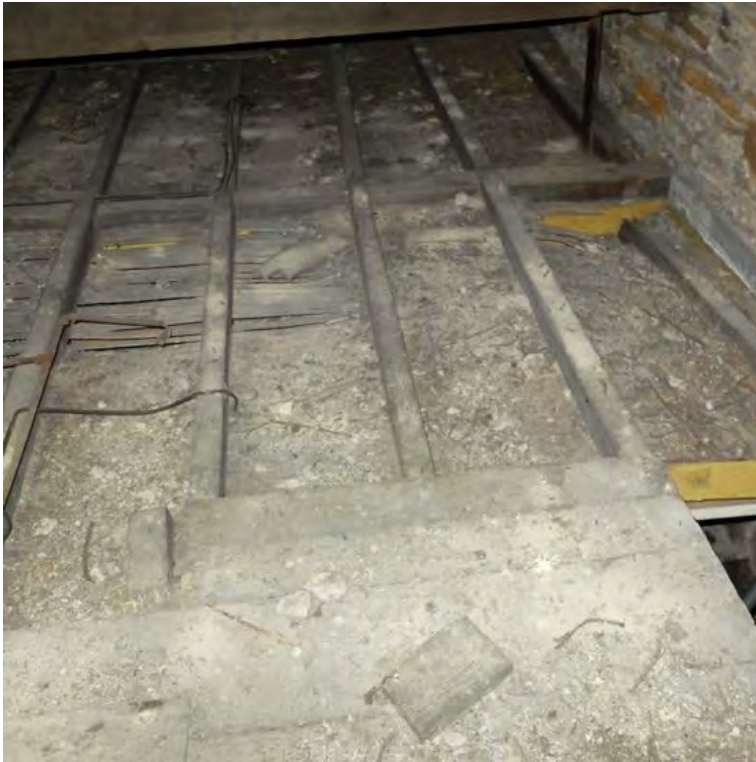
Photo. Ceiling joists with old nails indicating floor boarding.

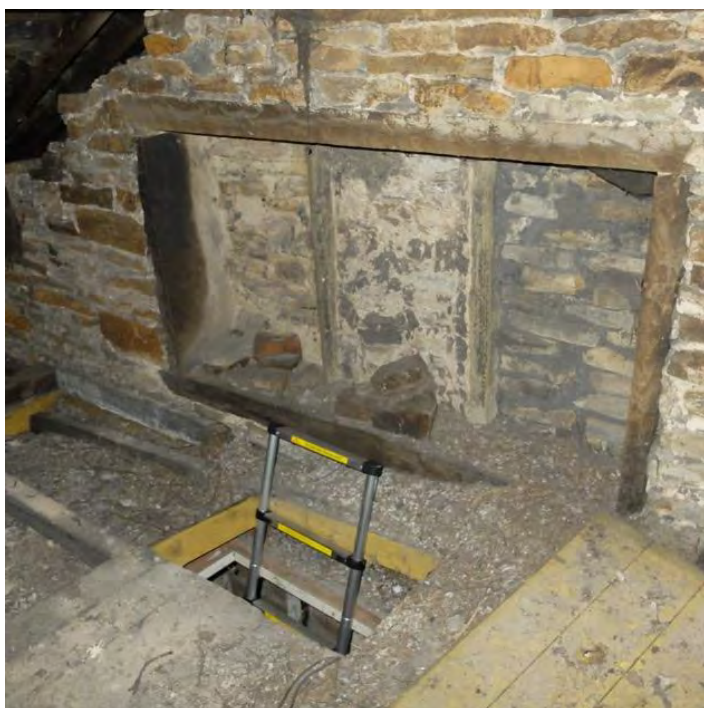
Photo. Infilled window to east gable.

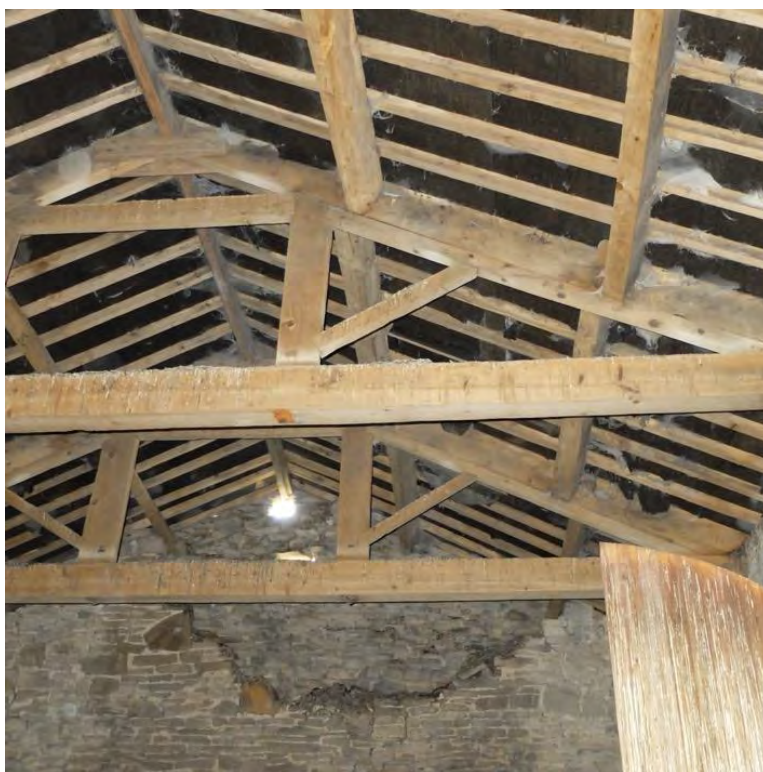
The roof structure of the barn can be viewed from the underside as this is an open construction. The roof is supported on 3 no queen post trusses. These are of a softwood construction and appear to be late Victorian. The trusses support 2 no purlins per slope which appear to be approximately 350 x 125mm in size which is similar to the purlins within the main farmhouse. The purlins are positioned so that the top chord is level with the top chord of the principal rafter which is unusual as the purlins normally sit above the truss. This may have been an oversight by the carpenters to prevent having to build up the walls, it is assumed the original oak construction would have been slenderer than the softwood replacement.

Photo. Queen post roof structure of barn (considered 1900s)

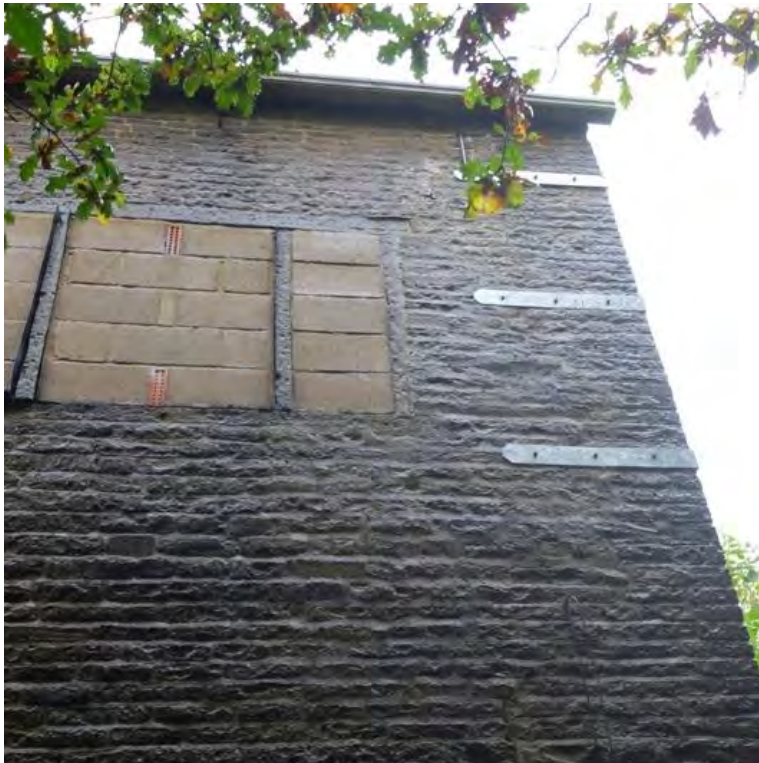
Photo. Diagonal crack above ground floor window to extension

There is a vertical crack which follows the lines of perpendicular joints in the stone and extends from the roof at the top right corner of the first floor extension window down to the right side of the ground floor window and then to ground.

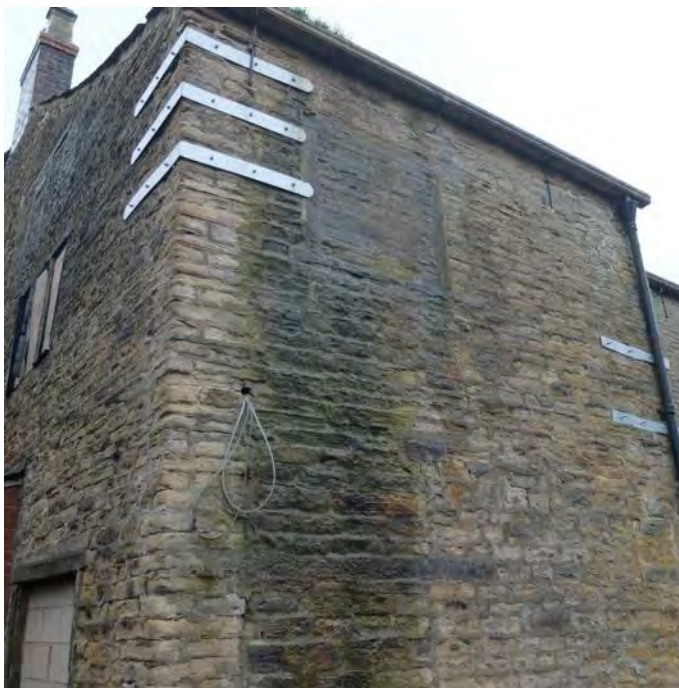
Corner ties been added to the upper corners to both sides of the outrigger to restrict movement between walls.

Photo. Corner straps to high level.

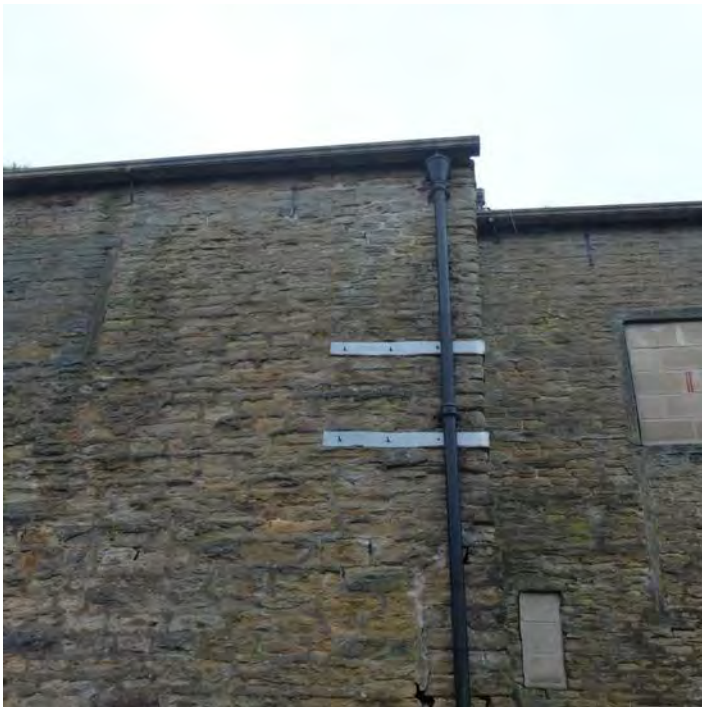
Photo. Corner steps to upper corner

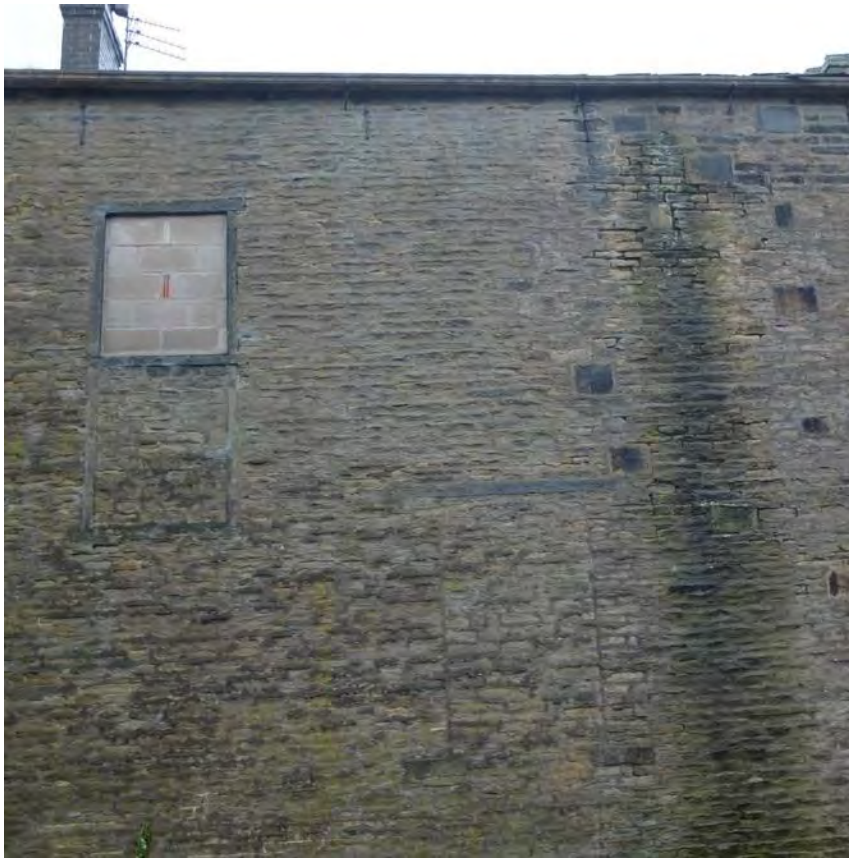
There is evidence of windows which have been blocked up on the rear elevation.

Photo. Infilled windows to rear elevation.

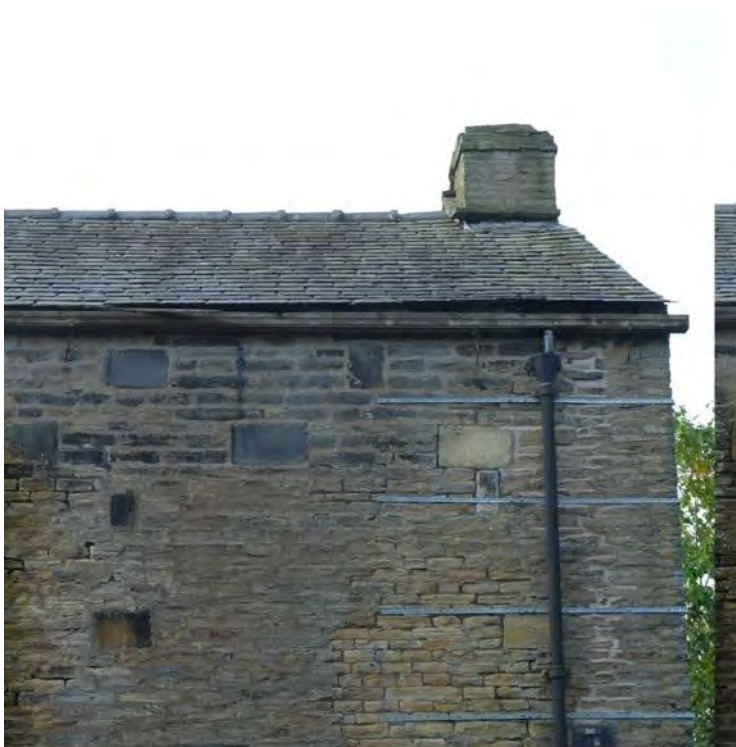
There is a vertical crack which extends from ground floor to the roof which follows the lease line of resistance within the perp joints of the stone this is approximately 600 mm from the west corner.

Large restraint straps have been added to the west corner to restrict movement.

Photo. Corner strapping

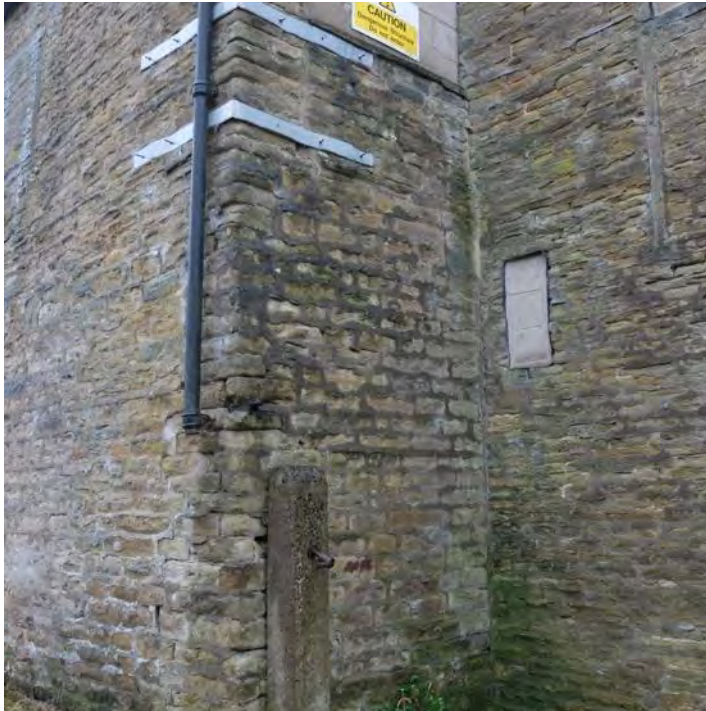
There is a large area of corroded stone to the face of the wall from ground up to the first floor window.

Photo. Eroded stone

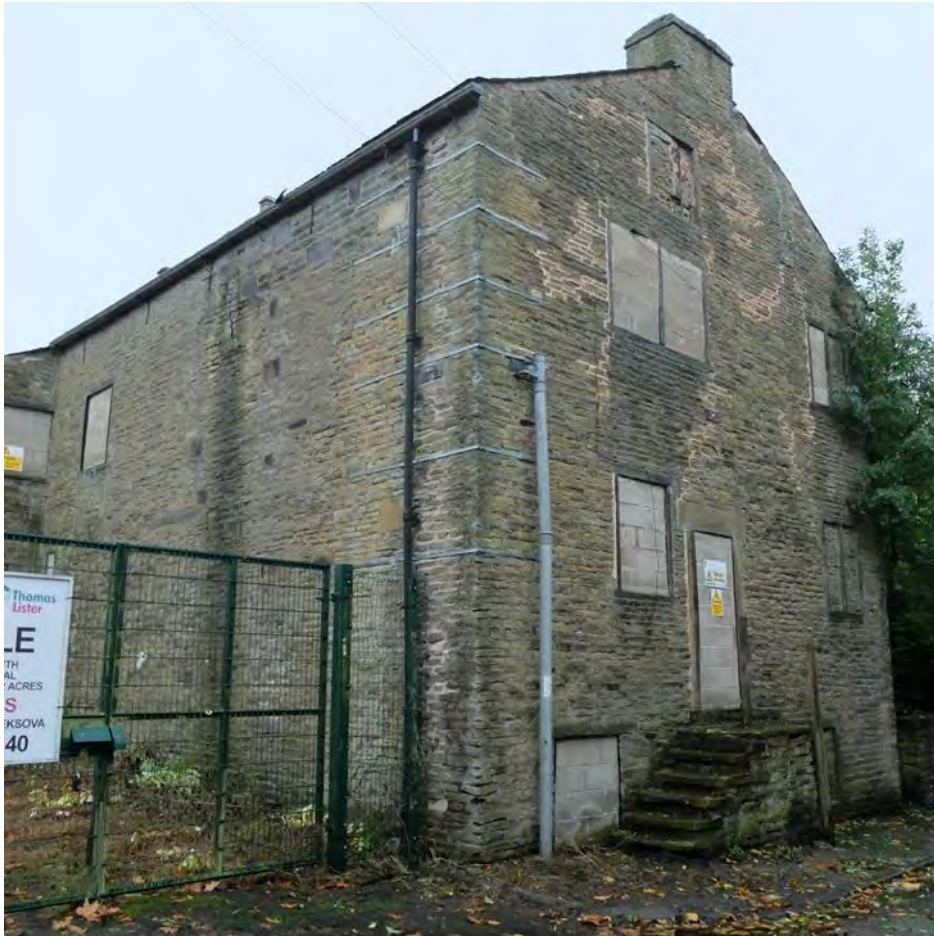
This elevation appears to have been repointed in a hard sand and cement material.

There are approximately 7 areas of cracking which appear to have been patch repointed.

Photo. Full view of gable which overlooks road

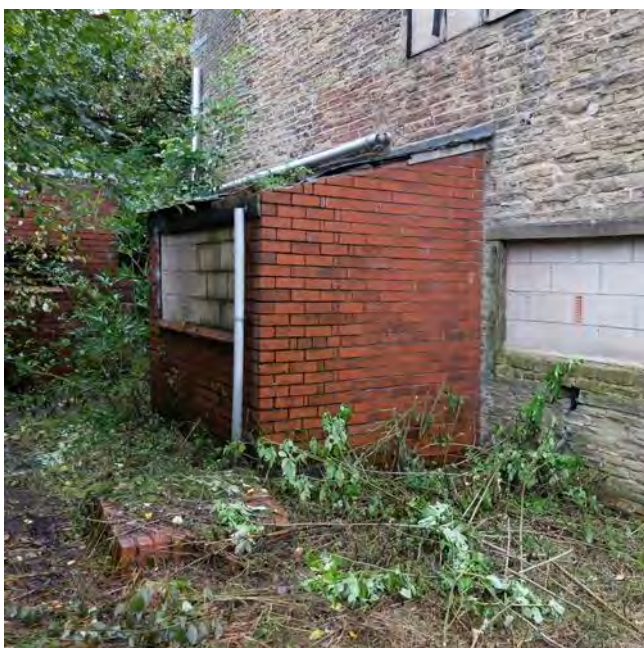
There is a small brick porch which is located on the right-hand gable. This is constructed in redbrick and black ash mortar and appears to have been constructed around the 1900s which is the same time as the other outbuildings on site.

Photo. Brick porch, poor quality

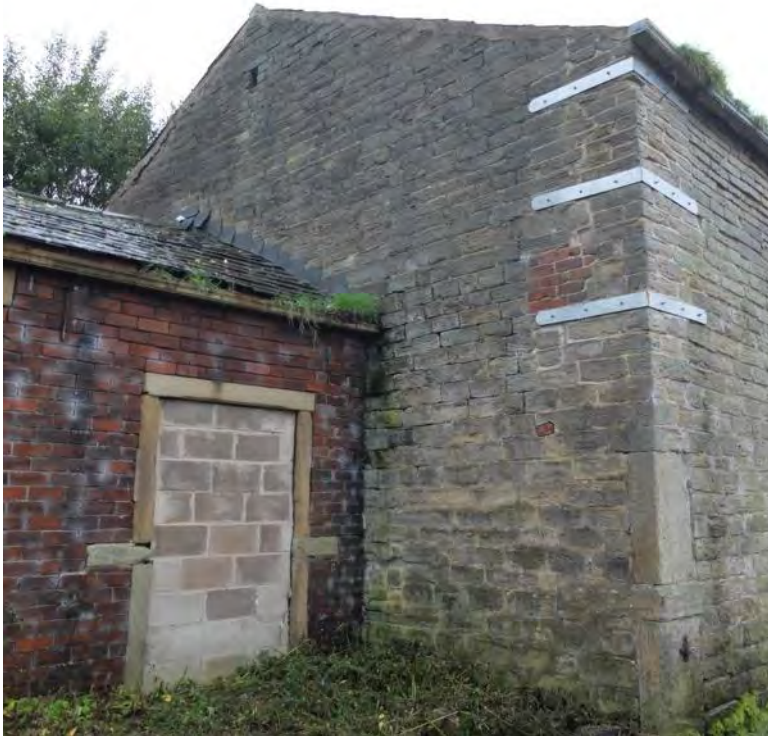
On the rear corner with the rear elevation clay brick has been used to repair a hole which may have been an old metal flue for a heater. The brick does not bond well with the stone and creates a weak point.

Large stones laid vertically have been used on the rear corner. This may have been a striking or hinge point for an old gate to the farmyard the large stones have no bond with the masonry which abuts this and creates a weak point in the construction.

Photo. Old bricked up flue and corner strapping

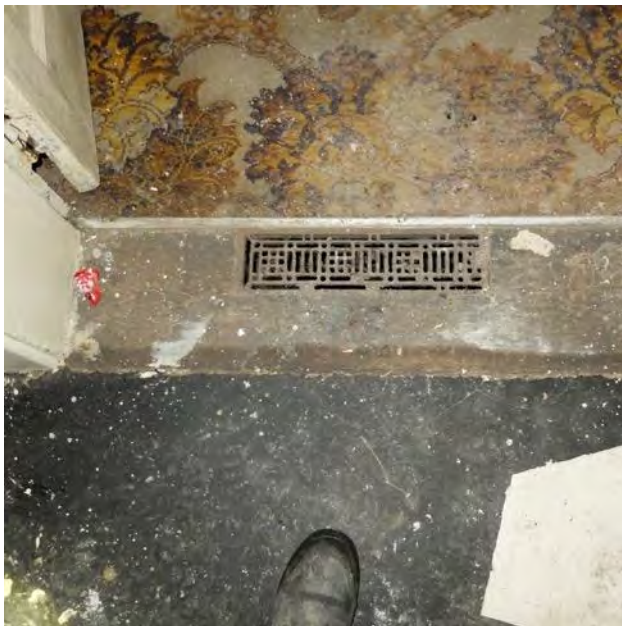
In room G.03 where there is a suspended timber floor there is a floor mounted decorative grill which will provide some ventilation.

Photo. Decorative vent in floor surface investigation required to determine function.

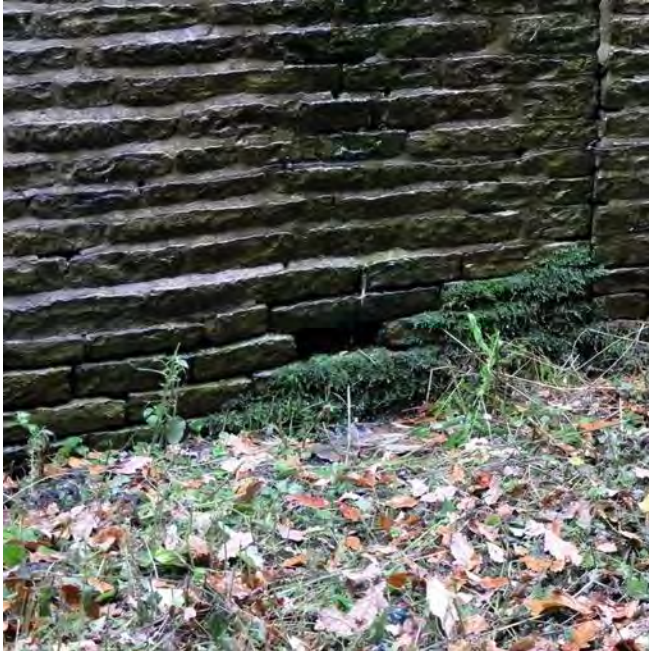
Within the front elevation there are indications of openings within the low level stonework adjacent this room, however further investigation is required to establish whether these are actual air vents. The frequency and size of the vents do not comply with Building Regulations.

Photo. Air vent in front elevation

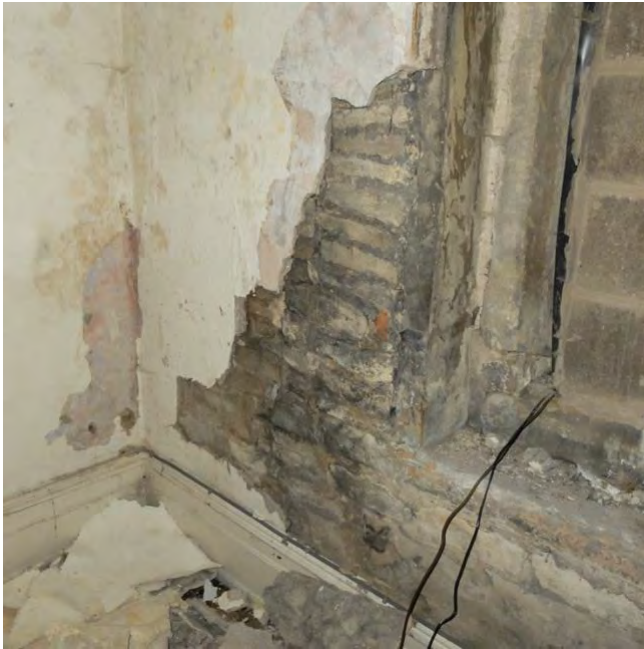
Throughout the building there are areas of cracked plasterwork which coincides with cracking and movement to the outside of the building.

There are also areas of damage due to old leaks from roof and around window openings.

Photo. Added plaster from elevation Room G.03

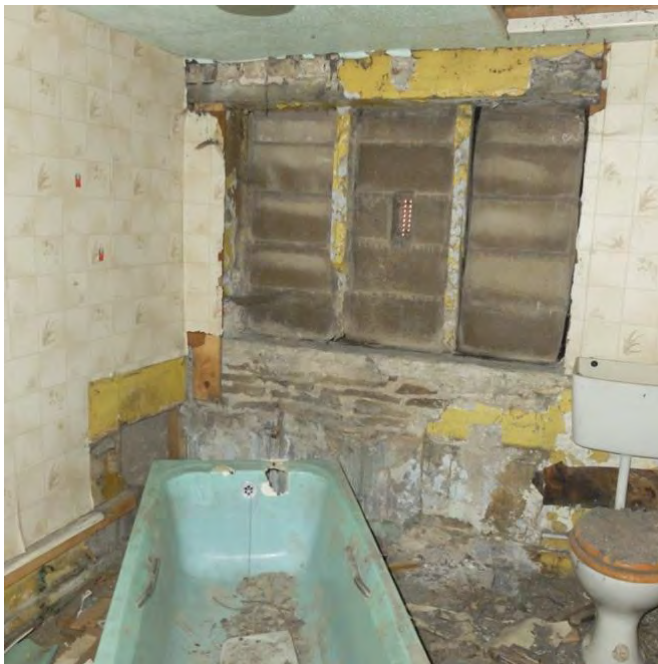
The cracking and movement appears to follow the least line of resistance where the length and the distance between perpendicular joints provides a very limited horizontal bond between the stone courses.

Photo. Added and damaged plaster east gable. Room F.08

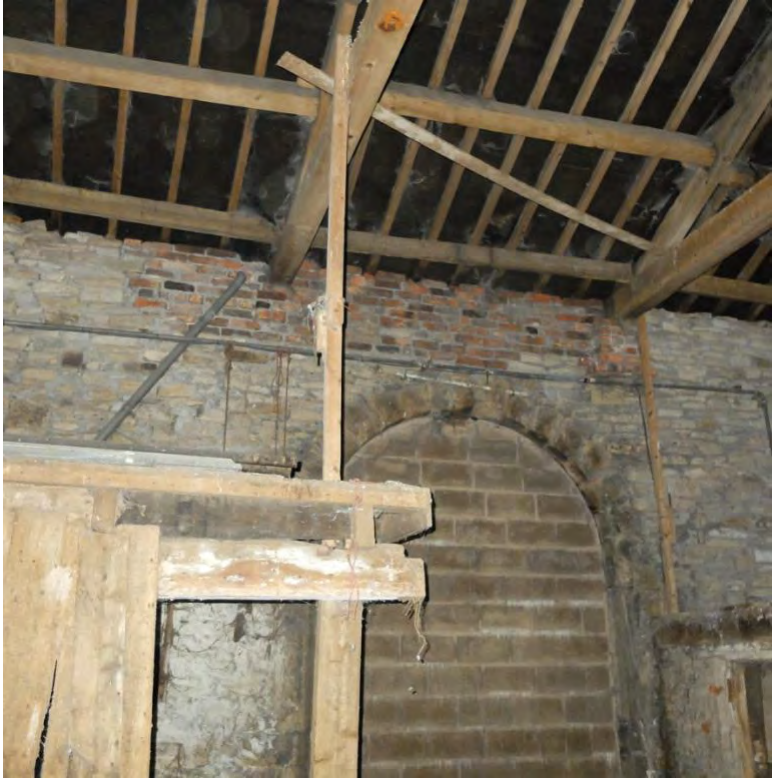
It would appear the upper sections of the internal leaf to the front elevation above the threshing door has been replaced in brickwork.

Photo. Rebuilding inner leaf in. brickwork

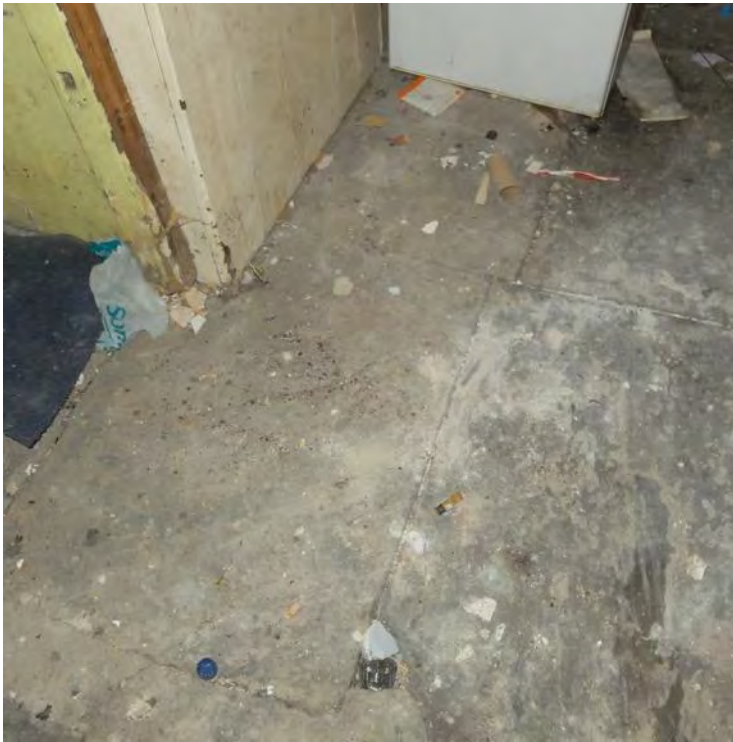
The floor surface above is York stone paving which is laid on a bed of sand on top of the timber floor. This type of construction was not uncommon however a major problem is the amount of interstitial condensation to the underside of the York stone slabs which in turn will hold the moisture within the timber floor construction which will promote decay and deterioration. Along the top surface it was

evident that some sections of the York stone paving had been overlaid with levelling screeds to support carpets and other linings.

Photo. Suspended York stone floor to ground level Room F.04

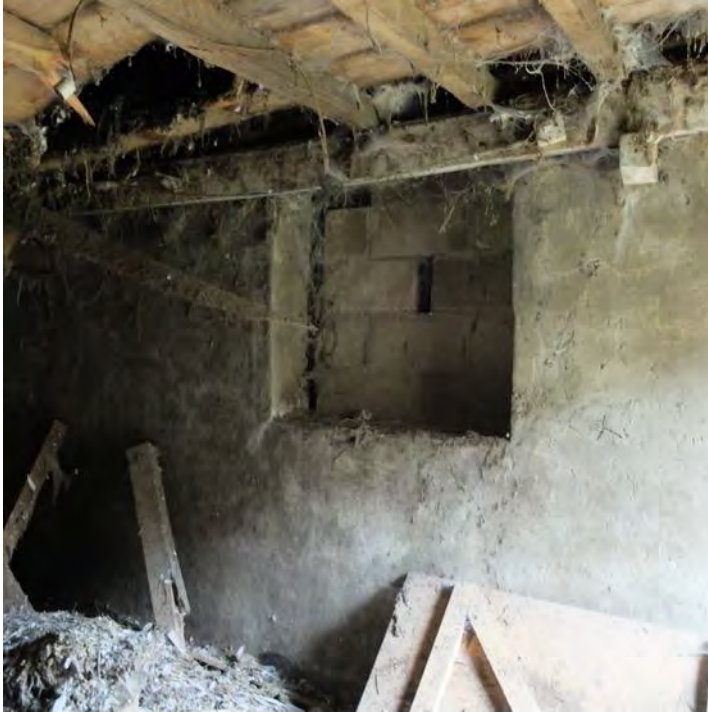
Along the left hand side there is a suspended timber loft floor which is additionally reinforced with steel beams.

This appears in a poor condition and has been considerably damaged by the falling masonry from the gable wall.

Photo. Loft floor above left hand section of the barn

It was noted that the timber joists to this loft floor do not enter the external walls and that the fixings into the gable have been formed on a timber pole plate which sits on the face of the gable.

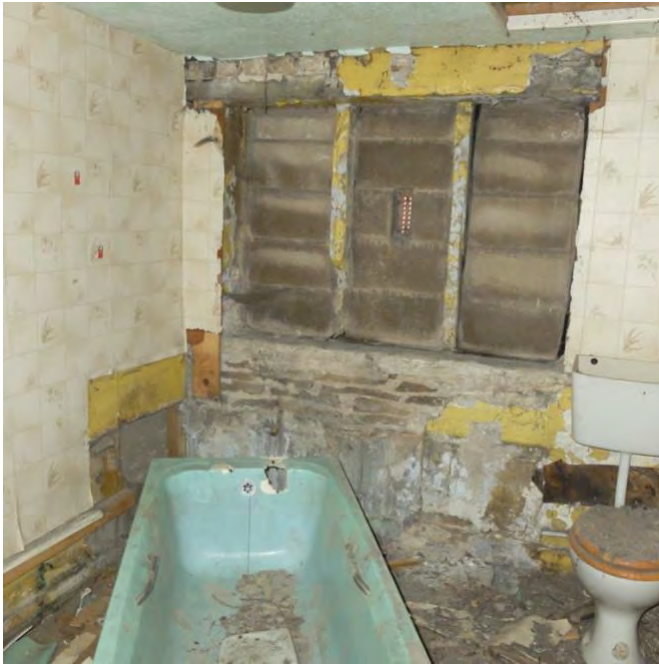
Photo. Bathroom

Walls, hard plaster and papered

Ceilings, Plasterboard and paper
