23261

FALINGE PARK – ROCHDALE

AUGUST 2023

# REPORT ON STRUCTURE

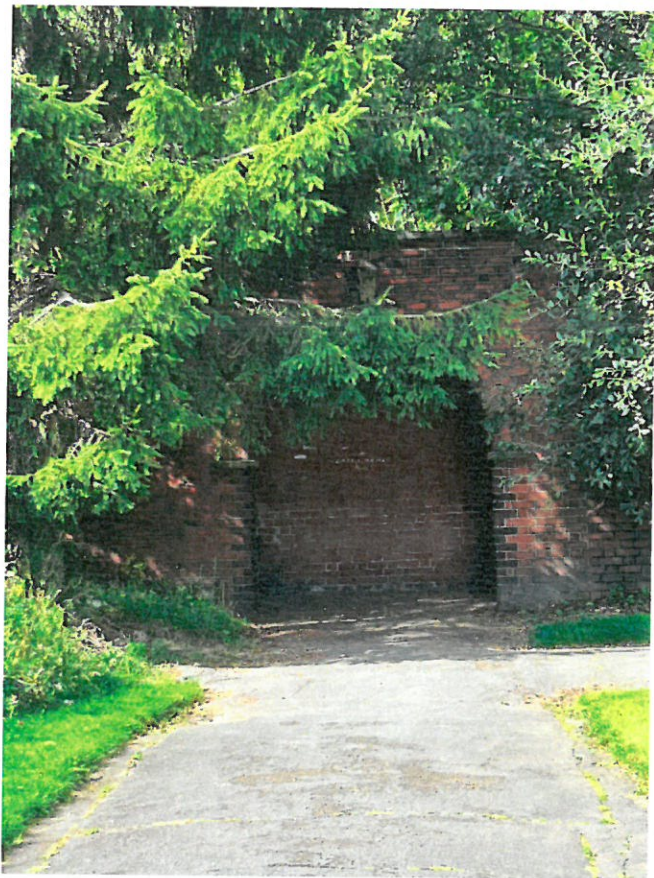
Photograph 5

- 2.03** There is a small courtyard surrounded by brickwork immediately in front of the wall, photograph 4.
- 2.04** The wall extends both to the left and to the right. At each end is a single recessed area, each accessed via a single brick arch, photographs 5 & 6, are of the left and right respectively.
