**385 Bury & Rochdale Old Rd, Rochdale**

**BAT SURVEY REPORT**

**October 2024**

**Report Ref:** KSE\_M+P\_02\_02

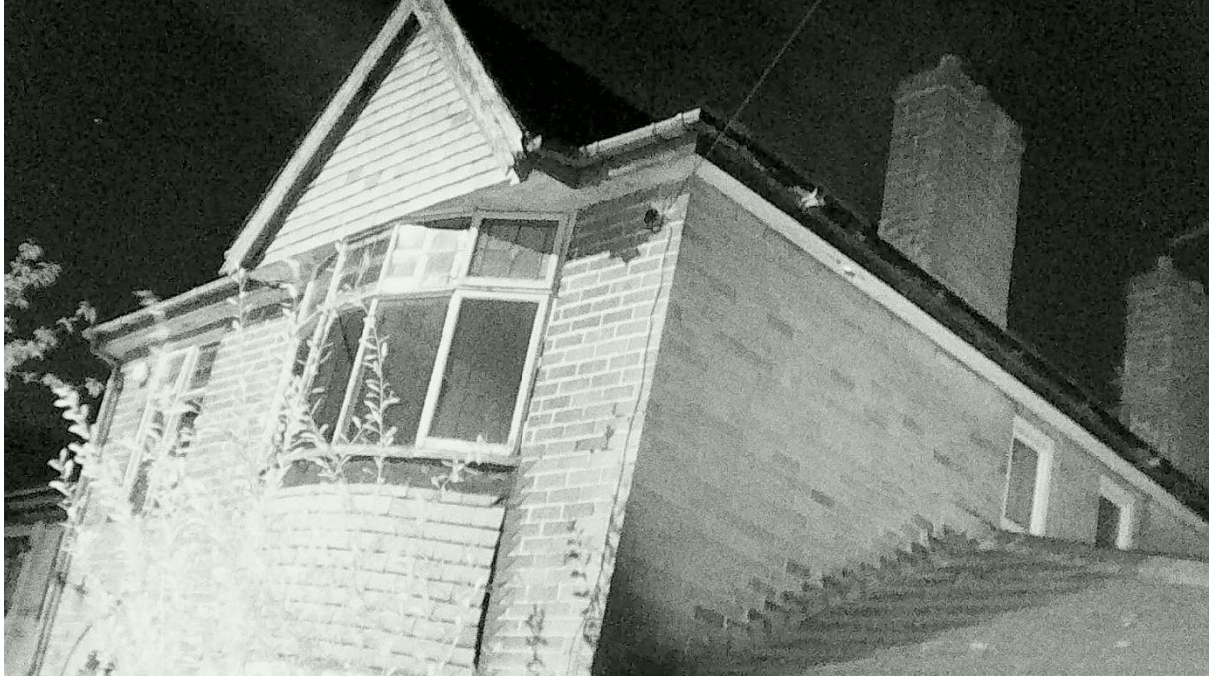
Front and east side elevation (10/08/2024)

| Date | Activity Summary |
|---|---|
| 10 <sup>th</sup> August 2024<br>(sunset 20:47) | First bat (common pipistrelle) recorded at 20:47 (pass not seen). At least three further passes recorded from rear of site southwards between 20:53 and 21:00. Common pipistrelle constantly to frequently foraging during the first hour. Activity decreased thereafter. One noctule pass recorded (not seen). No emergence observed on site or on the NVA footage. |

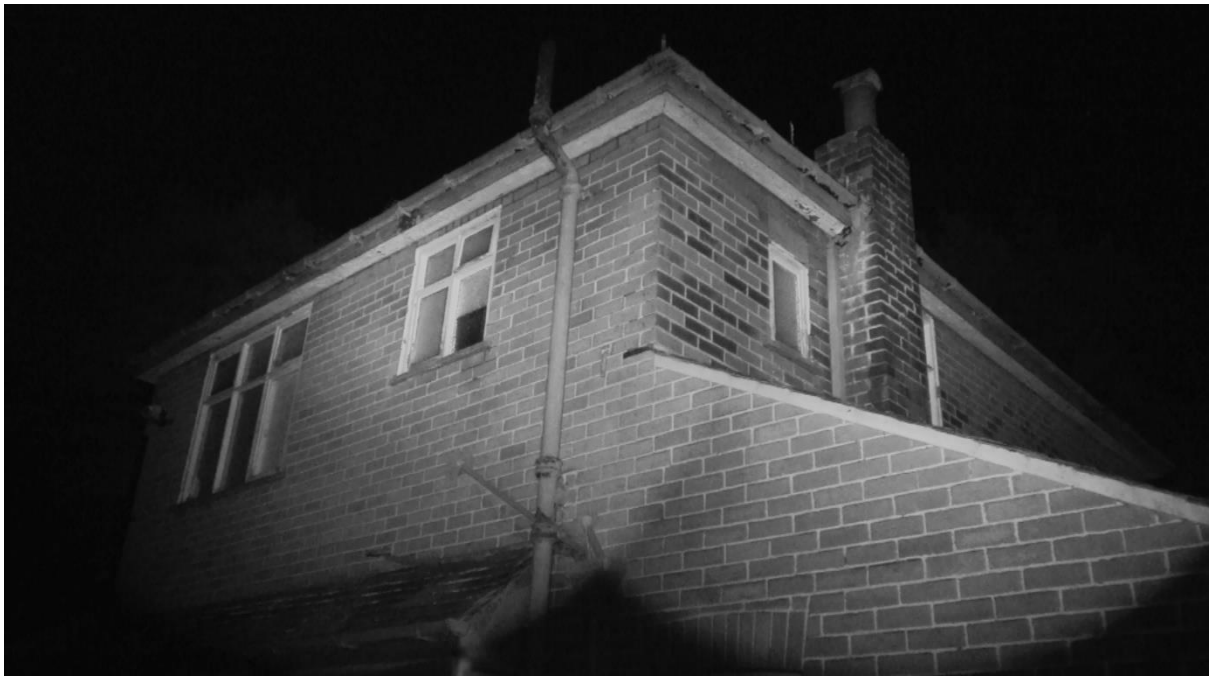
Rear and west side elevation (02/09/2024)

| Date | Activity Summary |
|---|---|
| 28th August 2024<br>(sunset 19:55) | First bat (common pipistrelle) recorded at 20:00 (pass from rear garden to south). The survey position on the rear and west elevations recorded 13 common pipistrelle foraging passes only and two noctule bat passes. The front elevation recorded seven common pipistrelle commuting passes within the first 15 minutes and occasional foraging only thereafter with no activity recorded after 20:32. No emergence observed on site or on the NVA footage. |
