## **WORMS EYE**

Our Ref: Inchfield Close/OL11 5SB/2017  
Date: 26 April 2017

**2 INCHFIELD CLOSE, NORDEN, OL11 5SB**  
**COAL MINING RISK ASSESSMENT**

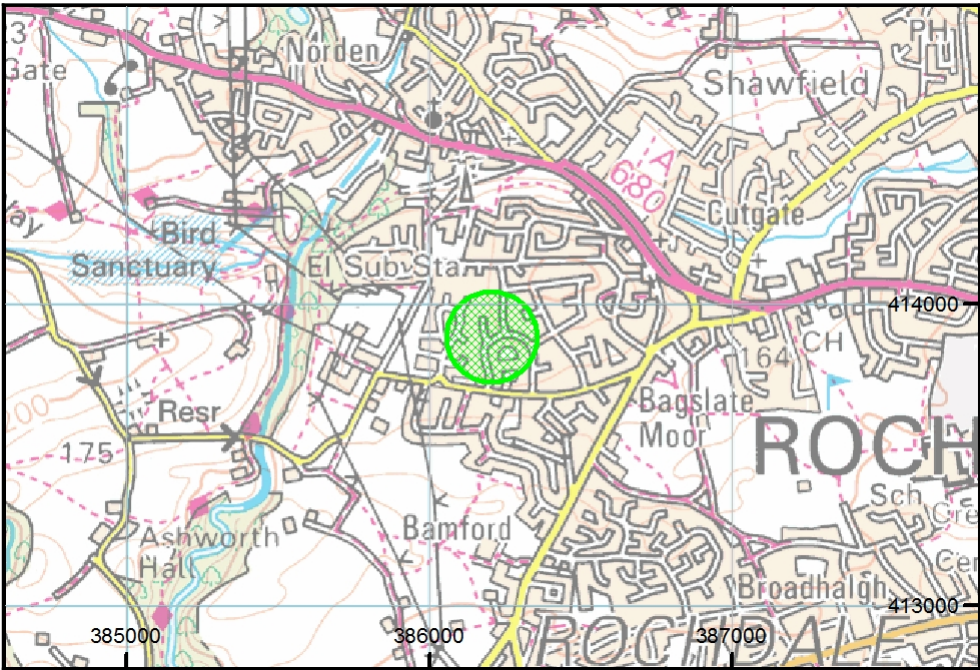
Location map

This plan shows the approximate location of the disused mine entry / entries referred to in the attached mining report. For reasons of clarity, mine entry symbols may not be drawn to the same scale as the plan.

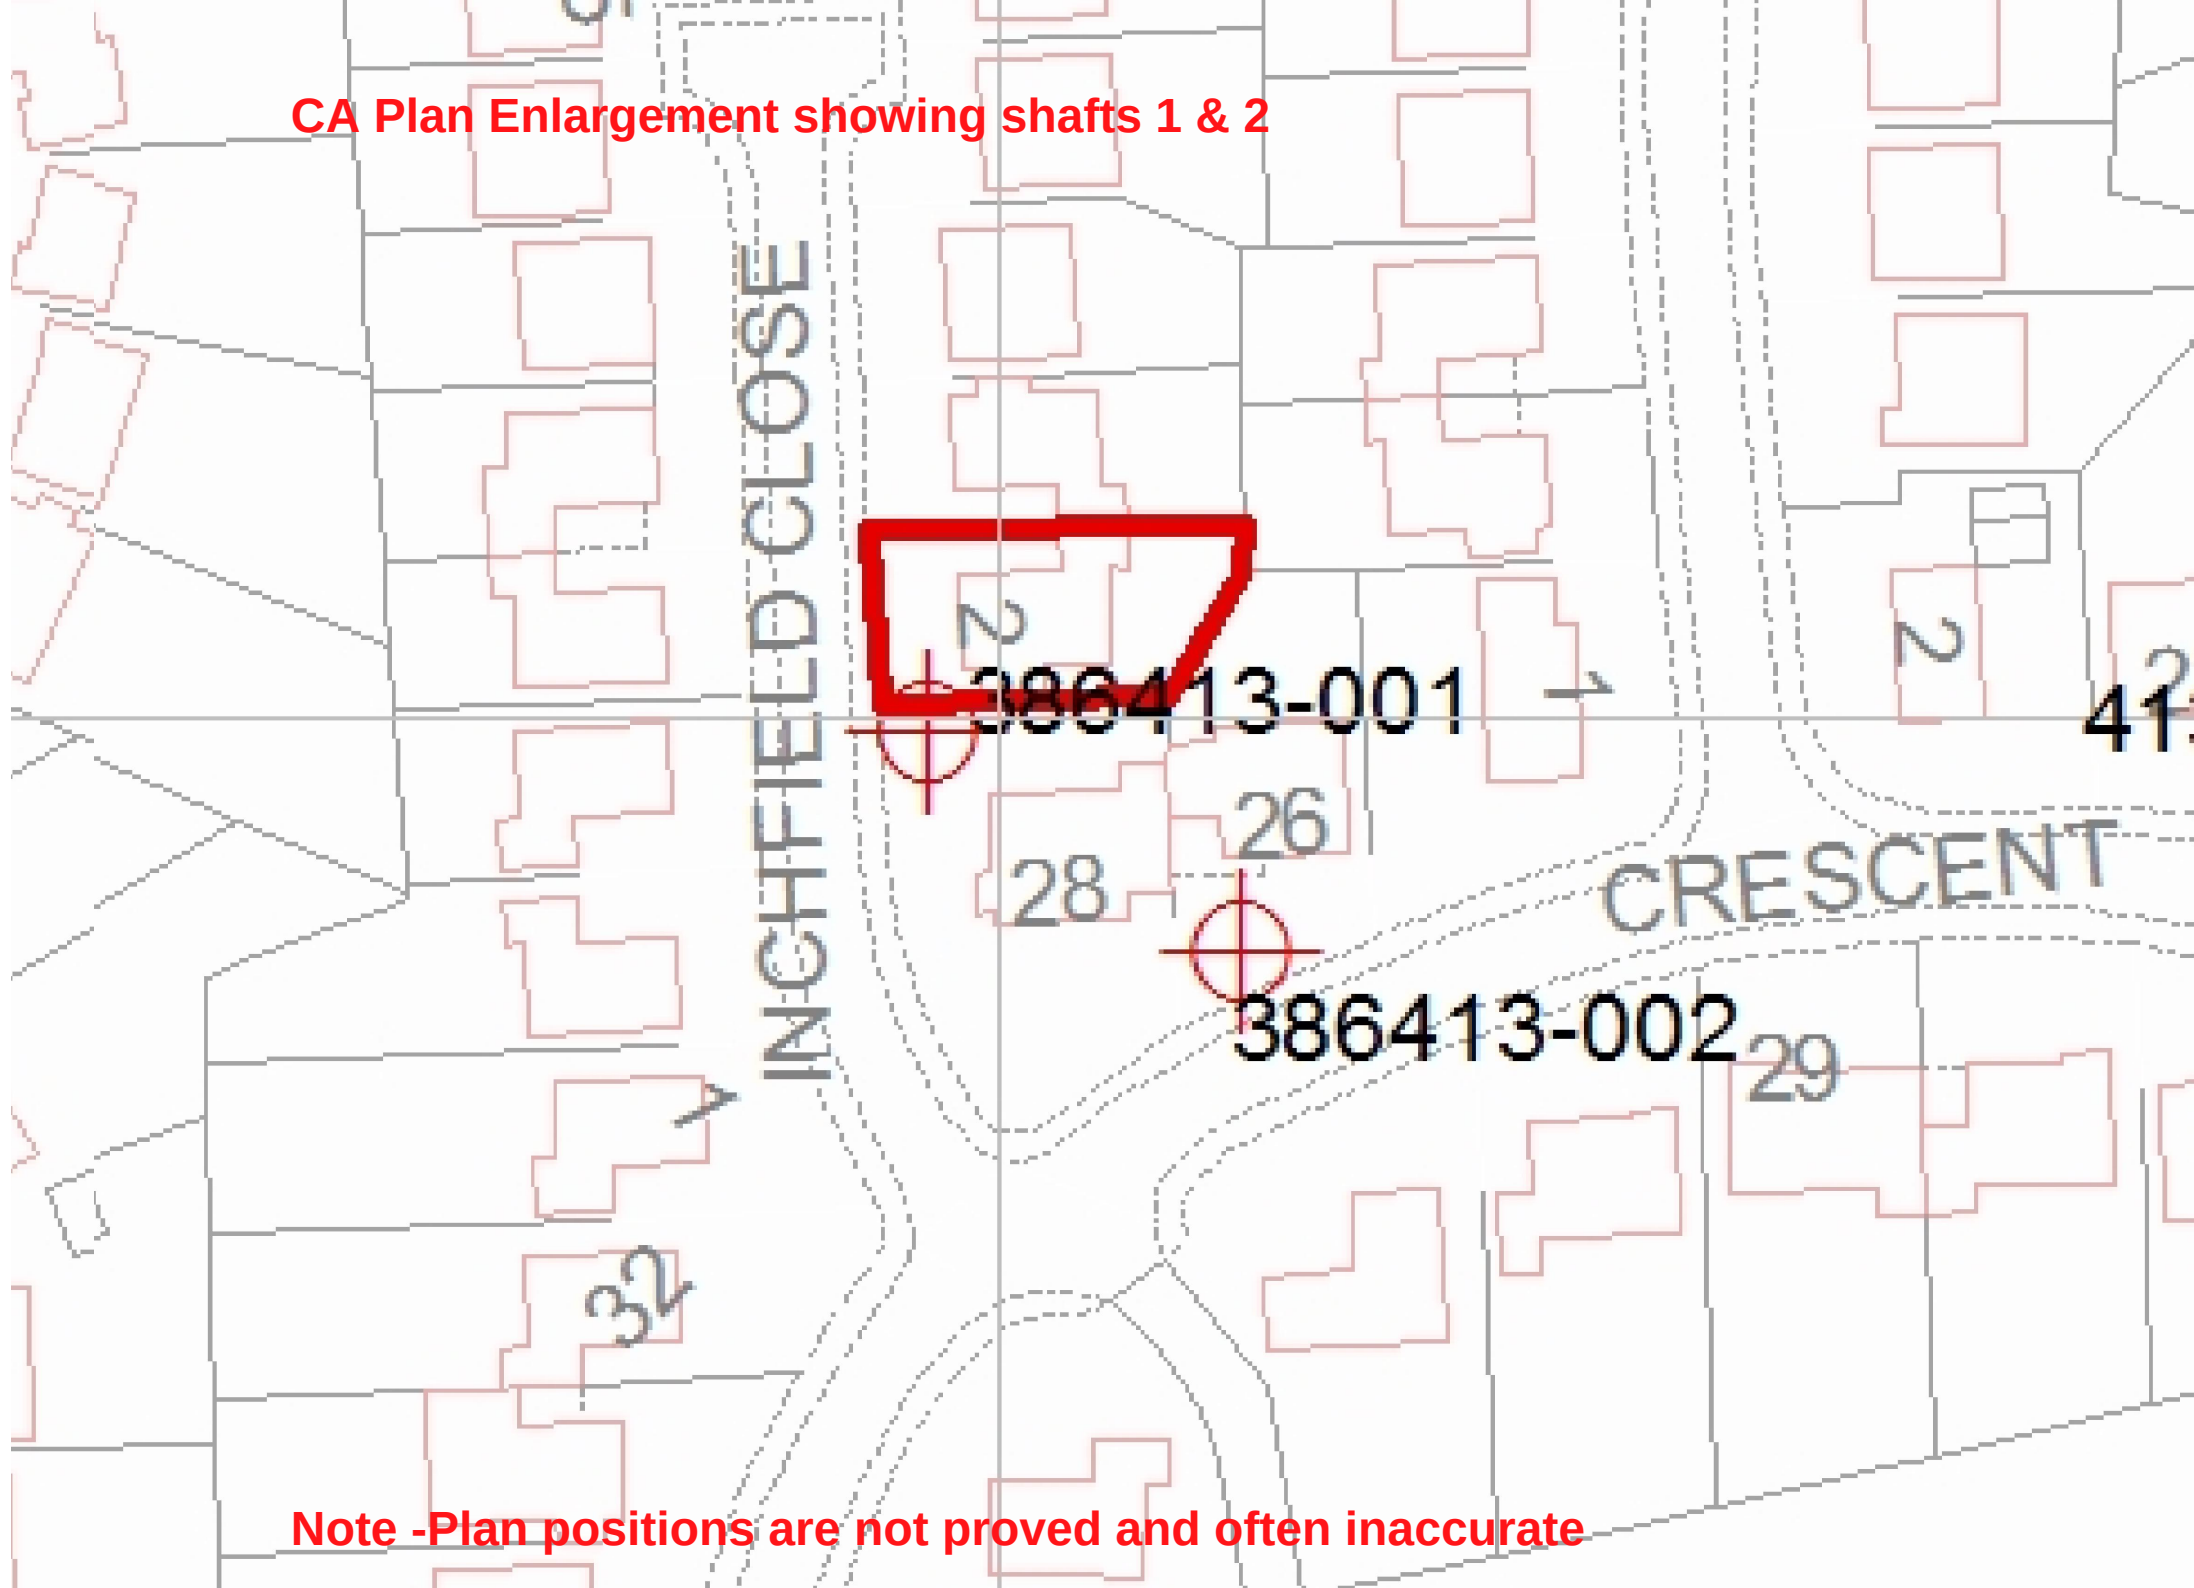
CA Plan Enlargement showing shafts 1 & 2

The shaft 1 metres south is of greatest concern and a collapse of this could cause catastrophic damage to the development.

Note -Plan positions are not proved and often inaccurate

SD81SE 398 8612 1390

If the shaft can be found fully on site (unlikely), a remediation scheme could be designed to cap the shaft. However, a no build zone is still likely to be imposed by the Coal Authority around the capped shaft.

Even if the shaft can be proved to not be on site, the zone of potential damage would extend onto much of the site and remedial works would be required to prevent damage.
