**Issue Date**  
6<sup>th</sup> April 2022

**Reference Number**  
HCA02250

## Asbestos Demolition Survey

**Site Address**  
Unit D8  
Fieldhouse Industrial Estate  
Rochdale  
Lancashire  
OL12 0AA

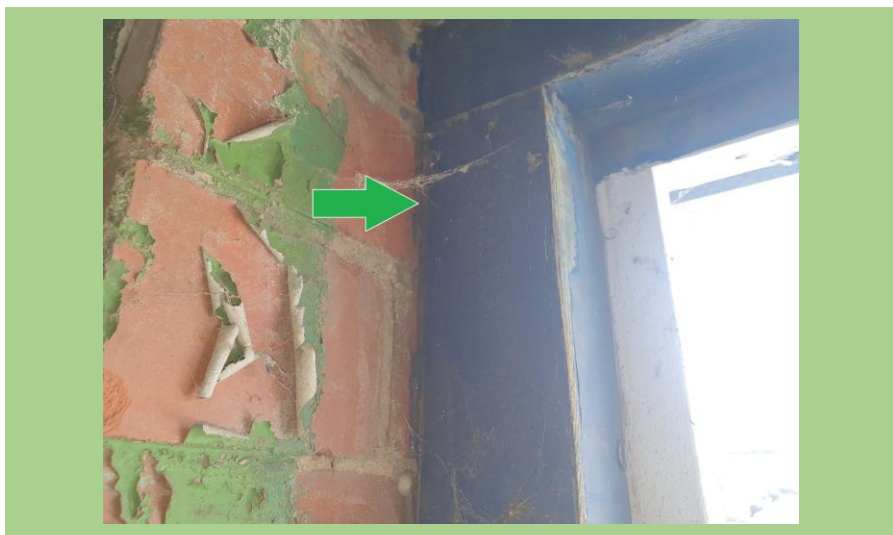
| Sample Number | 1 | No Asbestos Detected |

| Floor, Room | Ground floor, G.01 | Location | Entrance door |
| Material | Mastic | Quantity | 5 lin. m. |

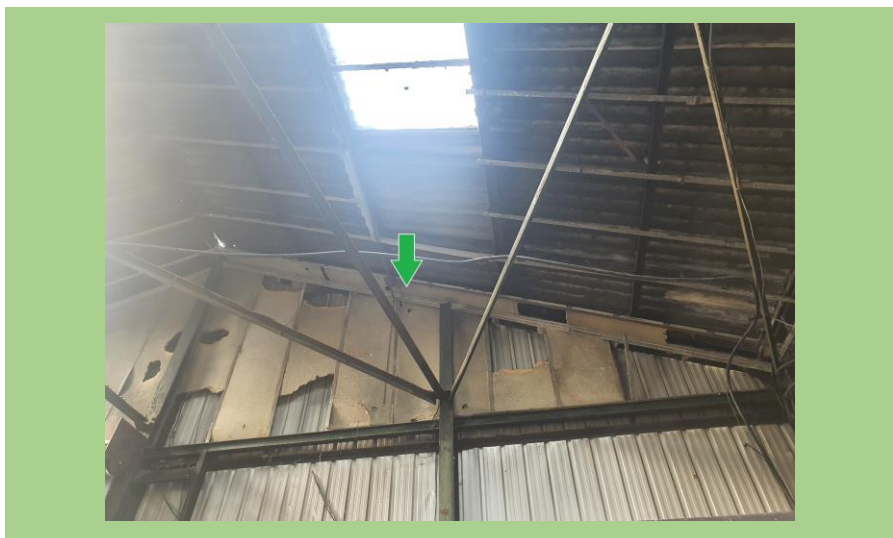
| Sample Number | 3 | No Asbestos Detected |

| Floor, Room | Ground floor, G.02 | Location | Underside of the roof, at the front of the unit |
| Material | Painted fibreboard | Quantity | 6 lin. m. |

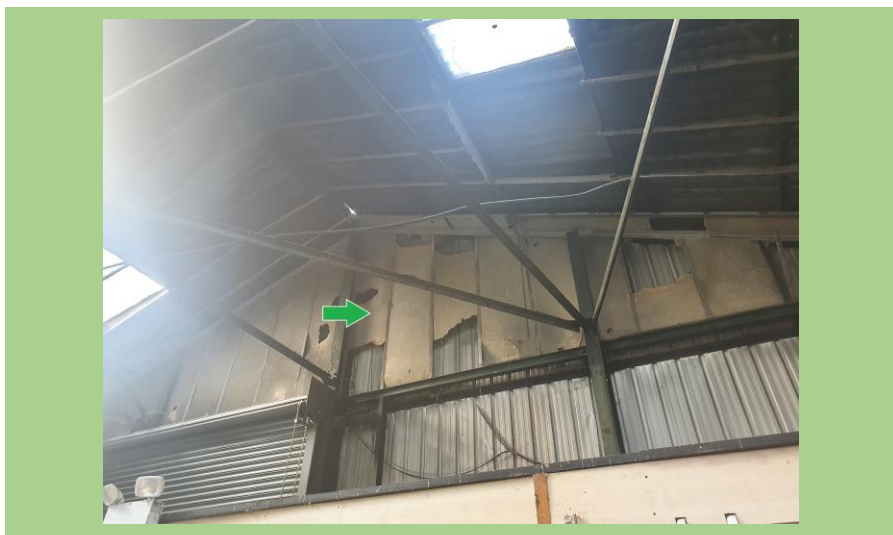
| Sample Number | 5 VI 3 | No Asbestos Detected |

| Floor, Room | Ground floor, G.02 | Location | High level walls, at the front and rear of the unit |
| Material | Painted fibreboard | Quantity | 40 sq. m. |

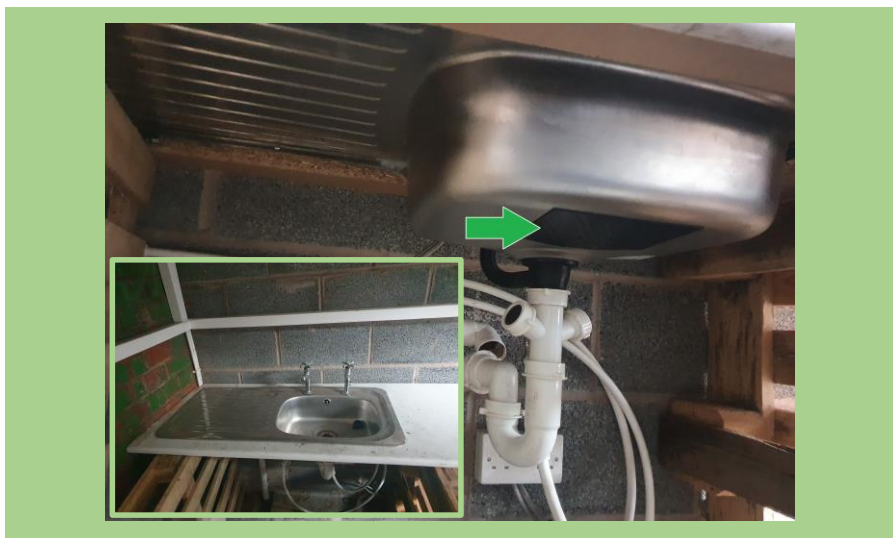
| Sample Number | 7 | No Asbestos Detected |

| Floor, Room | Ground floor, G.04 | Location | Underside of the sink |
| Material | Bitumen pad | Quantity | 1 unit |

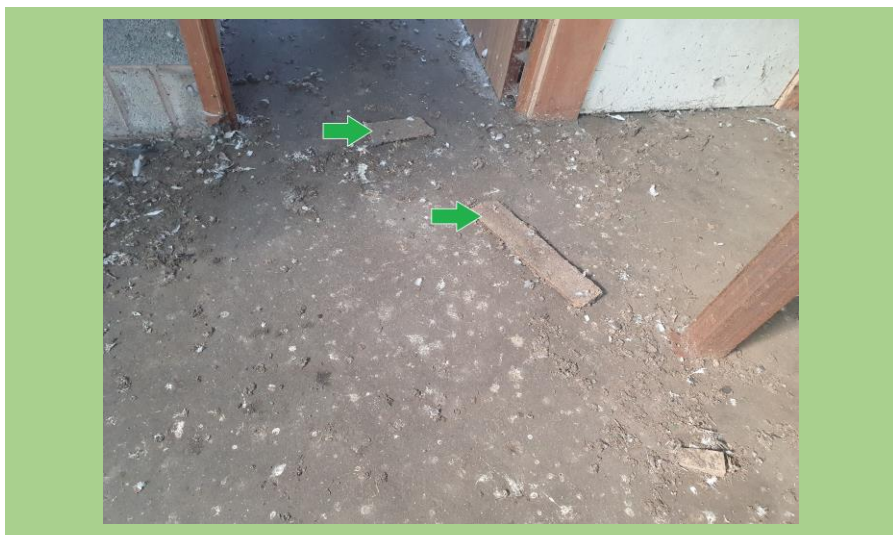
| Sample Number | 10 VI 3 | No Asbestos Detected |

| Floor, Room | Ground floor, G.02 | Location | Laying loose on the floor |
| Material | Painted fibreboard debris | Quantity | < 1 sq. m. |

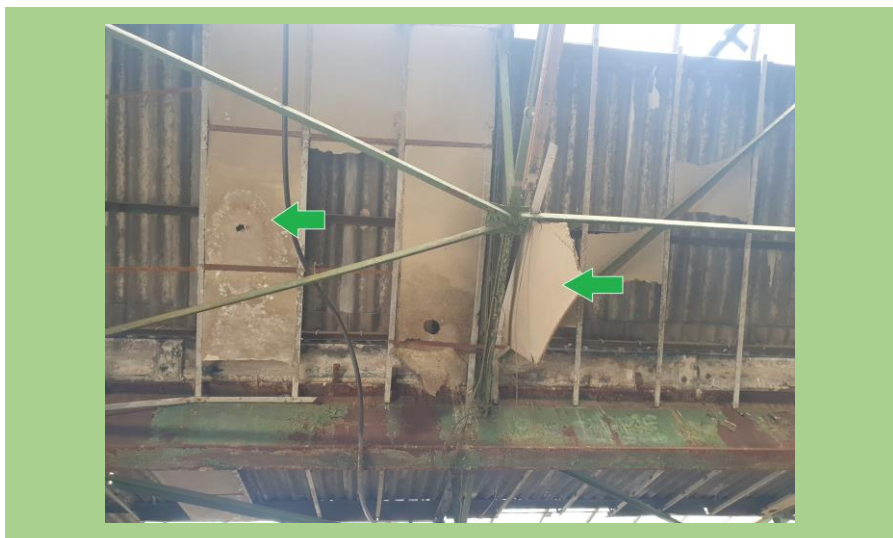
| Sample Number | 12 | No Asbestos Detected |

| Floor, Room | Ground floor, G.05 | Location | Lining the underside of the roof |
| Material | Painted fibreboard | Quantity | 400 sq. m. |

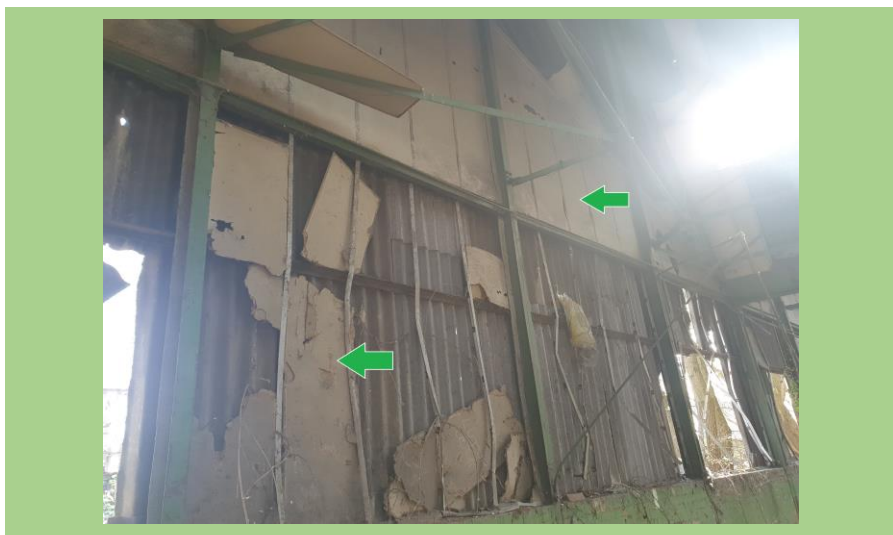
| Sample Number | 14 VI 12 | No Asbestos Detected |

| Floor, Room | Ground floor, G.05 | Location | Lining the perimeter walls |
| Material | Painted fibreboard | Quantity | 300 |

The non-asbestos containing material extends downwards into rooms G.07 and G.08.

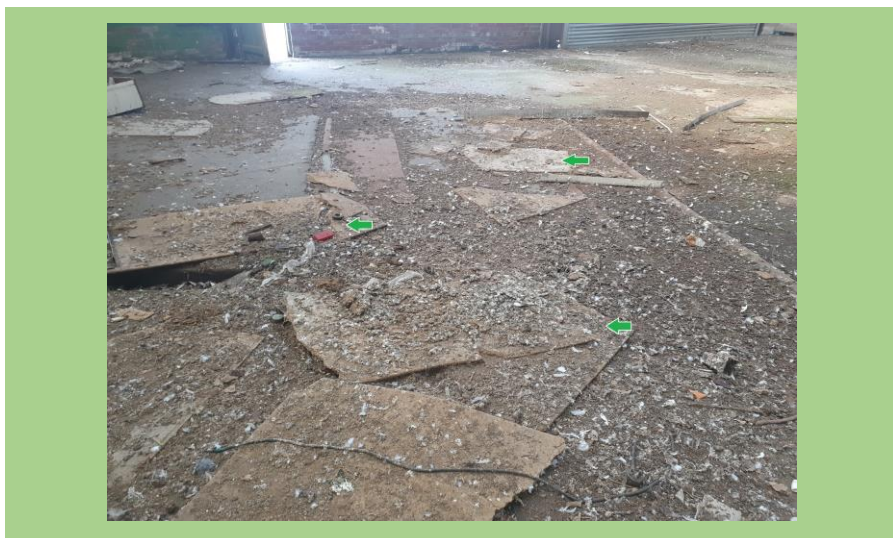
| Sample Number | 19 VI 12 | No Asbestos Detected |

| Floor, Room | Ground floor, G.05 | Location | Laying loose on the floor |
| Material | Painted fibreboard debris | Quantity | 15 sq. m. |

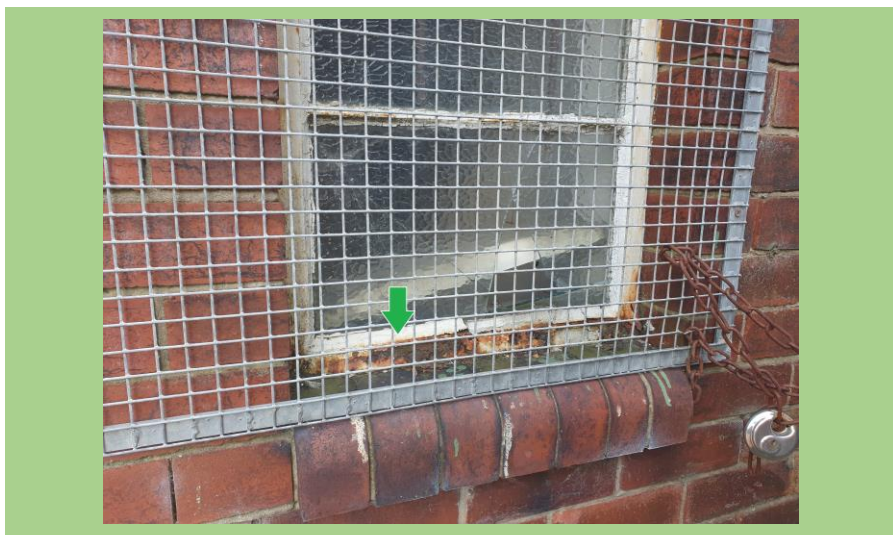
| Sample Number | 25 | No Asbestos Detected |

| Floor, Room | External | Location | Windows |
| Material | Putty | Quantity | 40 lin. m. |

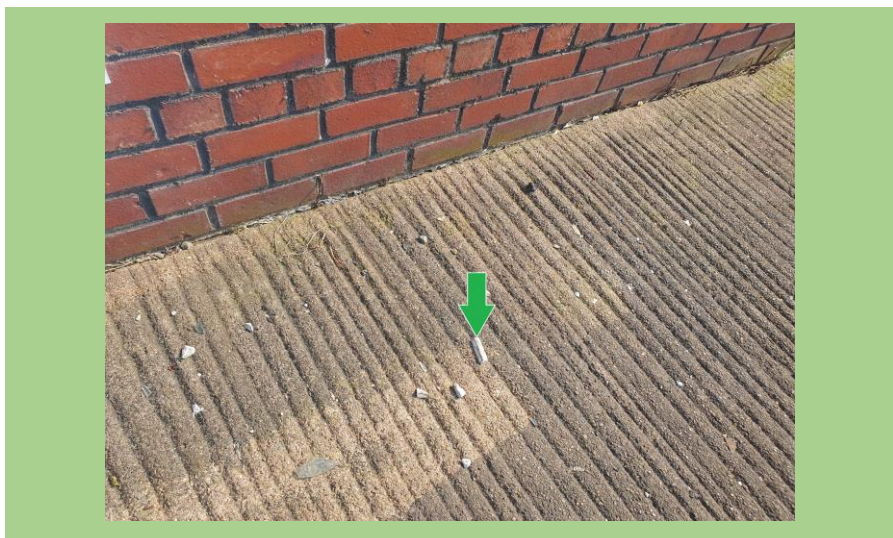
| Sample Number | 27 VI 25 | No Asbestos Detected |

| Floor, Room | External | Location | Laying loose on the floor |
| Material | Putty debris | Quantity | <1 lin. m. |

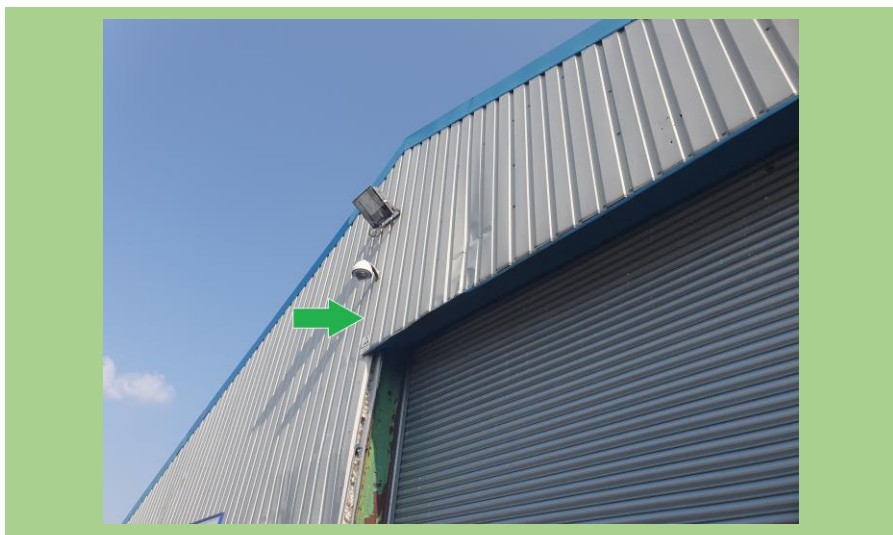
| Sample Number | 28 | No Asbestos Detected |

| Floor, Room | External | Location | Grey metal sheeting |
| Material | Composite coating | Quantity | 160 sq. m. |

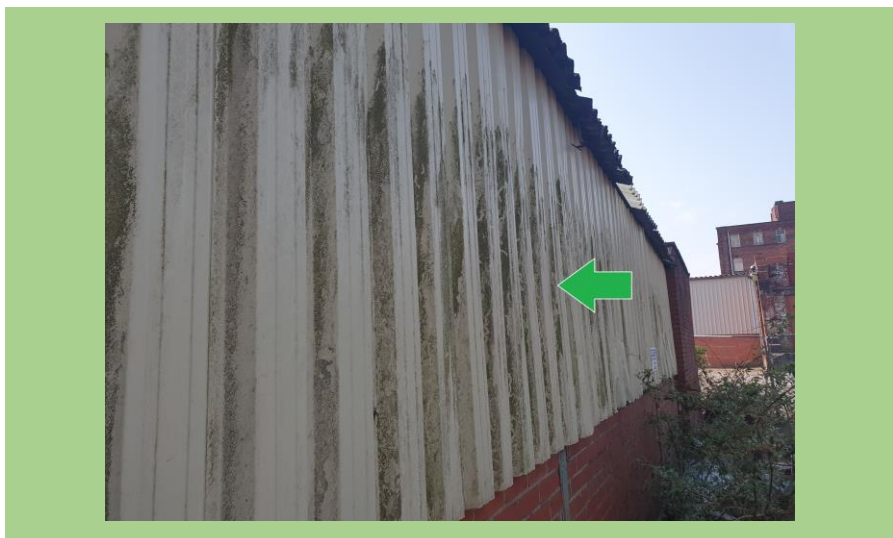
| Sample Number | 29 | No Asbestos Detected |

| Floor, Room | External | Location | Yellow metal sheeting |
| Material | Composite coating | Quantity | 40 sq. m. |
