SITE: STAKEHILL LANE, MIDDLETON

## Terrain Surveys Site Attendance Report

**Client:** BWB Consulting (Birmingham)  
**Contact:** Lucy Reeves  
**Date:** 8<sup>th</sup> July 2024  
**Site:** Stakehill Industrial Estate  
**Job Ref:** TS24-386

Attended site to undertake an investigation/connectivity survey of the surface water and foul water drainage systems within the land to the north and east of Stakehill Industrial Park, focusing on specific sections of drainage systems & watercourses.

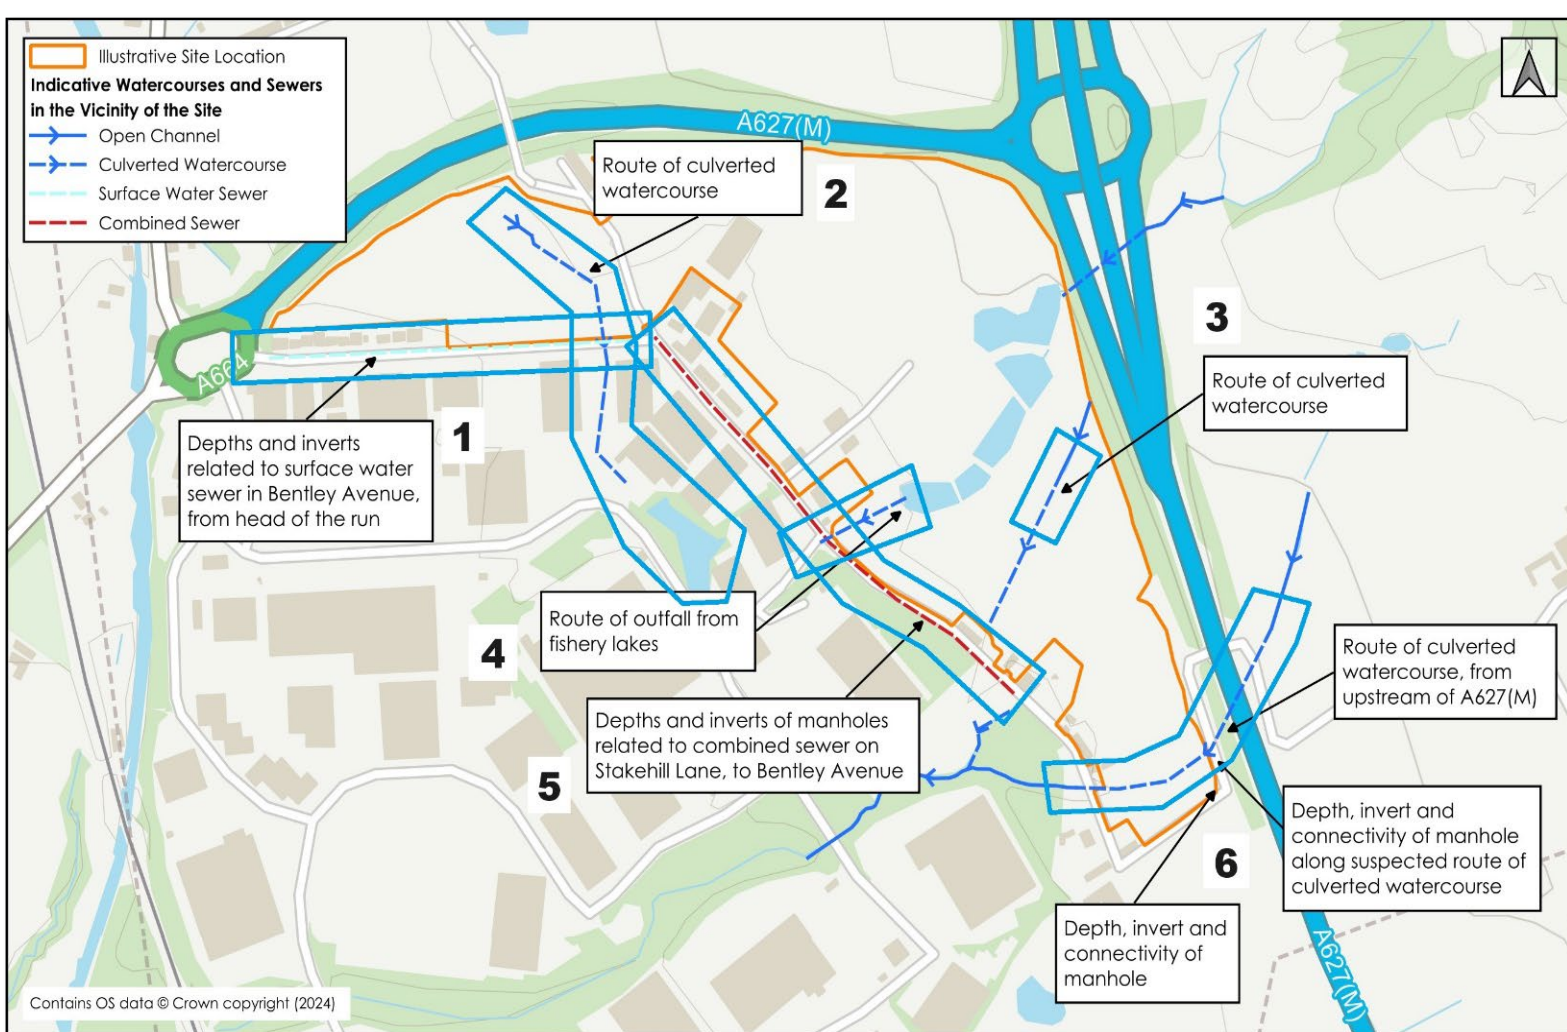
Set up temporary traffic management to safely access & lift all accessible manholes within Bentley Ave and undertook a connectivity survey of the surface water system, including recording measurements to complete detailed manhole cards.

Manhole S5 was confirmed to be the head of the surface water run serving this section of carriageway before flowing downstream through to manhole S8.

The main line was noted to be free flowing although during the survey several of the road gullies were observed to be blocked and causing localised flooding.

- Combination Lorry Jetting Unit to attend site to empty and HPWJ all road gullys serving Bentley Ave
- Break out and replace seized manhole MH2 to complete survey of chamber and verify possible connectivity with MH3 (see Area 2)
