# BRIEF ENVIRONMENTAL AUDIT

Branch Road Farm

Littleborough

Author: Daniel Slattery  
Client: Mr Wildman.  
Reference: rep-tjba-wildman-branch rd farm-brief env  
audit-101219.docx

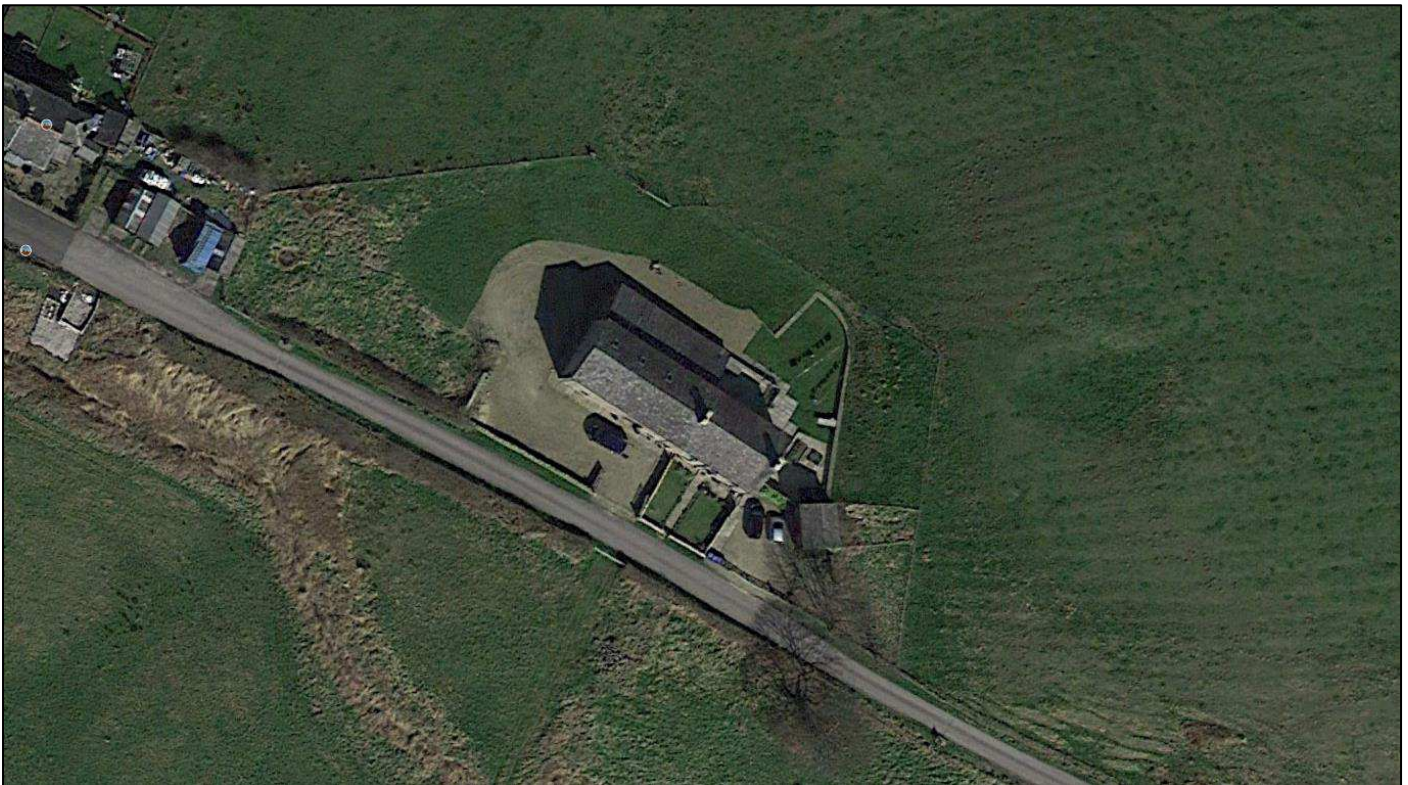
9.8. Google Earth c2016

| c2016 | All outbuildings removed and existing hardstanding area concrete appears to have been replaced with alternative hardstanding also in place of the former outbuildings. Part of the surrounding agricultural field has been fenced off to be included in the Site curtilage and turned in to lawns. | N/A. |

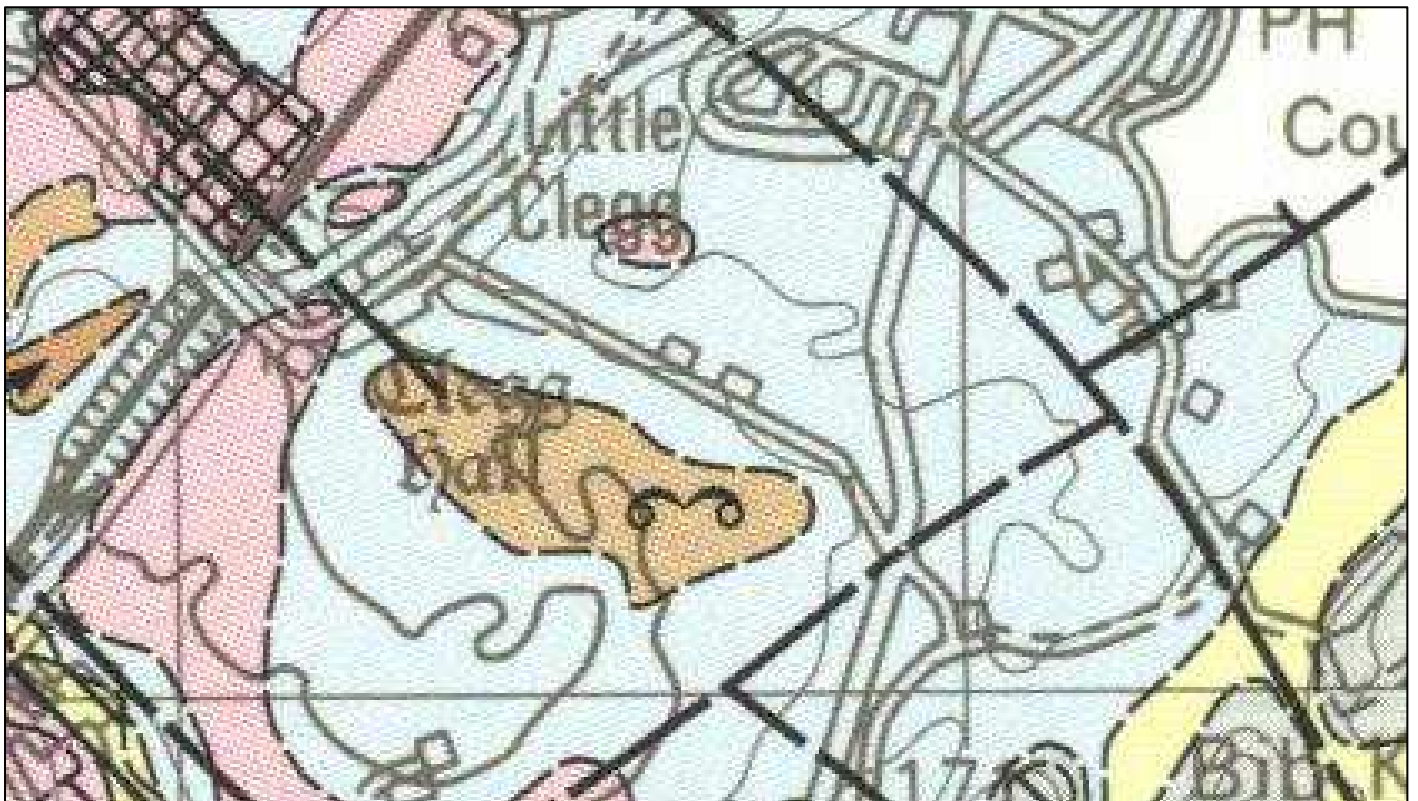
9.10. BGS Geological Map (Superficial).

| Superficial Geology: | The majority of the area comprises boulder clay, with some sand & gravel deposits to Owl Hill (N) approx. 100m distant. Lacustrine deposits noted to the low lying fields approx. 100m to the S. |
