06<sup>th</sup> October 2022

Bloor Homes North West  
2 - 4 Whiteside Business Park  
Station Road  
Holmes Chapel  
Cheshire  
CW4 8AA

## LAND OFF HOLLINGWORTH ROAD, LITTLEBOROUGH HYDROLOGICAL ASSESSMENT

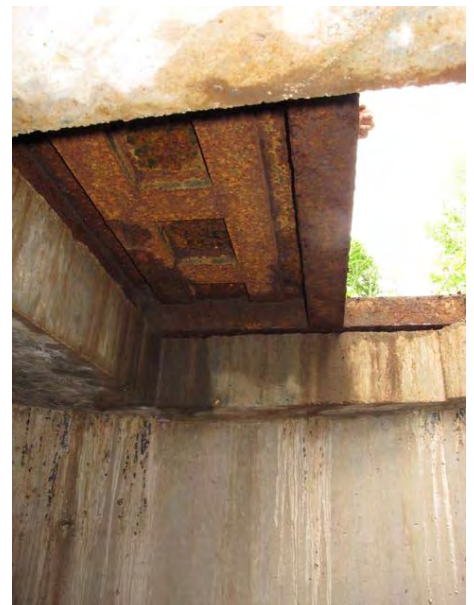
Water infiltration and associated scaling has occurred at Level 1 of the chamber. Water appears to be ingressing at the joint between at the top most MH ring and the reducing slab. Some of the grouted up lifting holes in the MH rings are weeping slightly.

View from Level 1 of MH rings showing infiltration.

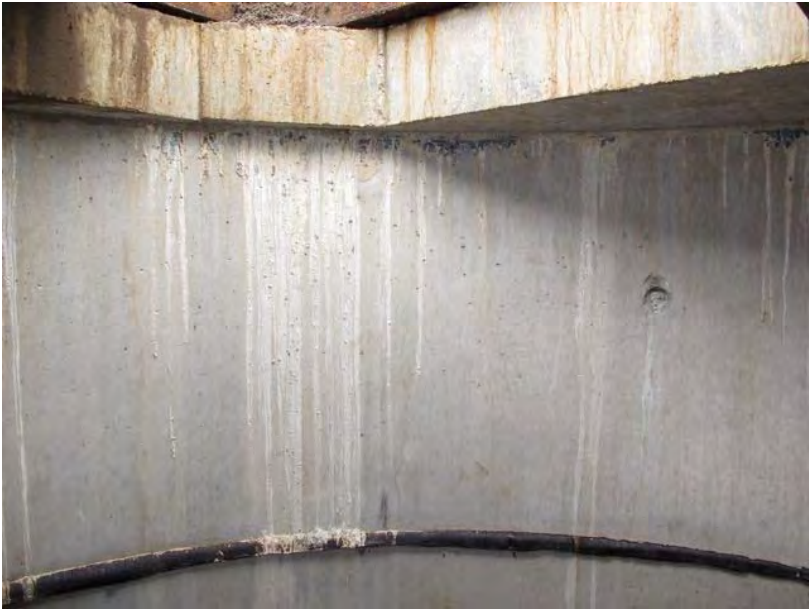
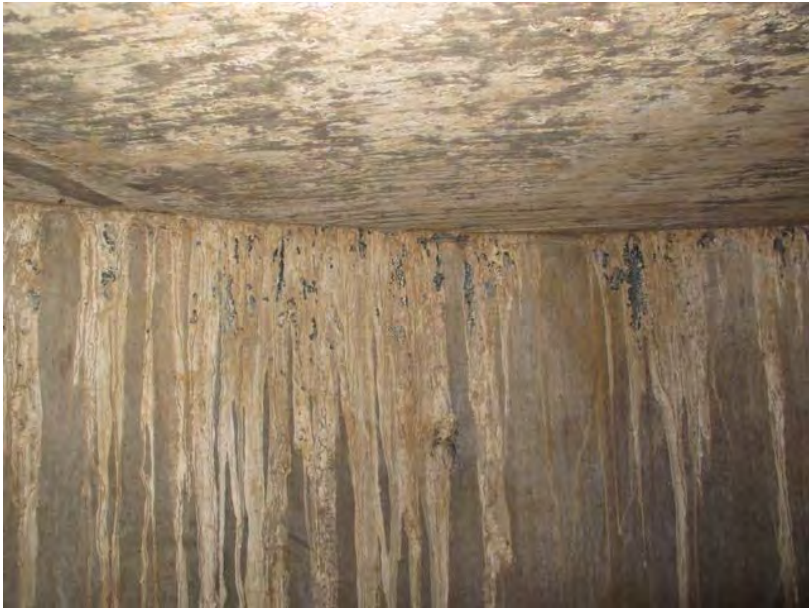
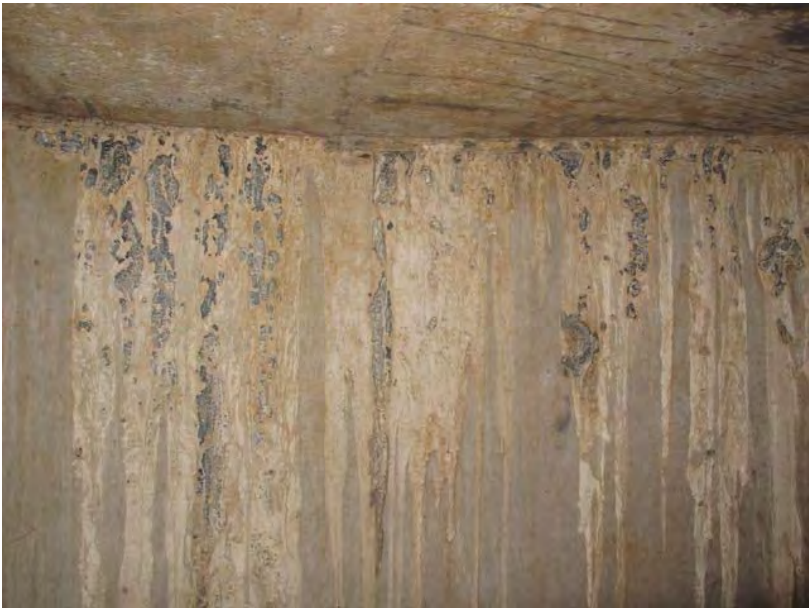
View from Level 1 through to Level 2

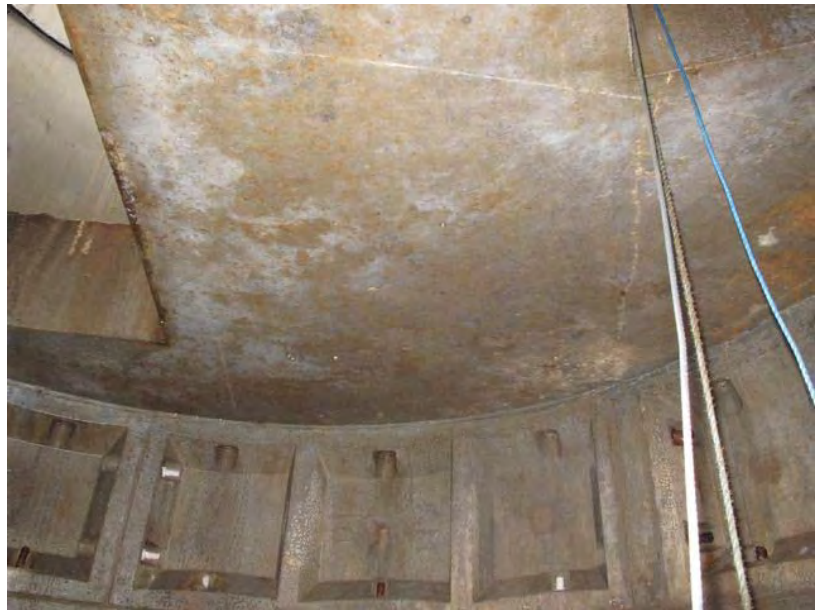
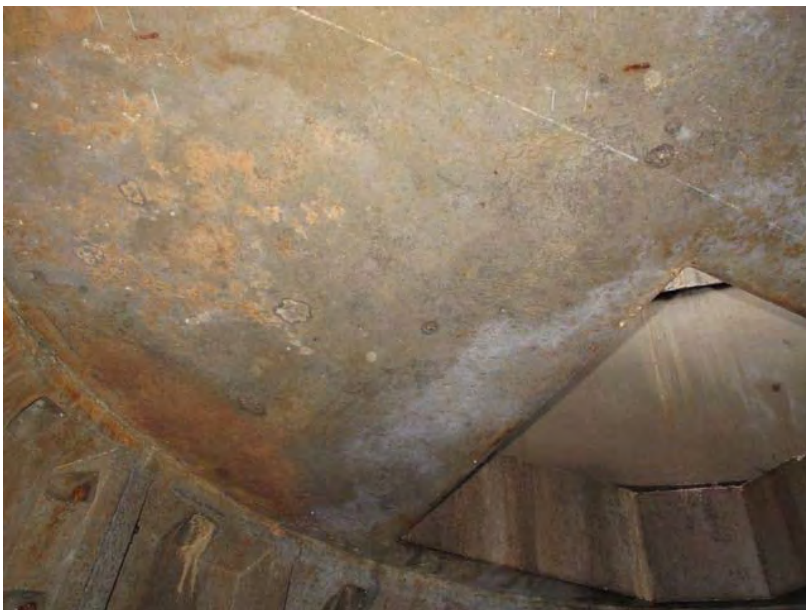
The stainless ladder from Level 1 to Level 2 is in good condition and is secure. The landing at Level 2 has some debris (stones and broken masonry) which does not appear to have been part of the original chamber structure. The reducing slab structure appears to be in good condition.

Views from Level 2 Landing  
Showing Debris, Ladders and  
Cover Slab above.

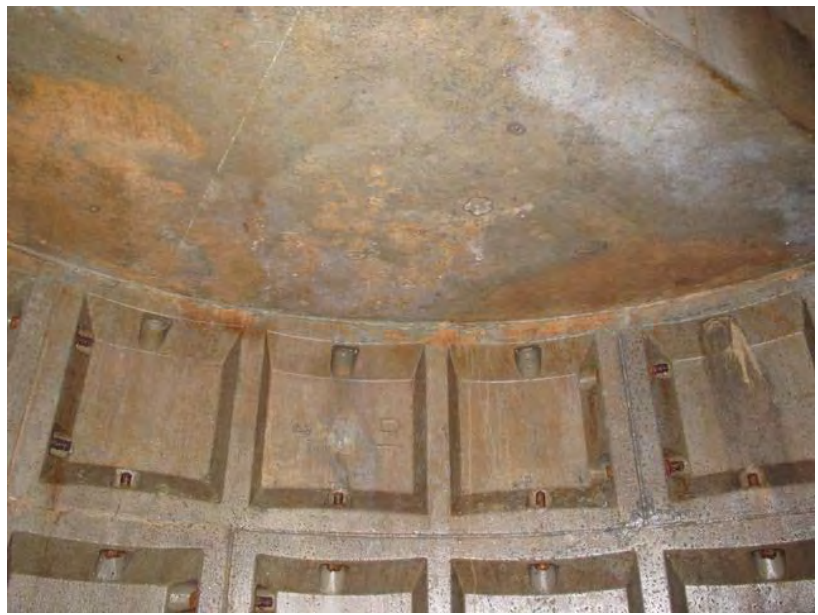
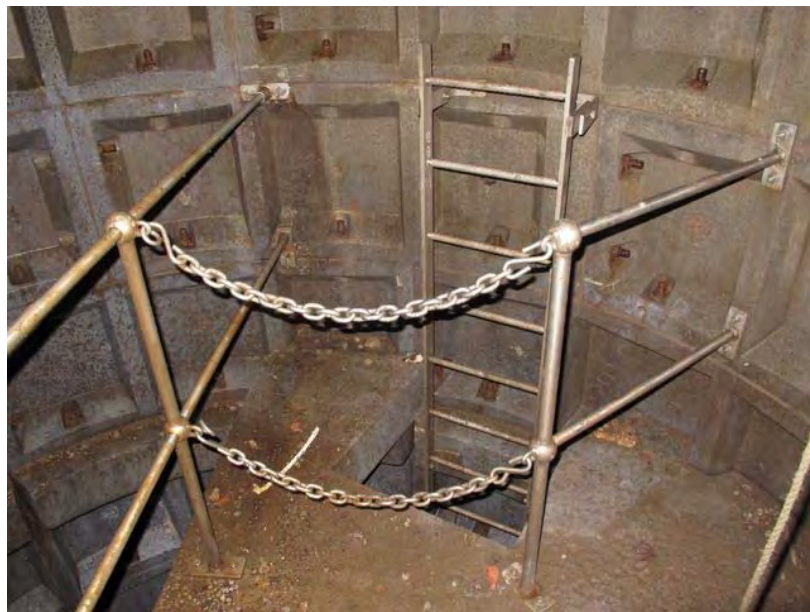
The stainless hand rails and chains are secure and in good condition.

View of Access Ladder to Level 3, Hand  
Rails and Safety Chains.

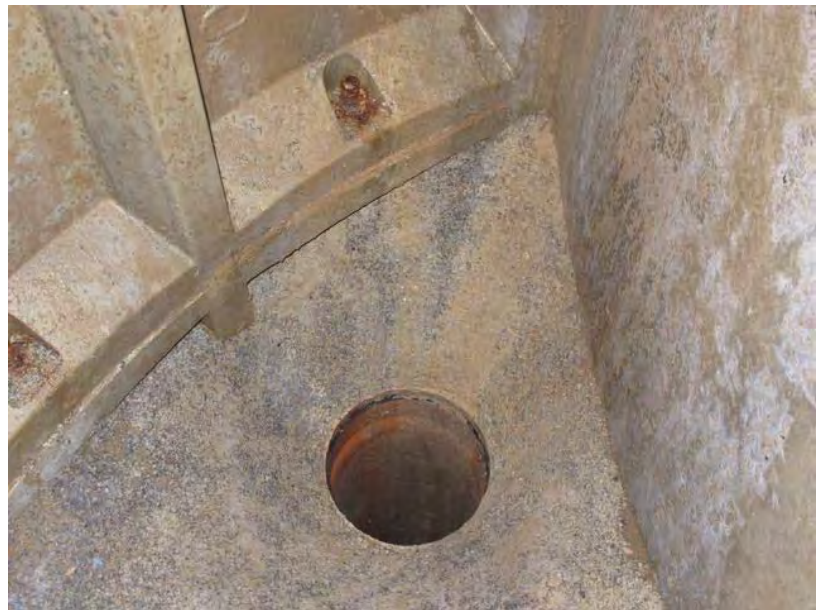
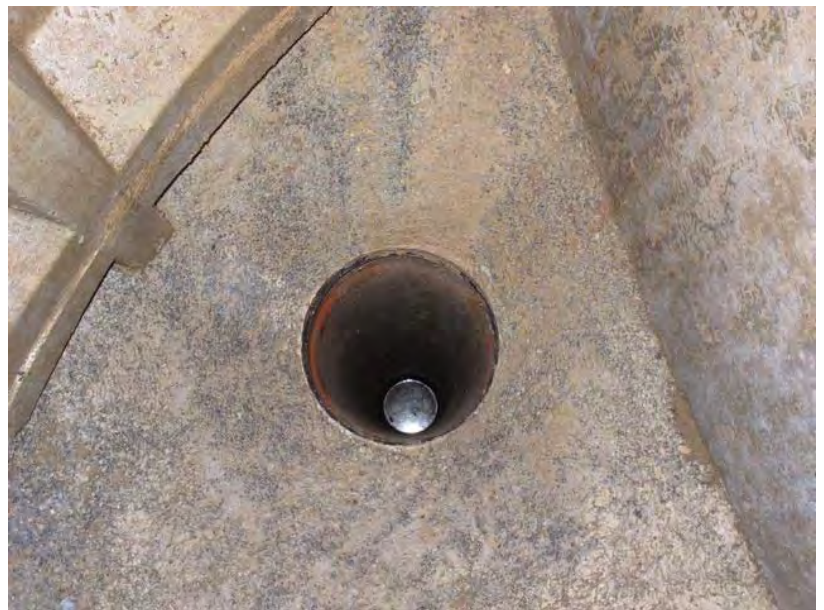
There is infiltration through some of the PCC bolted sections and minor rusting of the bolts and fasteners. None appeared to be missing or broken at the time of our inspection.

Typical Detail of PCC Bolted Sections and Fasteners.

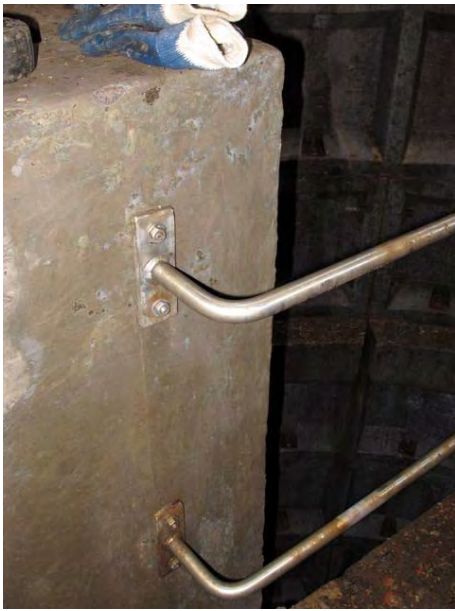
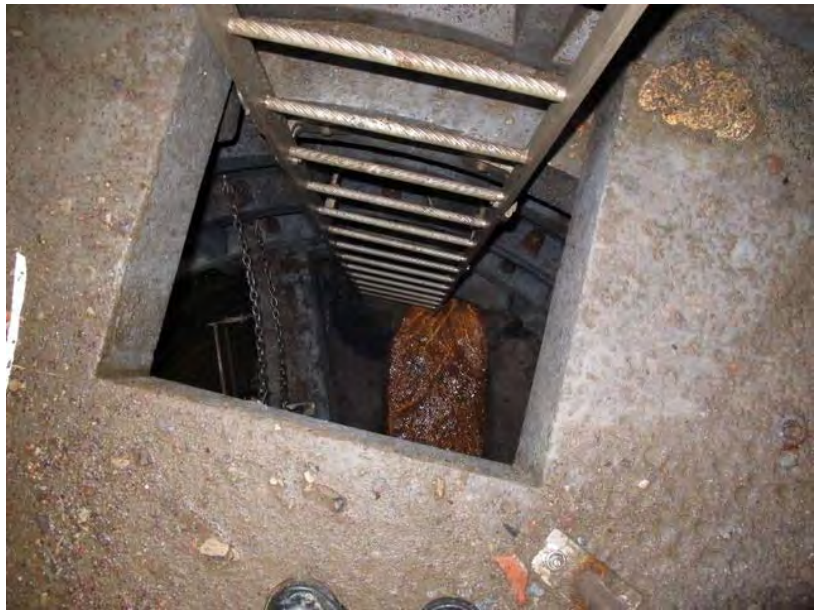
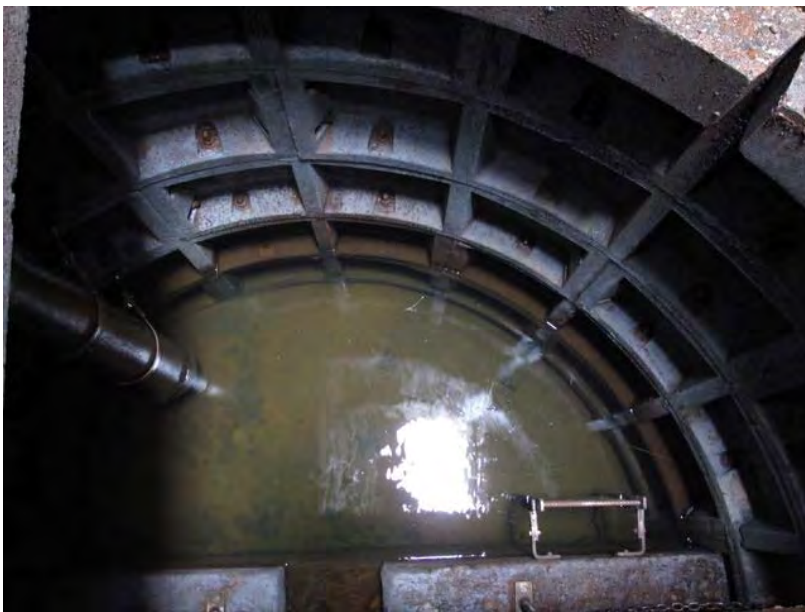
Views from Level 2

Foot of Ladder and Outlet Pipe at Level 3

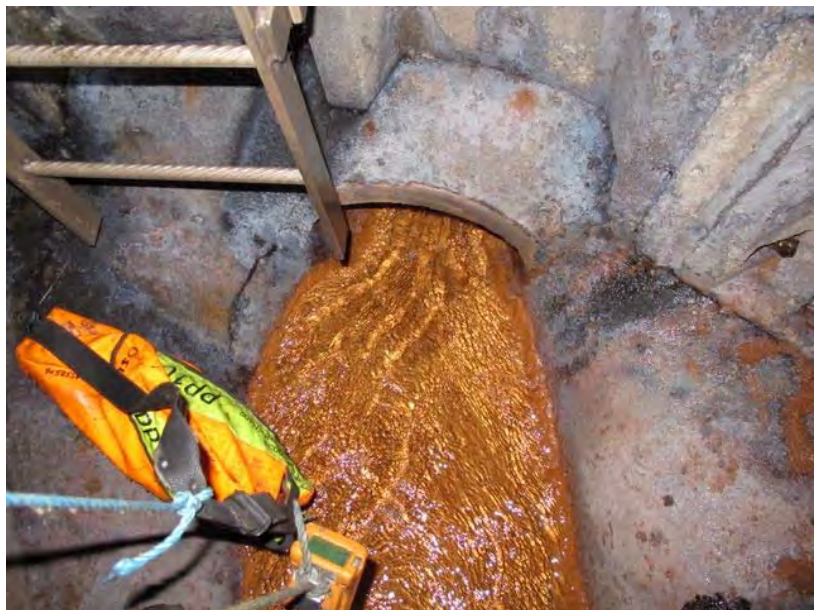
The stainless ladder from Level 2 to Level 3 is in good condition and is secure. The benching around the 375mm pipe has a thin layer of greasy material and slime. A bag (possibly rat control) is lying on the benching.

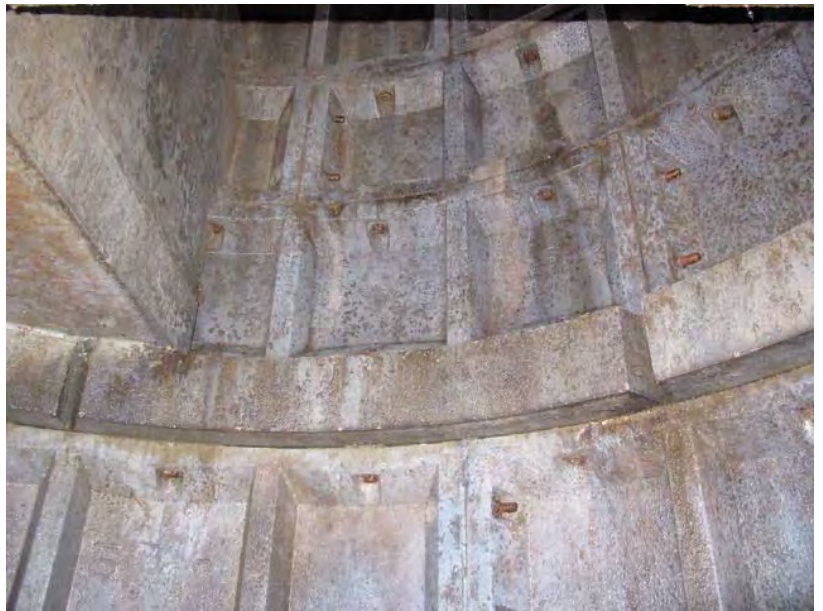
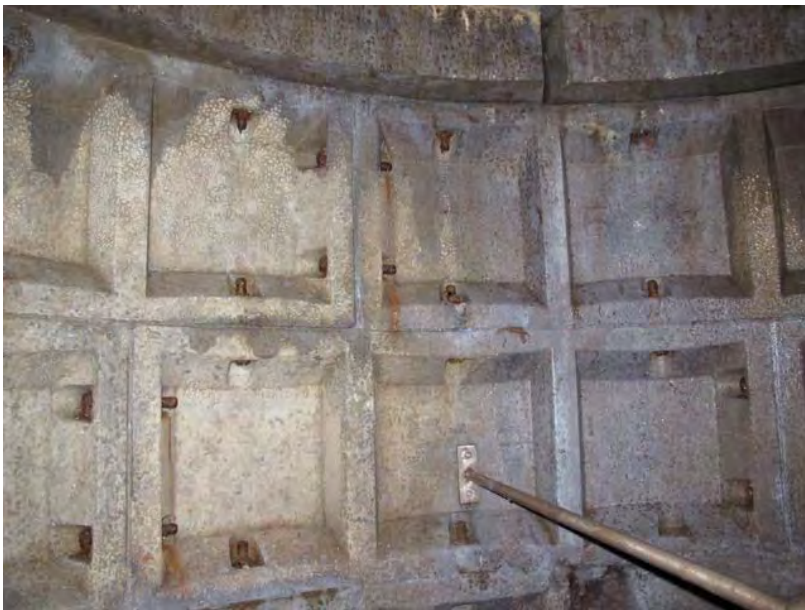
There is some infiltration at the side of the inlet pipe on top of the benching. The area is blackened.

Views of MH Walls at Level 3

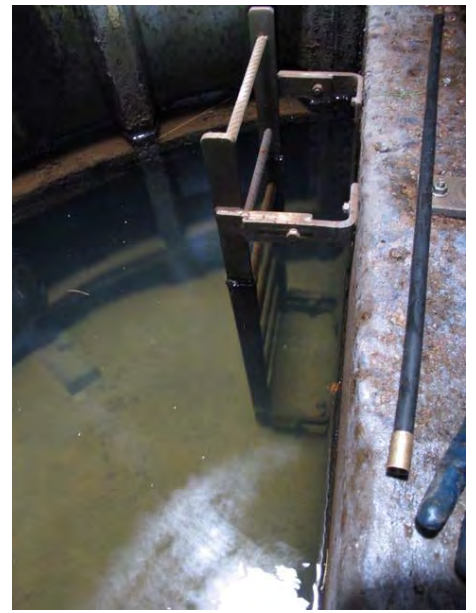
Outlet Pipe

The wall forming the pocket chamber is in good condition as is the outlet pipe and concrete benching.

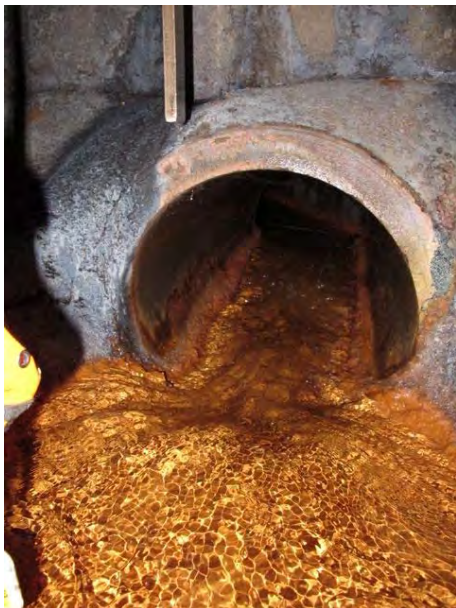
Channel

The 375mm channel is lined with an ochre deposit and is clearly visible in the photographs. There was very little loose debris in the channel in the pipe at the time of the inspection. The water level in the channel was fast moving ( $>0.5\text{m/s}$ ) and at approximately 30% level.
