MILNROW LIBRARY  
SPECIALIST INVESTIGATIONS  
January 2022

**Bradshaw Gass & Hope LLP**  
**Architects Consulting Engineers Quantity Surveyors**  
**21 Silverwell Street Bolton BL1 1PR**

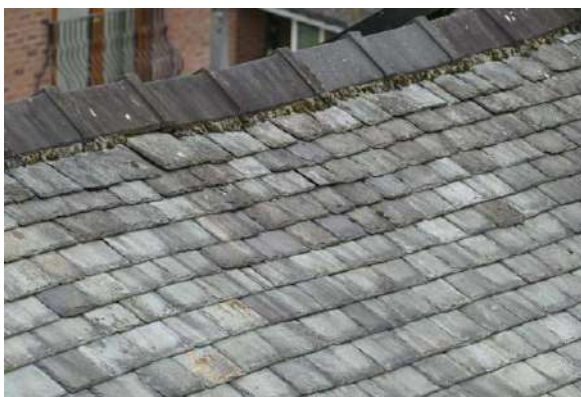
There are two distinct dips in the line of the ridge. It is not wholly clear if these were present during the 2000 refurbishment.

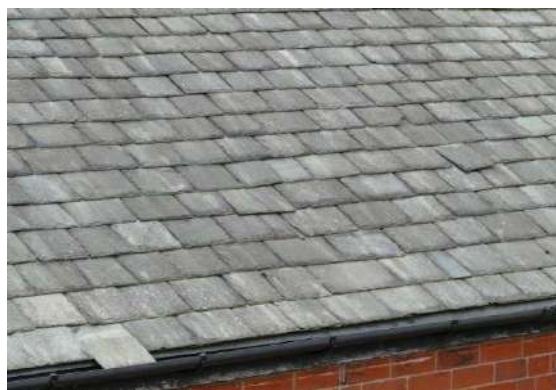
South several slipped slates and several with initial lamination or splits (south slope)

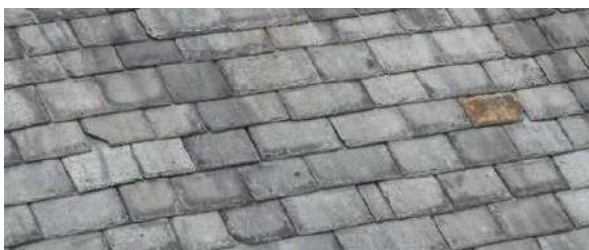
Damaged slates (South slope)

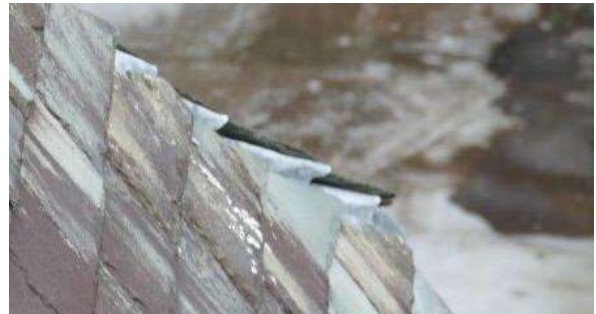
Mitred lead hip detail has lifted leaving the edge slates vulnerable to wind damage. Some re-fixing and re-dressing is now required to ensure integrity.

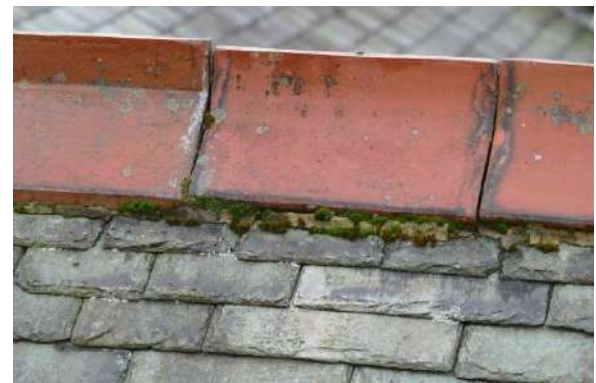
Open joints and split bedding to ridge tiles. Past use of different section ridge tiles for repairs.

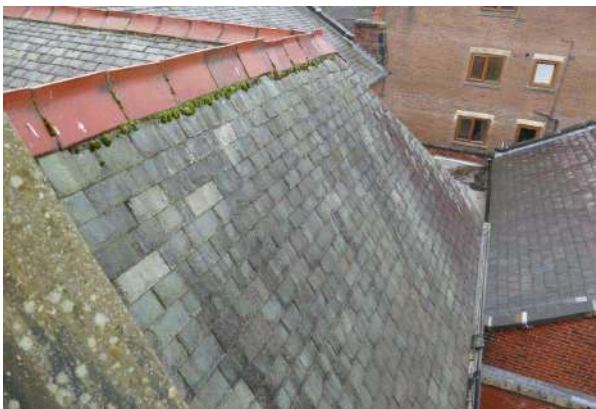
Slipped slate visible in gutter. Spalled/shaled slates and displaced ridge slate. Mis-match in clay ridge tiles.

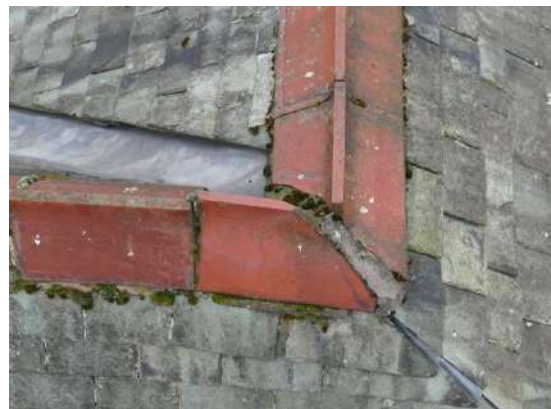
Open joints and split bedding to ridge tiles. Past use of different section ridge tiles for repairs.

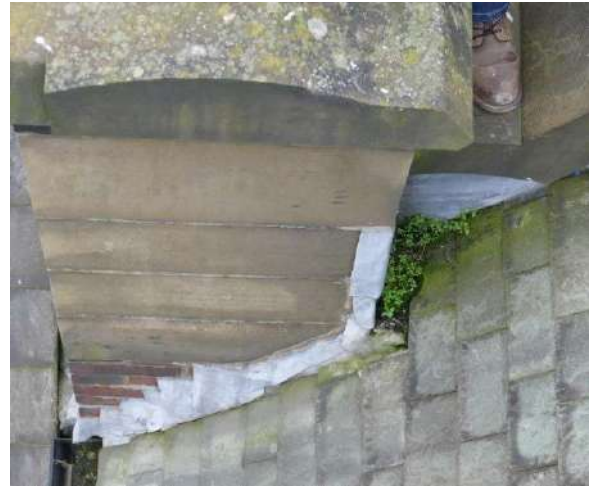
Insufficient lap to soakers/cover flashings where displaced and narrow back gutter blocked with debris..

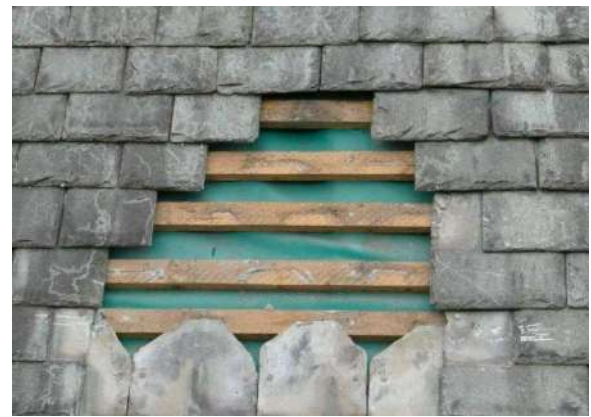
Opened up area reveals breathable felt, battens, fixings and slate all to be in good condition.

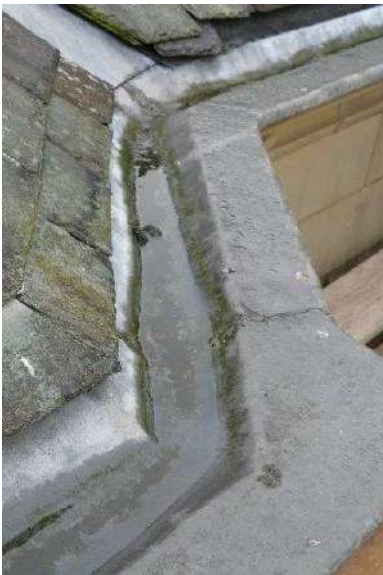
Welded lead gutter lining/apron excessively long and vulnerable to thermal movement. The welded joints show hairline cracks.

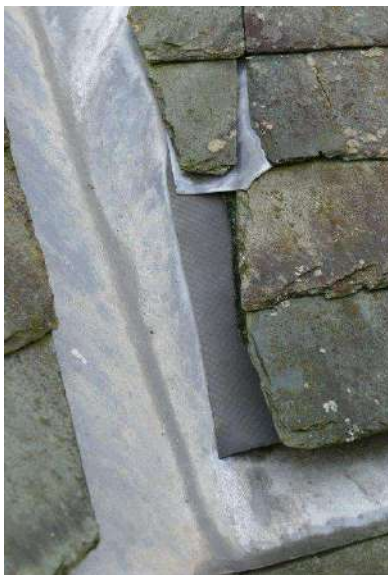
Vulnerable soaker detail and exposed dpc repair vulnerable to UV degeneration.. Possibly also vulnerable to wind blown rain.

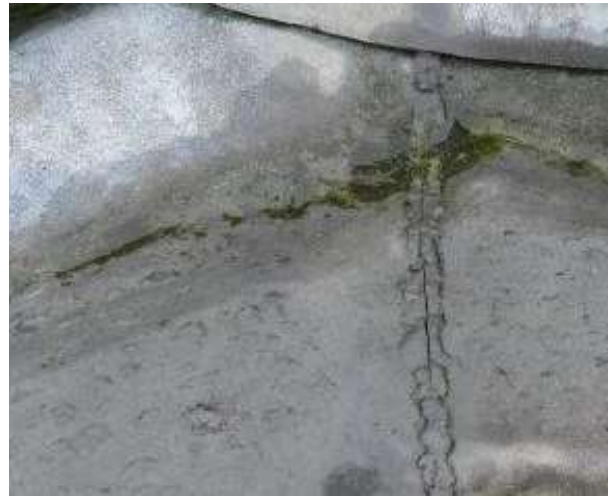
Split in weld to gutter liner from thermal movement of excessively long lead sections with no provision for movement.

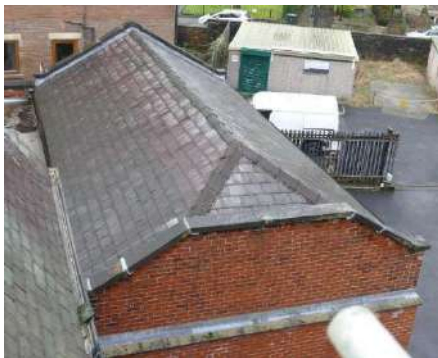
Library roof with concrete ridge tiles and welsh blue and heather slates

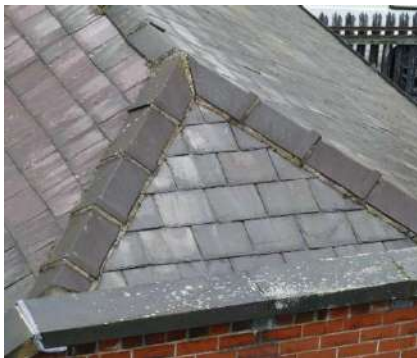
Copings have lead joint flashings but these will hold water as the pointing has in places failed..

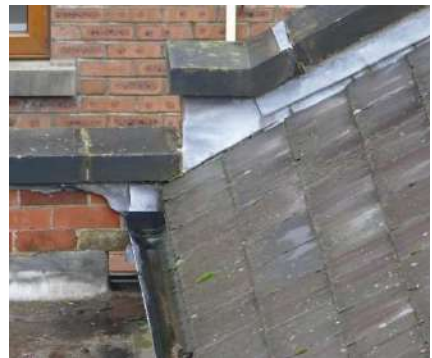
Shallow lap of flashings and vulnerable abutment of wall/coping details

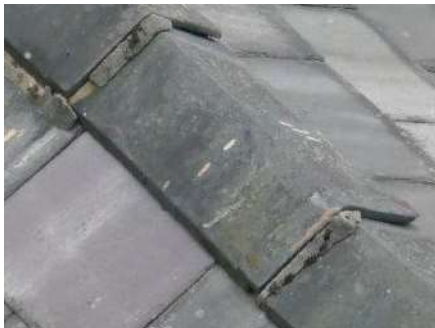
Loss of ridge pointing and bedding mortar.

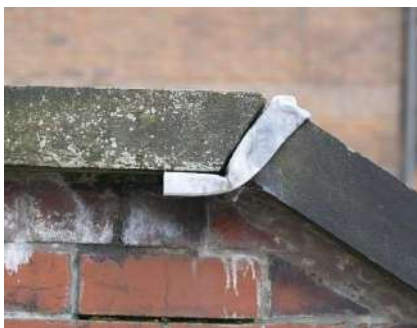
Lead flashing and run off from coping impacting the brickwork.

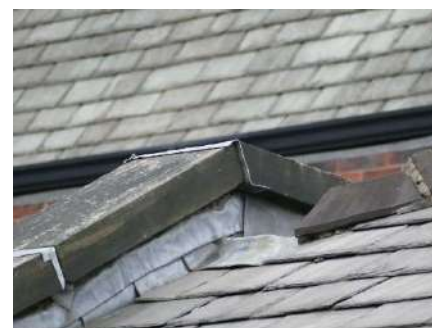
Flashings have a minimal lap and are vulnerable to heavy rain..

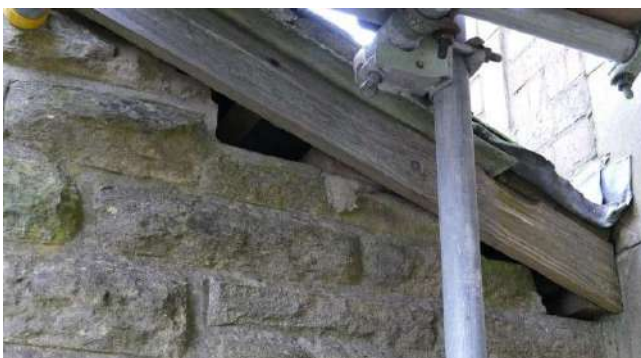
Poorly finished detail to adjoining verge. Open gaps will allow bird and insect access. Poorly finished detail where the back flashing to the abutment meets the verge.

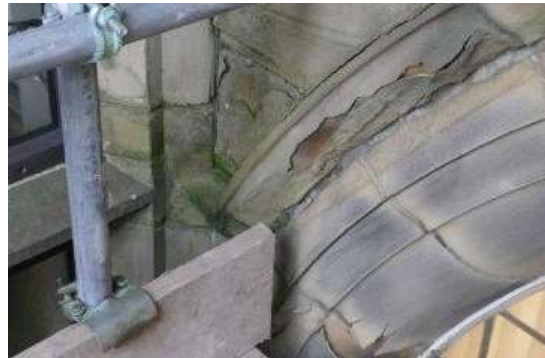
Deterioration of stone facings from saturation below the adjacent flashing detail. This must be addressed to slow the deterioration.

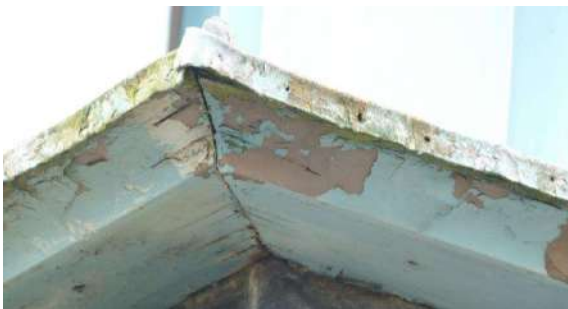
Spalling paint and bare timber to turret base. There is no drip throating in the timber base. Some timber repairs may be required.

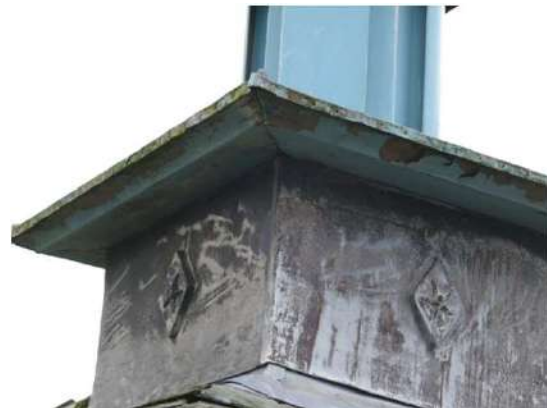
The lead facing to the turret plinth boxing is oxidised and there are hairline cracks and ruffles from thermal movement and tightly dressed corners and fixings.

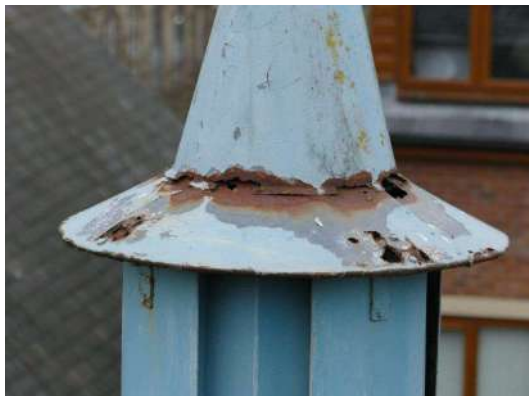
Steel turret cap heavily corroded. Appears to be mild steel replacement of original but not wholly clear. Removal required for repair and re-coating

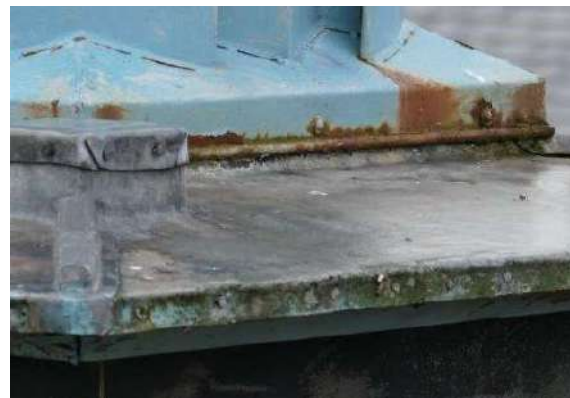
The lower drip detail of the turret is also showing signs of corrosion and fixings may be compromised.

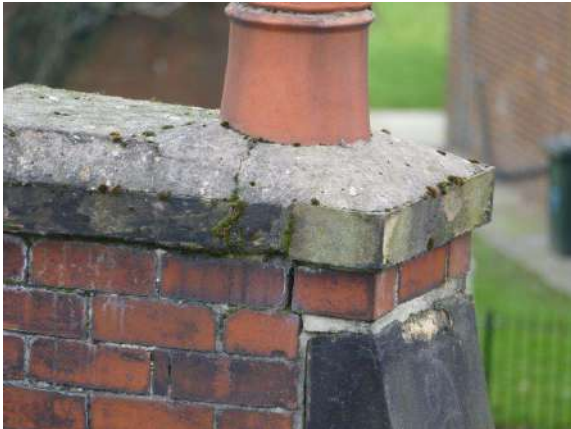
Split in the brickwork, capping and stone facing to the south of the chimney. Open joint from flaunching into the construction.

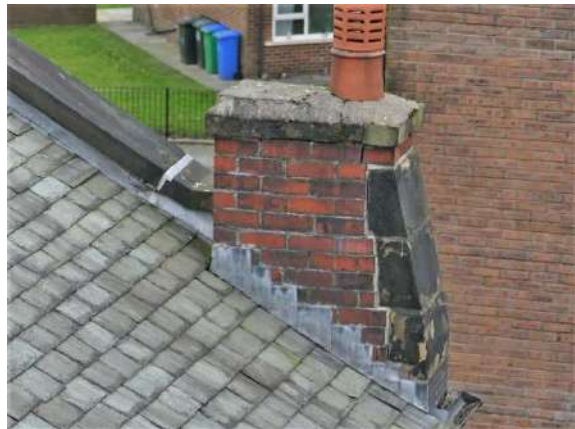
Shallow flashings and outfall detail leaving the chimney vulnerable to water ingress.

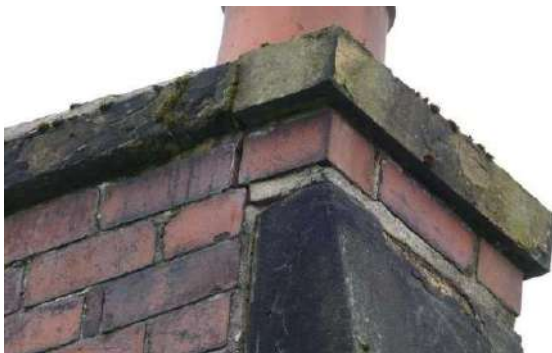
Displaced bricks and capping.

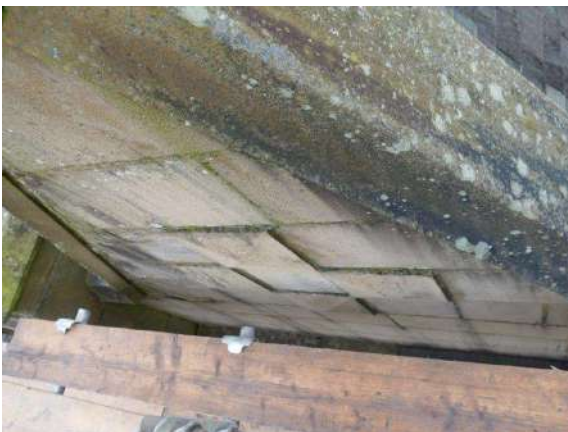
Exposed ledges to the stone detailing relief are vulnerable to standing water and freeze thaw damage. The green algae shows where moisture ledges..

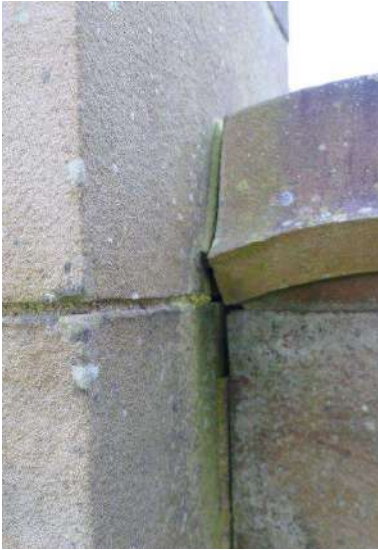
Open vertical joint between copings and buttress finial extended pier.

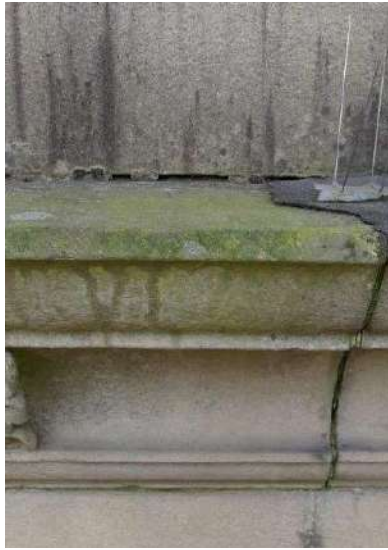
Open joint to the foot of the loose gable panel & window head below.

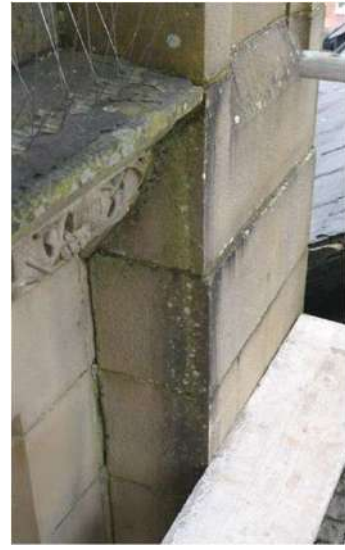
Open joint and displaced masonry to the entrance gable piers..

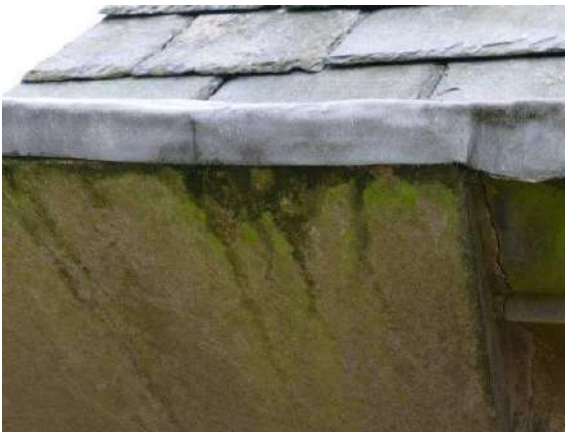
Lead drip capping to oriel window too shallow to fully protect the upper stonework.

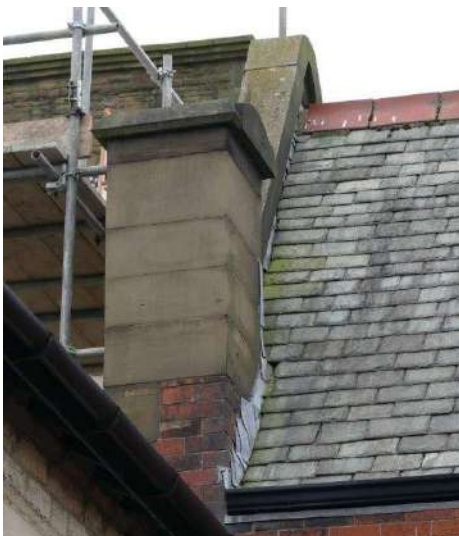
The south pier extension is displaced from the central wall panel and appears to be

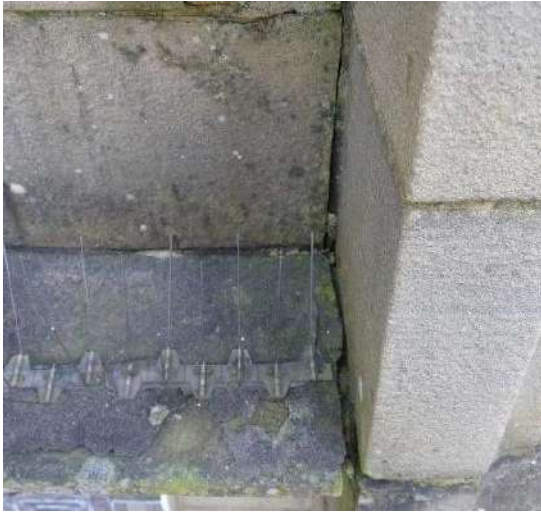
Open joints to the edges of the compromised gable panel.

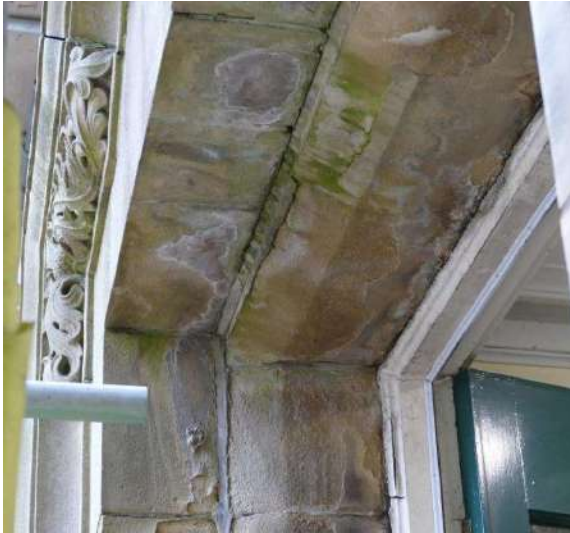
Open joints and displaced spandrel panel above main doorway.

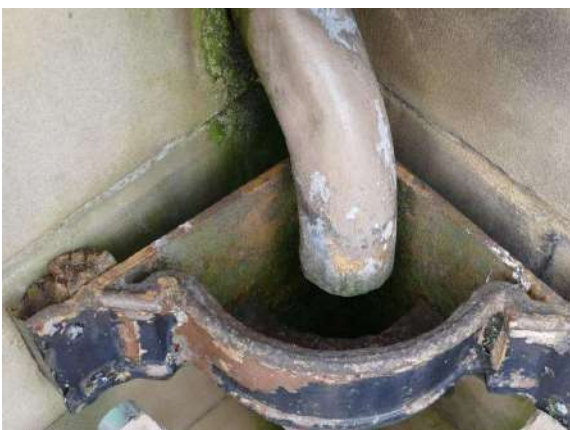
Weathered decoration and rusting of the original cast iron hopper heads. Narrow

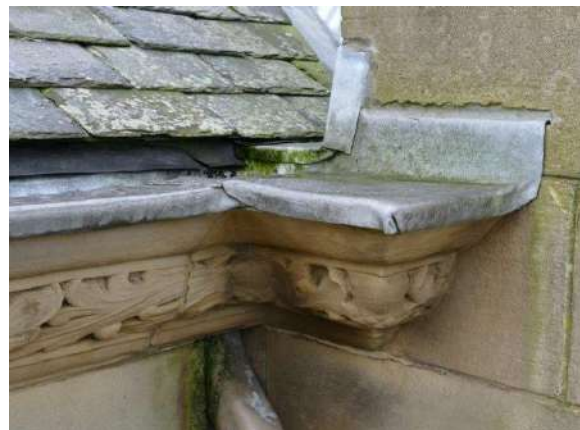
Water ingress around oriel roof gutter outlet. The shallow laps & upstands are likely to be the cause of water leaking through the outlet & staining the stonework.

- Introducing lead dpc to stone copings and re-setting, clipping and pointing
- Replacement of the oriel window gutter flashings with one detailed to accommodate thermal movement.

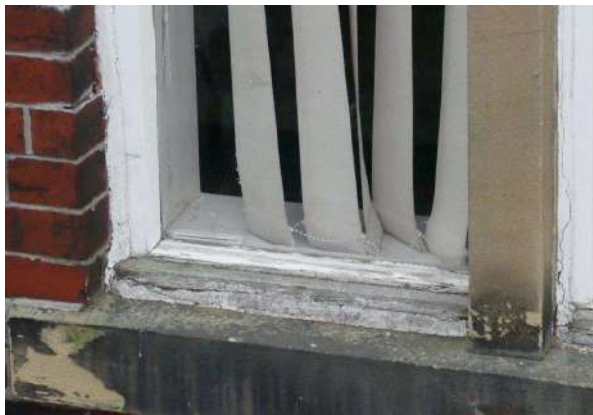
Weathered cill of fixed light window and need for repair and full re-priming and decoration.

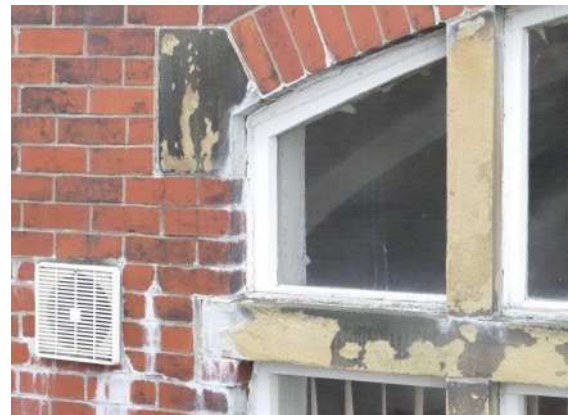
Open joints around casements, extract of warm air that appears to be routed through the chimney flue, cement pointed joints and a lack of drip detailing all appear to have contributed to moisture levels in the wall. The transoms appear to slope back to the frame in places.

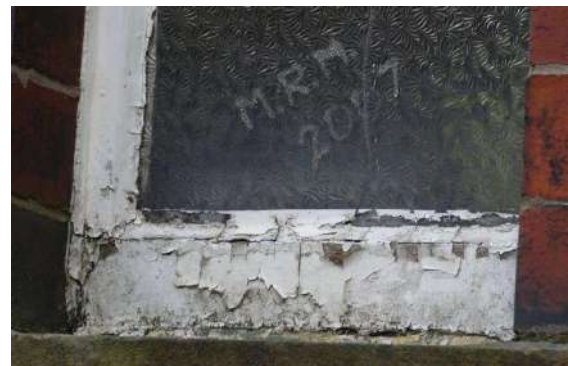
Cill timbers and the lower side of the rails have suffered most from degradation.

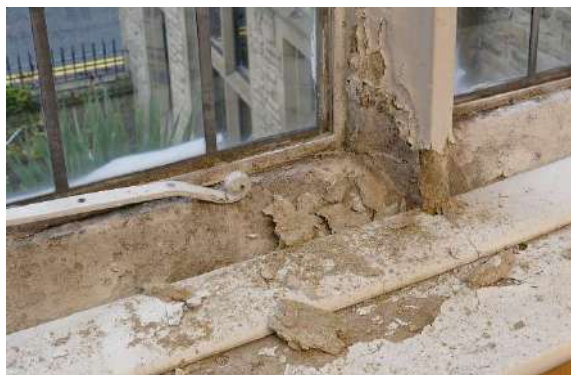
Spalling stone and vinyl paint covering. Consider removing the paint & tidying the stone. Oriel window.

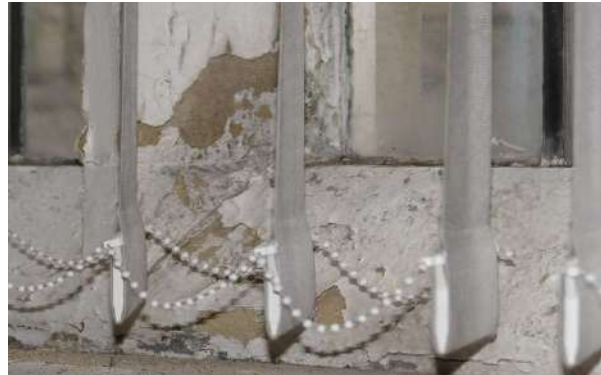
Spalling stone and vinyl paint covering. Consider removing the paint and tidying the stone. Stair window.

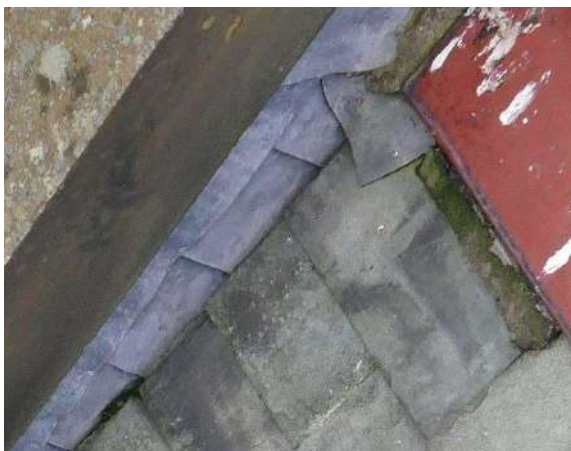
Displacement of the gable appears to have stretched the soakers, reducing their lap with the cover flashings to 30mm in places. This is a likely source of water ingress.

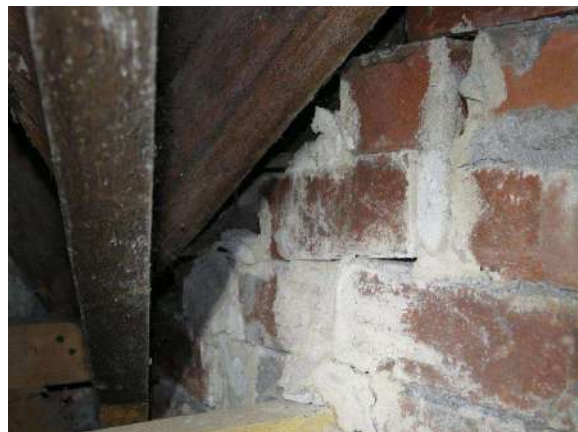
The brickwork to the side of the gable, which coincides with the south east pier and capping, is displaced and lifted. This may have been displaced by the movement in the external pier. This should be assessed during the future dismantling.

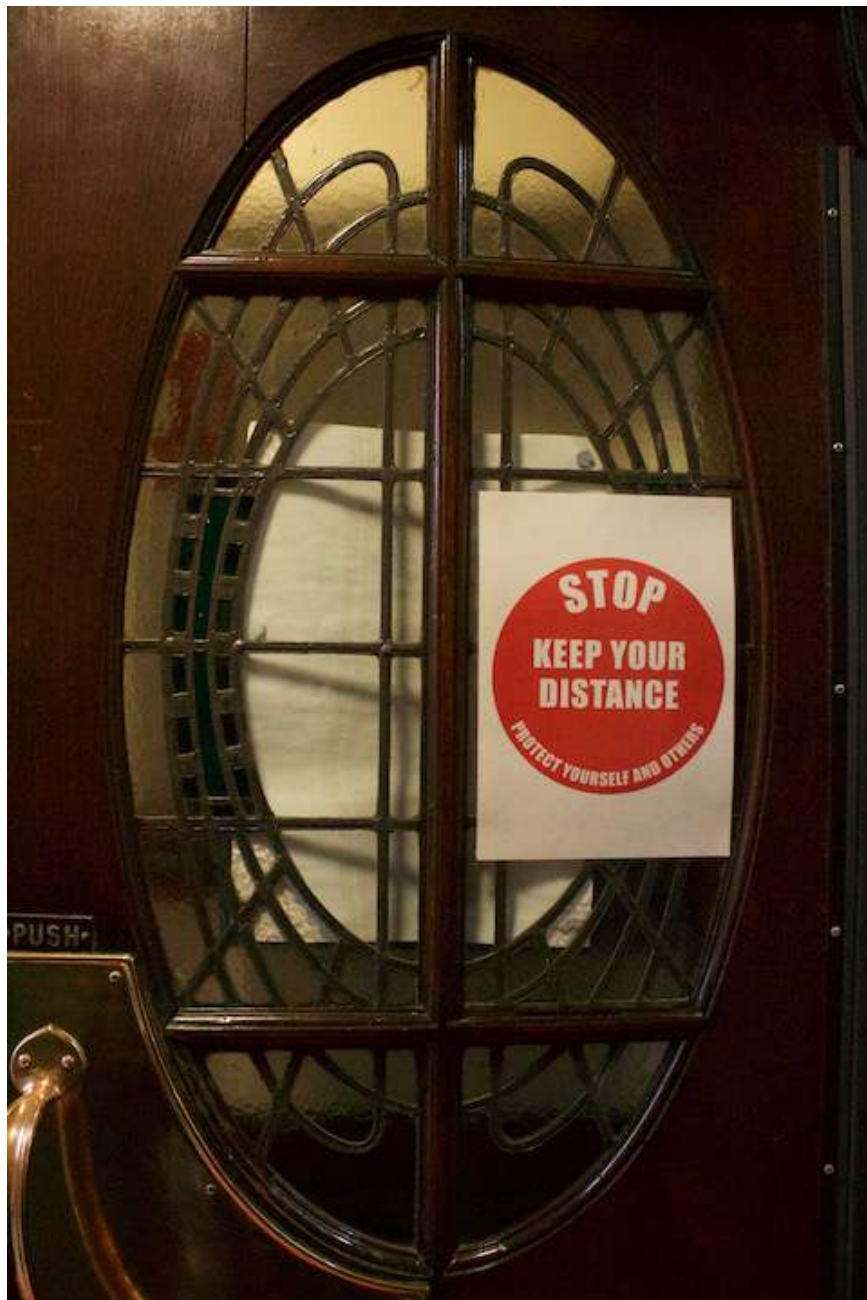
**Left internal porch door**

Some panels are slightly bowing

**Recommendation** – No work required

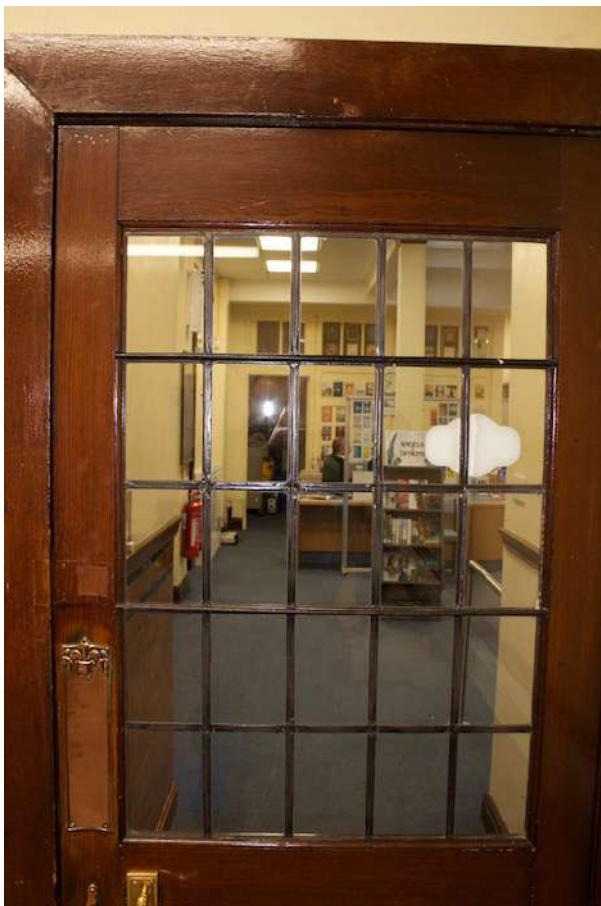
**Computer room door**

Panel moves / rattles when touched

**Recommendation** – Remove, re-lead and re-fit

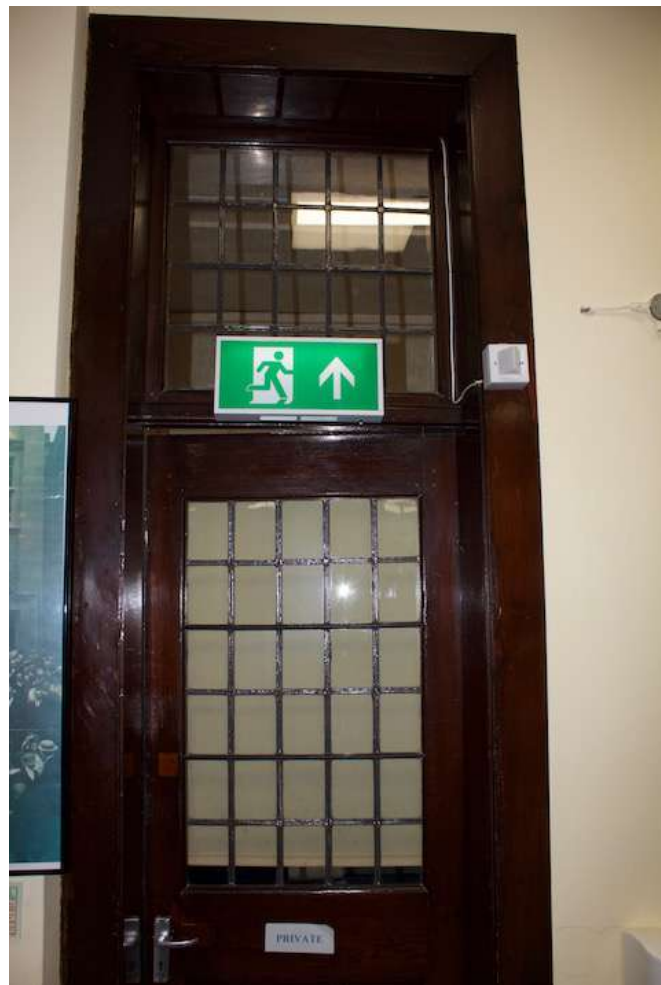
**Door to staff room**

There are quite a few square-leaded internal windows in the main library rooms these are all in satisfactory condition. There is one damaged pane to one of the windows between the two rooms (this could be repaired in-situ although it is not in danger of falling out). The door to the staff room has had some previous in-situ repairs and the panel is slightly loose, this needs monitoring. The only panel that needs work is the door to the computer room mentioned earlier in this report

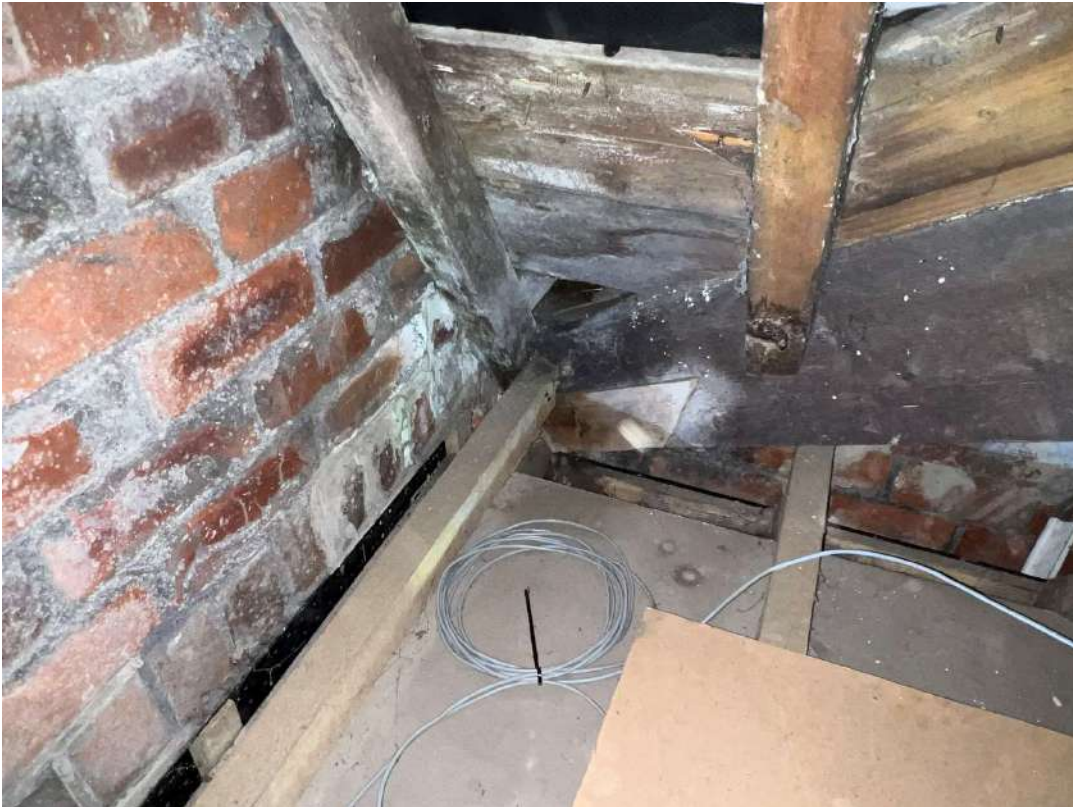
Repaired hip and new ceiling joist above stairs with un-insulated ceiling

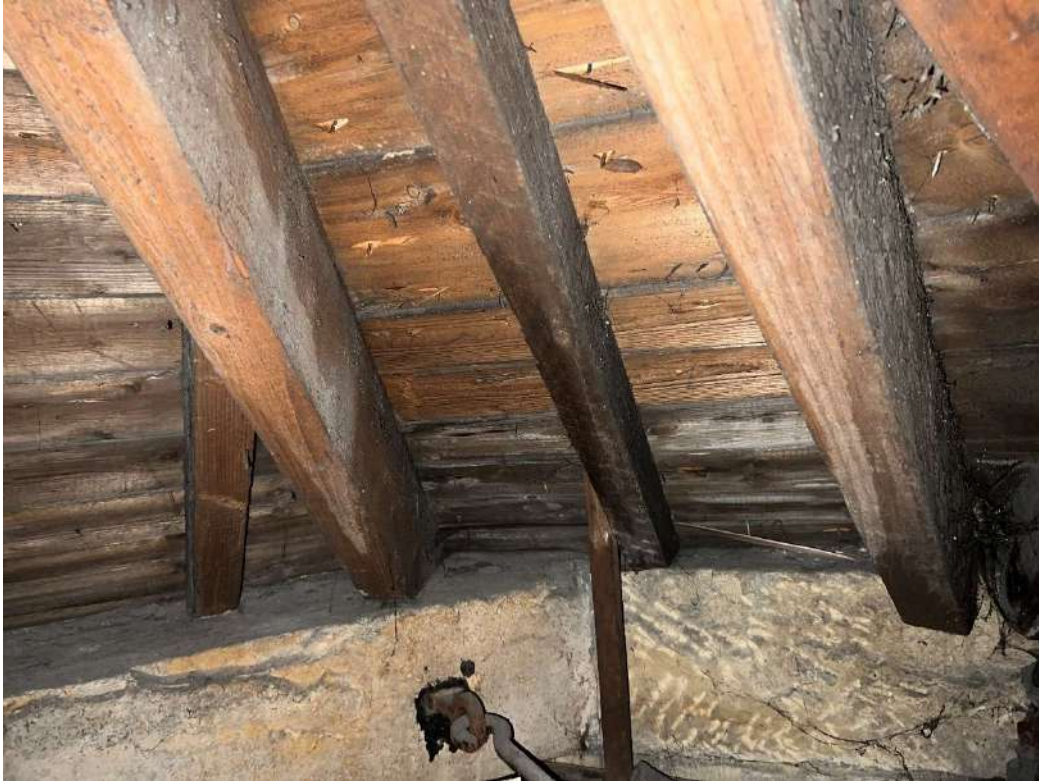
Dry timbers to bay and large member of steel supporting hip to main first floor roof void
