## Rochdale Corner Plot

14834-BKP-V1-XX-RP-S-010

Existing Bulding Condition Report

29-31 Maclure Road, Rochdale

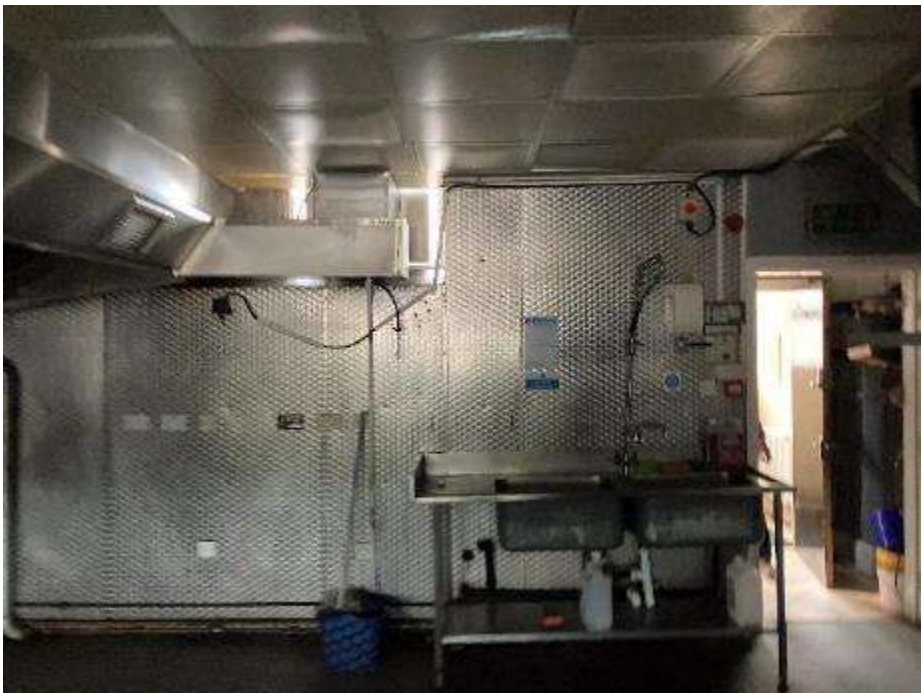
Figure 13 – View on Rear Wall of Existing Kitchen Area

Kitchen Area Generally – Kitchen area of the building includes significant kitchen fit out equipment, including large extractor system, aluminium splashback wall coverings, countertops, etc, along with tiled suspended ceiling. Floor has received vinyl covering and appears to be in good condition, with no obvious signs of excessive deflection / bounce witnessed.

Given current usage of the building and significant finishes witnessed on site, inspection of structural elements, including masonry walls, floor structures over, etc, was not possible during this inspection. For details of recommended further intrusive investigations refer to BKP intrusive investigation drawing information (refer to Appendix D of this report).

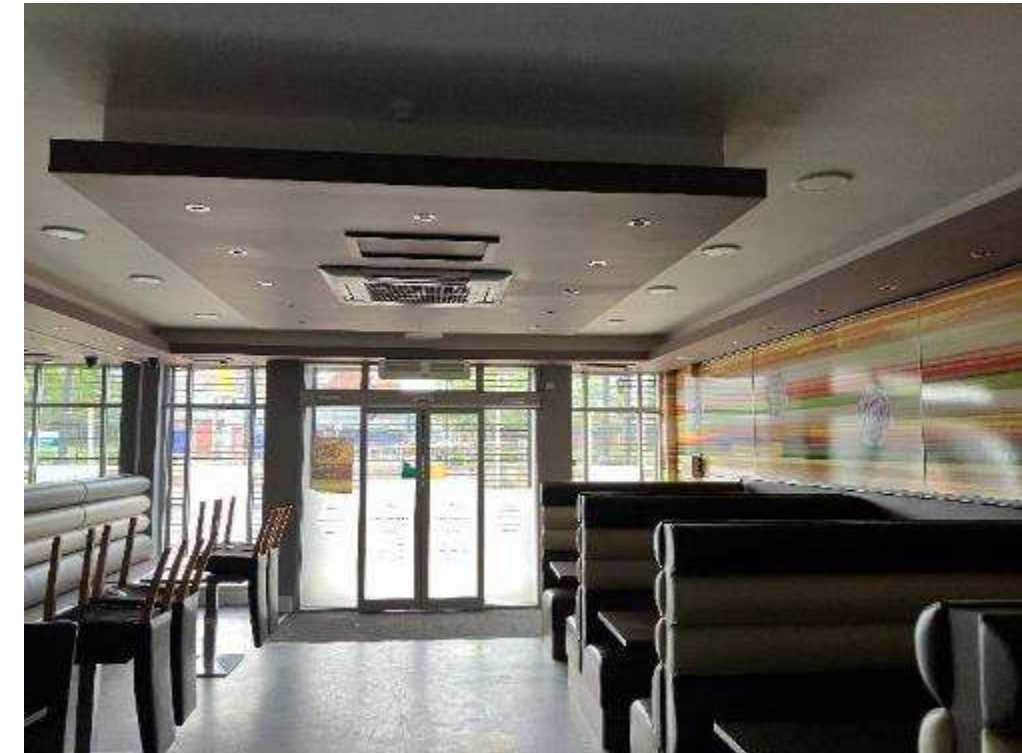
*Figure 15 – View on Main Entrance to Restaurant Area*

Restaurant Area Generally- Restaurant area includes significant fixed seating to both sides, along with serving counter to the rear of the building and access to adjacent washroom (part of rear lean-to structures). This area includes plasterboard suspended ceiling, with a number of feature downstands (refer to Figure 15 below) along with decorative wall finishes. Floor has received vinyl covering and appears to be in good condition, with no obvious signs of excessive deflection / bounce witnessed.

- South gable wall to the building has received timber repairs to ground floor structure (witnessed from basement level, as noted in section 3.2 above), likely required following historic water ingress. Whilst exact cause of historic water ingress is unknown, it is likely this has originated from the junction between the south gable wall and the adjacent single storey commercial unit roof. Given that the flat roof to the adjacent building coincides with approximate 1st floor level to the 3-storey building, it is recommended that intrusive investigations are carried out to expose underside of 1st floor joists at interface with the south gable wall and investigate potential water ingress / timber damage at this location.

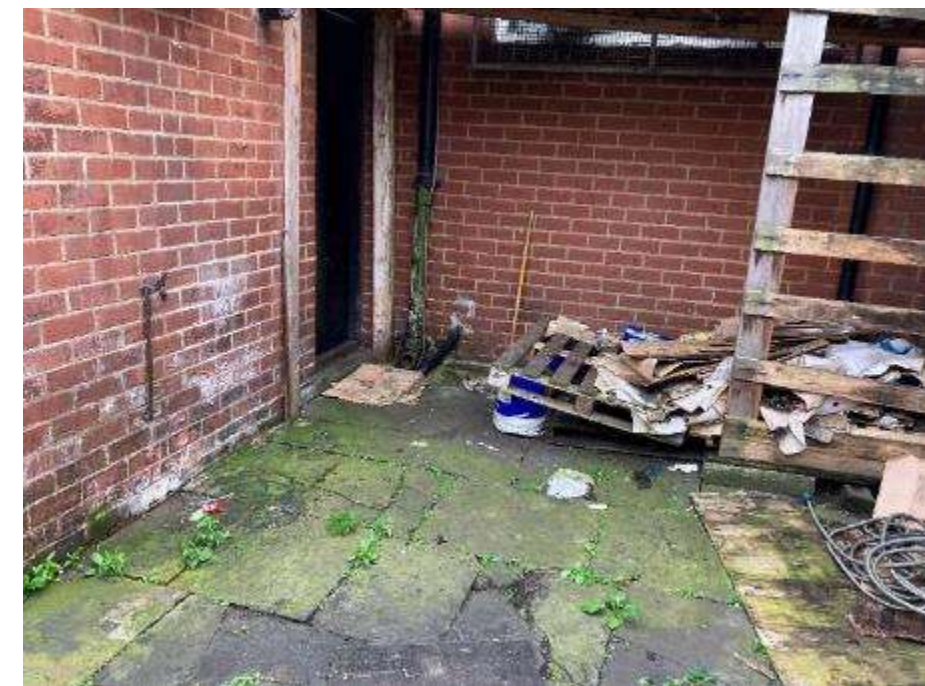
*Figure 21 – View on Rear Access Door Via Yard Area*

Visual inspection of the part of the rear courtyard to the building has been carried out, consisting of stone flag paving and free-standing brickwork yard walls. It is noted that significant debris is present within the rear yard area (including timber pallets, bins, etc).

Full access to the rear courtyard (including external access to basement) was not available during this inspection due to presence of significantly leaning / potentially dangerous existing yard wall. This was witnessed as leaning significantly into the yard area and removal of this section of wall should be considered prior to any further inspection works.

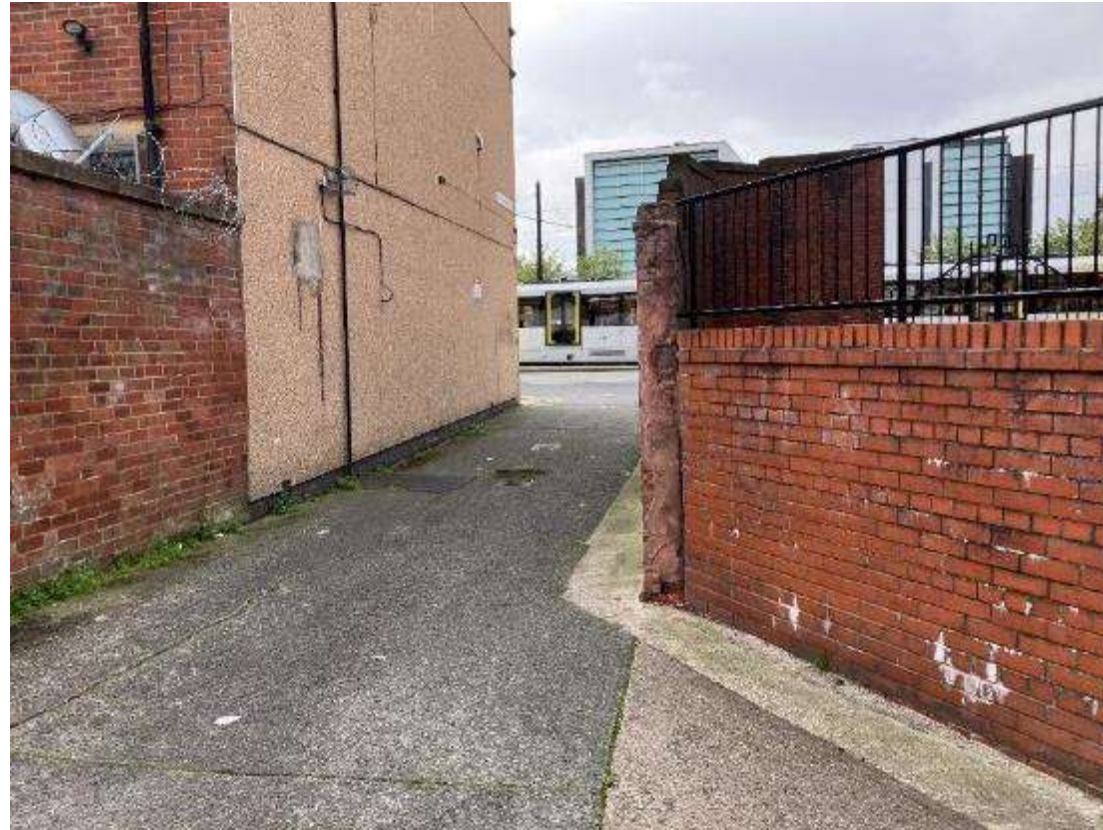
*Figure 25 – View on Fire Station Yard to the North of the Existing Building*

A number of existing drainage features were noted within the unnamed access road to the rear of the building and within Fire Station Yard to the north of the building (including possible manhole covers, gulleys and downpipes from the adjacent single storey building). It is recommended that these drainage features are further investigated, along with additional services searches carried out in this area.
