Phase II Geoenvironmental Site Assessment  
Land at Greenbooth Road and Edenfield Road, Norden

Reference: 16-465-R2-2  
Date: June 2023

## **PHASE II GEOENVIRONMENTAL SITE ASSESSMENT**

Land at Greenbooth Road and Edenfield Road  
Norden  
Rochdale  
OL12 7TD

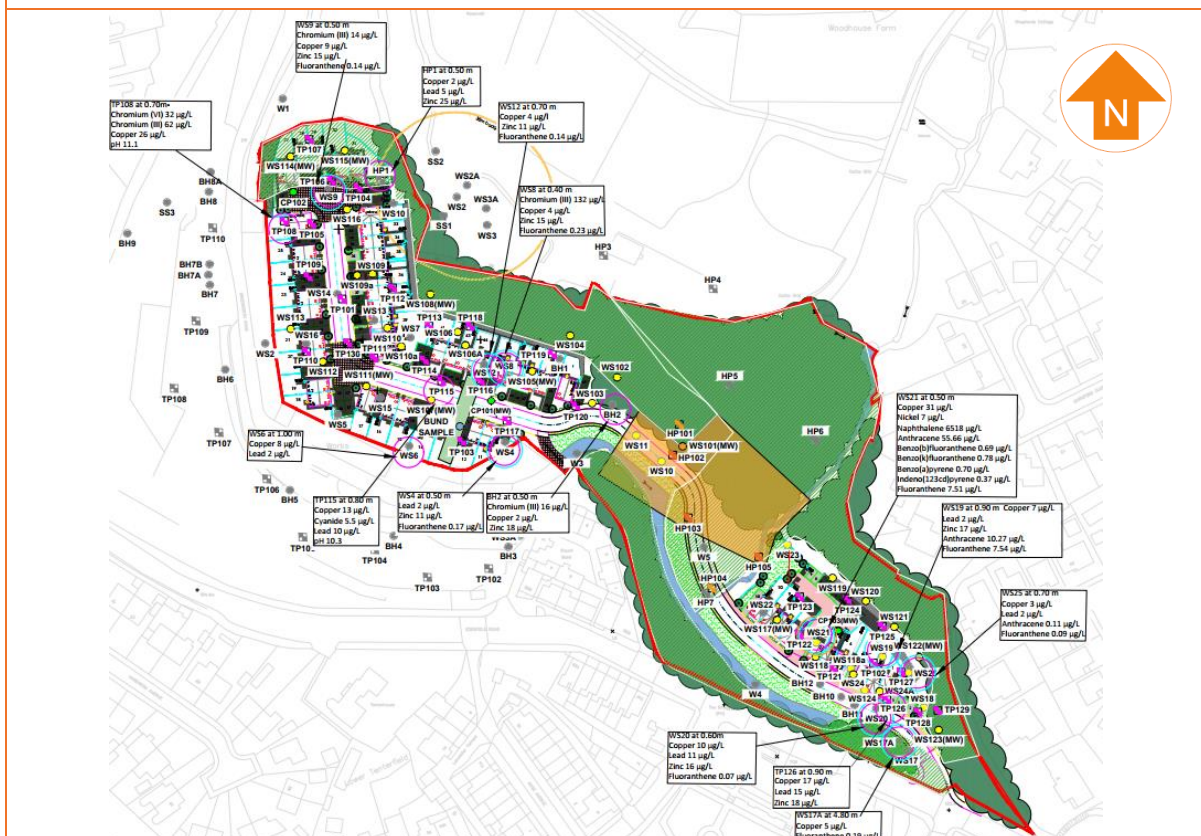
FIGURE 4.10 CONTAMINATION ISSUES PLAN – LEACHATE

Concentrations of chromium (III) were found to be in exceedance of the EQS within leachate samples taken by E3P and leachate, groundwater and surface water samples taken by Encia. Non-volatile PAHs were also identified within the chemical testing in surface water samples taken downstream of Woodhouse Lane Brook (E3P, Woodhouse Lane Downstream) and Naden Brook (Encia, W4). This shows lateral migration of contaminants identified within soils and groundwater is occurring at the site and causing a detrimental impact on the surface water receptors.

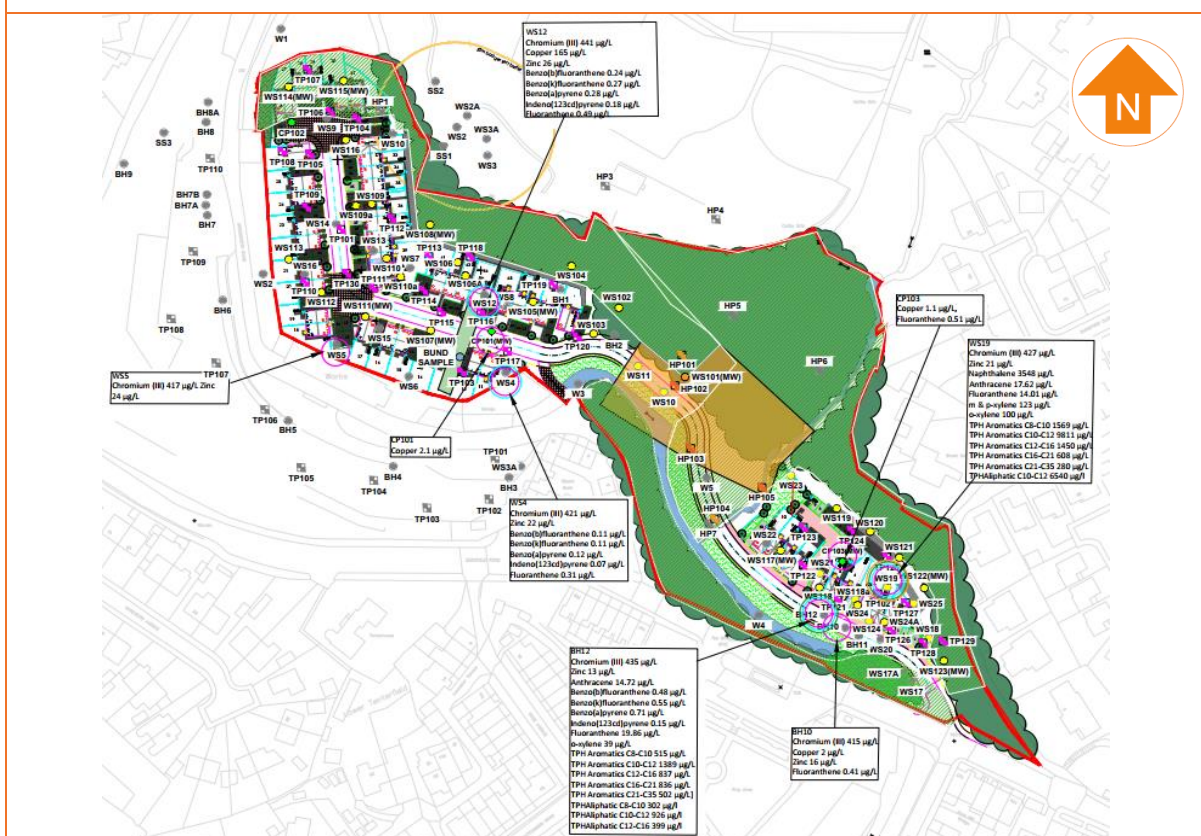
FIGURE 4.11 CONTAMINATION ISSUES PLAN – GROUNDWATER

It is noted that limited groundwater sampling was undertaken during the monitoring programme. This was due to the majority of monitoring wells either having insufficient or no groundwater within them. As such, it has not been possible to determine a groundwater flow direction.

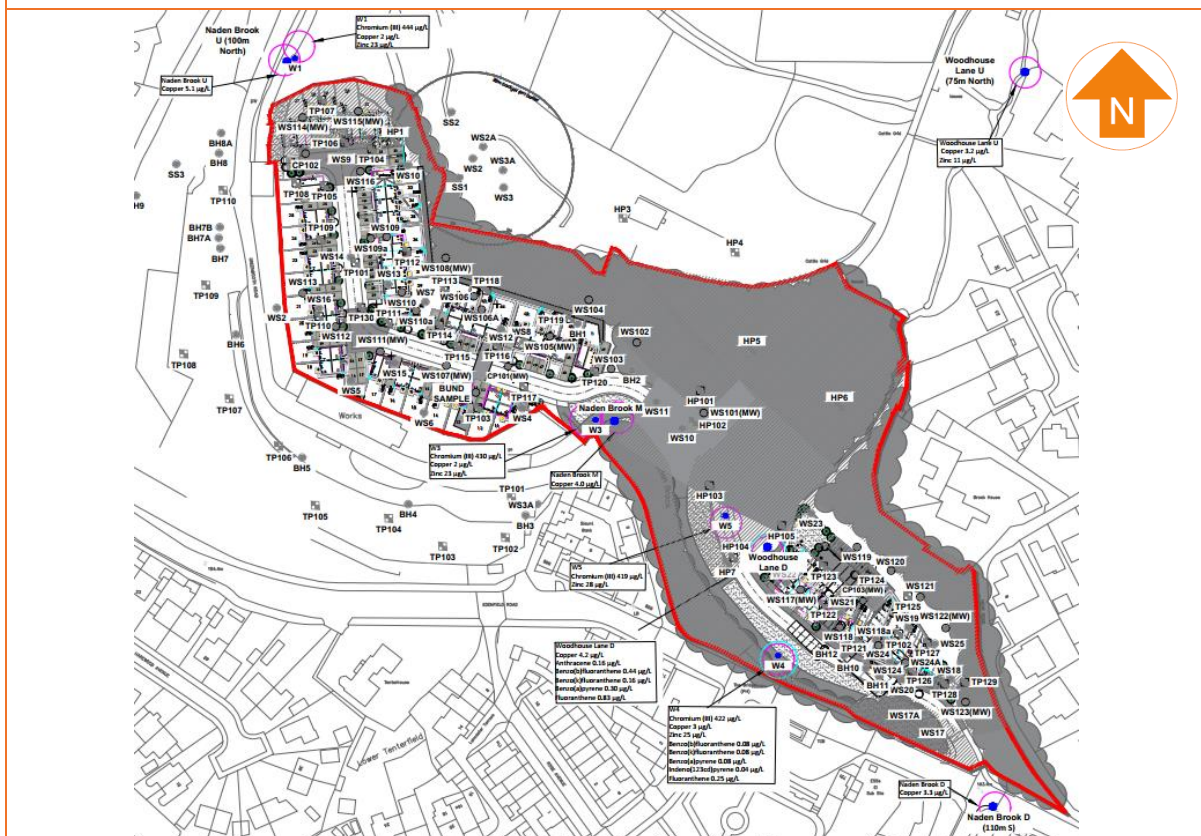
FIGURE 4.12 CONTAMINATION ISSUES PLAN – SURFACE WATER

Due to exceedances of the EQS for copper and zinc, an m-BAT assessment has been completed to assess the bioavailability of the metals with respect to surface water receptors (Naden Brook and Woodhouse Lane Brook). The chemical values from the surface water analysis have been input into the assessment.
