BRANCH ROAD FARM, BRANCH ROAD  
LITTLEBOROUGH – OL15 0AB

May 2021

Revised: 24<sup>th</sup> June 2022

# REPORT ON STRUCTURE

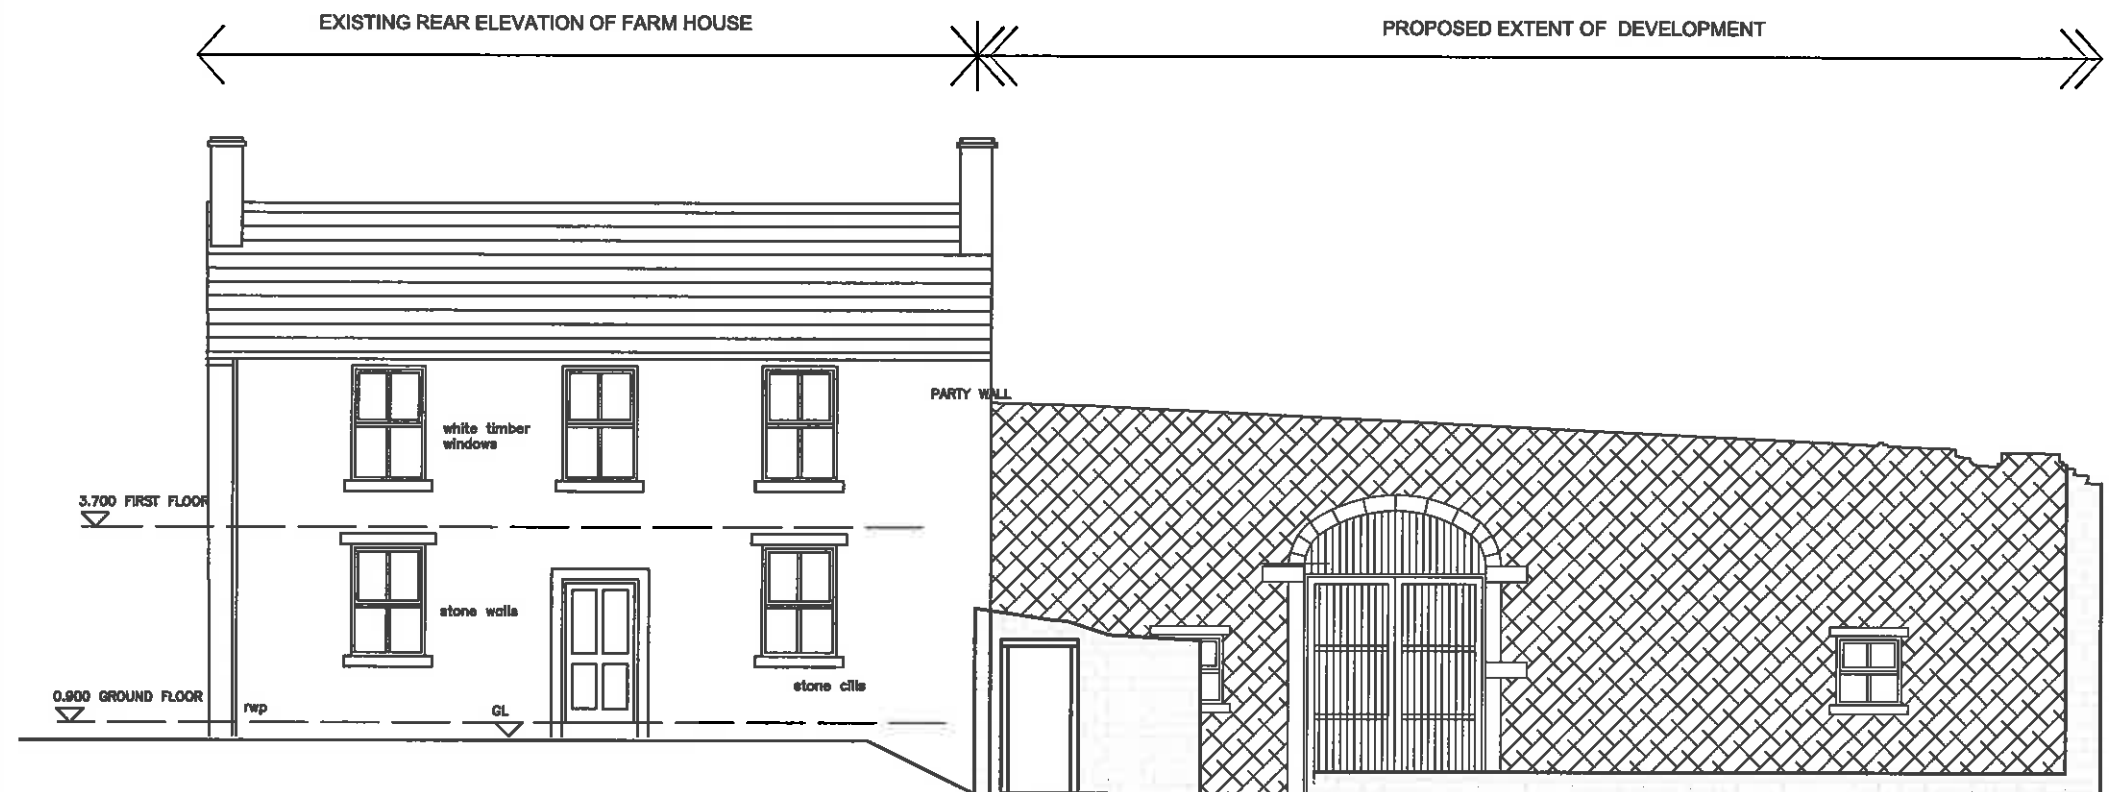
EXISTING REAR ELEVATION @ TIME OF SURVEY

- 4.01** We believe the collapse of the left-hand side and the rear elevation was inevitable given the condition of the walls and the poor quality of the inner leaf matrix and the loose rubble fill. See photographs 15 & 16. The loss of lateral restraint due to the removal of the roof was also a contributing factor.

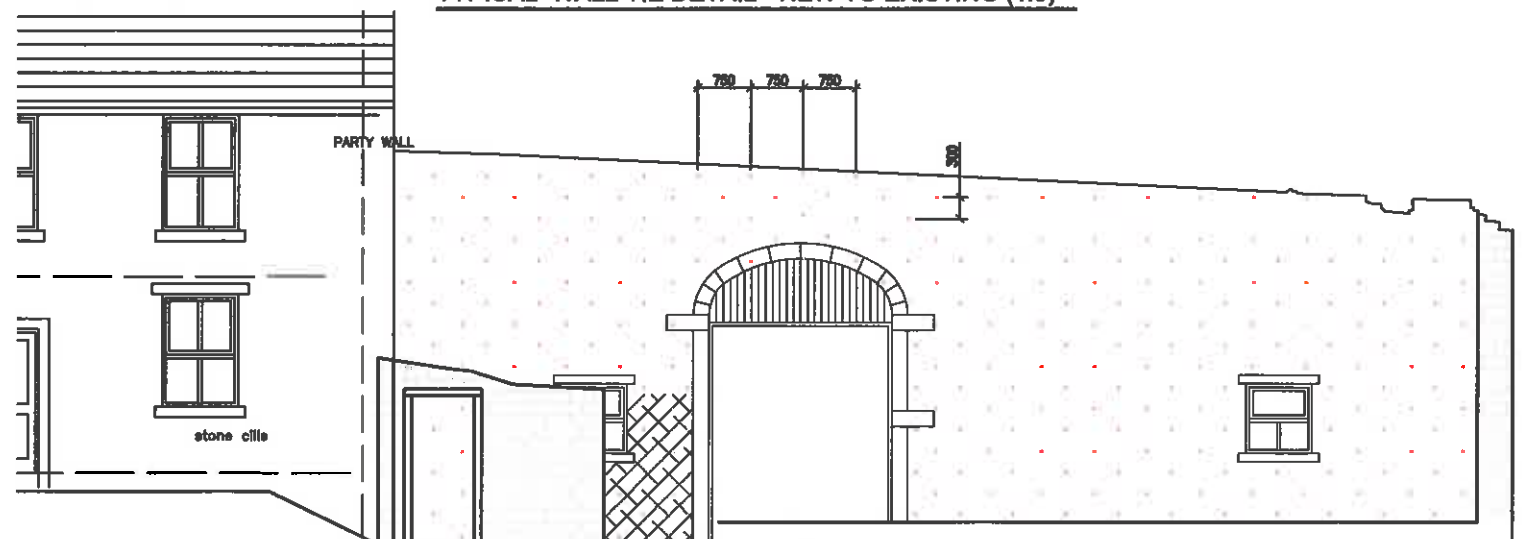
EXISTING INNER FACE OF FRONT ELEVATION  
SHOWING ARRANGEMENT OF WALL TIES (1:50)

The inner face is of random stone set in a relatively poor, lime mortar matrix. With local patch re-pointing in a lime mortar the inner leaf is deemed to be capable of being retained. In order to help stabilise the wall and avoid any further collapse, it is intended to carefully remove any loose mortar from the inner face and patch point as described.

Purpose made wall ties from stainless steel HELICAL welded to stainless steel fishtail tie.
