## BUILDING SURVEY REPORT AND REPAIR STATEMENT

### SILVERHILL FARM AND BARN ROCHDALE

Dated Feb 2022

Kevin M Neary Dip Surv, C. Build E FCABE AssocRICS  
Building Surveyor, Chartered Building Engineer,  
15 Litherland Ave  
Ashway Park  
Peel Hall  
Manchester  
M22 5LD  
Tel no 0161 436 4079  
Email [kevin@kevinneary.co.uk](mailto:kevin@kevinneary.co.uk)

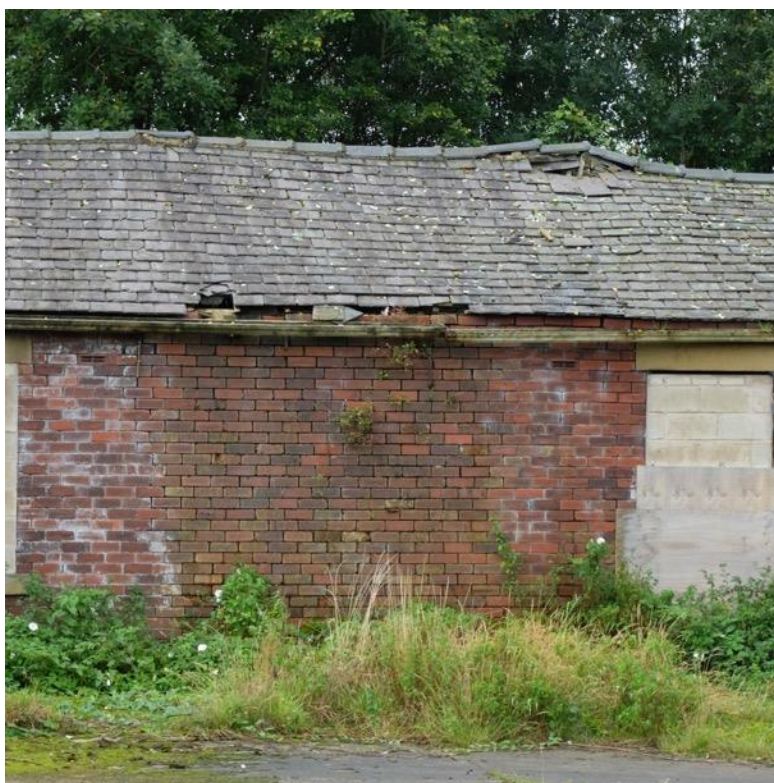
The roofs to the outbuildings are pitched and slated. The roof over the cowshed to the East elevation of the barn has been slated with an excellent quality wash 20 x 12" blue slate which should be salvaged for reuse.

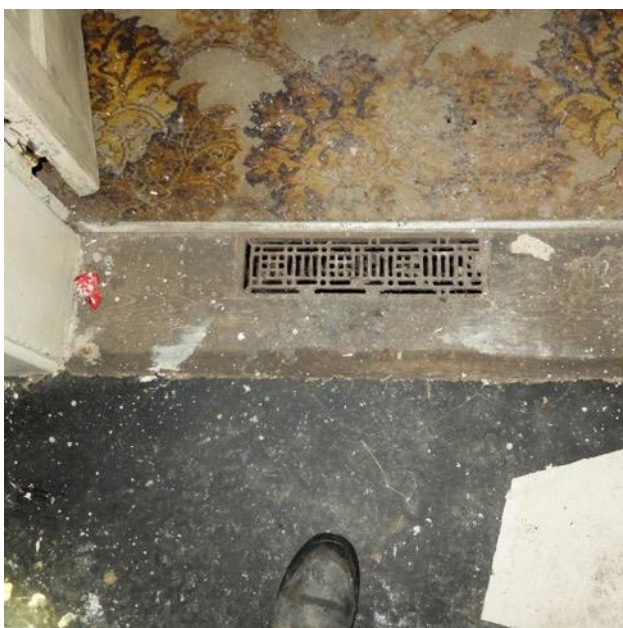
In room G.03 where there is a suspended timber floor there is a floor mounted decorative grill which will provide some ventilation.

Photo. Decorative vent in floor surface investigation required to determine function.

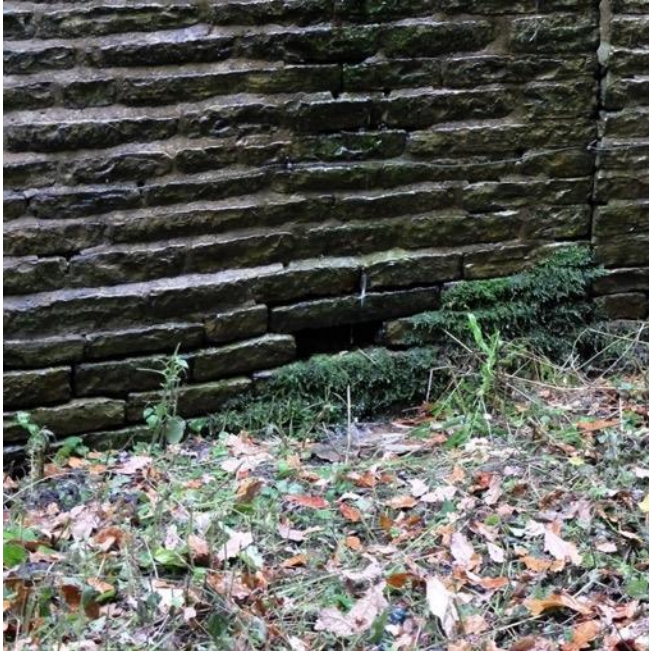
Within the front elevation there are indications of openings within the low level stonework adjacent this room, however further investigation is required to establish whether these are actual air vents. The frequency and size of the vents do not comply with Building Regulations.

Photo. Air vent in front elevation

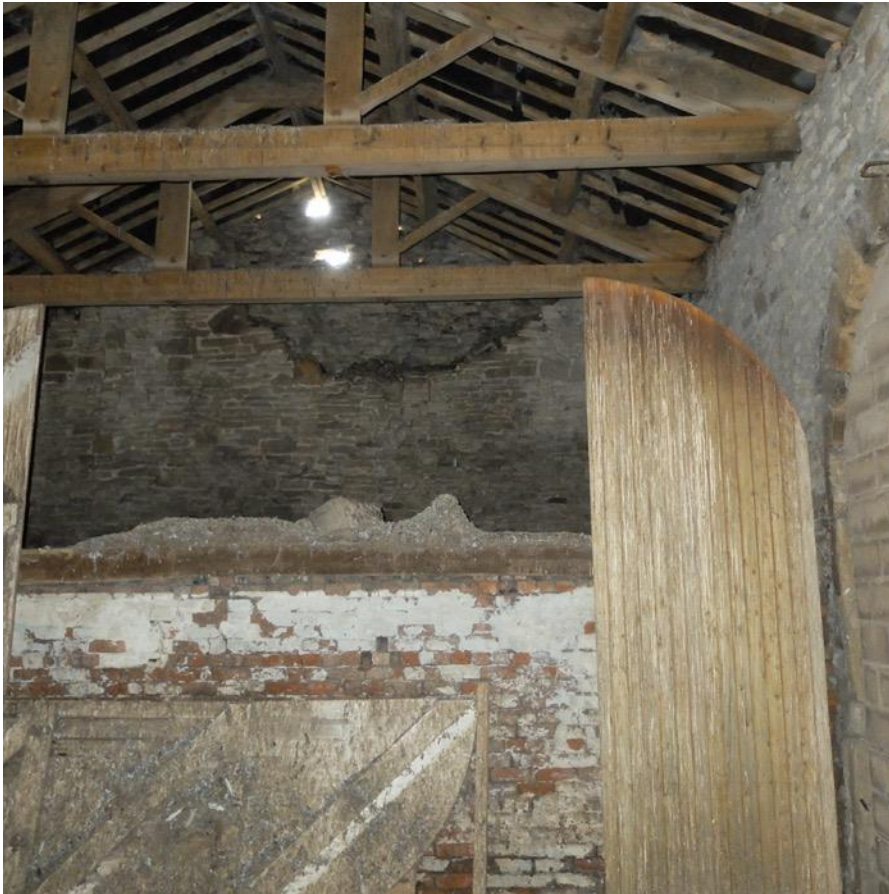
In the barn the door openings have been blocked up with concrete block or sheeted with timber stud and the plywood.

Photo. Threshing barn doors

Internally timber doors are still present and could be repaired and incorporated as a feature in the proposed conversion.

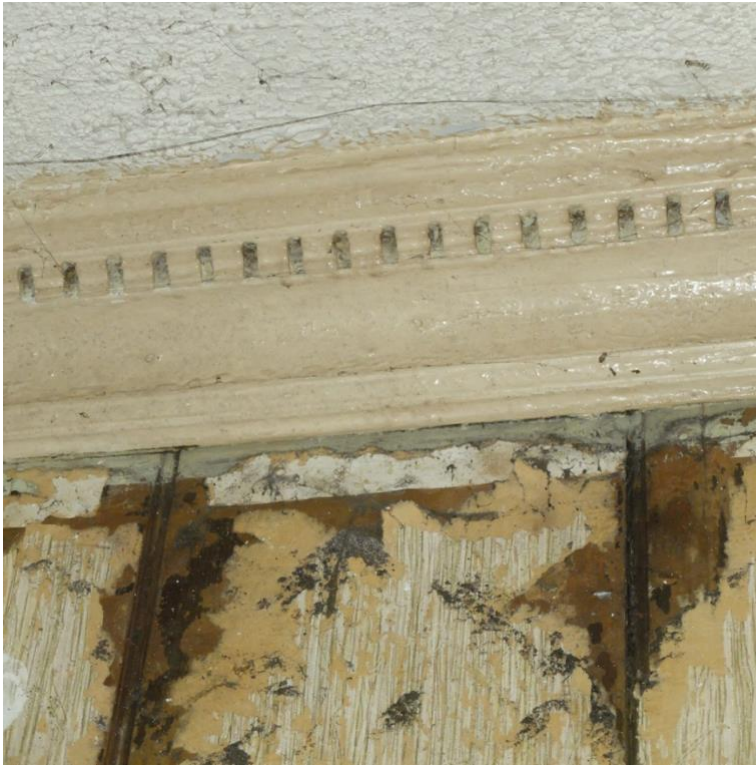
Some of the partition walls are of a lightweight timber construction which consist of painted vertical vee grooved planks with horizontal struts. Within Room G.04 there is a decorative timber cornice along the rear section only.

Photo. Timber partition with timber cornice

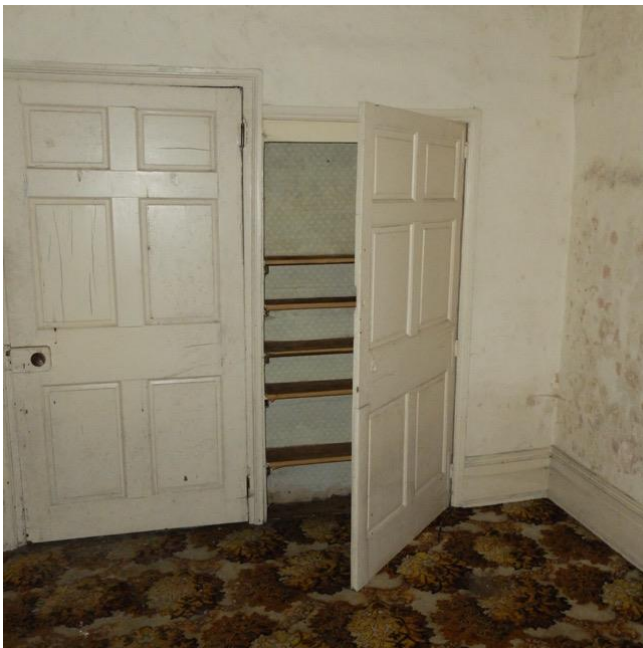
The internal doors to the building are mostly new however there are two original panel doors to the front middle room of the ground floor and an original framed and ledged plank doors to the first floor bedroom.

Photo. Original doors to farmhouse Room G.03

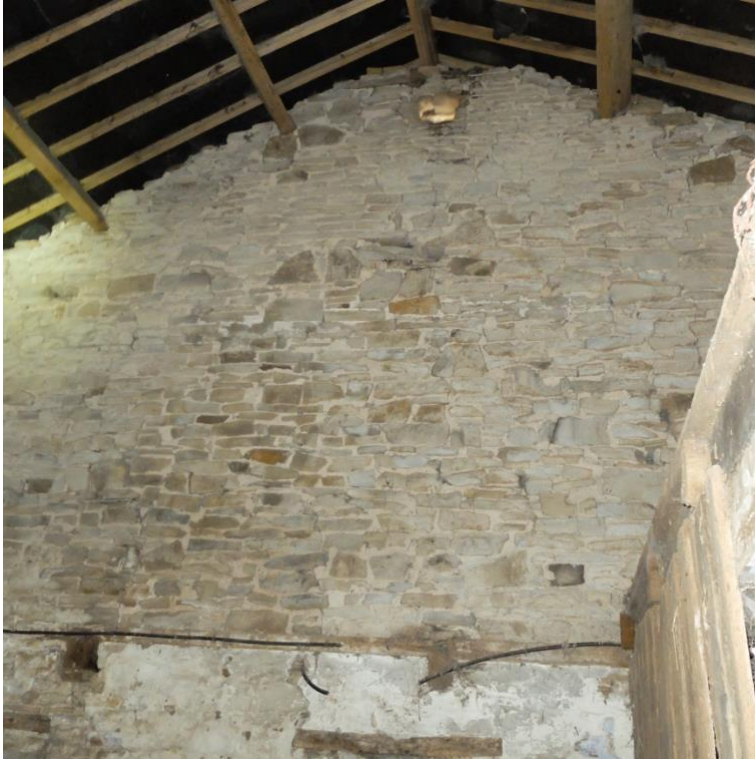
The internal face of the external walls to the barn appear to be random Stone. There is no evidence of plaster coatings and therefore any movement cracks can be seen on the inside face of the masonry.

Photo. Random stone to inside of barn.

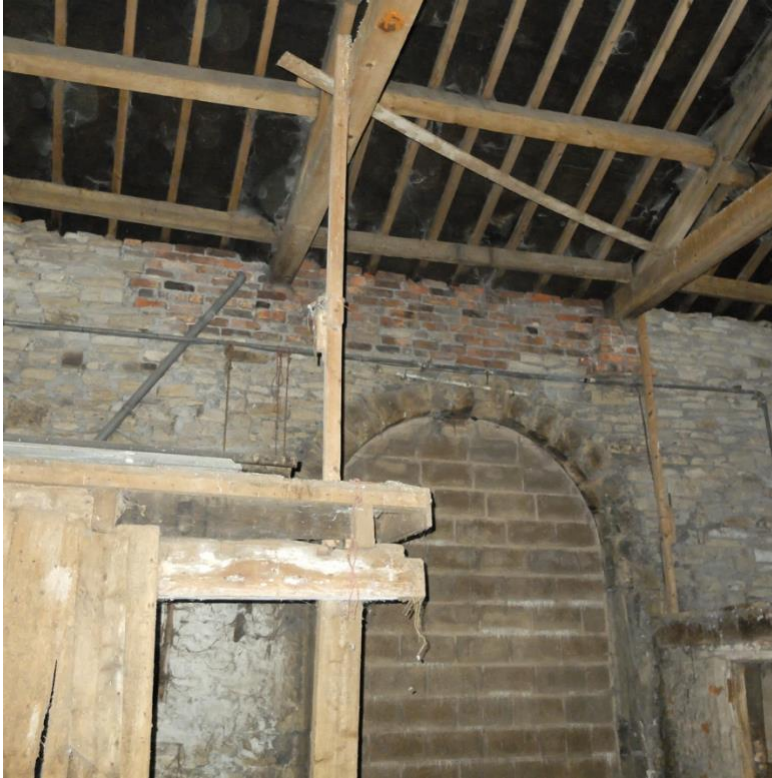
It would appear the upper sections of the internal leaf to the front elevation above the threshing door has been replaced in brickwork.

Photo. Rebuilding inner leaf in. brickwork

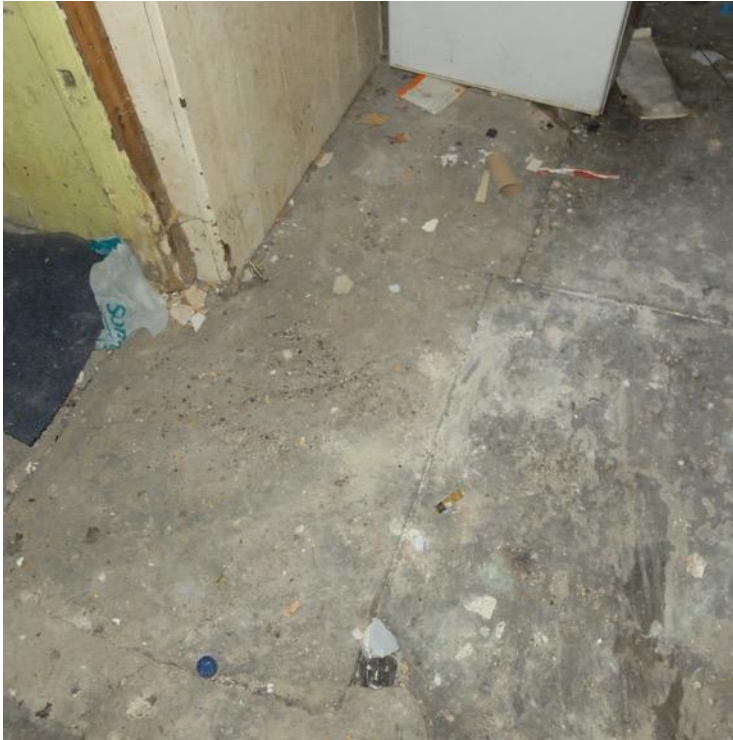
The floor surface above is York stone paving which is laid on a bed of sand on top of the timber floor. This type of construction was not uncommon however a major problem is the amount of interstitial condensation to the underside of the York stone slabs which in turn will hold the moisture within the timber floor construction which will promote decay and deterioration. Along the top surface it was

evident that some sections of the York stone paving had been overlaid with levelling screeds to support carpets and other linings.

Photo. Suspended York stone floor to ground level Room F.04

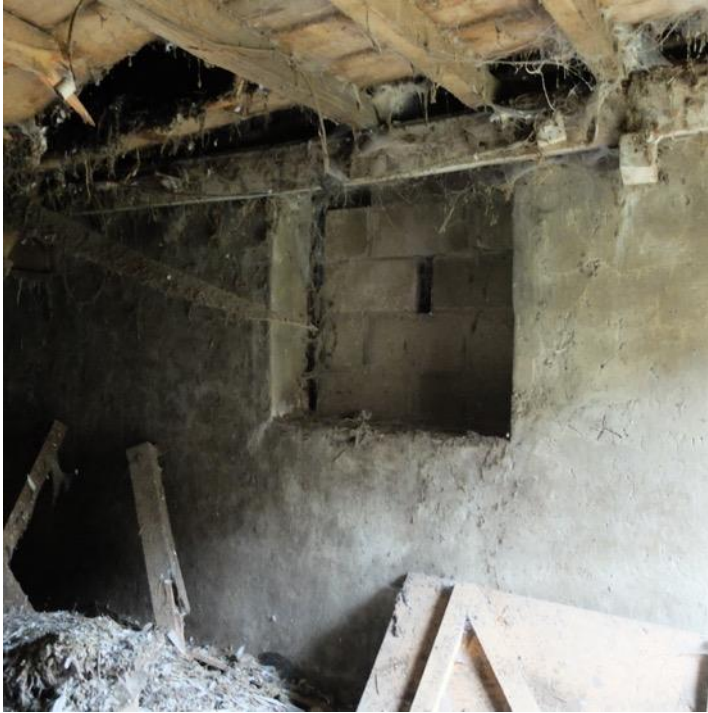
Along the left hand side there is a suspended timber loft floor which is additionally reinforced with steel beams.

This appears in a poor condition and has been considerably damaged by the falling masonry from the gable wall.

Photo. Loft floor above left hand section of the barn

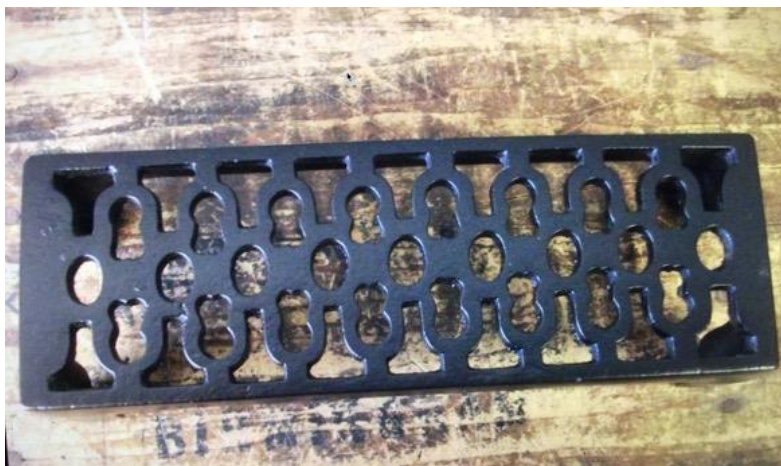
Photo, Example for proposed cast iron vent

Inevitably some external vents to brickwork will be required and these will be covered using a traditional cast iron vent with an insect mesh grill positioned on the inside face.
