MILNROW LIBRARY  
SPECIALIST INVESTIGATIONS  
EMERGENCY WORKS  
January 2022

**Bradshaw Gass & Hope LLP**  
**Architects Consulting Engineers Quantity Surveyors**  
**21 Silverwell Street Bolton BL1 1PR**

## 1.0 INTRODUCTION

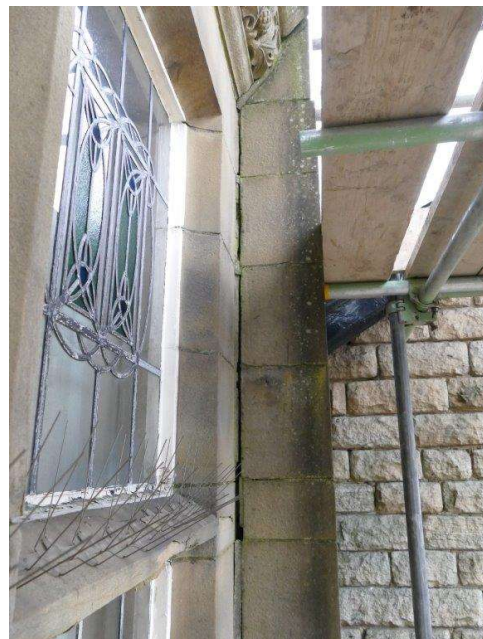
A crack has developed along the junction of the left hand pier and the wall and a significant open joint and displacement to the right hand side.

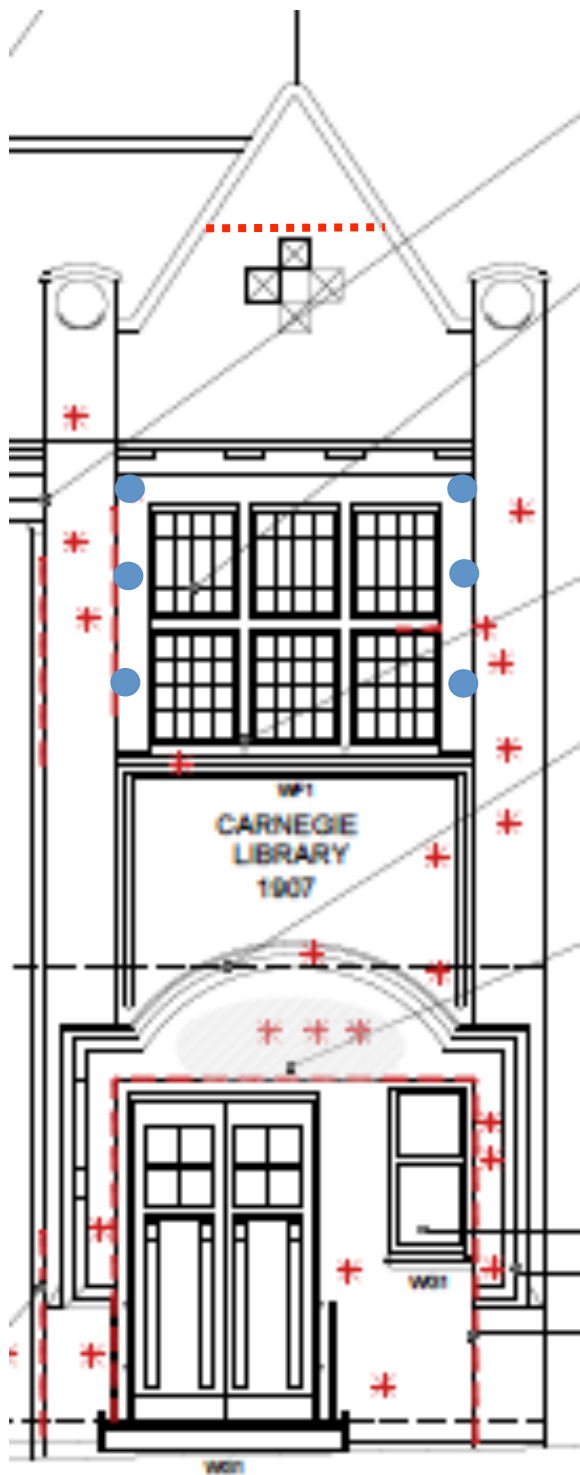
### New restraint to pillars

The existing stone pillars are not bonded to the stone face. There is a vertical mortar joint that has broken down and is allowing water to enter.

Angle at the face of the brick to be fixed with 6No M10 x 150mm long Hilti HAS-U A4 stainless steel anchor rods, each with a Hilti HVU-TZ capsule resin.

Angle to angle connections to be achieved using M10 grade 4.6 black bolts, 1No per member end.

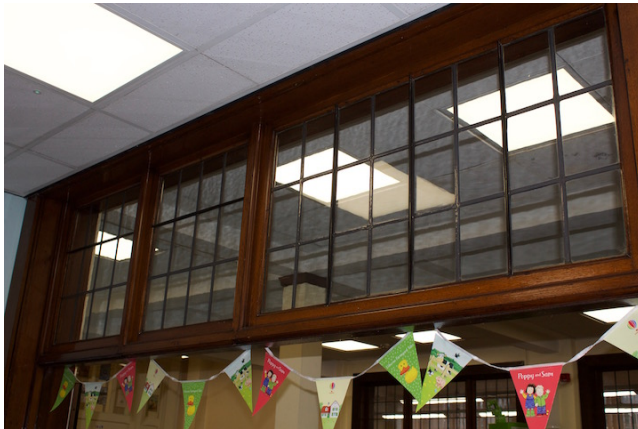
**Internal windows**

There are quite a few square-leaded internal windows in the main library rooms these are all in satisfactory condition. There is one damaged pane to one of the windows between the two rooms (this could be repaired in-situ although it is not in danger of falling out). The door to the staff room has had some previous in-situ repairs and the panel is slightly loose, this needs monitoring. The only panel that needs work is the door to the computer room mentioned earlier in this report
