**Project Name:** Tack Lea - Rochdale and Bury old rd

**Project Date:** 18/03/2021

## Section Inspection - 18/03/2021 - MH1X

## Section Inspection - 18/03/2021 - UpstreamX

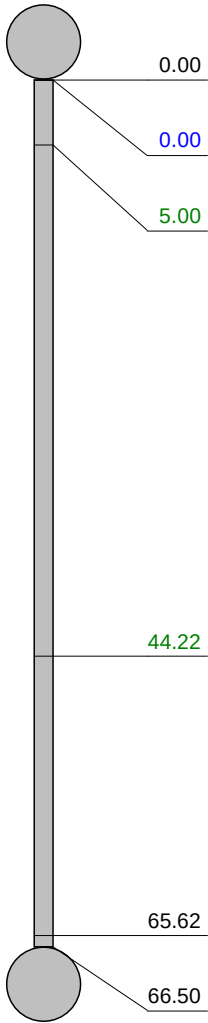
| Scale: 1:579 | Position [m] | Code | Observation | MPEG | Photo | Grade |
|---|---|---|---|---|---|---|
| 0.00 | MH | Start node type, manhole, reference number: MH1 | 00:00:00 | | | |
| 0.00 | WL | Water level, 15% of the vertical dimension | 00:00:02 | | | |
