Validation Report  
Land off Don Street, Middleton

Reference: 14-554-R8-1  
Date: January 2024

# REMEDIATION AND ENABLING WORKS VALIDATION PHASE 2A AND 3

Land off Don Street  
Middleton  
Greater Manchester  
M24 2DB

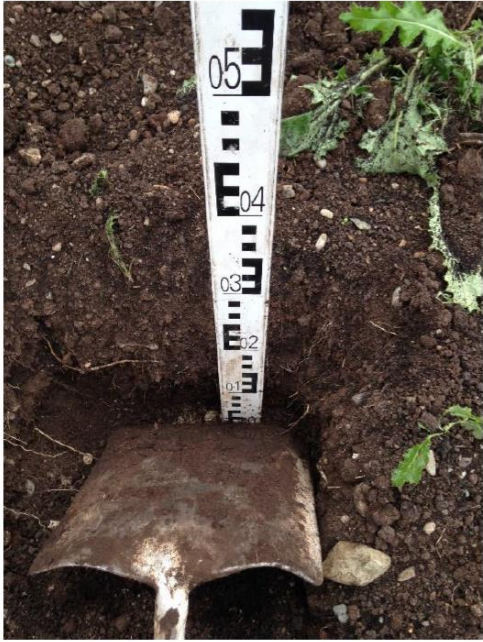
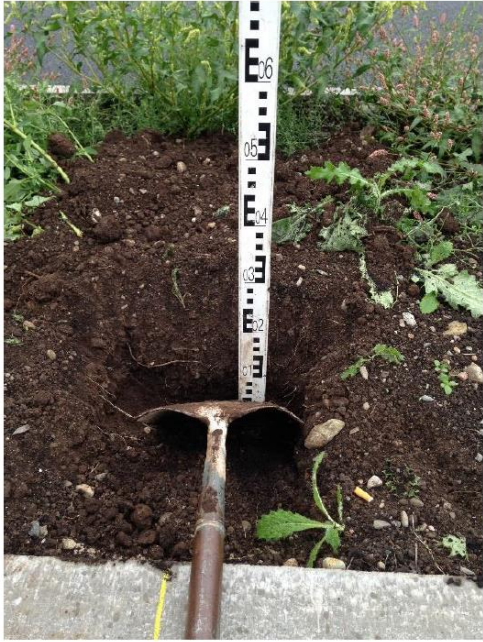
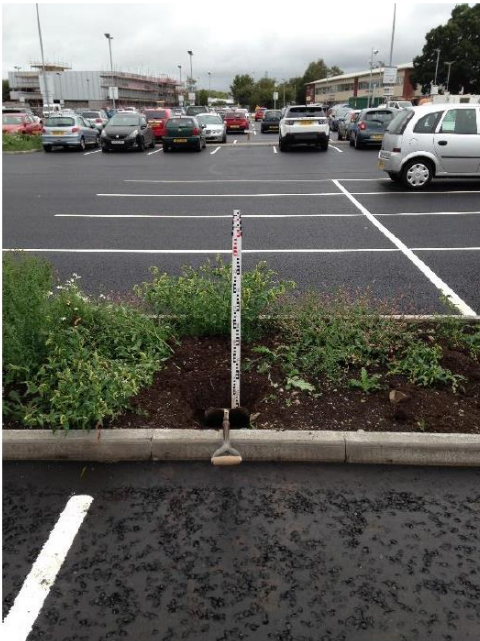
| Depth of Strata (m bgl) | 0.00-0.30 | Validated TOPSOIL |

*Depth of Cover System at Ground Level and in Relation to Unit / Structure*
