### Demolition Survey

**Redcross Street,  
Rochdale, OL12 0NZ**

Redcross Street,  
Rochdale, OL12 0NZ  
**Survey Date:- 6<sup>th</sup> November 2023**

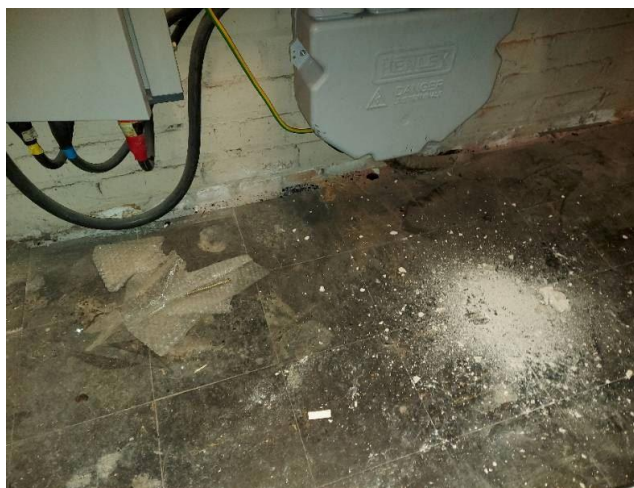
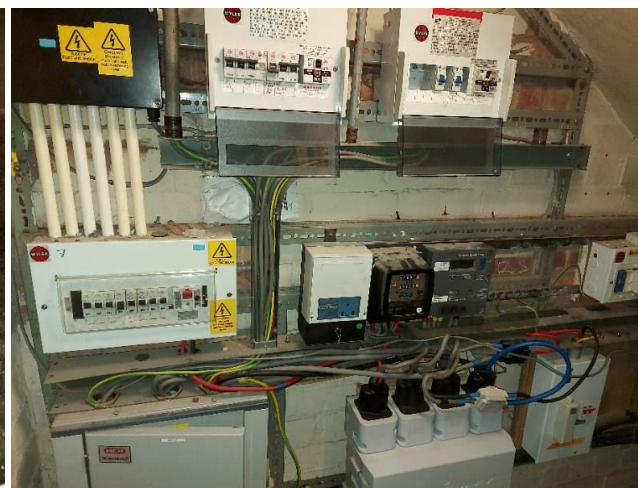
| <b>Room Ref:</b> | Electric cupboard | | |

| <b>Form:</b> | Bonded Materials | <b>Sample No:</b> | As RBH/ASB-63647 |
| <b>Extent:</b> | 3 sqm | <b>Lab Analysis Result:</b> | Chrysotile |
| <b>Location:</b> | Black floor tiles | | |

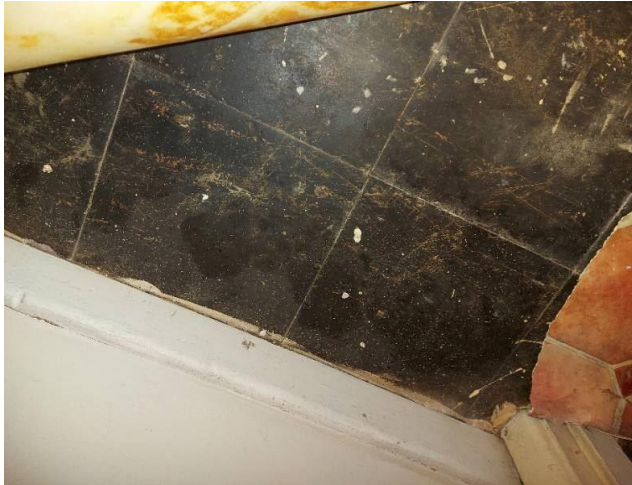
| <b>Room Ref:</b> | Emergency exit | | |

| <b>Form:</b> | Bonded Materials | <b>Sample No:</b> | As RBH/ASB-63647 |
| <b>Extent:</b> | 2 sqm | <b>Lab Analysis Result:</b> | Chrysotile |
| <b>Location:</b> | Black floor tiles | | |

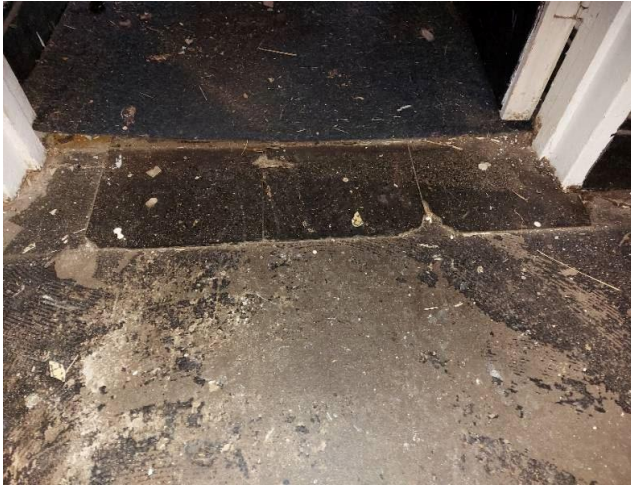
| <b>Extent:</b> | <1 sqm | <b>Lab Analysis Result:</b> | Chrysotile |
| <b>Location:</b> | Black floor tiles | | |

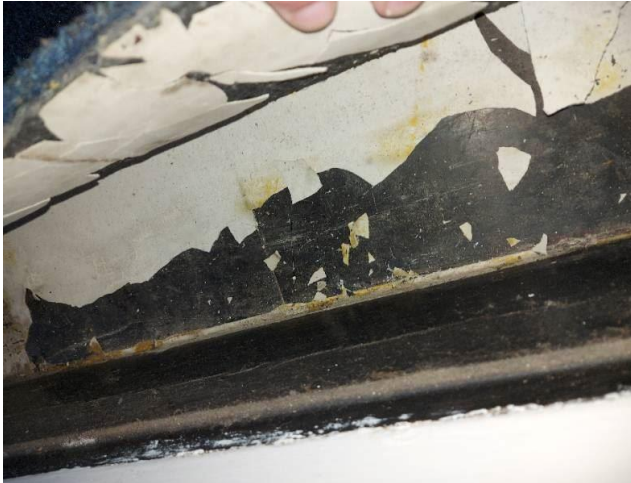
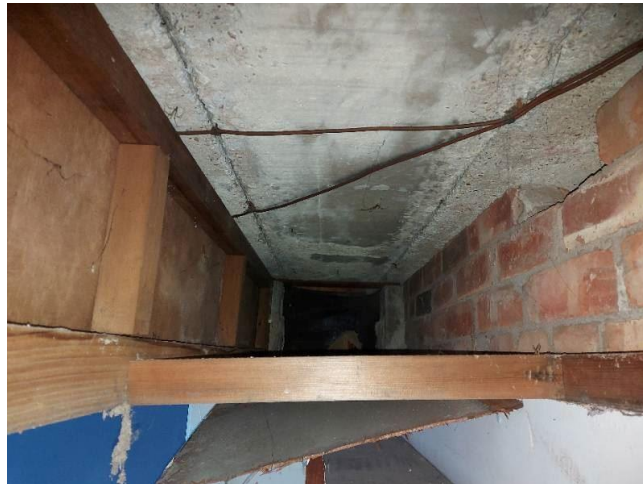
| <b>Extent:</b> | 14 sqm | <b>Lab Analysis Result:</b> | Chrysotile |
| <b>Location:</b> | Black floor tiles | | |

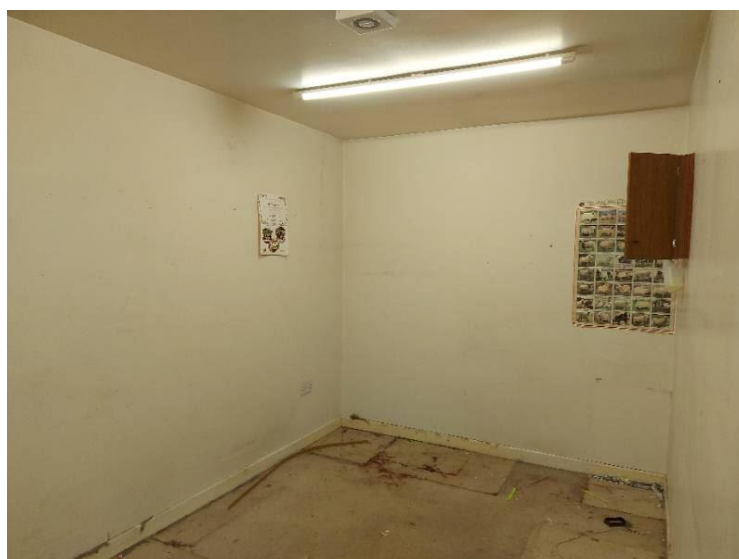
| <b>Room Ref:</b> | Public main reception store 01 | | |

| <b>Extent:</b> | - | <b>Lab Analysis Result:</b> | Not Detected |
| <b>Location:</b> | No asbestos detected | | |

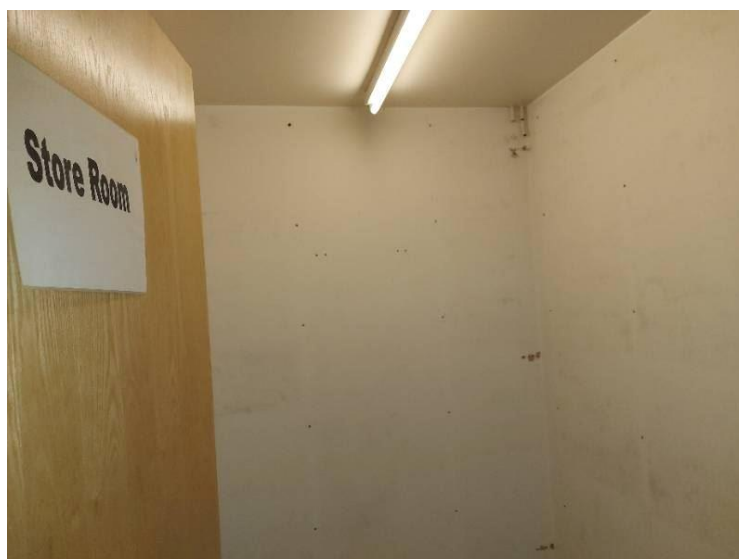
| <b>Room Ref:</b> | Public main reception store 02 | | |

| <b>Extent:</b> | - | <b>Lab Analysis Result:</b> | Not Detected |
| <b>Location:</b> | No asbestos detected | | |

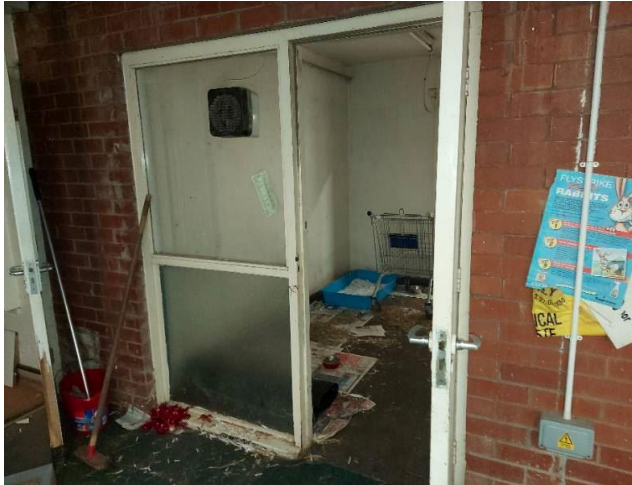
| <b>Room Ref:</b> | Rabbit room | | |

| <b>Form:</b> | Bonded Materials | <b>Sample No:</b> | As RBH/ASB-63650 |
| <b>Extent:</b> | 6 lin m | <b>Lab Analysis Result:</b> | Not Detected |
| <b>Location:</b> | DPC | | |

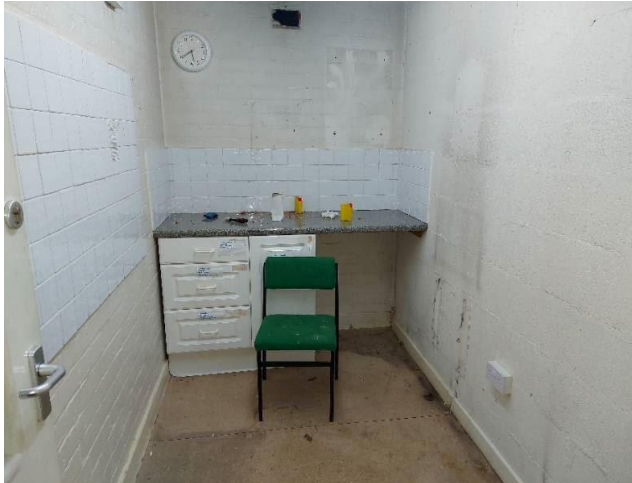
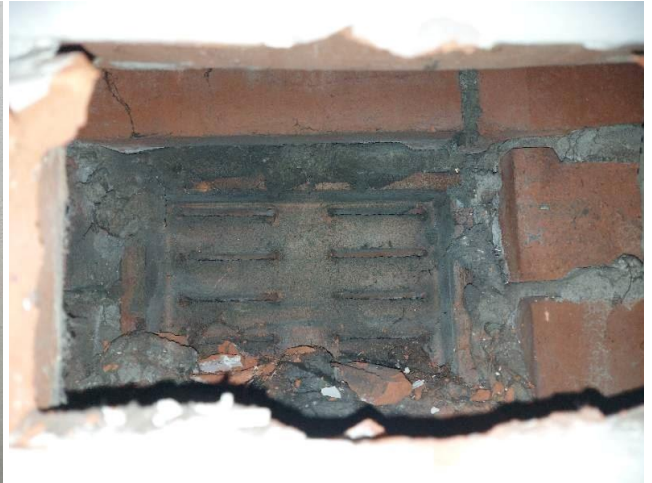
| <b>Room Ref:</b> | Room 11 | | |

| <b>Extent:</b> | - | <b>Lab Analysis Result:</b> | Not Detected |
| <b>Location:</b> | No asbestos detected | | |

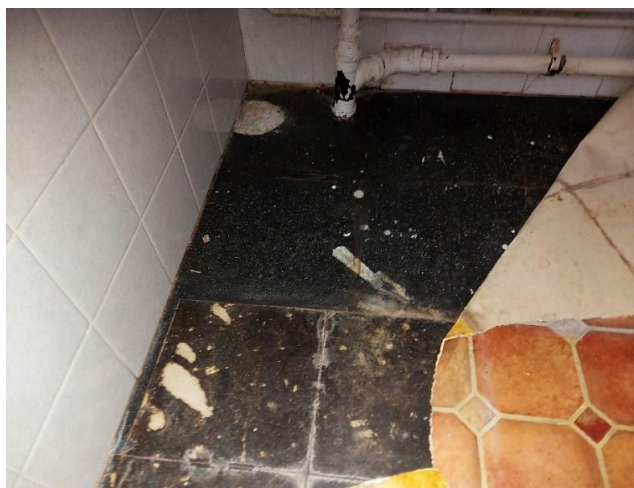
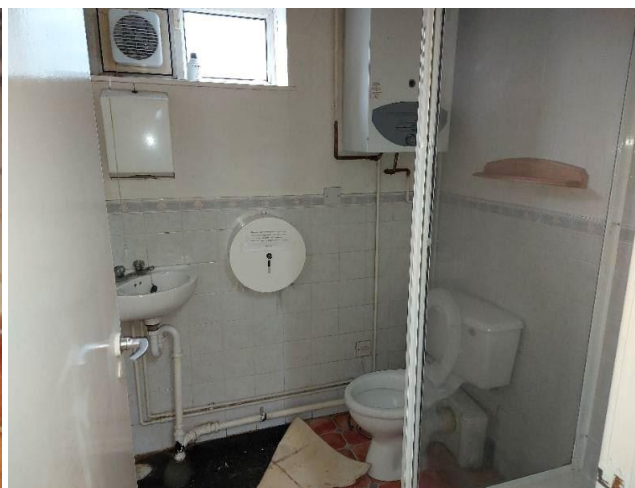
| <b>Room Ref:</b> | Shower room | | |

| <b>Form:</b> | Bonded Materials | <b>Sample No:</b> | As RBH/ASB-63647 |
| <b>Extent:</b> | 3 sqm | <b>Lab Analysis Result:</b> | Chrysotile |
| <b>Location:</b> | Black floor tiles | | |

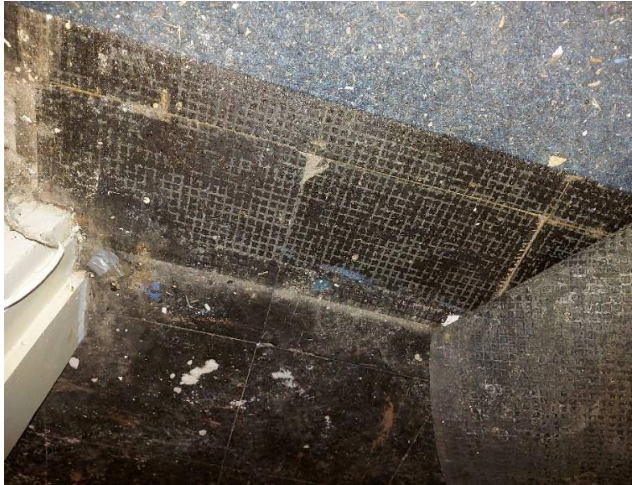
| <b>Room Ref:</b> | Stairs | | |

| <b>Form:</b> | Bonded Materials | <b>Sample No:</b> | As RBH/ASB-63647 |
| <b>Extent:</b> | 1 sqm | <b>Lab Analysis Result:</b> | Chrysotile |
| <b>Location:</b> | Black floor tiles | | |

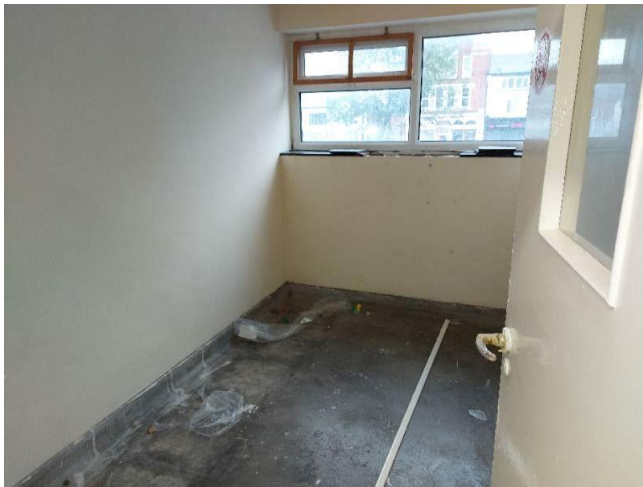
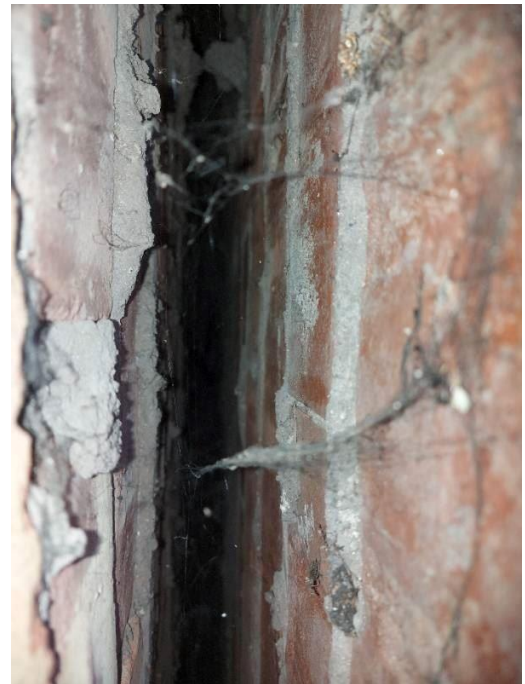
| <b>Room Ref:</b> | Store 01 | | |

| <b>Extent:</b> | - | <b>Lab Analysis Result:</b> | Not Detected |
| <b>Location:</b> | No asbestos detected | | |

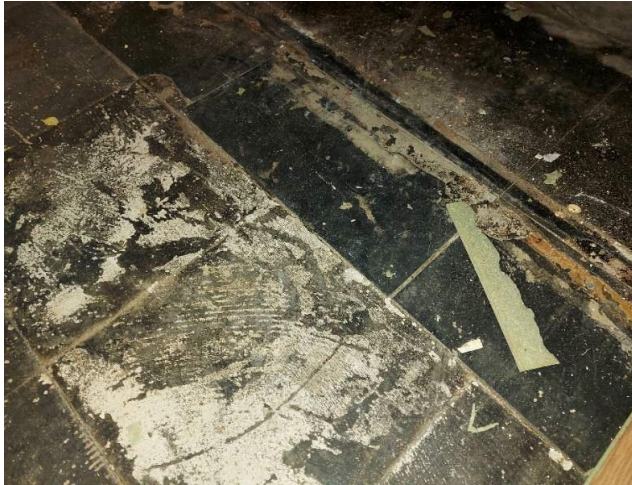
| <b>Room Ref:</b> | Store 02 | | |

| <b>Form:</b> | Bonded Materials | <b>Sample No:</b> | As RBH/ASB-63647 |
| <b>Extent:</b> | <1 sqm | <b>Lab Analysis Result:</b> | Chrysotile |
| <b>Location:</b> | Black floor tiles | | |

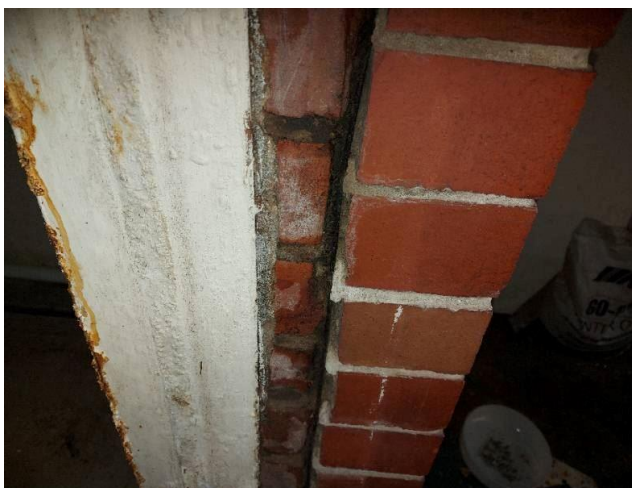
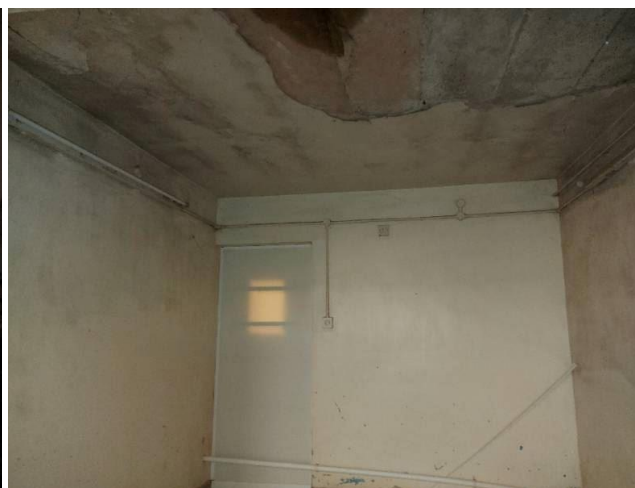
| <b>Room Ref:</b> | Store 03 | | |

| <b>Form:</b> | Bonded Materials | <b>Sample No:</b> | As RBH/ASB-63650 |
| <b>Extent:</b> | 6 lin m | <b>Lab Analysis Result:</b> | Not Detected |
| <b>Location:</b> | DPC | | |

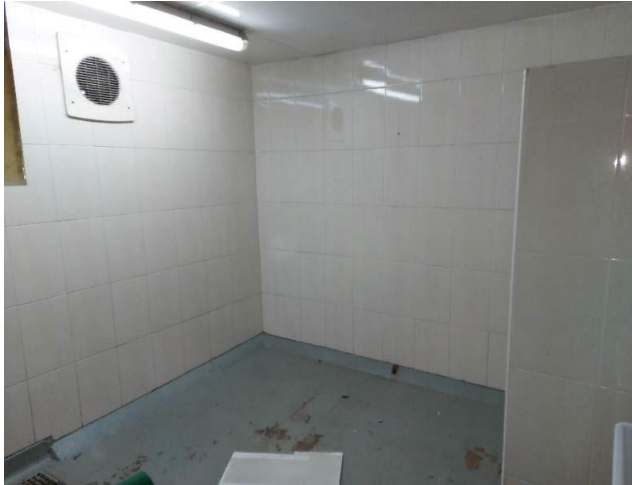
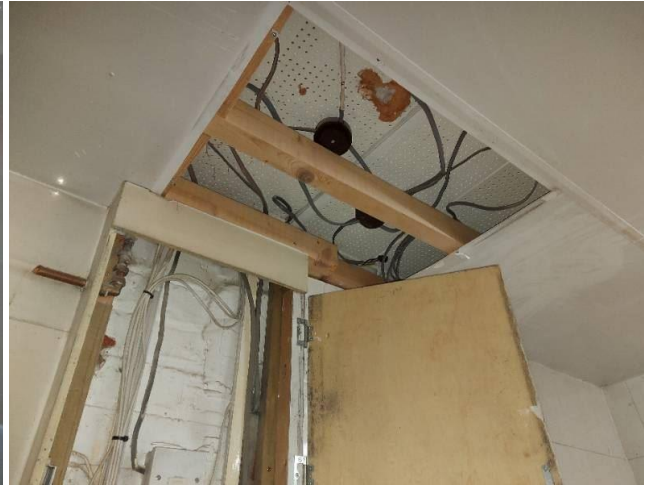
| <b>Room Ref:</b> | Wet room | | |

| <b>Extent:</b> | - | <b>Lab Analysis Result:</b> | Not Detected |
| <b>Location:</b> | No asbestos detected | | |

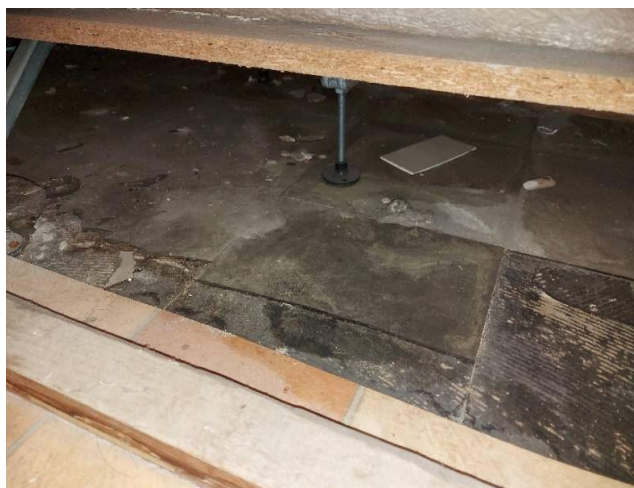
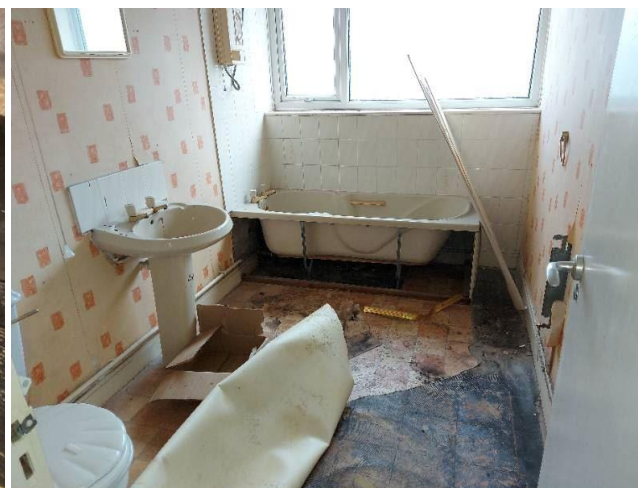
| <b>Room Ref:</b> | Bathroom | | |

| <b>Form:</b> | Bonded Materials | <b>Sample No:</b> | As RBH/ASB-63649 |
| <b>Extent:</b> | 2 sqm | <b>Lab Analysis Result:</b> | Chrysotile |
| <b>Location:</b> | Black floor tiles | | |

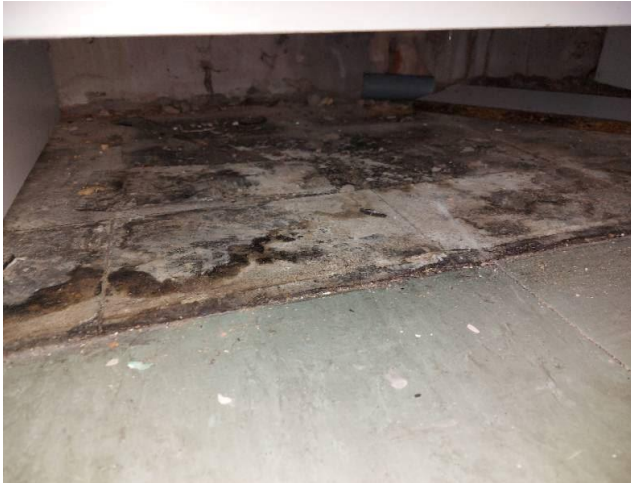
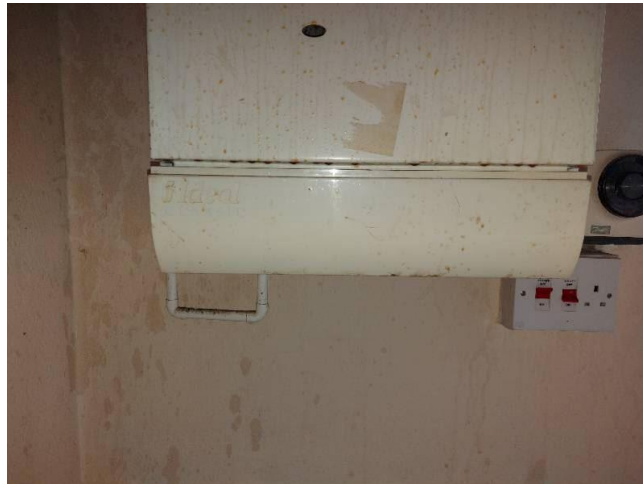
| <b>Room Ref:</b> | Kitchen | | |

| <b>Form:</b> | Bonded Materials | <b>Sample No:</b> | As RBH/ASB-63649 |
| <b>Extent:</b> | 3 sqm | <b>Lab Analysis Result:</b> | Chrysotile |
| <b>Location:</b> | Black floor tiles | | |

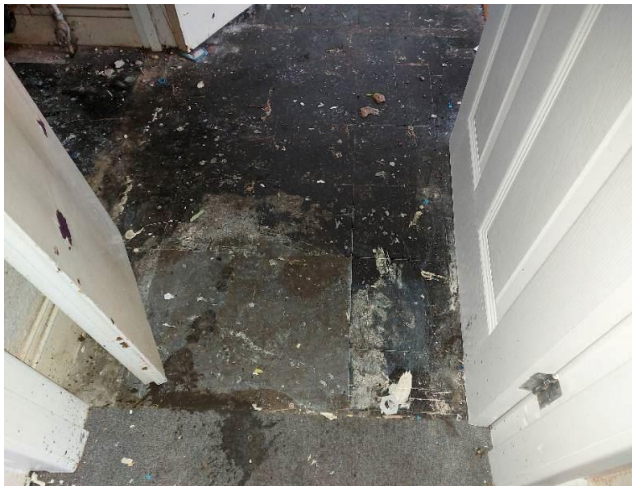
| <b>Extent:</b> | 6 sqm | <b>Lab Analysis Result:</b> | Chrysotile |
| <b>Location:</b> | Black floor tiles | | |

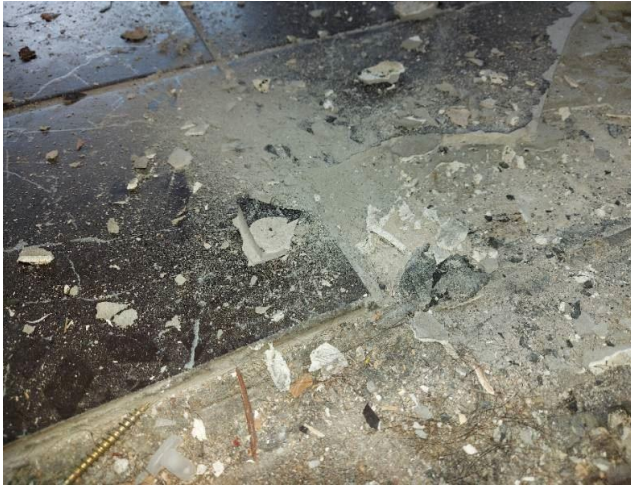
| <b>Room Ref:</b> | Office 01 | | |

| <b>Form:</b> | Bonded Materials | <b>Sample No:</b> | As RBH/ASB-63649 |
| <b>Extent:</b> | 14 sqm | <b>Lab Analysis Result:</b> | Chrysotile |
| <b>Location:</b> | Black floor tiles | | |

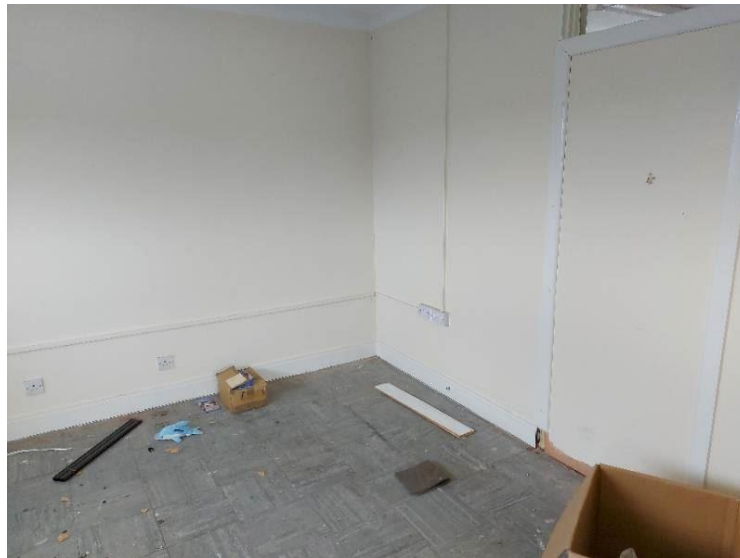
| <b>Room Ref:</b> | Office 02 | | |

| <b>Extent:</b> | - | <b>Lab Analysis Result:</b> | Not Detected |
| <b>Location:</b> | No asbestos detected | | |

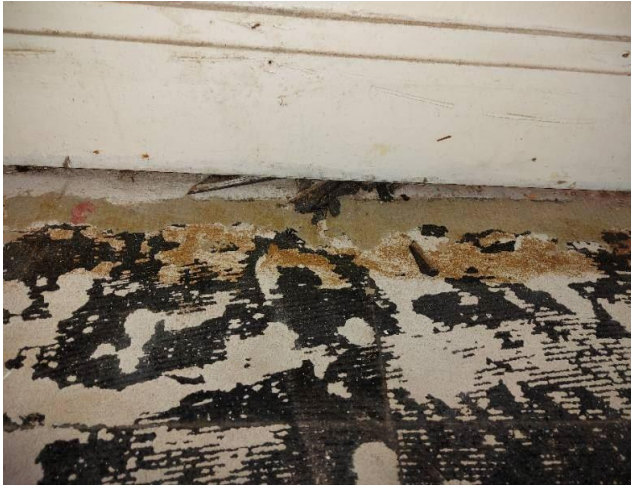
| <b>Room Ref:</b> | Office 03 | | |

| <b>Form:</b> | Bonded Materials | <b>Sample No:</b> | As RBH/ASB-63649 |
| <b>Extent:</b> | <1 sqm | <b>Lab Analysis Result:</b> | Chrysotile |
| <b>Location:</b> | Black floor tiles | | |

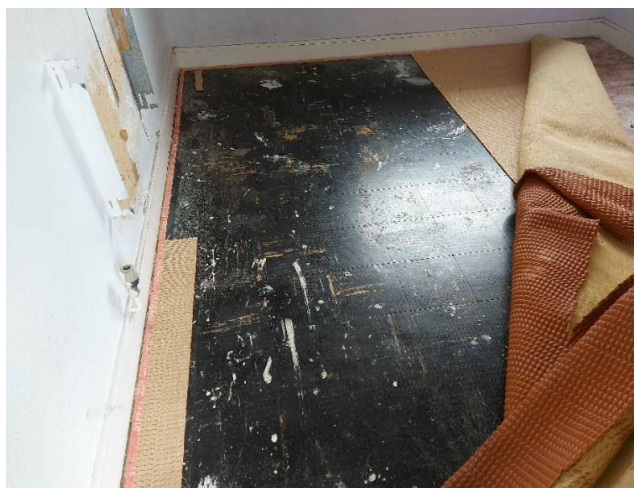
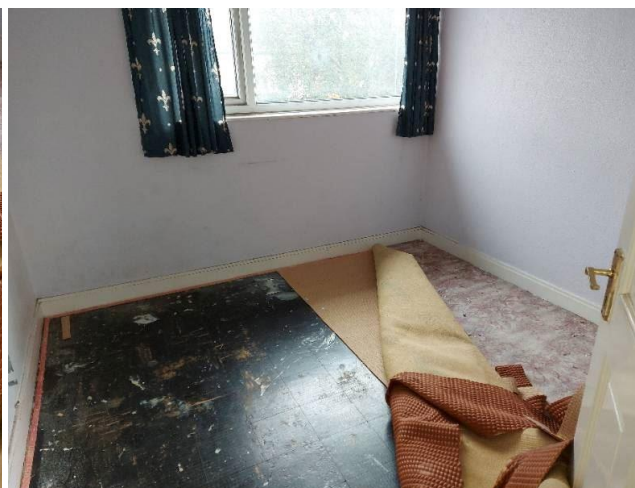
| <b>Room Ref:</b> | Office 04 | | |

| <b>Form:</b> | Bonded Materials | <b>Sample No:</b> | As RBH/ASB-63649 |
| <b>Extent:</b> | 12 sqm | <b>Lab Analysis Result:</b> | Chrysotile |
| <b>Location:</b> | Black floor tiles | | |

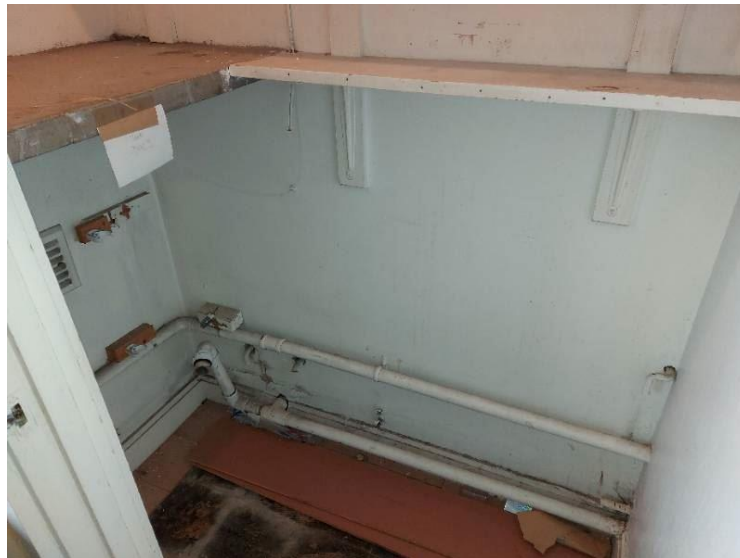
| <b>Room Ref:</b> | Pantry | | |

| <b>Extent:</b> | - | <b>Lab Analysis Result:</b> | Not Detected |
| <b>Location:</b> | No asbestos detected | | |

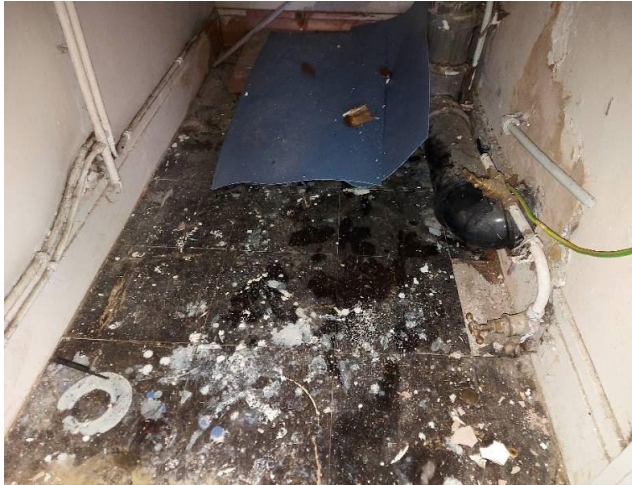
| <b>Room Ref:</b> | Store 01 | | |

| <b>Form:</b> | Bonded Materials | <b>Sample No:</b> | As RBH/ASB-63649 |
| <b>Extent:</b> | 2 sqm | <b>Lab Analysis Result:</b> | Chrysotile |
| <b>Location:</b> | Black floor tiles | | |

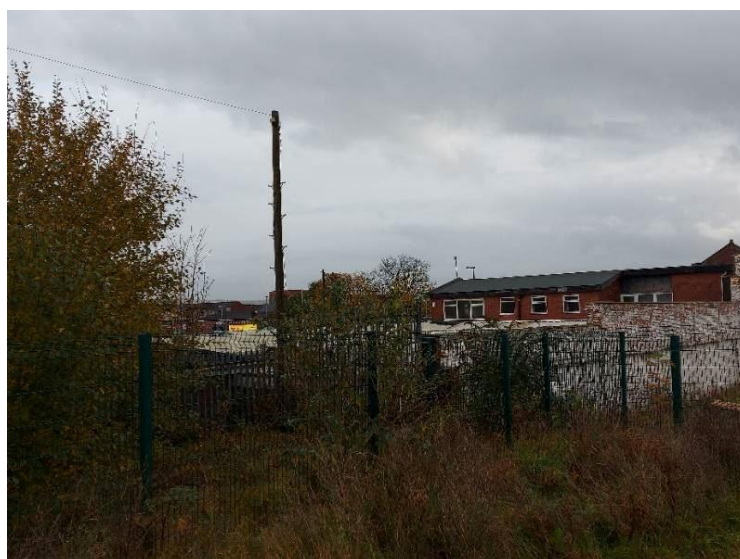
| <b>Extent:</b> | - | <b>Lab Analysis Result:</b> | Not Detected |
| <b>Location:</b> | No asbestos detected | | |

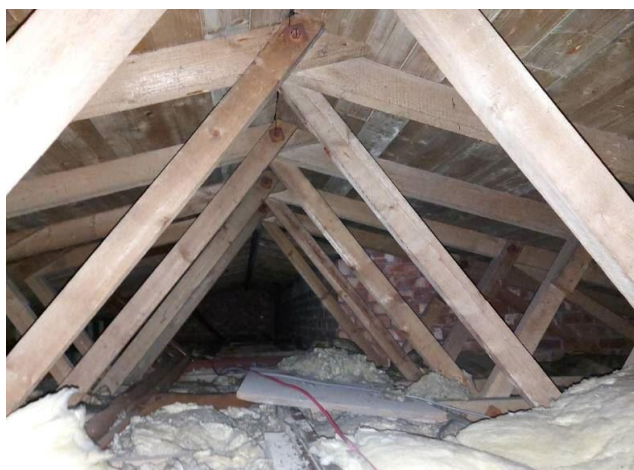
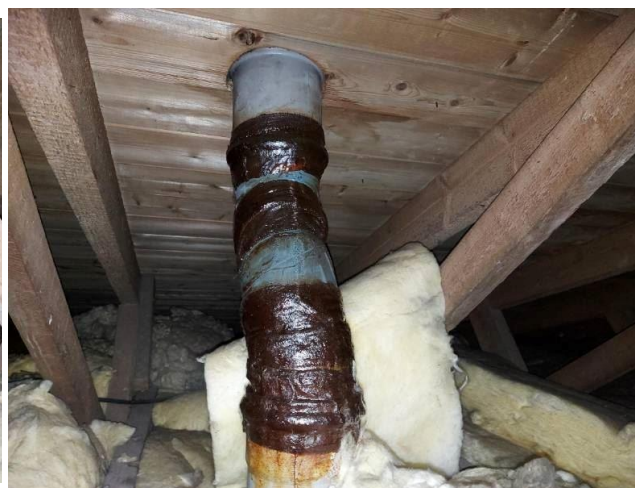
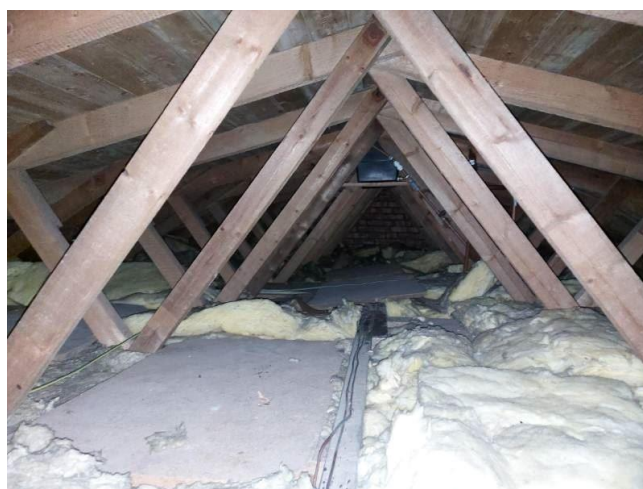
| <b>Extent:</b> | - | <b>Lab Analysis Result:</b> | Not Detected |
| <b>Location:</b> | No asbestos detected | | |
