# Preliminary Roost Assessment

132 Drake Street

Rochdale

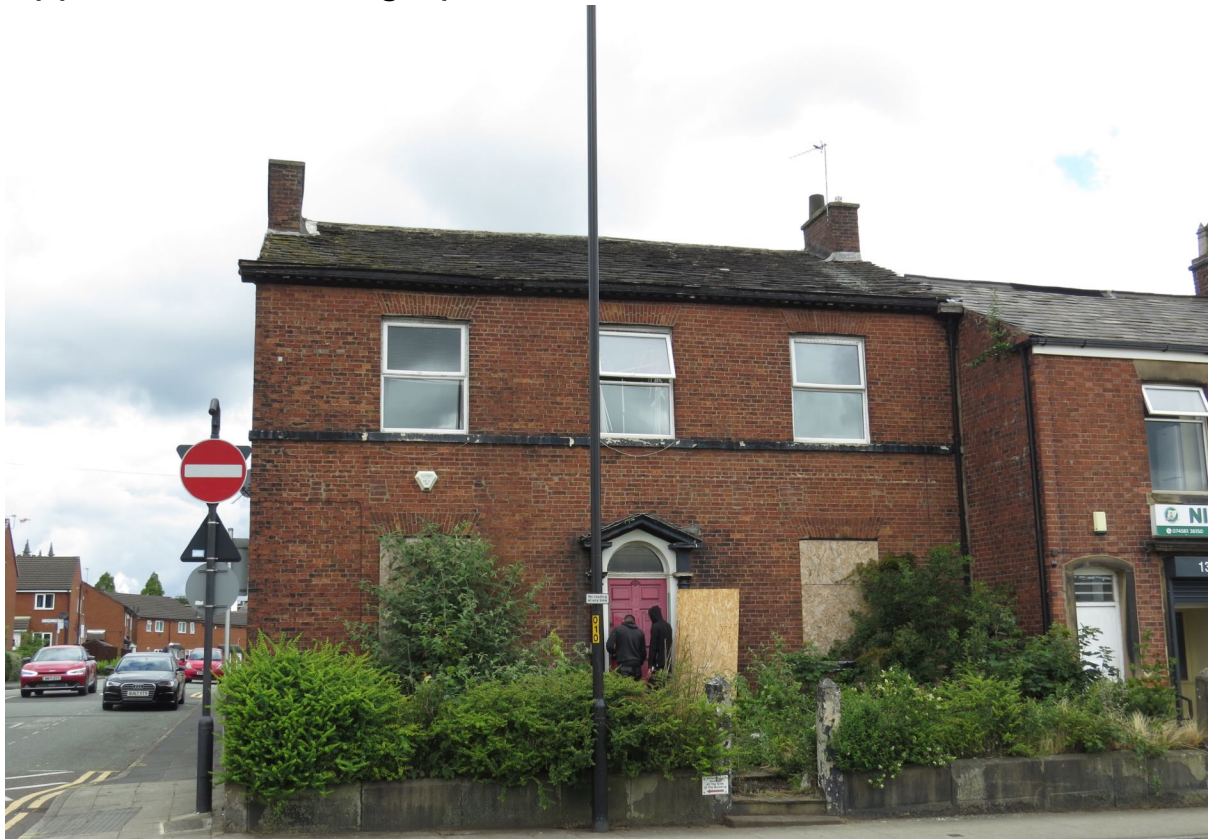
Roof pitches face northwest and southeast; the gable end faces southwest. Lead flashing has been removed and replaced with bitumen flash banding. Timber hidden gutters are fitted at the front of the building, timber fascia boards are fitted at the eaves and gable end.

The building is in poor condition. There are gaps between natural stone tiles, timbers at the eaves are in poor condition, windows could give access to the inside of the building. Fascia boards and hidden gutters are perished, with gaps between timbers and brickwork. Walls are in good condition, with no missing mortar or cracks.

1 – The front of the building.

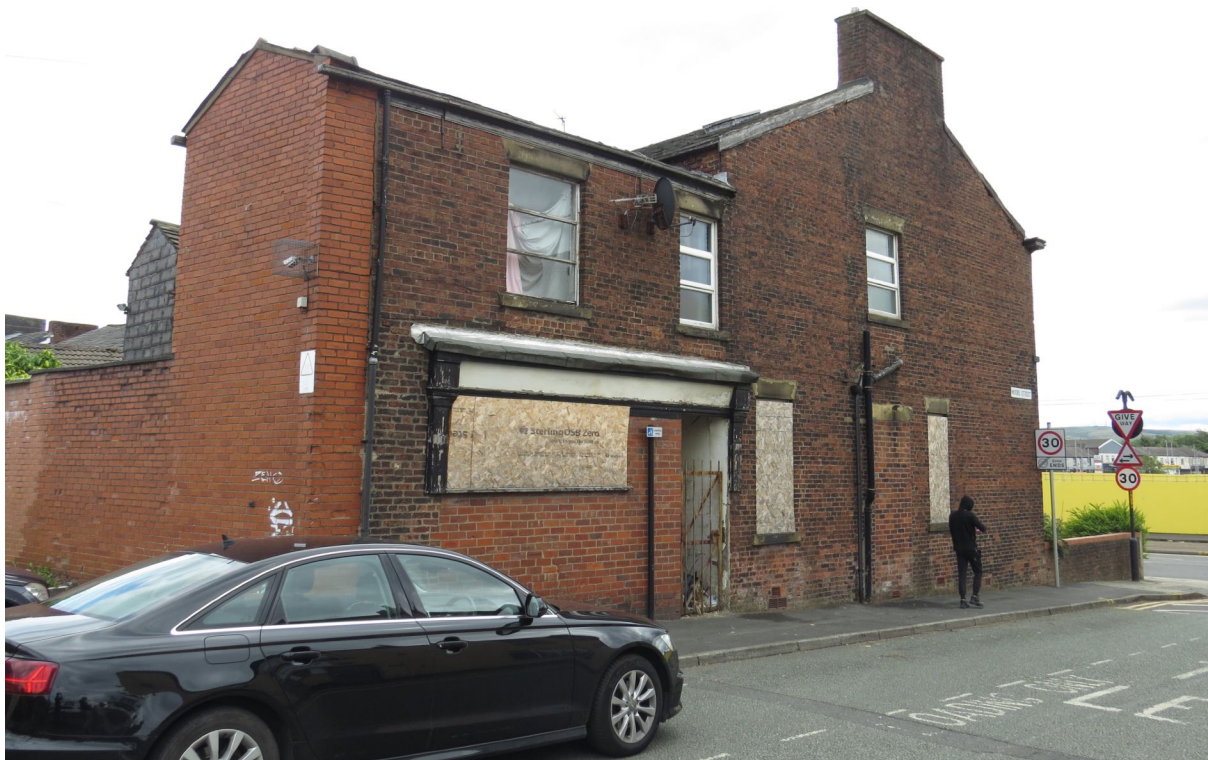
Walls are solid brick with no insulating cavity, slate hanging tiles are fitted to walls at the rear. Lintels are stone & flat-arched brickwork, sills are stone; window and door frames are timber and UPVC. Some windows are boarded, some glass is intact, some panes are broken, open, or missing.

2 – The rear of the building.
