**Lower Starring farm cottage**

## **Structural Engineers Report**

FS 4850 pkd/pkd

**Sir Frederick Snow & Partners**

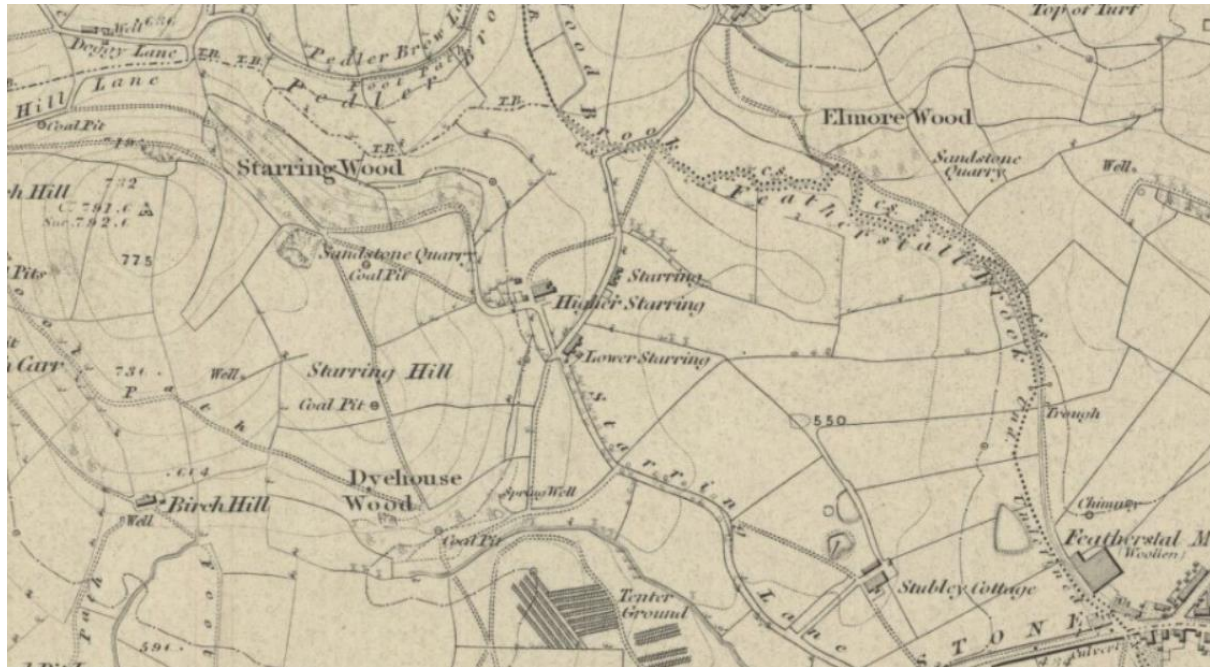
Lancashire LXXI 1851 extract.

The building is recorded on Lancashire LXXXI 1851 and the OS 1888 six inch to a mile series maps (extracts given over page). Which show the cottage/barn although they name it Starring / Middle Starring in the earlier version. Either way the basic structure is at least 130 years old.

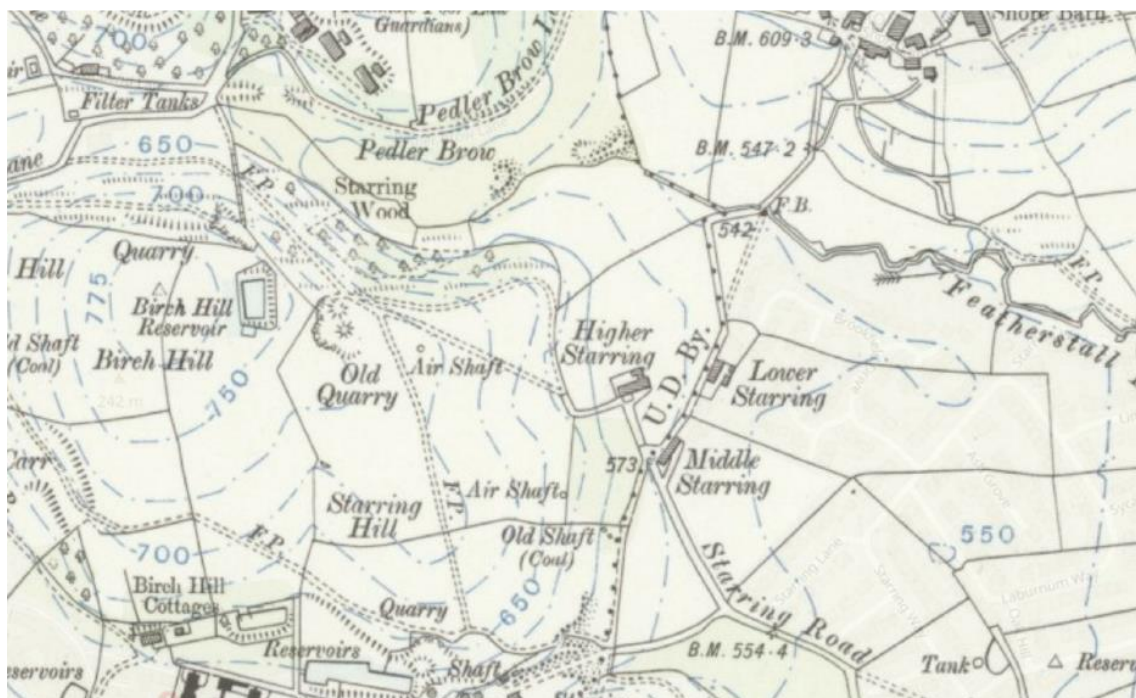
OS 6inch to 1 mile series 1888.

While both maps show there has been coal mining in the area there was no evidence of significant movement in the property and recent construction of the Estate around the cottage suggests that there is no issue from the old coal workings under Birch Hill.
