**Project Name:** HOLLINGWORTH RD, LITTLEBOROUGH  
**Project Date:** 27/04/2021  
**Inspection Standard:** MSCC3 Sewers & Drainage GB (SRM4 Scoring)

**Company:** VISTRY PARTNERSHIPS YORKSHIRE LTD  
**Contact:** IAN HEBBLETHWAITE  
**Street:** THUNDERHEAD RIDGE  
**Town or City:** GLASSHOUGHTON  
**County:** WEST YORKSHIRE  
**Post Code:** WF10 4UA

**Company:** SUB GROUP LTD  
**Description:** SURVEYING  
**Contact:** JOE WALSHAW  
**Department:** CCTV  
**Town or City:** DONCASTER  
**County:** SOUTH YORKSHIRE  
**Post Code:** DN3 1PQ  
**Phone:** 01302 880537  
**Email:** joe.walshaw@sub-group.co.uk

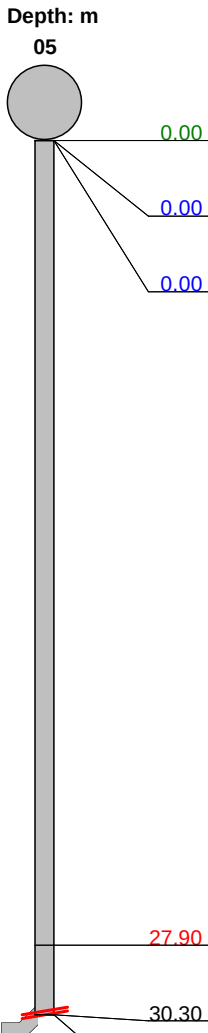
| Scale: | 1:262 | Position [m] | Code | Observation | MPEG | Photo | Grade |
|---|---|---|---|---|---|---|---|
| | | 27.90 | B | Broken sewer from 11 o'clock to 1 o'clock: SLAB BROKEN | 00:02:36 | ZZZX_e4a6e72c-c616-483d-9fd | 4 |

ZZZX\_e4a6e72c-c616-483d-9fda-125620884cf1\_20210427\_1  
12813\_967.jpg, 00:02:36, 27.90 m  
Broken sewer from 11 o'clock to 1 o'clock, SLAB BROKEN

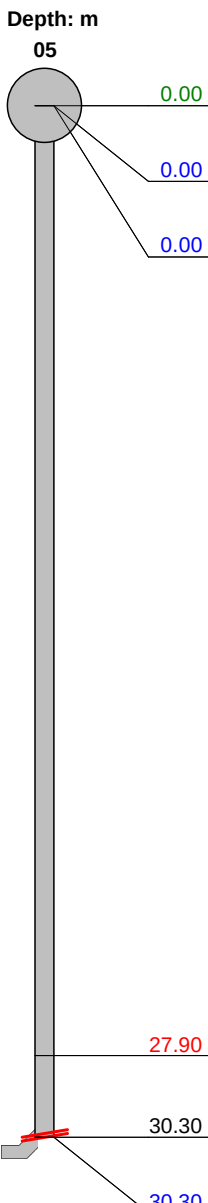
| Scale: 1:222 | Position [m] | Code | Observation | MPEG | Photo | Grade |
|---|---|---|---|---|---|---|
| | 27.90 | B | Broken sewer from 11 o'clock to 1 o'clock: SLAB BROKEN | 00:02:36 | | 4 |
