# **Site Tree Appraisal**

## ***5 Hillkirk Drive, Shawclough, Rochdale OL12 7HD***

Date: 11<sup>th</sup> November 2024

Ref: RTS/11112024

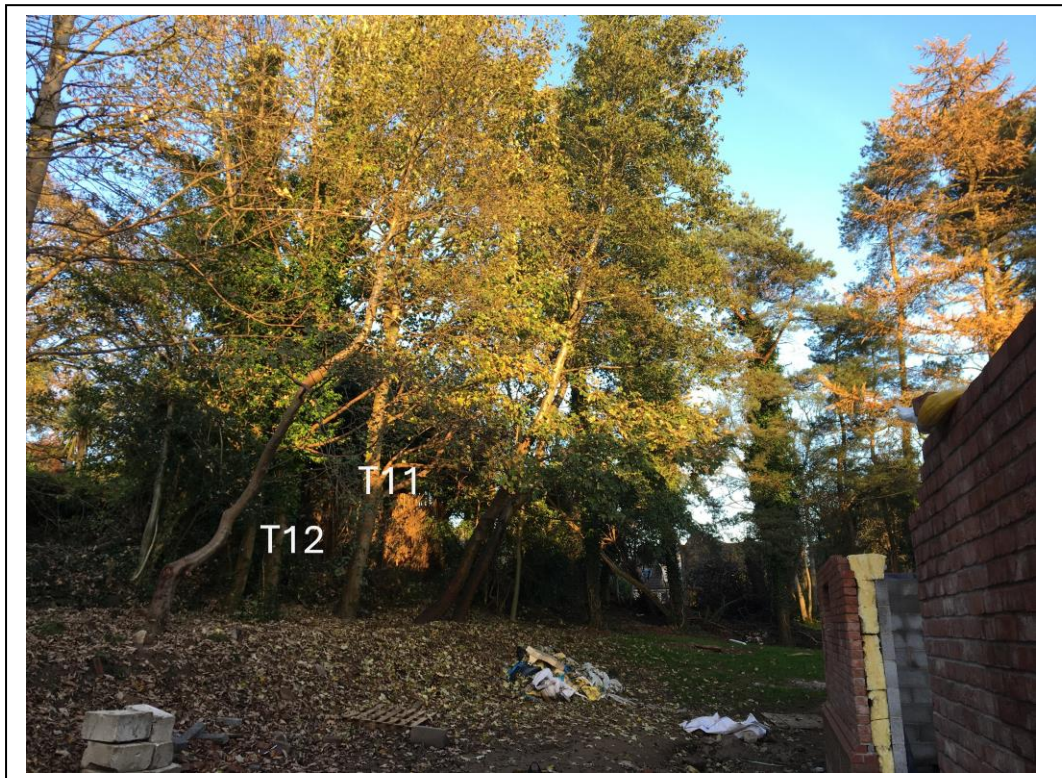
**Photo 04:**

- 3.4** There will be no requirement to excavate for the placement of foundations within the calculated root protection area (RPA) of any of the existing site trees. However, to deter building contractors from venturing into and storing building materials within a tree RPA it is recommended that temporary protective fencing be installed. To allow sufficient workspace, however, the protective fencing will have to be slightly offset around the RPA of trees T1 and T2. These exposed parts of T1 and T2 RPAs should be covered with temporary ground protection. The protective fencing and ground protection specifications are noted in the Recommendations, section 5 of the report.
- 3.5** Minor crown lift facilitation pruning is recommended to trees T11 and T12 (photo 04). The pruning specifications are noted in the Recommendations, section 5 of the report.
