COAL MINING RISK ASSESSMENT  
AT  
LAND ADJACENT TO 1018 EDENFIELD ROAD,  
NORDEN, ROCHDALE,  
OL12 7TR  
FOR  
MRS PEARSON  
REPORT REF: PRN 3528CMRA

# COAL MINING RISK ASSESSMENT

LAND ADJACENT TO 1018 EDENFIELD ROAD  
NORDEN, ROCHDALE, OL12 7TR

REPORT REF: PRN 3528CMRA

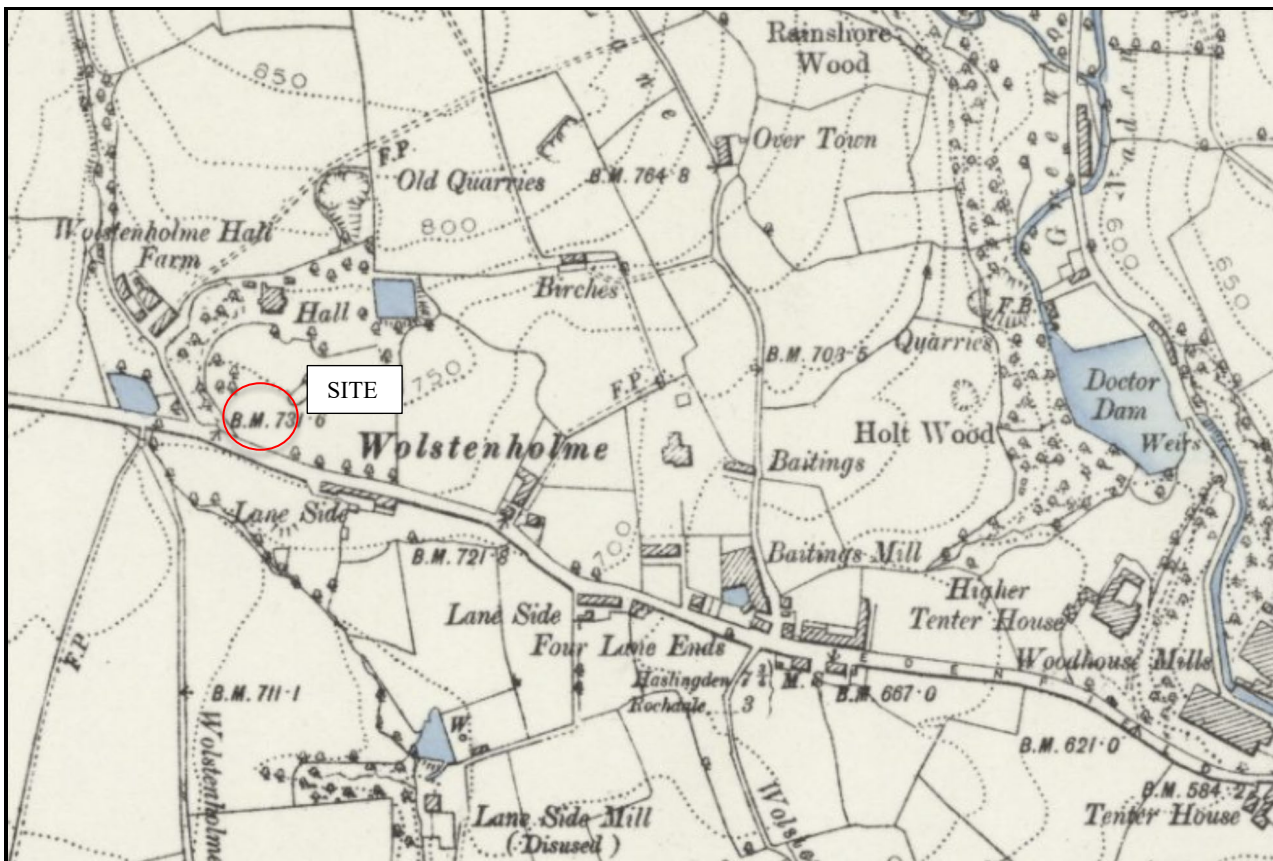
**Figure 5 OS Map 1894**

The OS map of 1854 indicates the area of the site to be generally open land with large numbers of coal pits and several local collieries at Lane Side, Hind Clough and Clifford Hall. By 1894 most of the small coal pits had ceased to exist with the collieries still working coal.

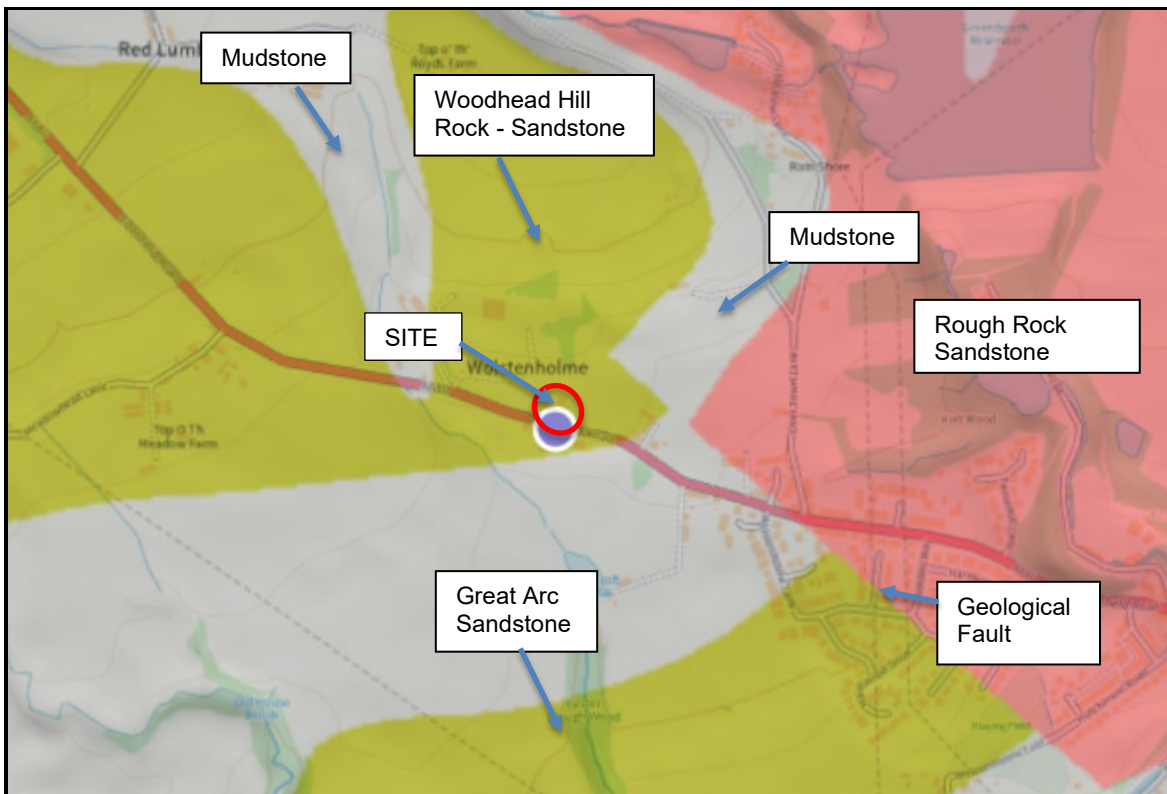
**Figure 6 Bedrock Geology**

Survey (BGS) geological maps of the area, Sheet SD81NW and NE at a scale of 1:10,000, show the site to be underlain by bedrock of the Lower Pennine Coal Measures. The site area is underlain by the Woodhead Hill Rock Sandstone in turn underlain by the Rough Rock Sandstone and Millstone Grit Series of sandstones and mudstones. Several workable coal seams lie at shallow depths (<30m) to 100m bgl in the vicinity of the site. The dip of the bedrock is generally to the south east.

There are superficial deposits overlying the bedrock in the form of Devensian Till, Diamicton, sedimentary deposits from the Quaternary Period comprising clay with silt and sand. Extracts of the BGS Geological Map are provided in Figures 6 and 7 below.

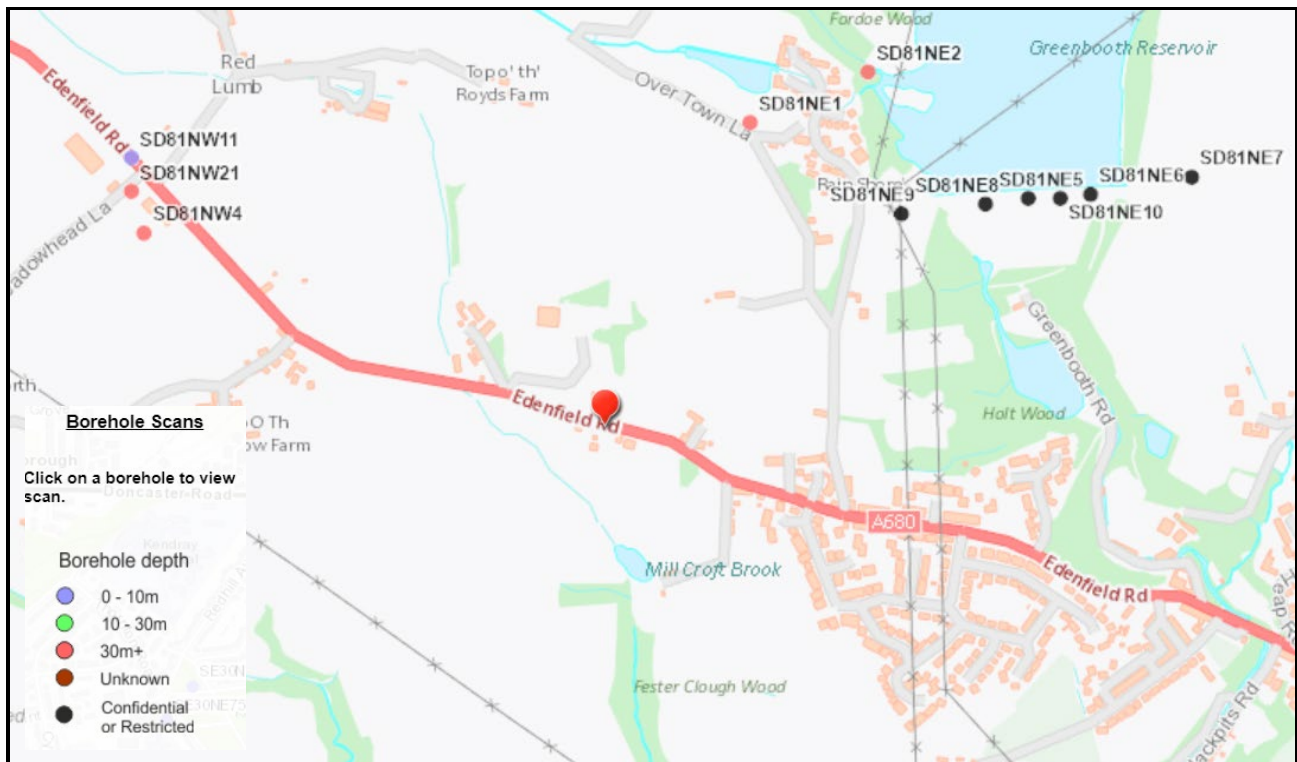
**Figure 8 Local Archival Borehole Locations**

BGS hold records of local boreholes have been used to assist in interpretation of the geology. Boreholes sunk in the vicinity of the site encountered strata as described in Table 1.

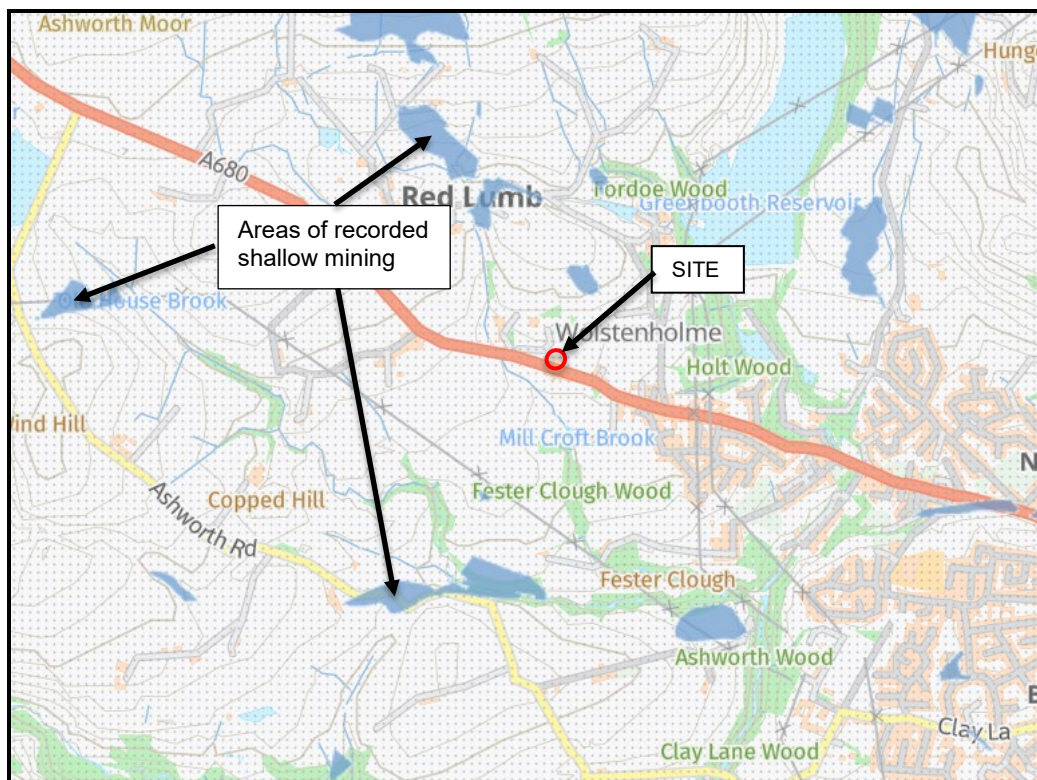
**Figure 11 Past Shallow Coal Workings**

The Sand Mine Coal is known to have been mined within vicinity of the site. The 6 inch coal and underlain Fireclay were possibly worked in the area. The Bassey Coal was generally 0.60m in the area and often mined for coal and underlying fireclay. The overlying Lower Foot Coal was of high quality and worked from day holes in the area. The overlying Lower Mountain Mine Coal was worked to near extinction in the area. There is therefore a high risk of mining being present beneath the site, which may be of such shallow depth as to cause ground subsidence in the future, particularly when the ground is loaded by the new development.

There is a **high risk** that the site has been undermined at <30m depth bgl. Any voids remaining in workings at this depth may, depending on coal thickness mined, migrate by successive roof collapse and reach the ground surface to cause subsidence in the future and damage to overlying structures.

If voids or loose ground and evidence of mining is detected a grouting programme may be required to enable development if insufficient cover of competent cover is present to prevent voids reaching the ground surface. Foundation design would need to take into account any grouted mine workings as the grout prevents roof collapse, but does not have bearing strength to support buildings.
