**Issue Date**  
17<sup>th</sup> April 2022

**Reference Number**  
HCA02246

## Asbestos Demolition Survey

Units F13, F14 and F15  
Fieldhouse Industrial Estate  
Rochdale  
Lancashire  
OL12 0AA

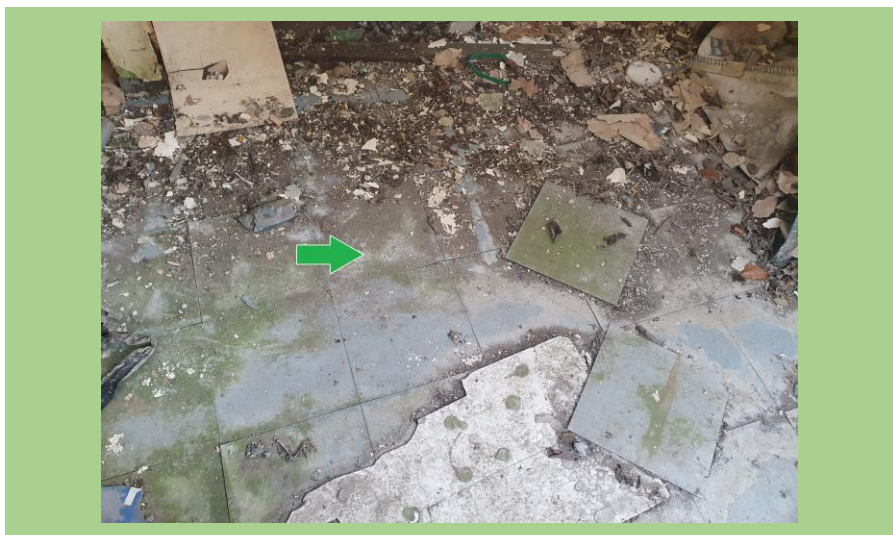
| Sample Number | 1 | No Asbestos Detected |

| Floor, Room | Ground floor, G.01 | Location | Floor |
| Material | Blue floor tiles | Quantity | 12 sq. m. |

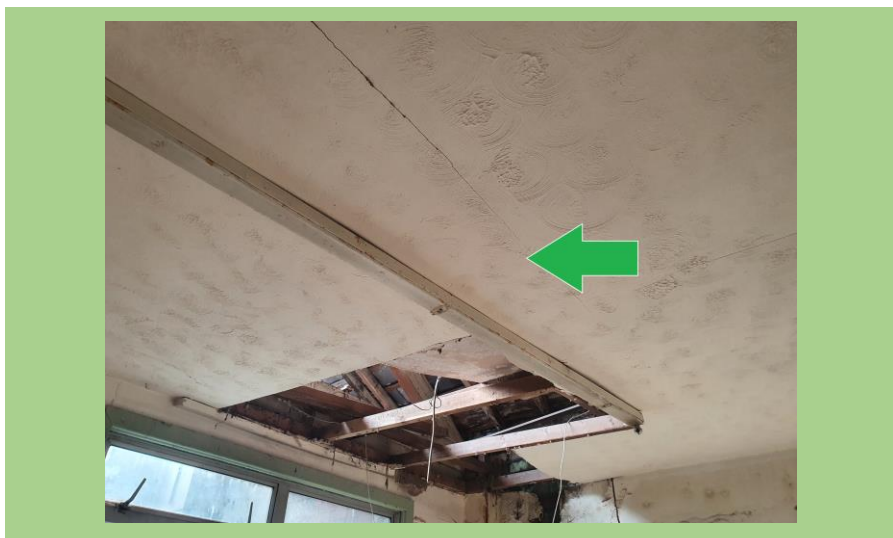
| Sample Number | 4 | No Asbestos Detected |

| Floor, Room | Ground floor, G.02 | Location | Ceiling |
| Material | Textured coating | Quantity | 12 sq. m. |

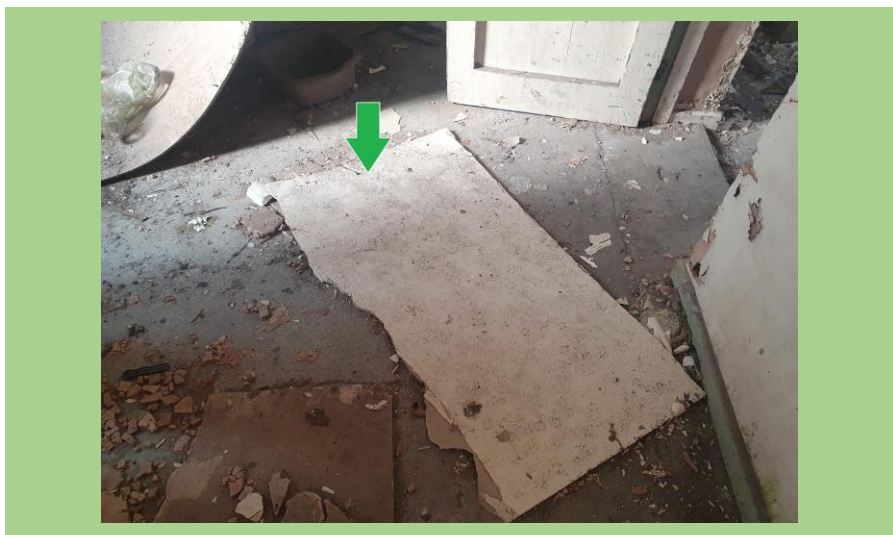
| Sample Number | 5 VI 4 | No Asbestos Detected |

| Floor, Room | Ground floor, G.02 | Location | Loose plasterboard sections on the floor |
| Material | Textured coating | Quantity | 4 sq. m. |

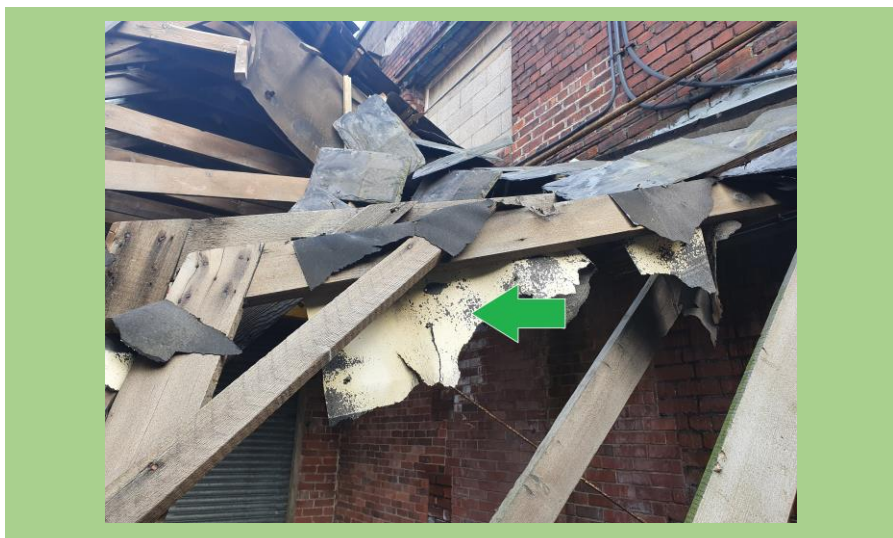
| Sample Number | 6 | No Asbestos Detected |

| Floor, Room | Ground floor, G.03 | Location | Laying loose on the floor and also within the collapsed roof structure |
| Material | Bituminous sarking felt | Quantity | 10 sq. m. |

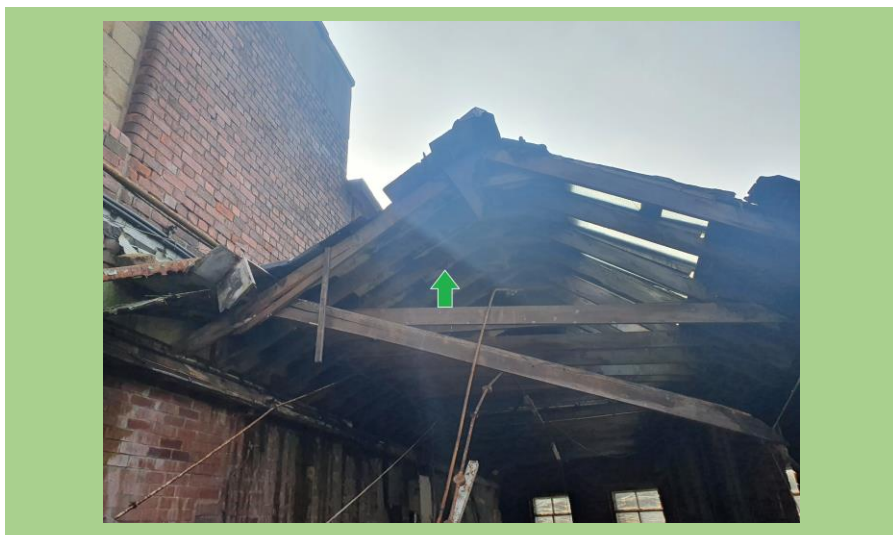
| Sample Number | 7 VI 6 | No Asbestos Detected |

| Floor, Room | Ground floor, G.03 | Location | Lining the underside of the roof |
| Material | Bituminous sarking felt | Quantity | 80 sq. m. |

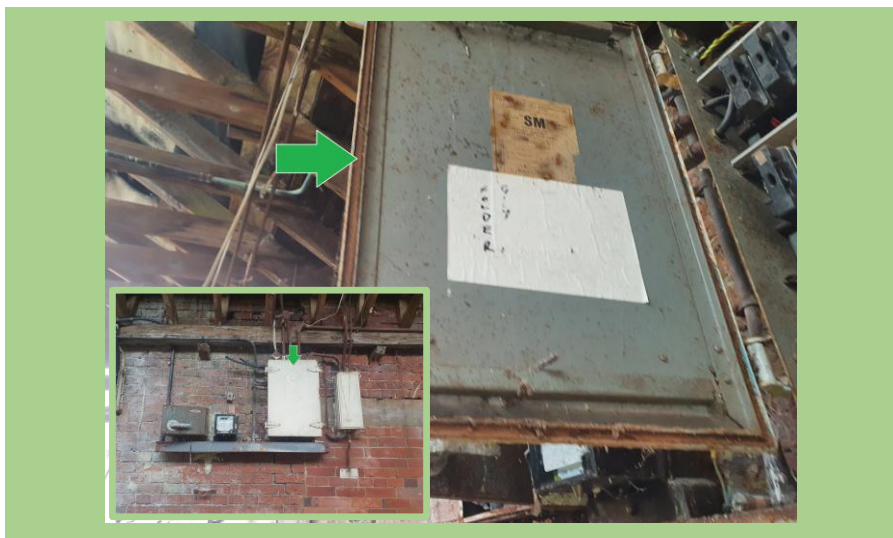
| Sample Number | 9 | No Asbestos Detected |

| Floor, Room | Ground floor, G.03 | Location | Within the wall mounted fuse box |
| Material | Textile rope seal to the door | Quantity | 1 unit |

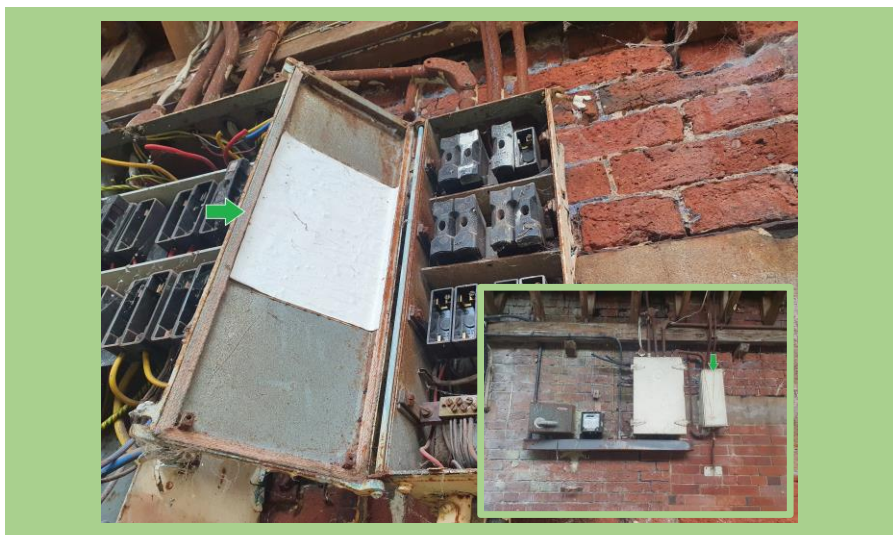
| Sample Number | 11 | No Asbestos Detected |

| Floor, Room | Ground floor, G.03 | Location | Within the wall mounted fuse box |
| Material | Textile rope seal to the door | Quantity | 1 unit |

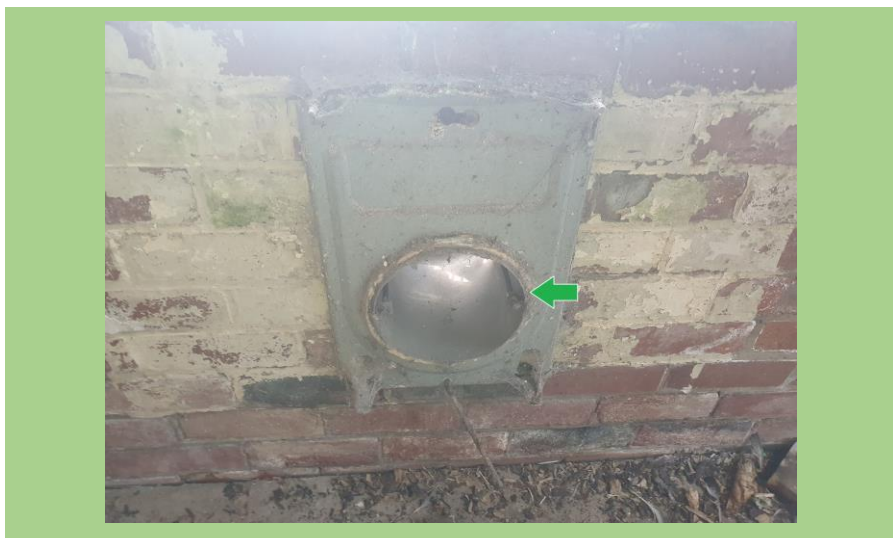
| Sample Number | 13 | No Asbestos Detected |

| Floor, Room | Ground floor, G.03 | Location | Flue pipe on the wall |
| Material | Textile rope seal | Quantity | 1 unit |

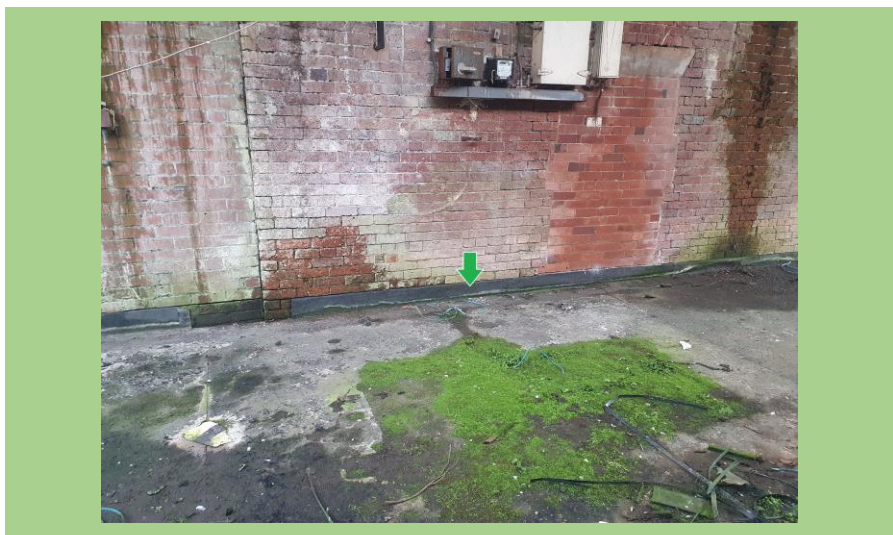
| Sample Number | 14 | No Asbestos Detected |

| Floor, Room | Ground floor, G.03 | Location | Skirting at the base of the wall |
| Material | Bituminous felt | Quantity | 14 lin. m. |

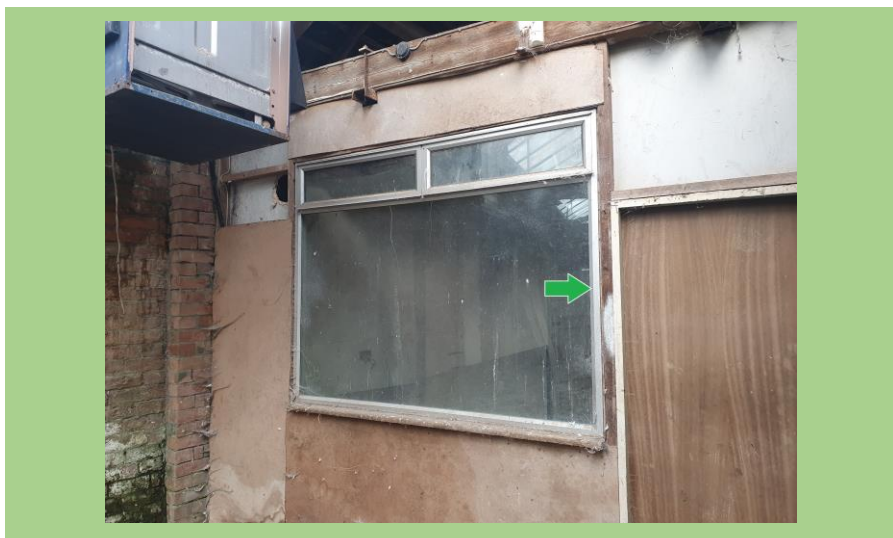
| Sample Number | 16 | No Asbestos Detected |

| Floor, Room | Ground floor, G.03 | Location | Window frame |
| Material | Putty | Quantity | 6 lin. m. |

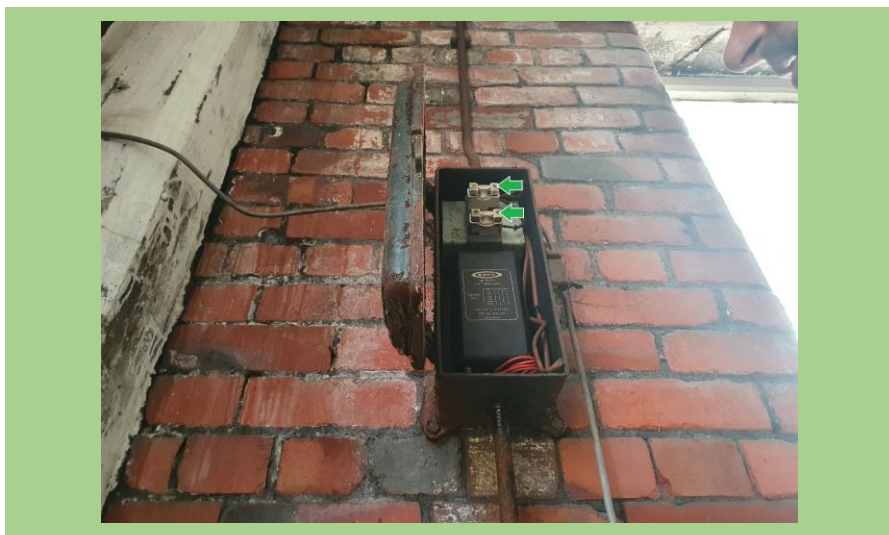
| Sample Number | 17 | No Asbestos Detected |

| Floor, Room | First floor, 1.01 | Location | Within the wall mounted fuse box |
| Material | Putty screw covers | Quantity | 4 units |

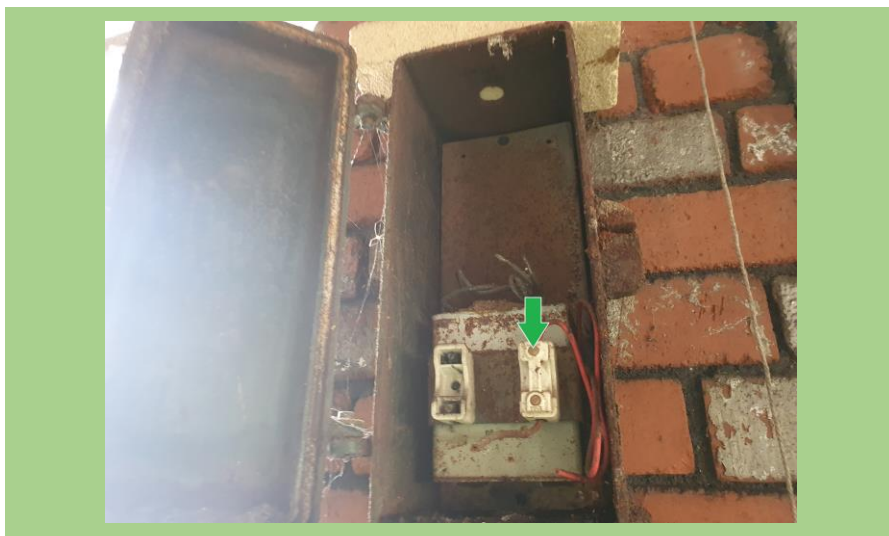
| Sample Number | 20 VI 17 | No Asbestos Detected |

| Floor, Room | First floor, 1.01 | Location | Within the wall mounted fuse box |
| Material | Putty screw covers | Quantity | 2 units |

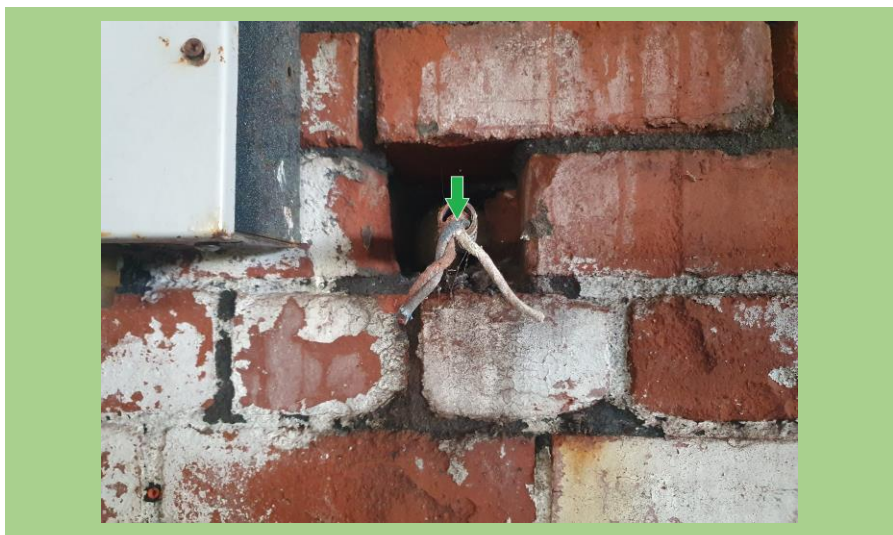
| Sample Number | 22 | No Asbestos Detected |

| Floor, Room | First floor, 1.01 | Location | Electrical cables penetrating the wall |
| Material | Textile wrap | Quantity | <1 lin. m. (visible) |

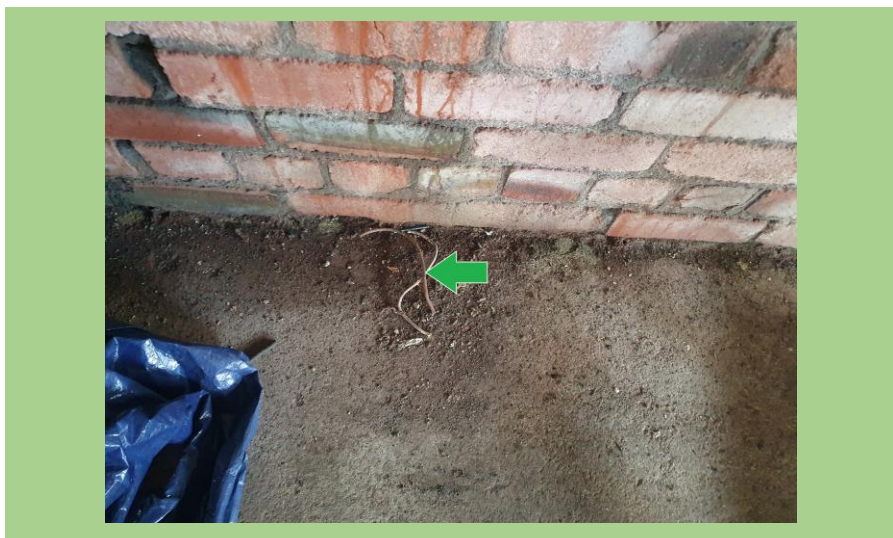
| Sample Number | 23 VI 22 | No Asbestos Detected |

| Floor, Room | First floor, 1.01 | Location | Loose laying electrical cables |
| Material | Textile wrap | Quantity | <1 lin. m. |

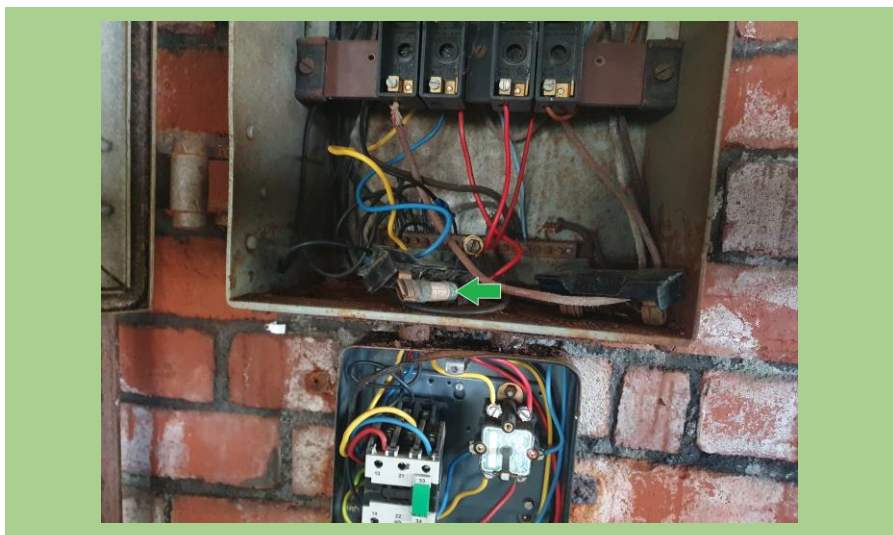
| Sample Number | 24 | No Asbestos Detected |

| Floor, Room | First floor, 1.01 | Location | Loose within the fuse box |
| Material | Millboard plug within the barrel fuse | Quantity | 1 unit |

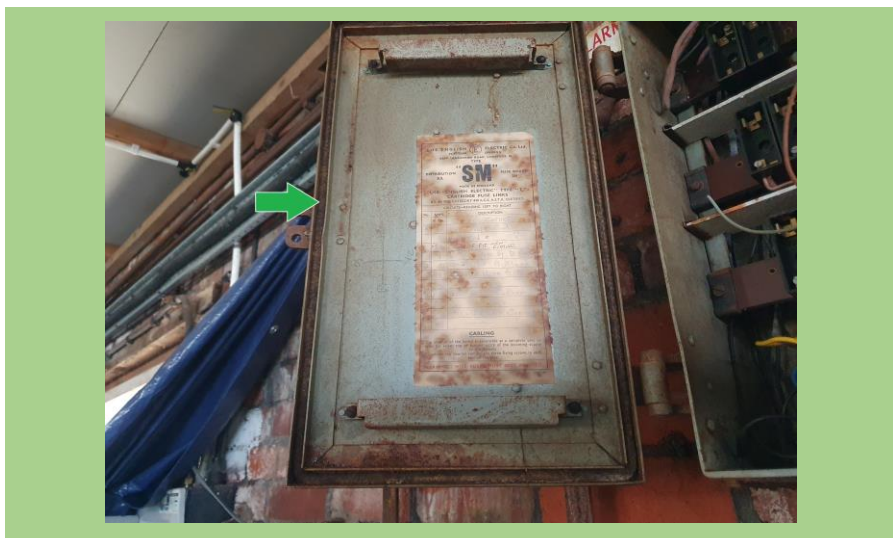
| Sample Number | 26 | No Asbestos Detected |

| Floor, Room | First floor, 1.01 | Location | Within the wall mounted fuse box |
| Material | Textile rope seal to the door | Quantity | 1 unit |

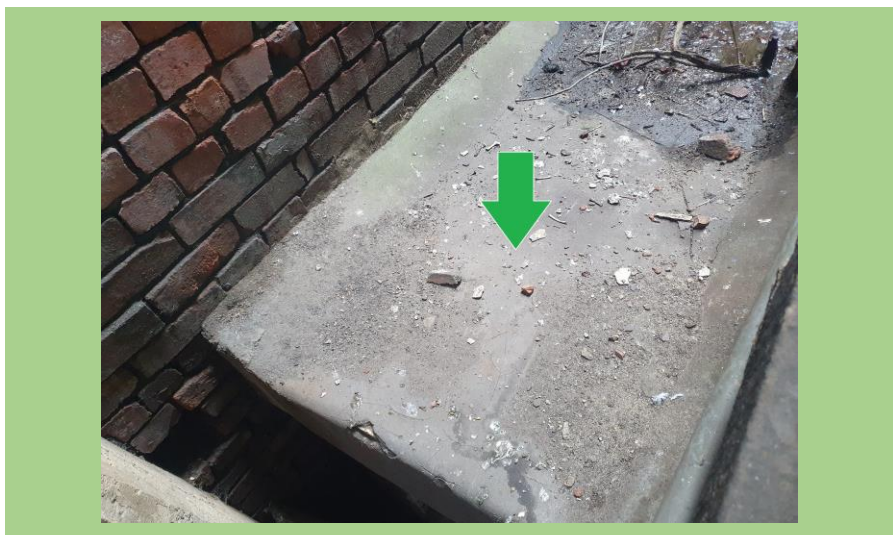
| Sample Number | 29 | No Asbestos Detected |

| Floor, Room | External, between the buildings | Location | Flat roofs |
| Material | Asphalt | Quantity | 10 sq. m. |

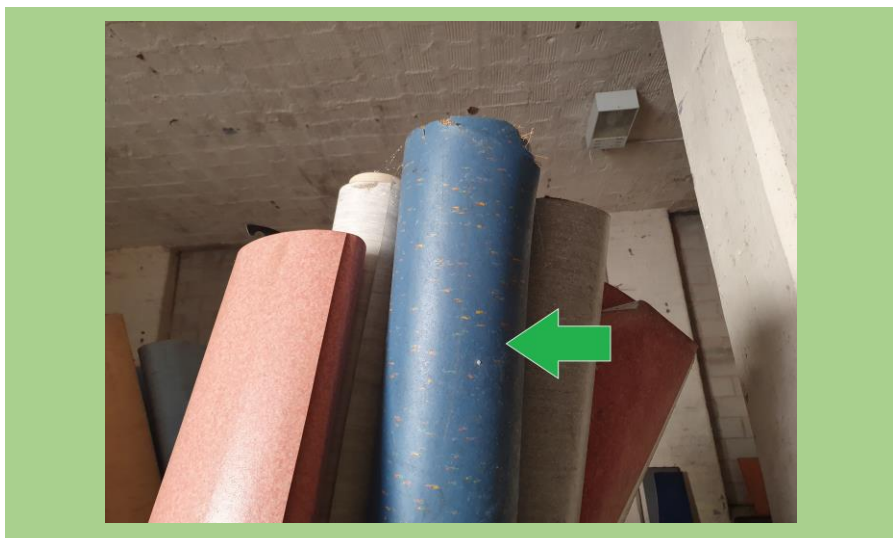
| Sample Number | 31 | No Asbestos Detected |

| Floor, Room | Ground floor, G.06 | Location | Loose within a storage cage |
| Material | Hessian backed linoleum | Quantity | 1 unit |

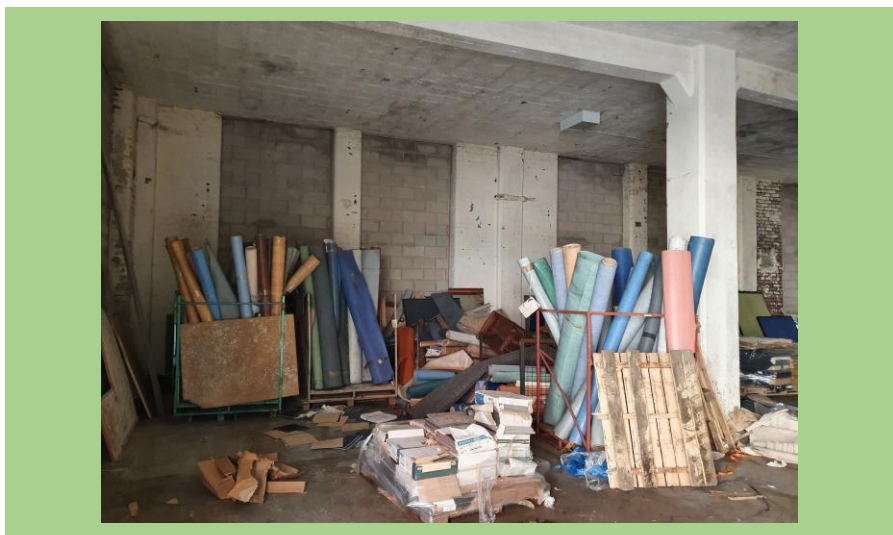
| Sample Number | 32 | No Asbestos Detected |

| Floor, Room | Ground floor, G.06 | Location | Loose on the floor and within the storage cages |
| Material | Flooring materials | Quantity | 100 units |

A composite sample of these modern non-asbestos containing flooring materials was procured.

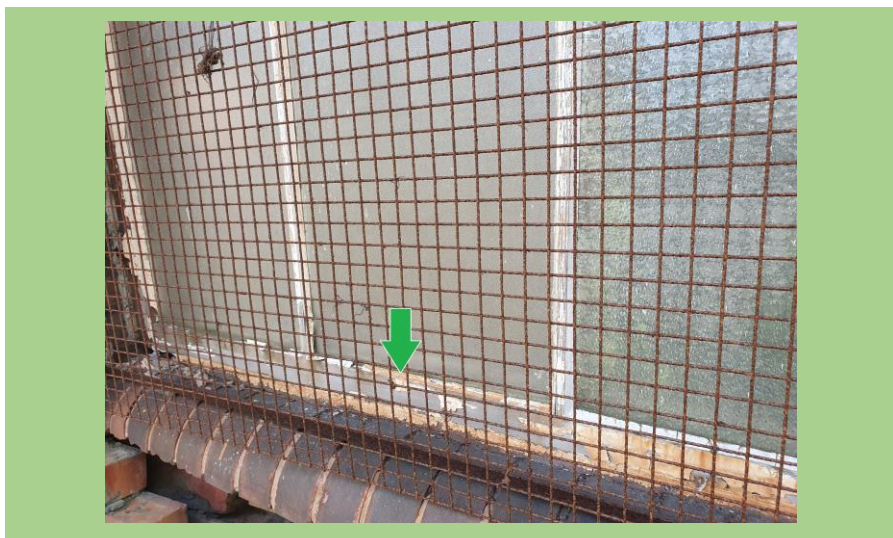
| Sample Number | 33 | No Asbestos Detected |

| Floor, Room | Ground floor, external | Location | Window frames |
| Material | Putty | Quantity | 12 lin. m. |

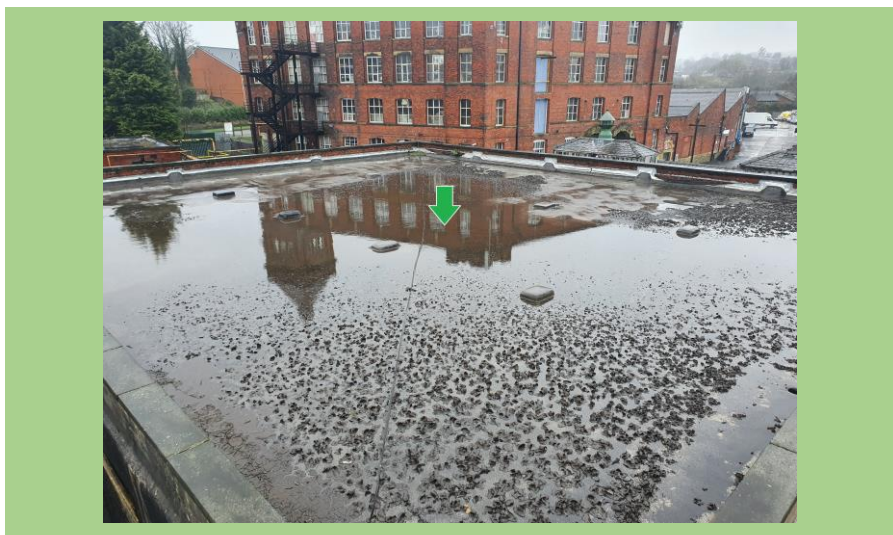
| Sample Number | 36 | No Asbestos Detected |

| Floor, Room | External | Location | Flat roof above Units F14 and F15 |
| Material | Asphalt | Quantity | 500 sq. m. |

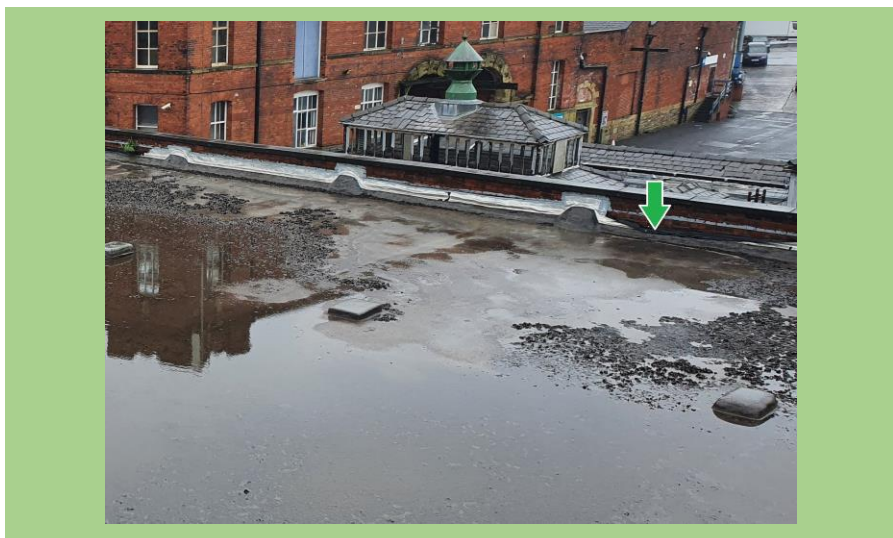
| Sample Number | 37 | No Asbestos Detected |

| Floor, Room | External | Location | Skirt to the flat roof above Units F14 and F15 |
| Material | Bituminous felt | Quantity | 500 sq. m. |
