**22581**

**FORMER SARTEX QUILTS & TEXTILES**

**RE-DEVELOPMENT OF THE FORMER WEAVING SHED  
MEASURES TO DISCHARGE PLANNING CONDITION 3 (XI)**

# STRUCTURAL ENGINEERS REPORT

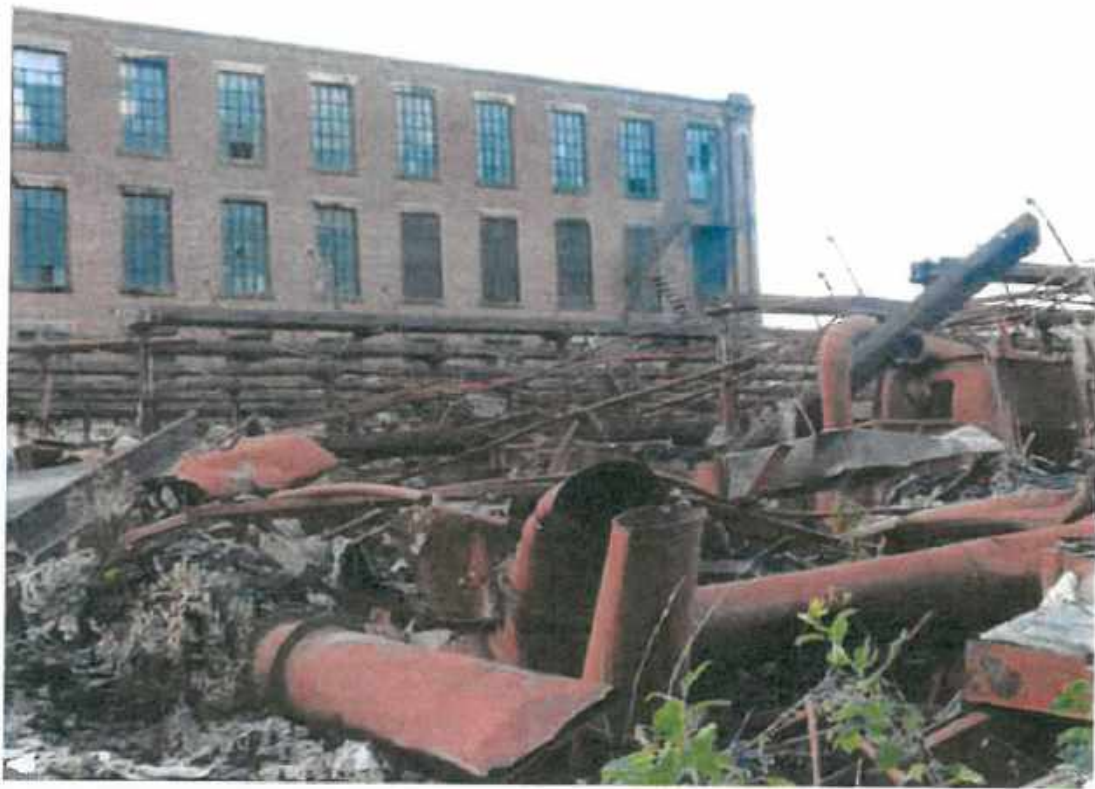
*Photograph 1*

- 2.01** The site is bounded by the Rochdale Canal on the East, Durham Street on the Northern boundary and Norwich Street on the Western edge. To the South is a further built mill of three storey proportions and an access road. See photograph No 1.

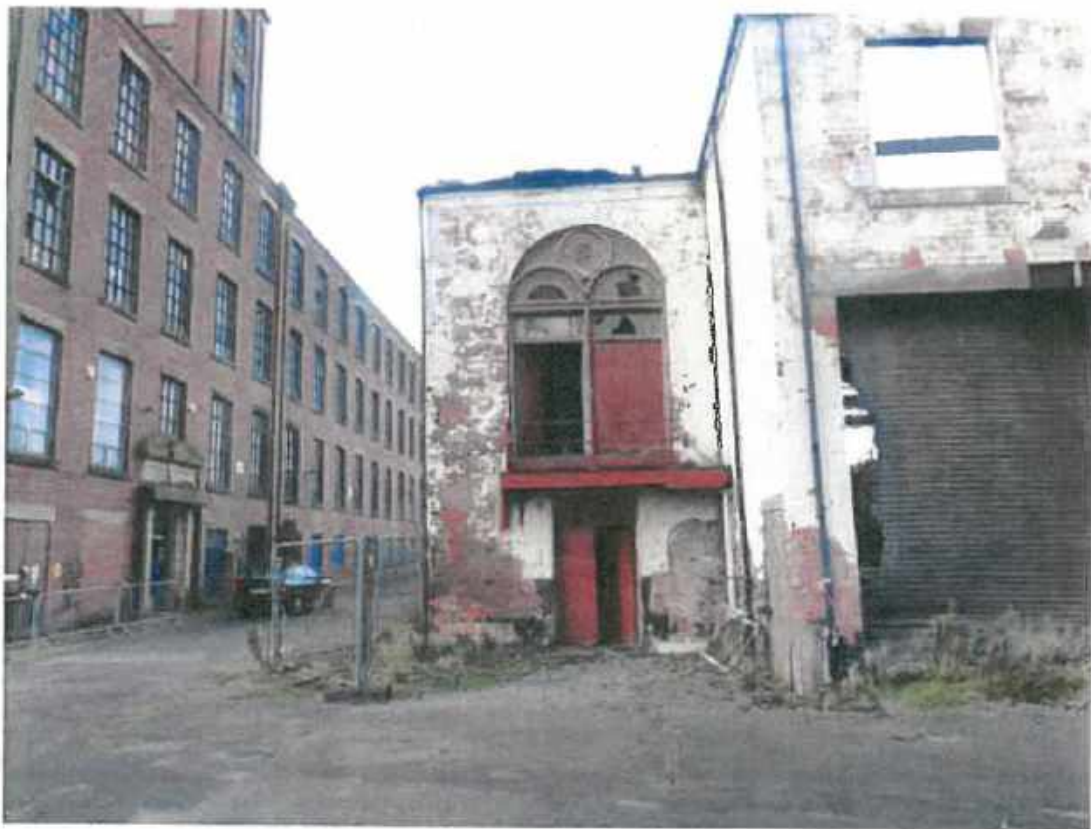
*Photograph 2*

- 2.03** On the front left hand corner is the remains of the engine house and an associated two storey section of unknown previous use. See photographs 2, 3 & 4.

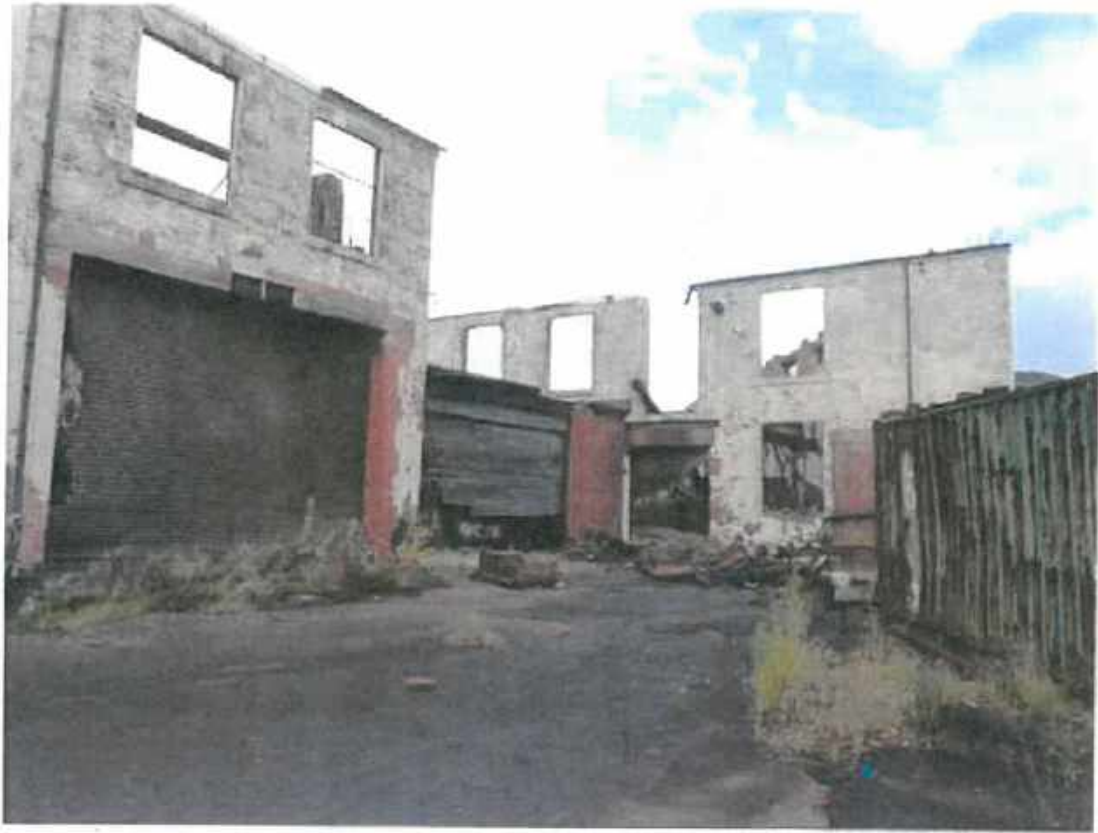
*Photograph 5*

- 2.04** To the right of this is a link section that appears to have been a single storey section linking the engine house to the mill – see photograph No 5.

- 2.05** The front section of the mill and the return elevation shown in photograph No 5 is of solid brick construction and is currently unrestrained for its full two storey height.

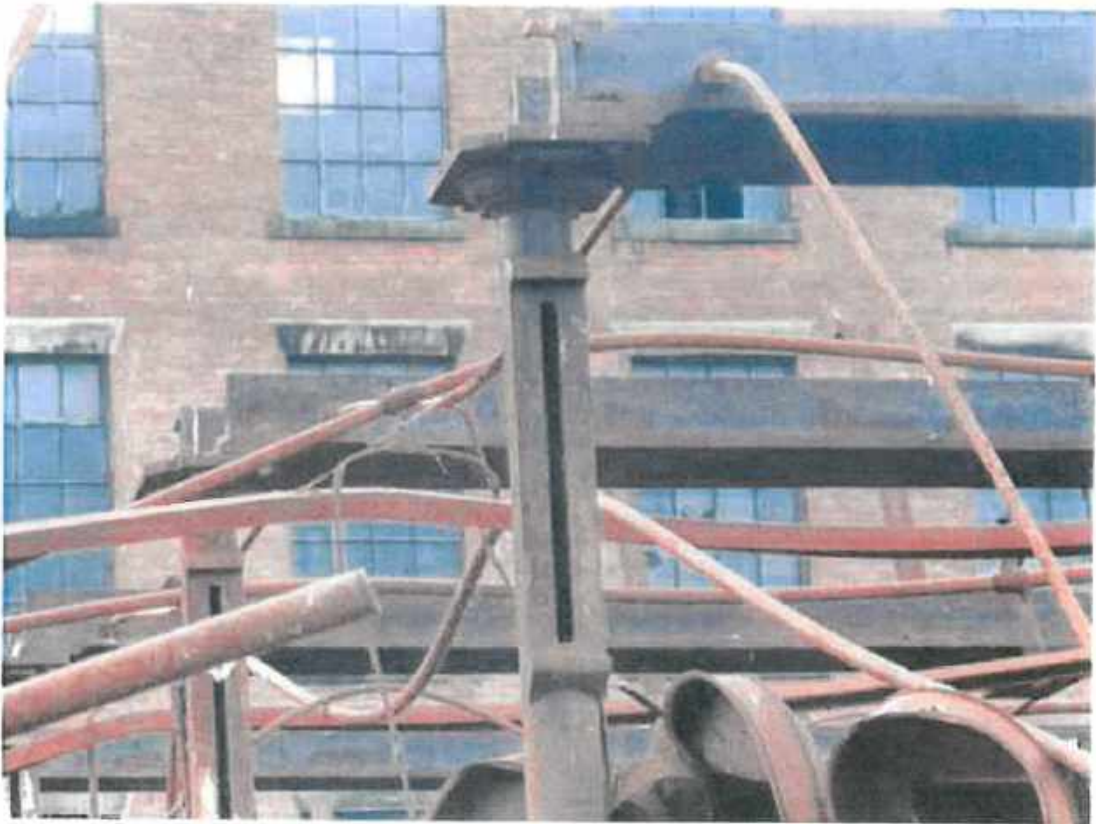
*Photograph 6*

- 2.06** The mill beyond has been reduced to cast iron columns, photograph No 6, that formerly supported wrought iron valley beams as part of a north light roof structure. None of the roof remains – photographs 6, 8 & 9 are typical.

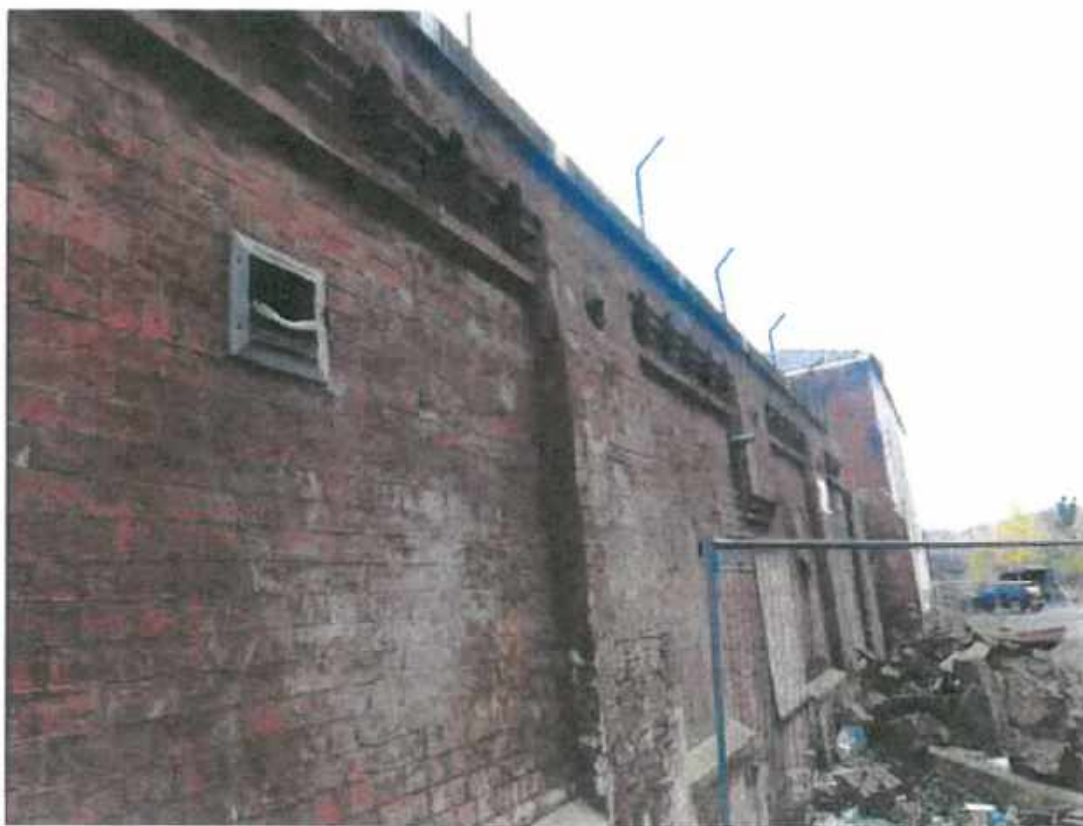
*Photograph 10*

- 2.07** The left hand boundary wall remains and is photographed in photographs 10 & 11. This retains part of the access road as one approaches Norwich Street.

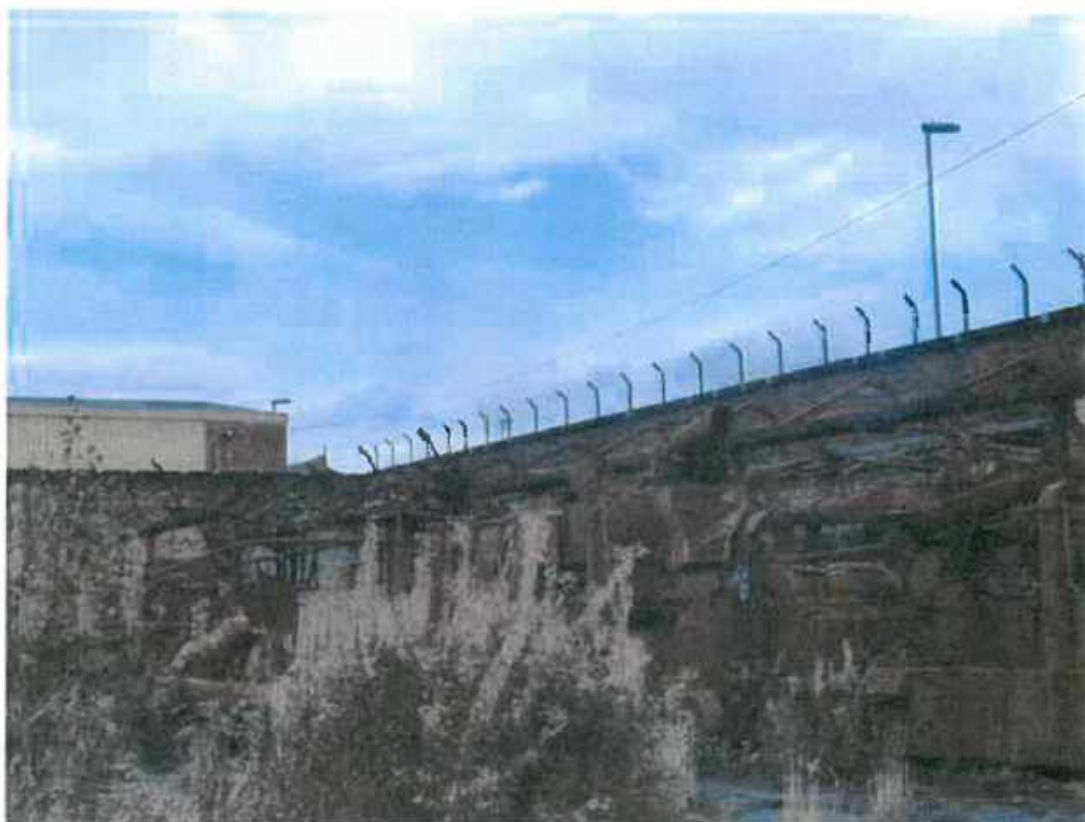
*Photograph 12*

- 2.08** The right hand return elevation is visible from Durham Street. This steps down to a parapet wall which ultimately runs along Durham Street and forms a boundary at the back of the footpath. Durham Street is retained in part, by this elevation. See photograph 12.

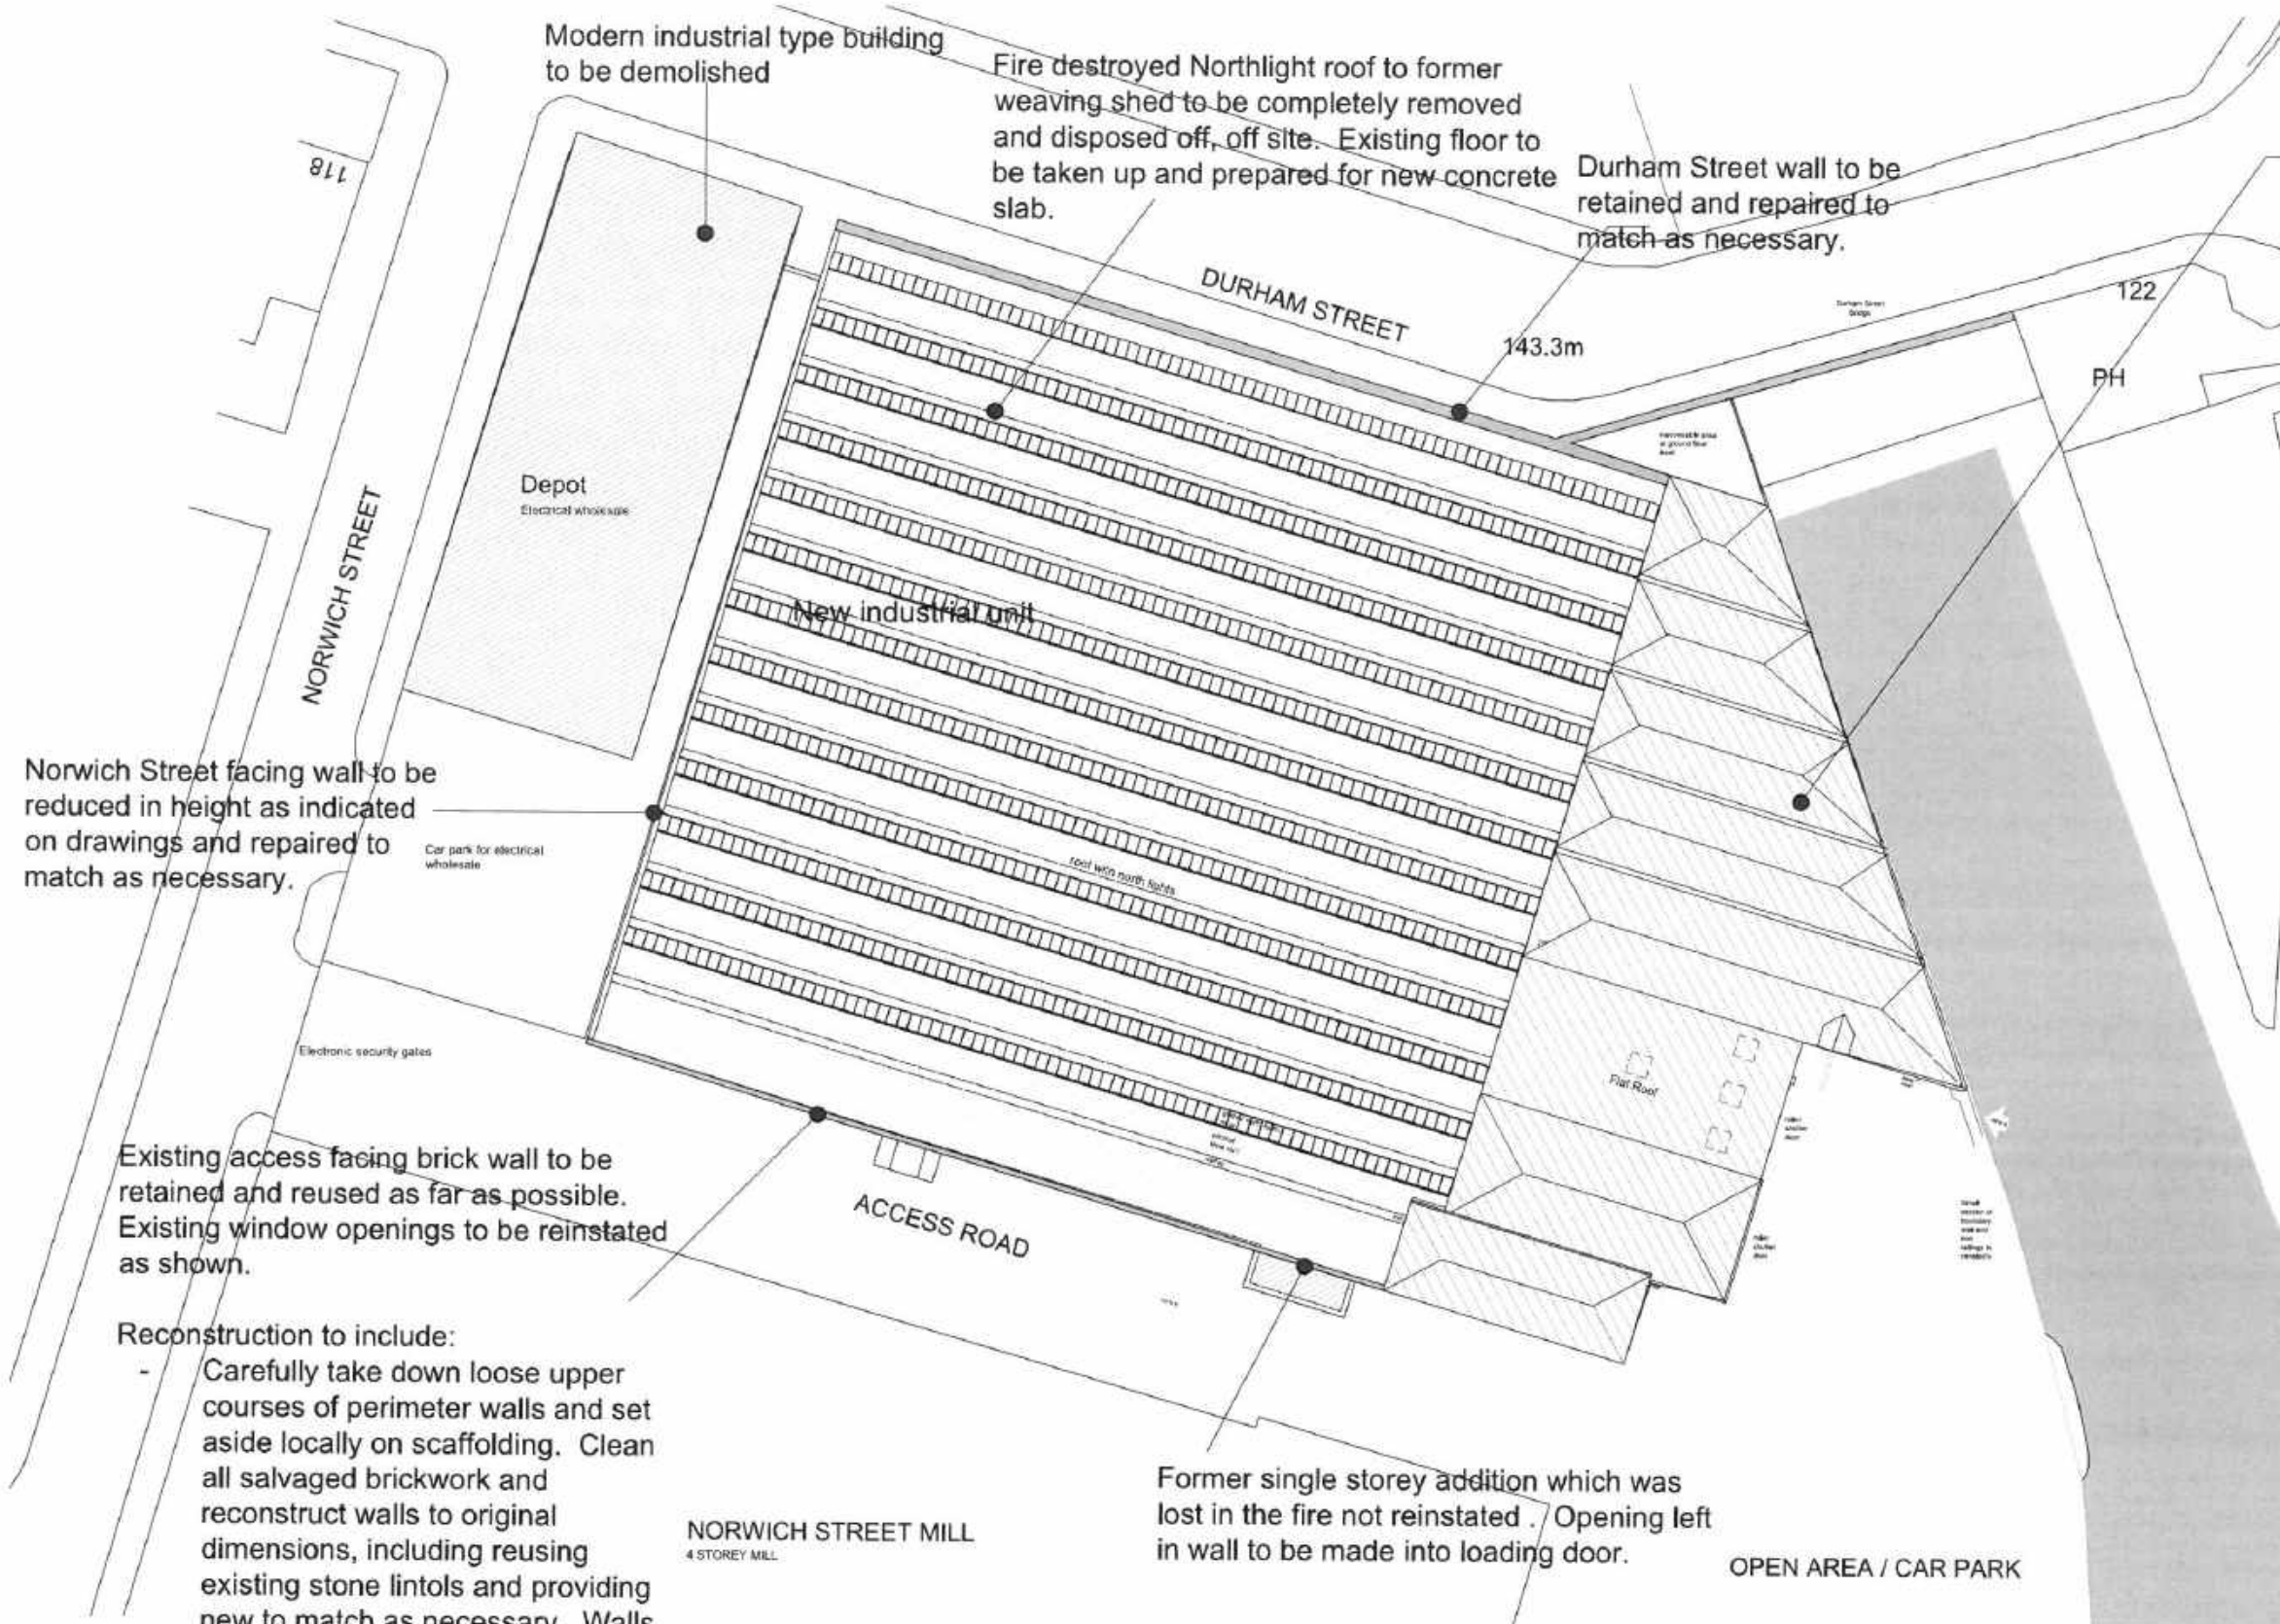
Dwg. Nr. S450-003/A

Existing canal frontage hatched thus to be retained. Carefully support remaining wall elements of original building and remove all fire damaged structure including roof and floor components and dispose off site. Strip out remaining window frames and prepare a drawing describing the existing windows, including overall dimensions, pattern, opening lights (if any), section sizes (head, cills, jambs, glazing bars etc). Set aside one frame and protect as a reference for reconstruction.

- New timber roof structure with internal steel secondary structure if required.
- Carefully take down loose upper courses of perimeter walls and set aside locally on scaffolding. Clean all salvaged brickwork and reconstruct walls to original dimensions, including reusing existing stone lintols and providing new to match as necessary, Walls to be reconstructed using lime mortar to approved specification
- Provide and install new timber windows to match original, modified to incorporate 14mm double glazing with black warm edge spacers and triangular 'putty style beads.
- New solid timber doors .
