**Re: Report on a tree for No 33 Fisherfield (located in the neighbouring garden of 35 Fisherfield, Rochdale OL12 7QW)**

## PRELIMINARY ARBORICULTURAL REPORT

Survey address: 33 Fisherfield, Rochdale OL12 7QW

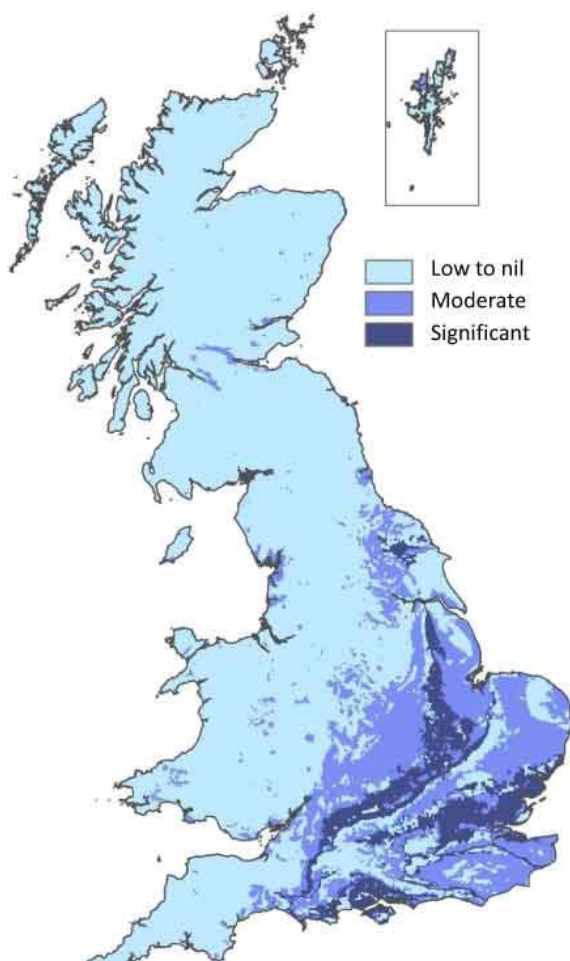
The soil on site was assessed to a depth of 1200mm, in two locations (see Location Plan 1, Fig 2) using a manually operated soil auger. This revealed a moist clay loam to 300mm, overlying sandy clay to 1200mm. This soil is likely to be free draining, allowing rapid rehydration of the clay component. The local geography, geology, soil characteristics and climate are all conducive to stable soil conditions and persistent soil moisture deficits are not anticipated.

Fig 2. Swell/Shrink potential of soil within the UK. British Geological Survey. (National Environment Research Council)
