Re: 4 MOORGATE EAST FARM – THE OLD STABLE,  
BROAD LANE, ROCHDALE, OL16 4QL

# METHOD STATEMENT

MOORGATE EAST FARM, BURNEDGE LANE,  
ROCHDALE – OL16 4QL

# REPORT ON STRUCTURE

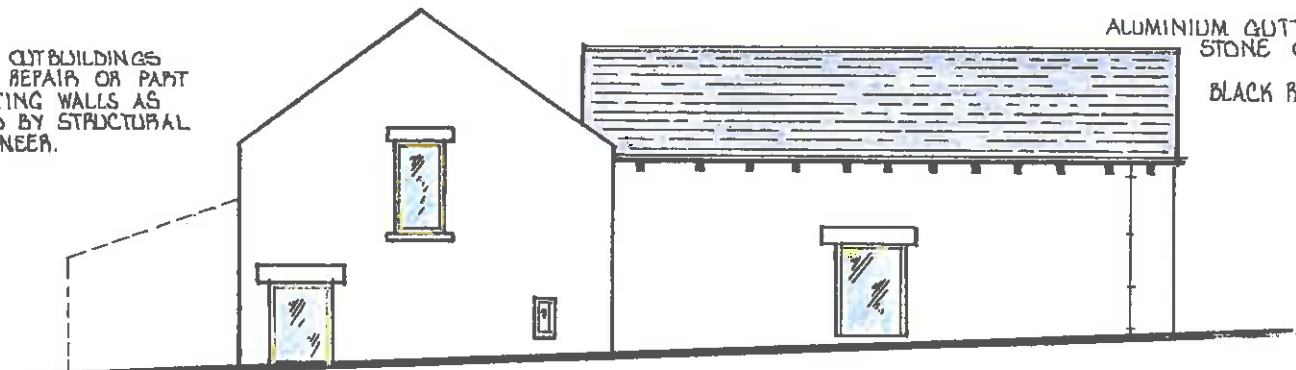
SOUTH EAST ELEVATION

9. On the South-East elevation, there is a nominal area above the door where local rebuilding will be required. See Appendix C. This is due to local bulging. This will need to be rebuilt in order to be tied to the new inner leaf.
10. Repairs are likely to be required to the King Post trusses. This is likely to involve new steel shoes at bearing positions. Most of the rafters are likely to require renewal.
11. The North-West elevation does not require any major structural intervention. This will simply require making good where the existing buildings have been removed.
12. The external elevations will ultimately require repointing with an approved, lime-based mortar.

DEMOLISH EXISTING OUTBUILDINGS  
& EXTENSIONS & REPAIR OR PART  
REBUILD EXISTING WALLS AS  
SPECIFIED BY STRUCTURAL  
ENGINEER.

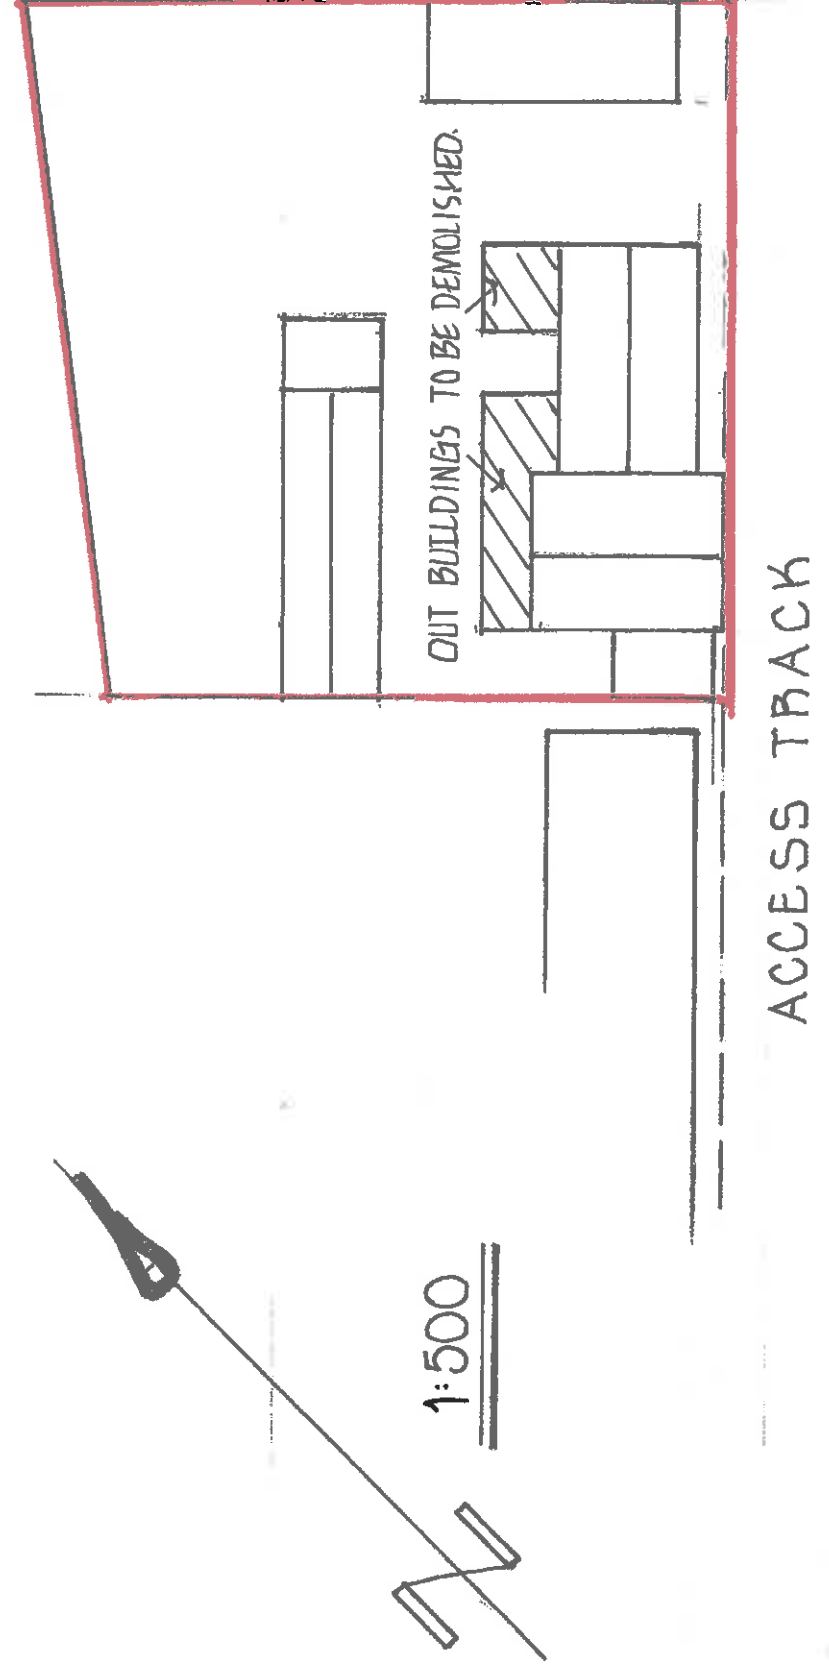
SITE LAYOUT PLAN AS EXISTING

The two minor structures comprising of stable blocks and stores are to be removed from the North-West elevation. See Appendix C and photographs 5 & 6.

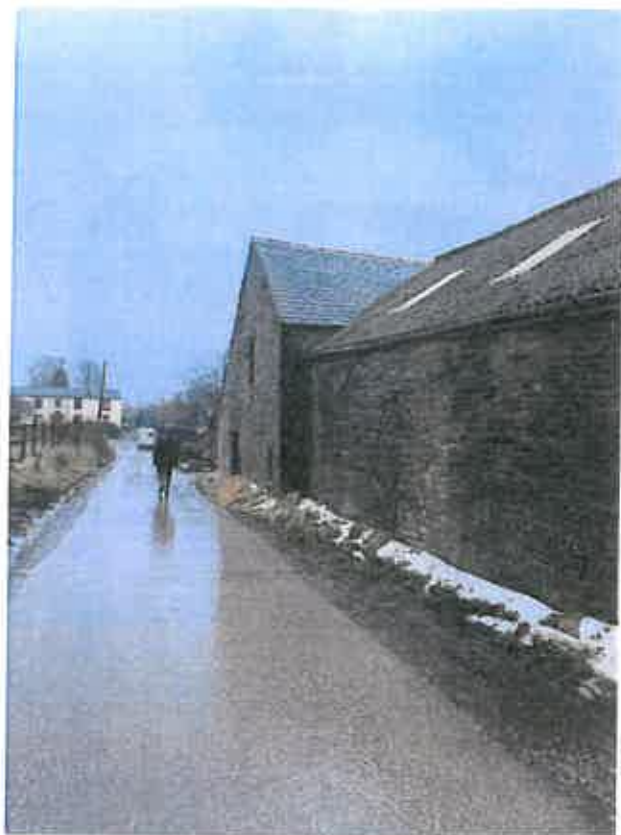
Photograph 1

When viewed from Burnedge Lane, the original stone-built barns present a gable elevation on the left and a simple eaves elevation on the right. The latter is of slightly lesser vertical proportions. See photograph 1.

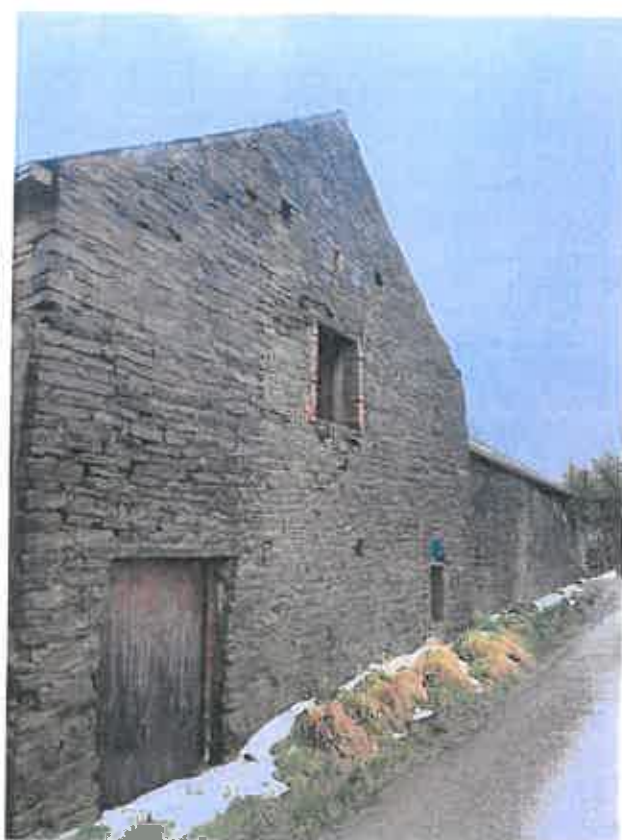
Photograph 2

- 2.02** For descriptive purposes, we have named the areas Barn 1, on the left and Barn 2 on the right. Barn 1 has its gable facing Burnedge Lane. See photograph 2.

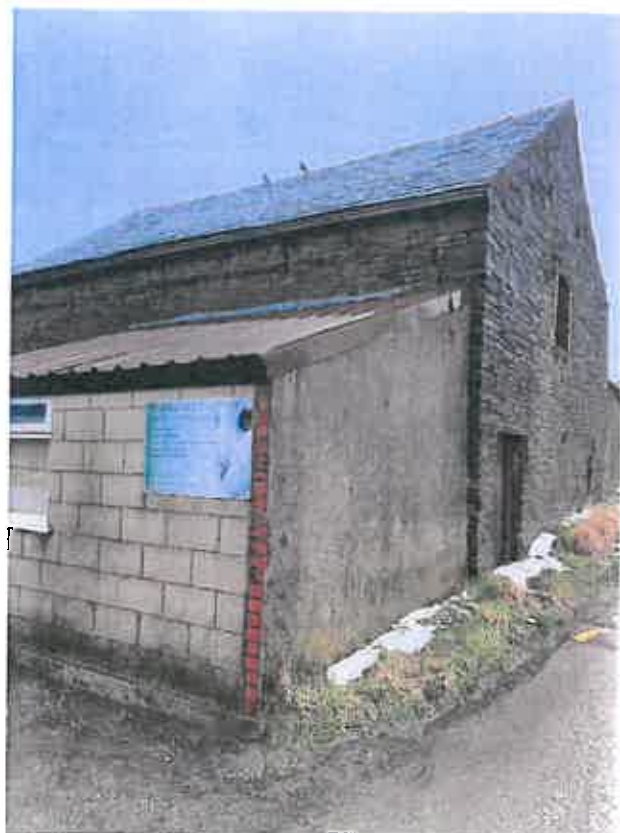
Photograph 3

- 2.03** To the left of Barn 1, is a single storey lean-to, rendered on the Burnedge Lane elevation and faced with blockwork to the side and rear. This has a metal deck roof. See photographs 3, 4 & 5.

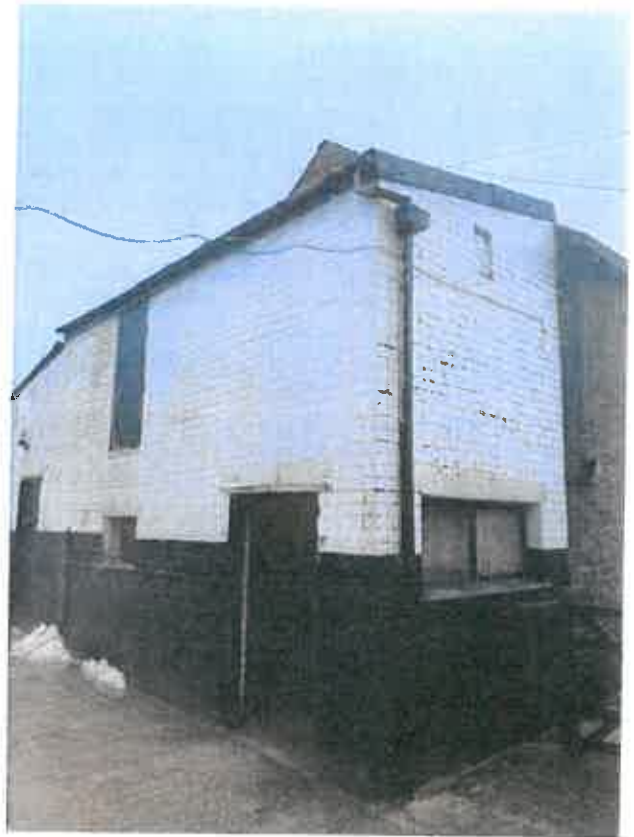
*Photograph 6*

- 2.04** At the rear there is a brick extension. See photographs 6 & 7.
- 2.05** Barn 1 has a slated roof on relatively new timber purlins. The purlins are two per slope. There are new timber rafters.

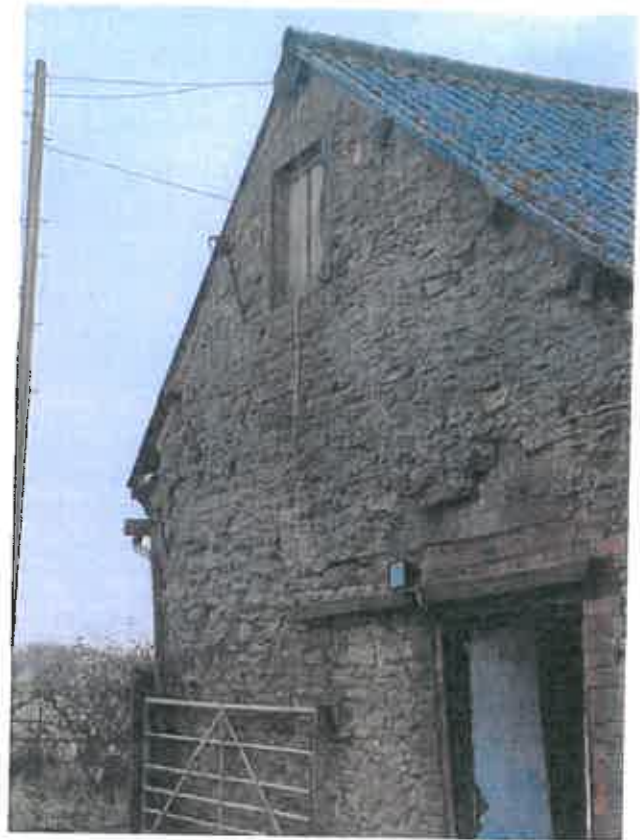
*Photograph 10*

- 2.08** The gable elevation has a single window at the apex and a sliding to the rear. See photograph 10.
- 2.09** There are further brick-built stables to the rear. See photographs 11 & 12.
