**ROCHDALE BOROUGH COOUNCIL**

**MILNROW LIBRARY  
CONDITION SURVEY & REPAIRS  
TO THE ROOF AND WINDOWS  
PHOTOGRAPHS**

**January 2021**

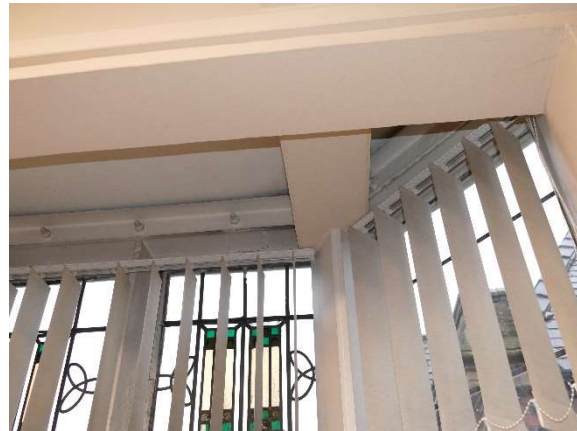
STR2- The head of the oriel window has been reinforced with steel in the past but the lower section appears to have continued to rotate.

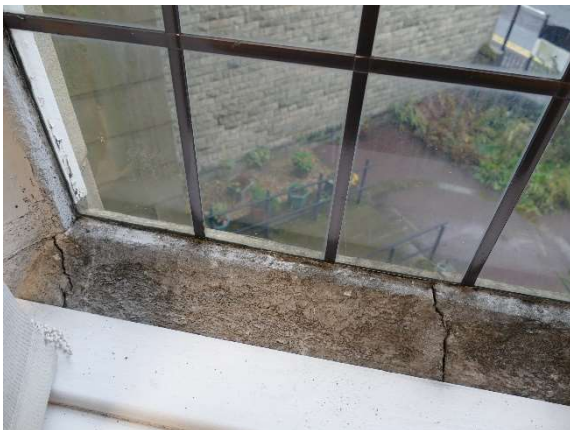
STR3- The displacement of the bay has sheared the cill of the side light in two places and the other in one along with a split in the head.

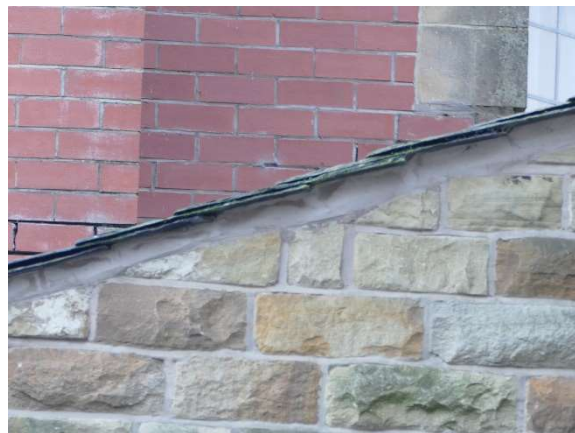
STR8- There is also a stepped joint visible in the west side of the stage area. This is only just visible from ground level and would warrant closer inspection.

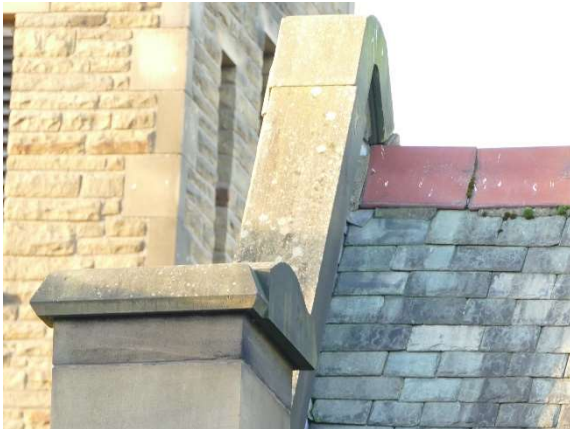
ST9- Open joints and a displaced capping stone to the coping above the front entrance.

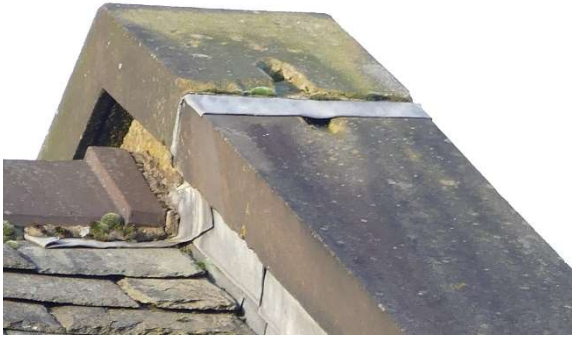
R11- Copings to the library are set on lead flashings and these are dressed over the joints. Recesses for cramps are open and likely hold water

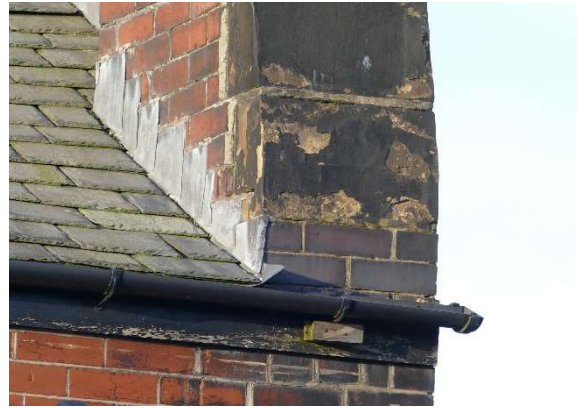
R12- There is no outlet to the gutter of the roof over the meeting room and this washes over in heavy rain.

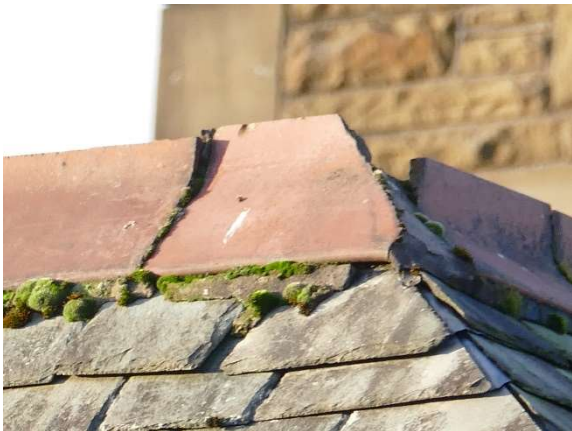
R13 The ridge detail to the corner of the roof is weathered and uneven and will not be protecting the head of the mitred hip flashings.

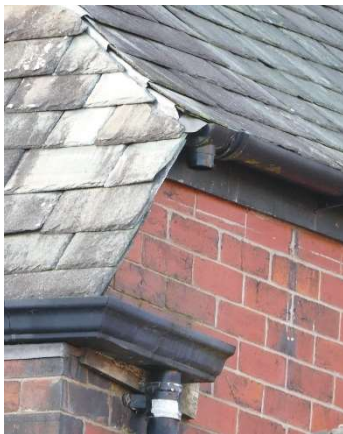
RWP3- The gutter to the back of the stairwell has no fall pipe and expels onto the roof below.
