## Rochdale Corner Plot

14834-BKP-V1-XX-RP-S-010

Existing Bulding Condition Report

29-31 Maclure Road, Rochdale

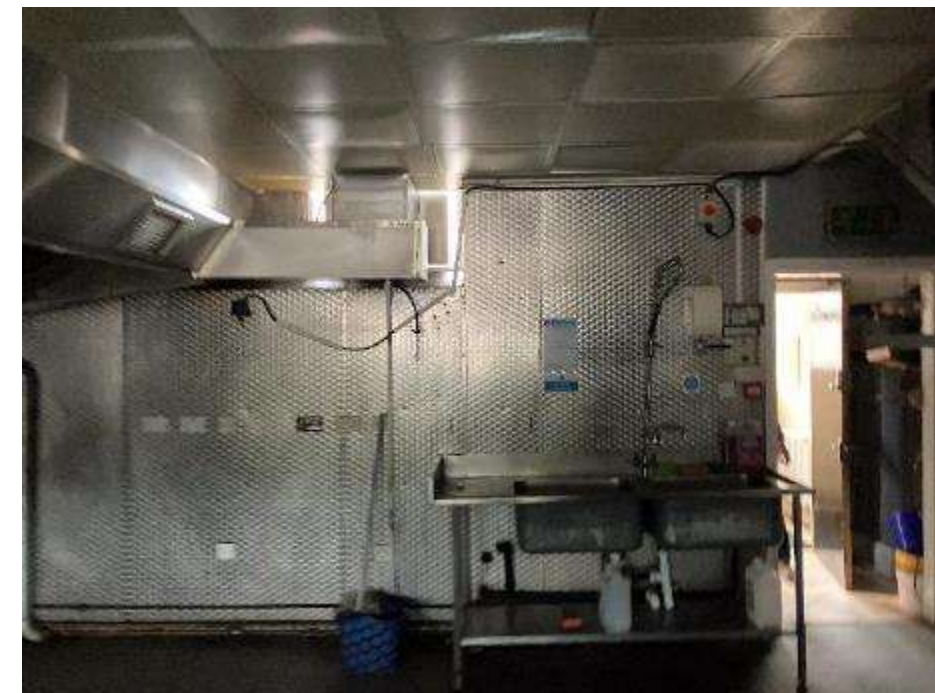
*Figure 13 – View on Rear Wall of Existing Kitchen Area*

Given current usage of the building and significant finishes witnessed on site, inspection of structural elements, including masonry walls, floor structures over, etc, was not possible during this inspection. For details of recommended further intrusive investigations refer to BKP intrusive investigation drawing information (refer to Appendix D of this report).

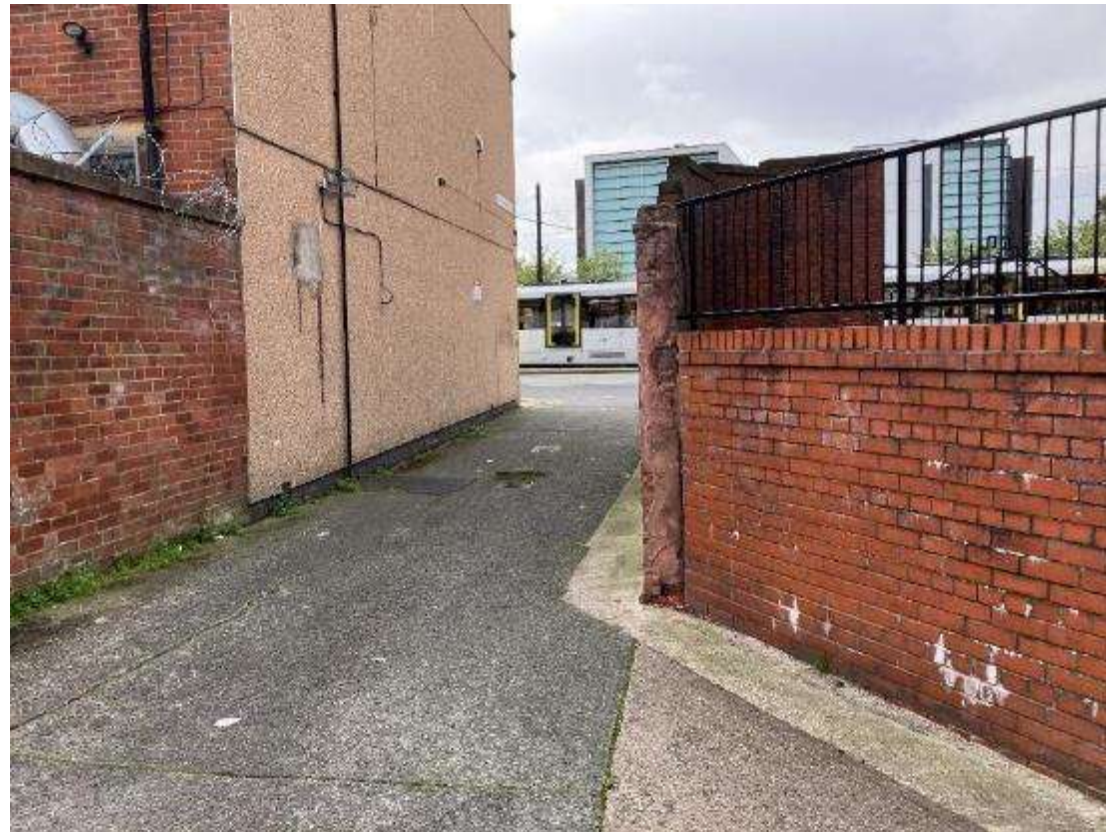
*Figure 25 – View on Fire Station Yard to the North of the Existing Building*

A number of existing drainage features were noted within the unnamed access road to the rear of the building and within Fire Station Yard to the north of the building (including possible manhole covers, gulleys and downpipes from the adjacent single storey building). It is recommended that these drainage features are further investigated, along with additional services searches carried out in this area.
