# TREE SURVEY & REPORT

For  
Mr F Garvey  
71 Clay Lane  
OL11 5RH

## TREE SURVEY / SCHEDULE AND REPORT

TPO name: Clay Lane adjacent to 75

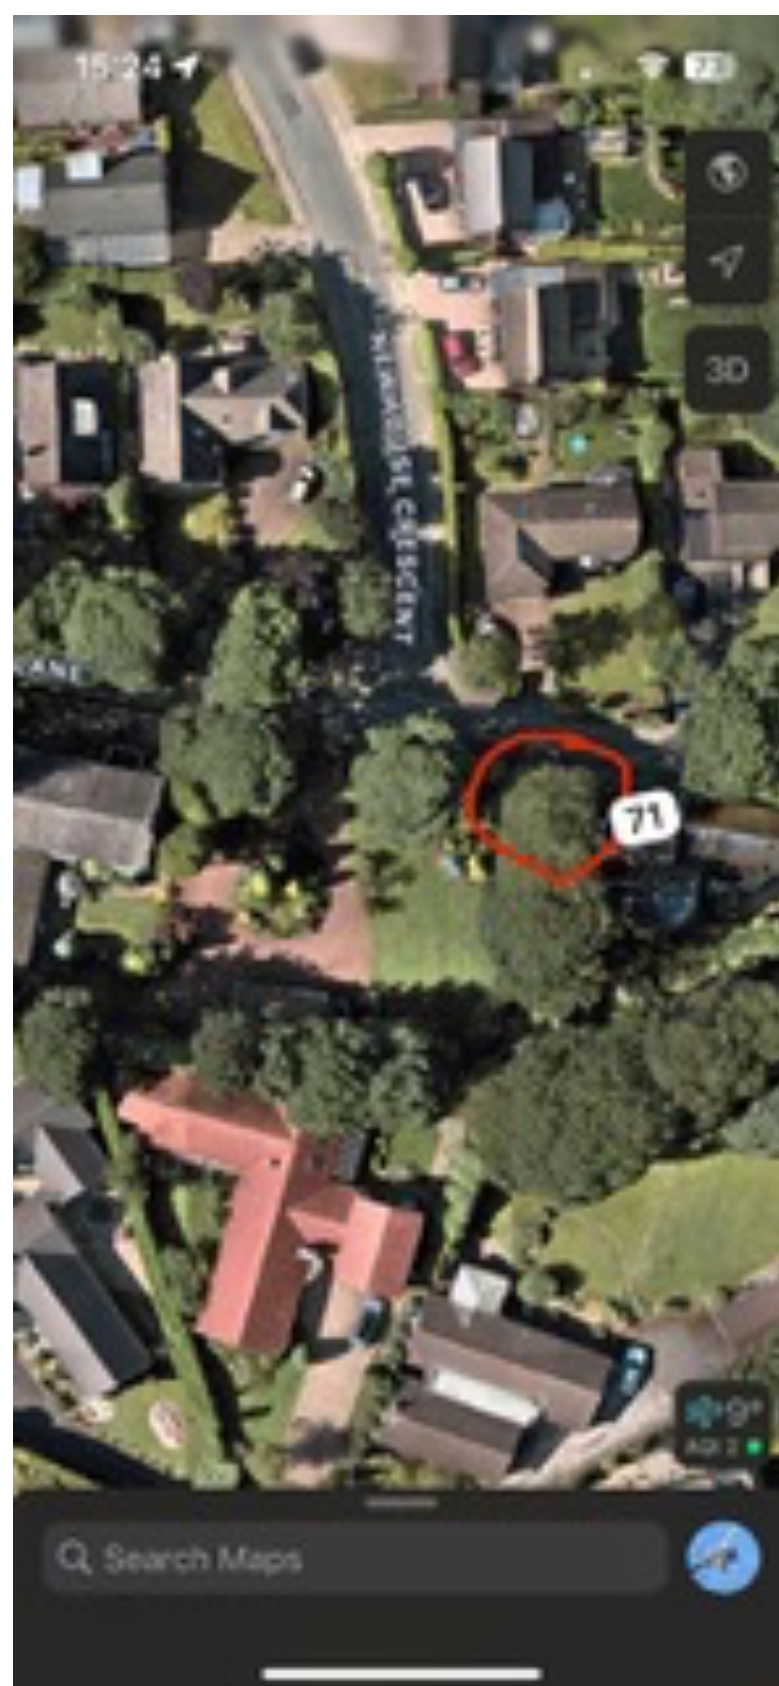
The tree is extremely close to 71 Clay Lane and its crown predominantly dominates causing great concern given its size, proximity and the fact it has a declining canopy; which will only decay further and get worse, making the tree dangerous & unsafe and more liable to fail in a bad storm.

Reduce crown to old  
pollard cuts
