## Asbestos Refurbishment Survey

### Milnrow Building - Middleton

**A & L Reference : 37263**

Rochdale Road  
Middleton  
Greater Manchester  
M24 6XH

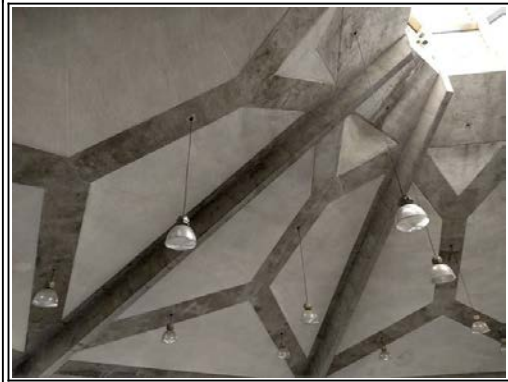
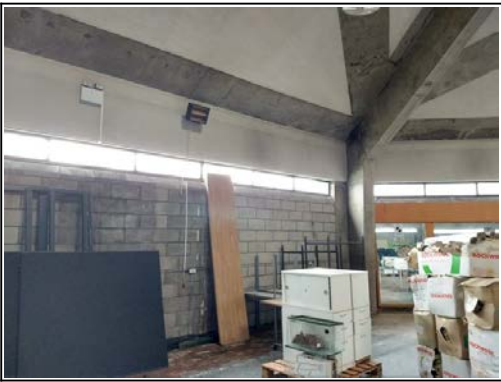
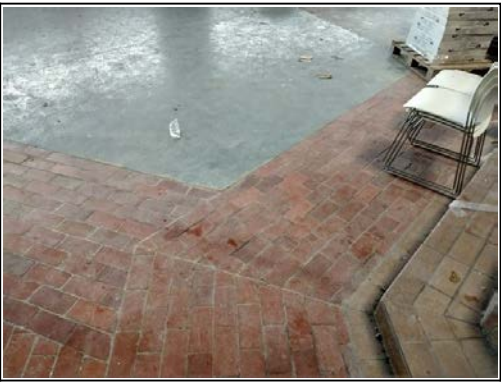
| Ceilings: Concrete ceiling with sprayed coating finish | Walls: Concrete and solid masonry partly texture coated | Floors: Solid floor partly quarry tiled | Other: N/A |

Asbestos containing materials have been identified in this area. Please see the full asbestos register for further details.

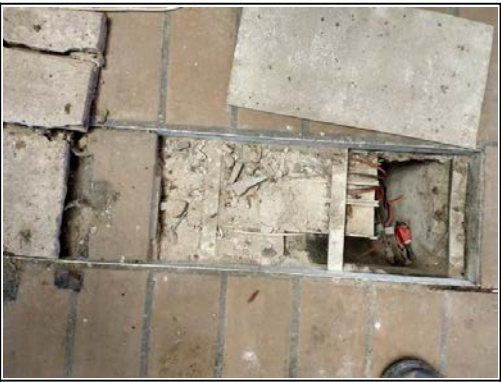
| Ceilings: N/A | Walls: N/A | Floors: Tiles already removed | Other: N/A |

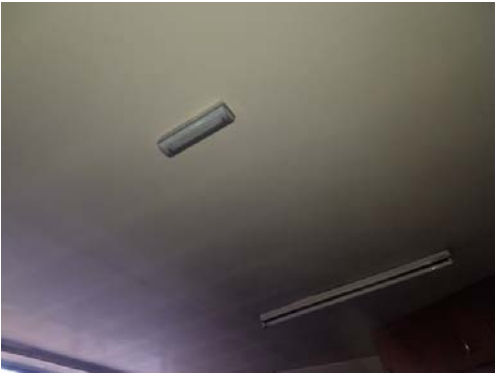
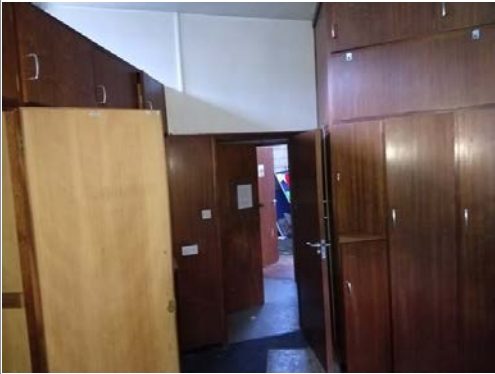
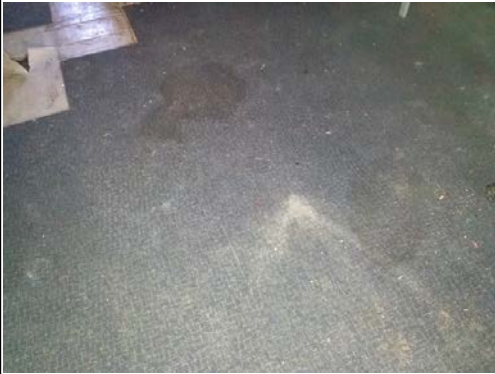
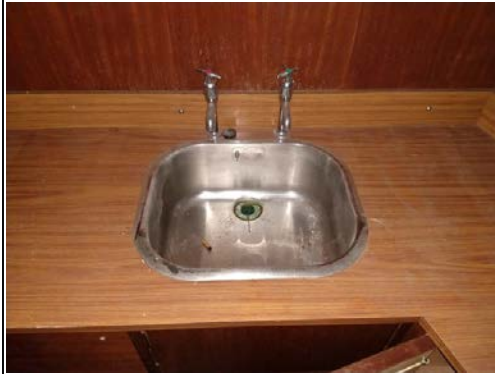
| Ceilings: Plasterboard to wooden joists | Walls: Solid walls with plaster skim | Floors: Solid floor under carpet and vinyl | Other: Negative sink unit. |

Asbestos containing materials have been identified in this area. Please see the full asbestos register for further details.

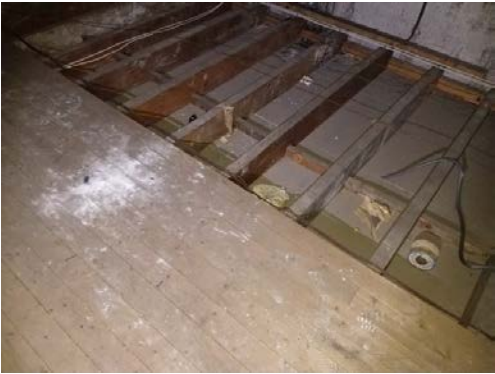
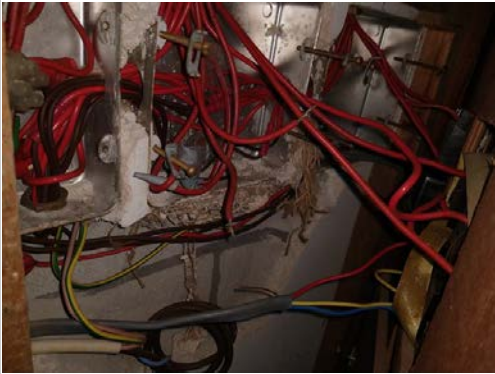
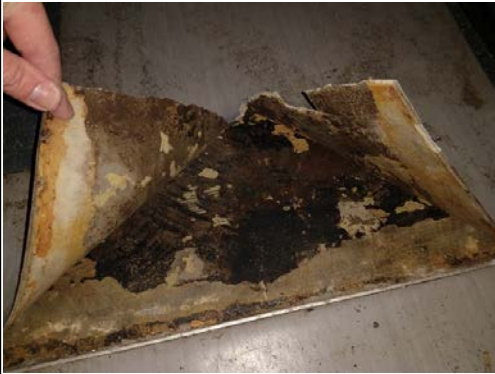
| Ceilings: Visible in Loft space | Walls: Holes already present and visible within electrical cupboard | Floors: Lifted carpet and vinyl | Other: N/A |

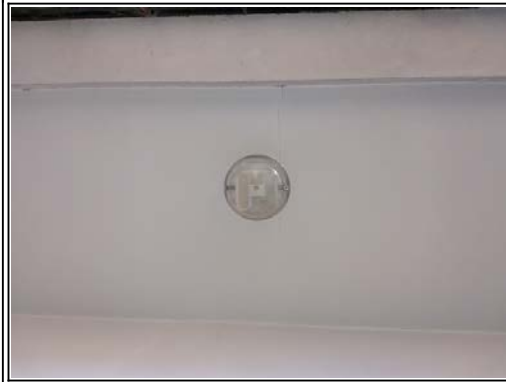
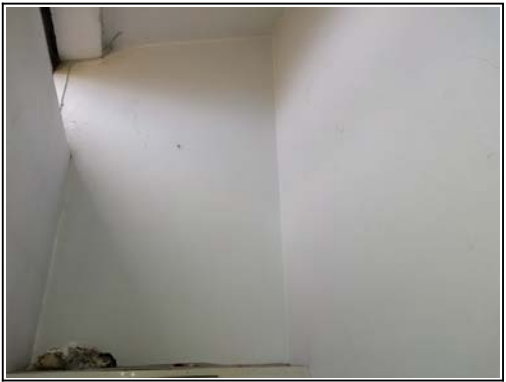
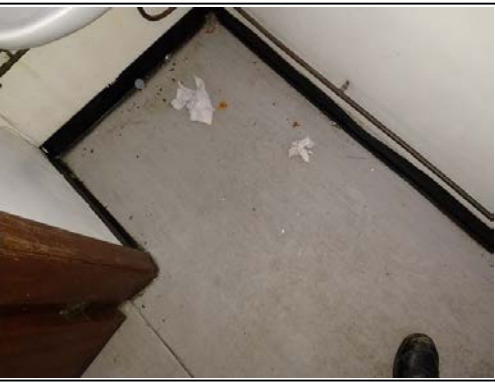
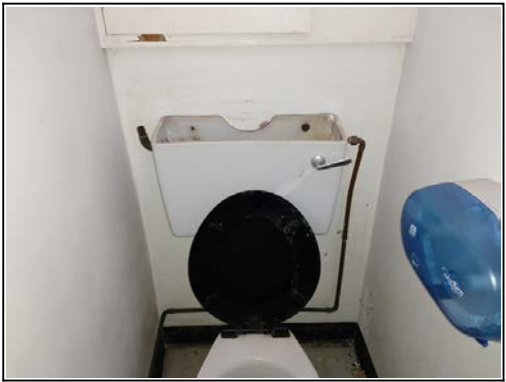
| Ceilings: Plasterboard to wooden joists | Walls: Solid walls with plaster skim | Floors: Solid floor under vinyl | Other: Ceramic toilet cistern(s) |

Asbestos containing materials have been identified in this area. Please see the full asbestos register for further details.

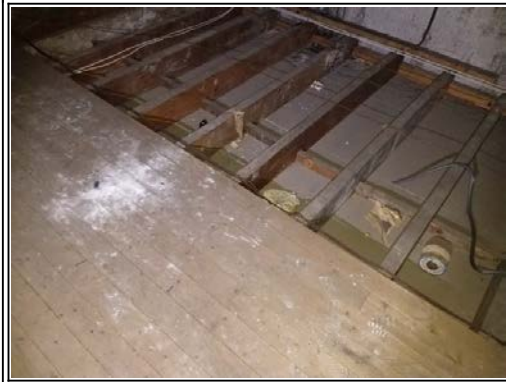
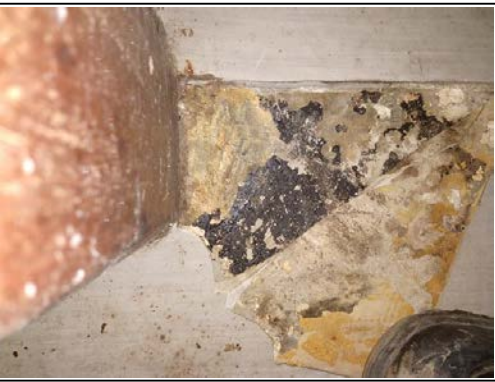
| Ceilings: Visible in Loft space | Walls: N/A | Floors: Lifted vinyl | Other: N/A |

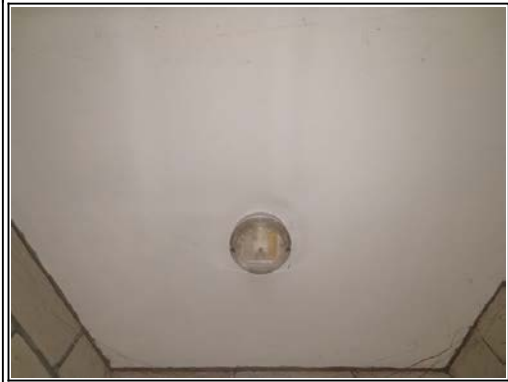
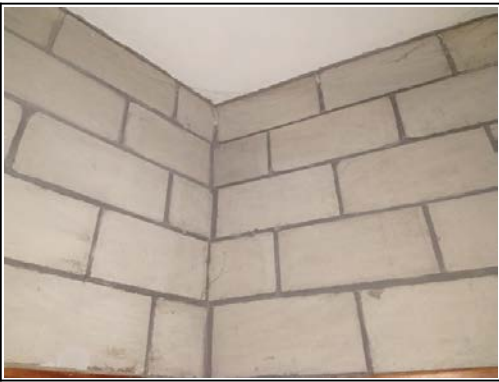
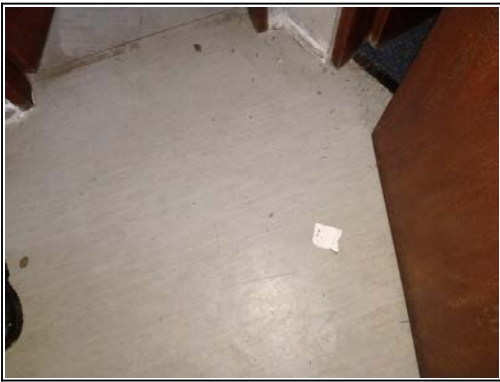
| Ceilings: Plasterboard to wooden joists | Walls: Solid masonry | Floors: Solid floor under vinyl | Other: N/A |

Asbestos containing materials have been identified in this area. Please see the full asbestos register for further details.

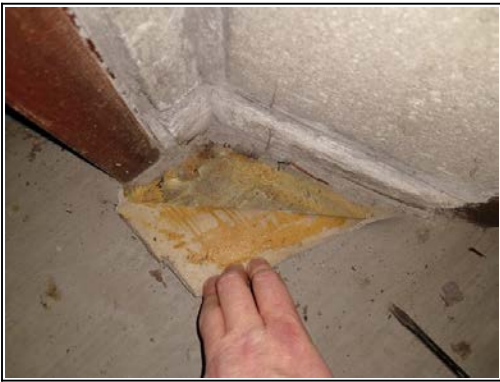
| Ceilings: Visible in Loft space | Walls: N/A | Floors: Lifted vinyl | Other: N/A |

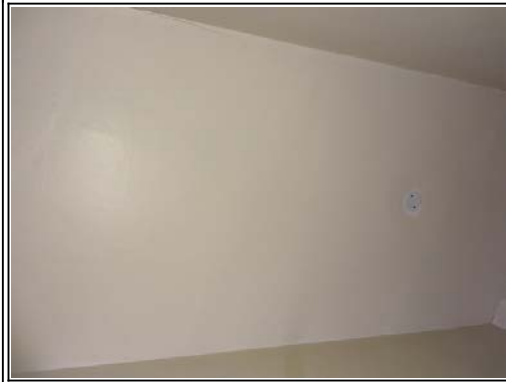
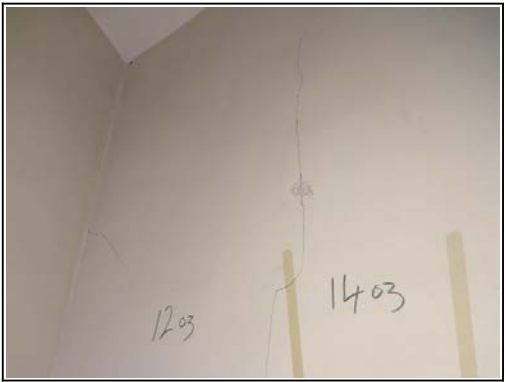
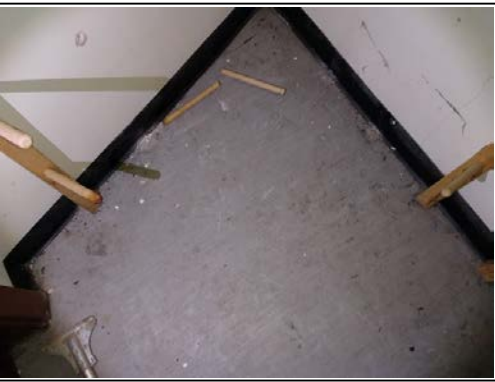
| Ceilings: Plasterboard to wooden joists | Walls: Solid walls with plaster skim | Floors: Solid floor under vinyl | Other: N/A |

Asbestos containing materials have been identified in this area. Please see the full asbestos register for further details.

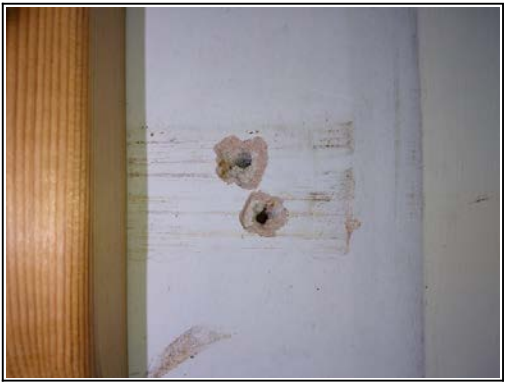
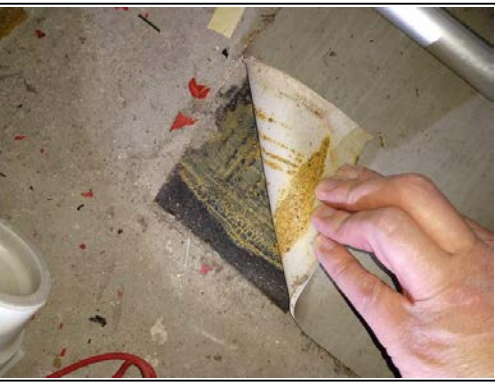
| Ceilings: Visible in Loft space | Walls: Holes already present | Floors: Lifted vinyl | Other: N/A |

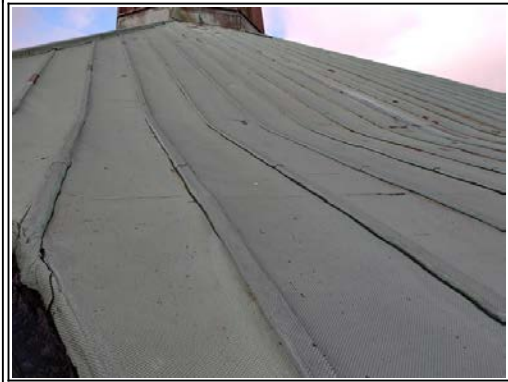
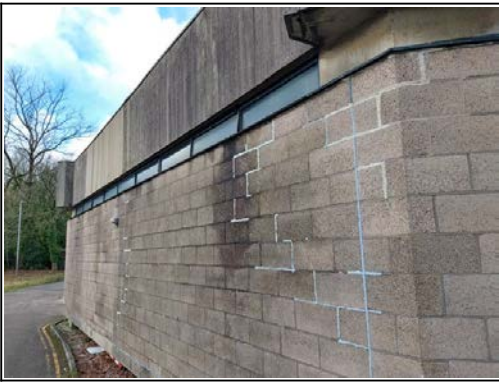
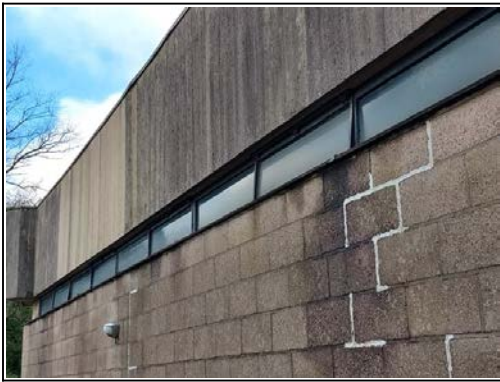
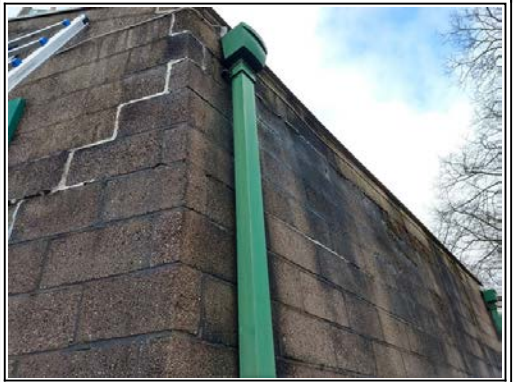
General Room Pictures

| Roof Coverings: Solid roof with felt and copper coverings | Walls and Signage: Concrete and solid masonry | Fenestration/Soffits/Facias: Wooden doors and metal framed windows | Rainwater/Other: Metal guttering and rainwater goods |
