Phase I Geoenvironmental Site Assessment  
Harrow Avenue, Rochdale

Reference: 17-039-R1-1  
Date: July 2023

# PHASE I GEOENVIRONMENTAL SITE ASSESSMENT

Land off Harrow Avenue  
Rochdale  
OL11 4DS

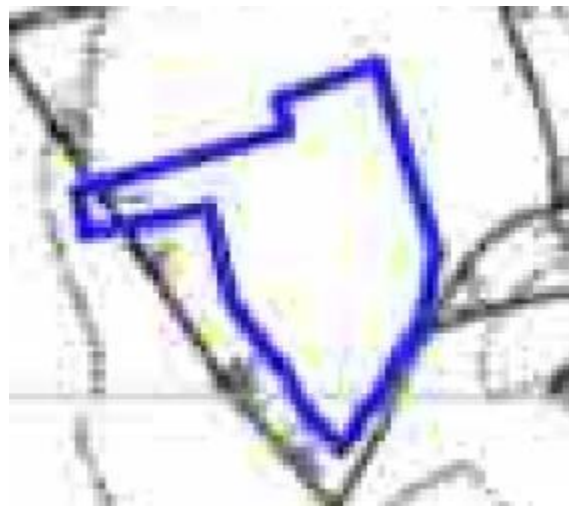
| MAP EDITION | HISTORICAL LAND USE | HISTORICAL MAP EXCERPT |
|---|---|---|
| 1851<br>1:10,560 | The Site is undeveloped agricultural land with a field boundary in the northwest. | |

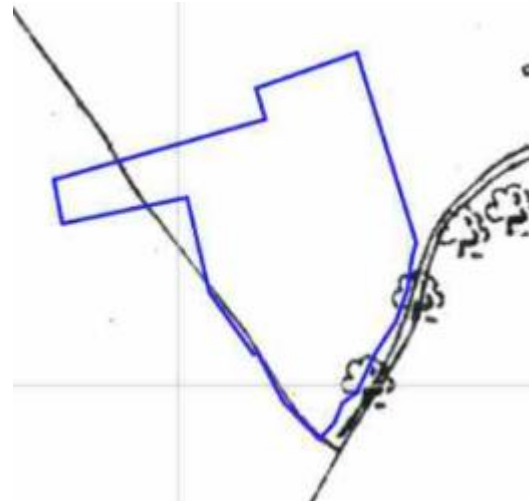
| MAP EDITION | HISTORICAL LAND USE | HISTORICAL MAP EXCERPT |
|---|---|---|
| <b>1890-1891</b><br><b>1:2,500</b> | A stream is present along the southeast site boundary, with sporadic trees. | |

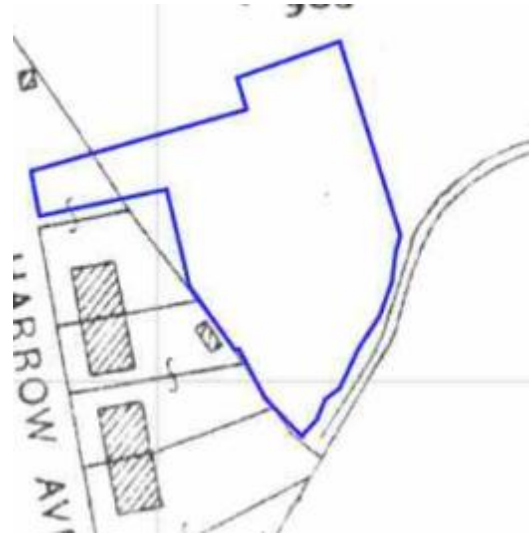
| MAP EDITION | HISTORICAL LAND USE | HISTORICAL MAP EXCERPT |
|---|---|---|
| <b>1930</b><br><b>1:2,500</b> | There are no changes to the subject site. Residential properties have been constructed adjacent to the west of the Site. | |

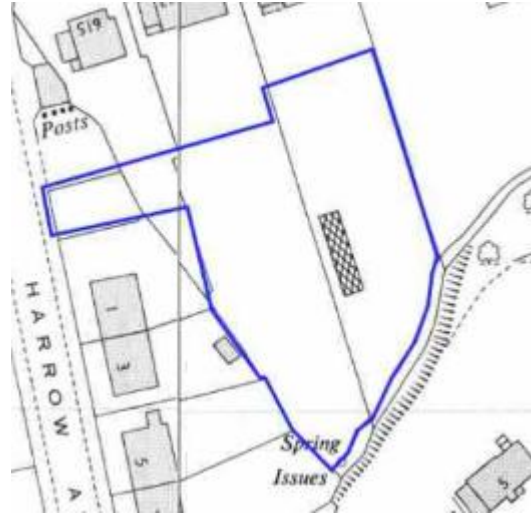
| MAP EDITION | HISTORICAL LAND USE | HISTORICAL MAP EXCERPT |
|---|---|---|
| <p><b>1956-1959</b><br/><b>1:1,250</b></p> | <p>A glasshouse (greenhouse) is recorded in the centre of the Site and the Site appears to be segregated into garden areas for the residential properties to the north.</p> <p>A spring is recorded at the southern site boundary.</p> | |

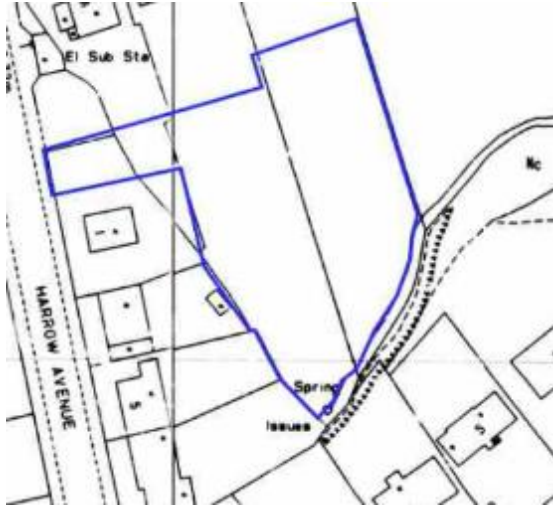
| MAP EDITION | HISTORICAL LAND USE | HISTORICAL MAP EXCERPT |
|---|---|---|
| <p><b>1992</b><br/><b>1:1,250</b></p> | <p>The greenhouse is no longer recorded.</p> | |

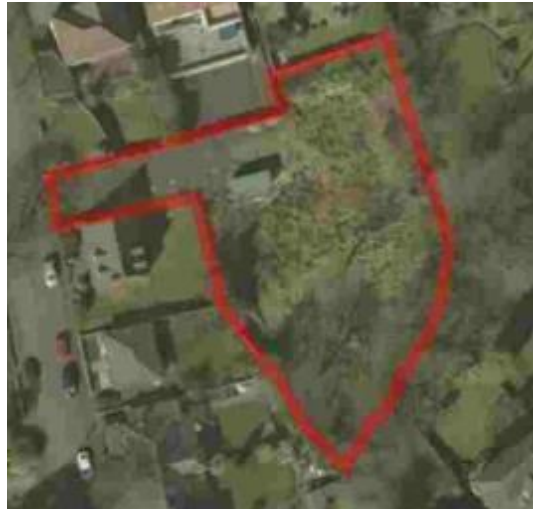
| MAP EDITION | HISTORICAL LAND USE | HISTORICAL MAP EXCERPT |
|---|---|---|
| <b>2012</b><br><b>Aerial</b><br><b>Photograph</b> | <p>The field boundary in the northwest is no longer recorded and a hard standing access track is present.</p> <p>A small structure is present in the north of the Site.</p> <p>The Site no longer appears to be split into different parcels. The majority of the Site is covered in dense vegetation.</p> | |

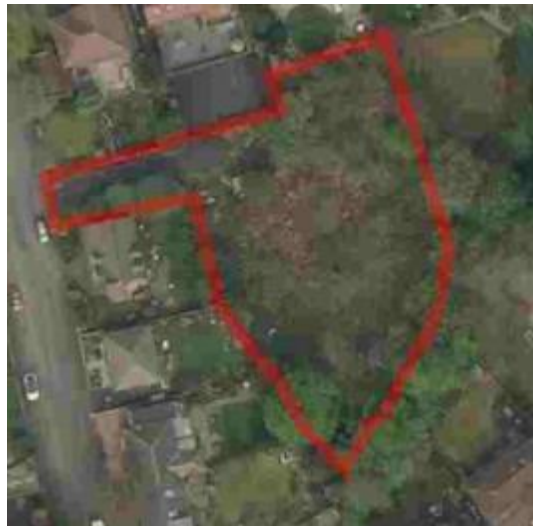
| MAP EDITION | HISTORICAL LAND USE | HISTORICAL MAP EXCERPT |
|---|---|---|
| <b>2019</b><br><b>Aerial</b><br><b>Photograph</b> | <p>Further trees are shown in the north and northwest of the Site.</p> | |

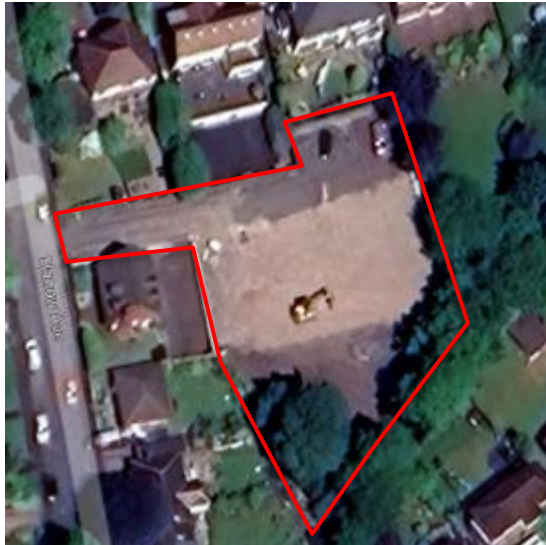
| MAP EDITION | HISTORICAL LAND USE | HISTORICAL MAP EXCERPT |
|---|---|---|
| 2023<br>Google Earth<br>Image | <p>The majority of the Site has been cleared of vegetation.</p> <p>The surface cover appears to be a combination of topsoil and gravel.</p> | An aerial photograph showing a residential neighborhood. A red outline highlights a specific area, likely the site of interest. The area within the outline is mostly cleared, showing a mix of brown and tan colors, which corresponds to the text description of topsoil and gravel. Surrounding the site are green trees and other residential buildings. |

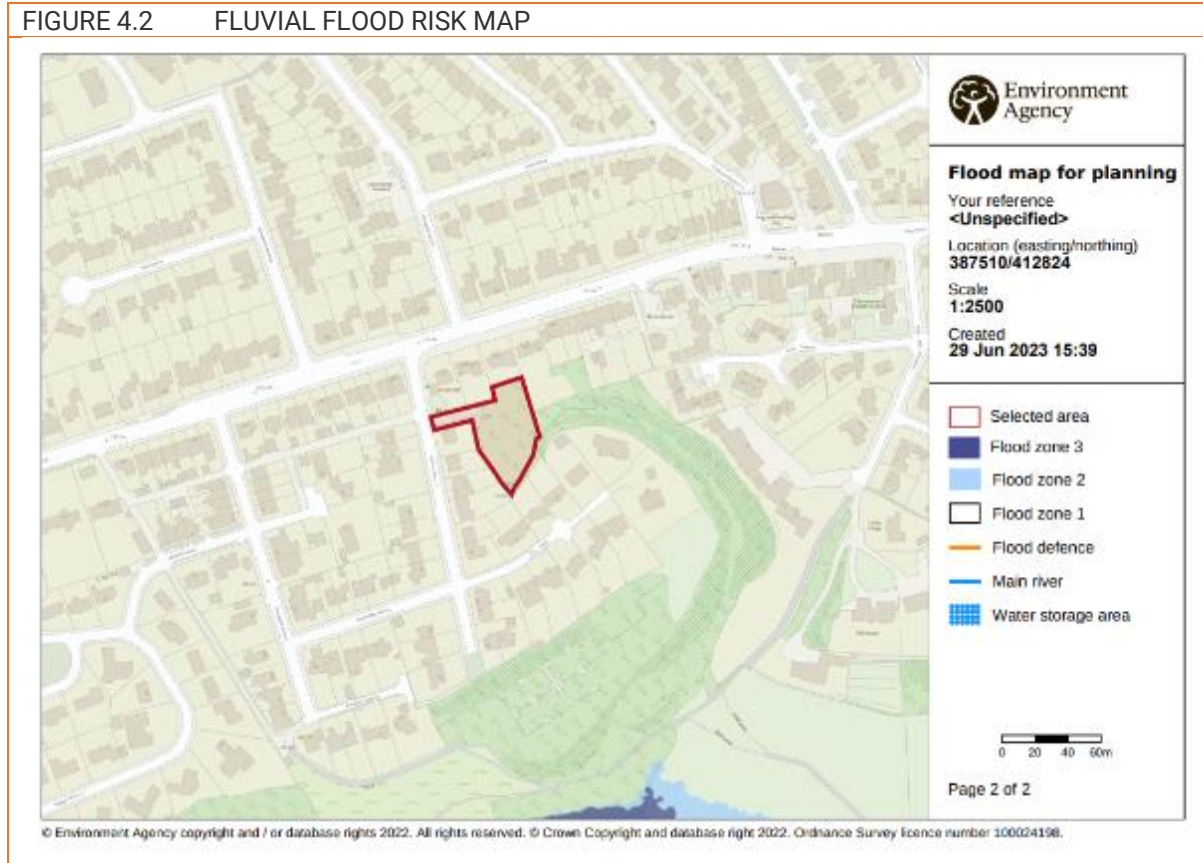
FIGURE 4.2 FLUVIAL FLOOD RISK MAP

The Site is located within a currently defined “Flood Risk Zone 1”; defined as land assessed as having less than 1 in 1,000 annual probability of river or sea flooding (< 0.1%), and as such is considered to be unaffected by river flooding. The Fluvial Flood Risk Map is presented in Figure 4.2.

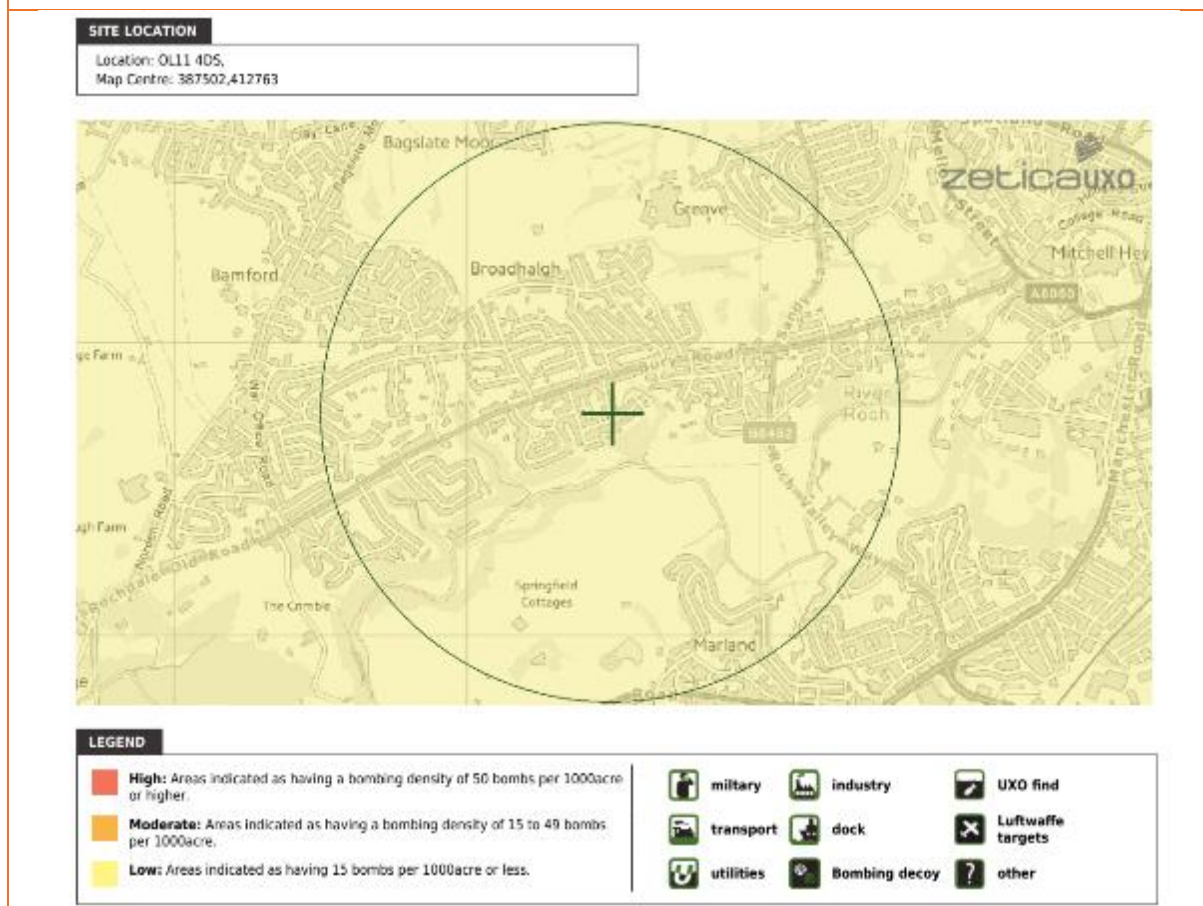
FIGURE 4.3 ZETICA UXO RISK MAP

The regional unexploded bomb risk map from Zetica (2014) indicates that the Site is in an area at low risk from possible unexploded ordnance (UXO) resulting from the Second World War. The Zetica UXO Risk Map is presented in Figure 4.3.

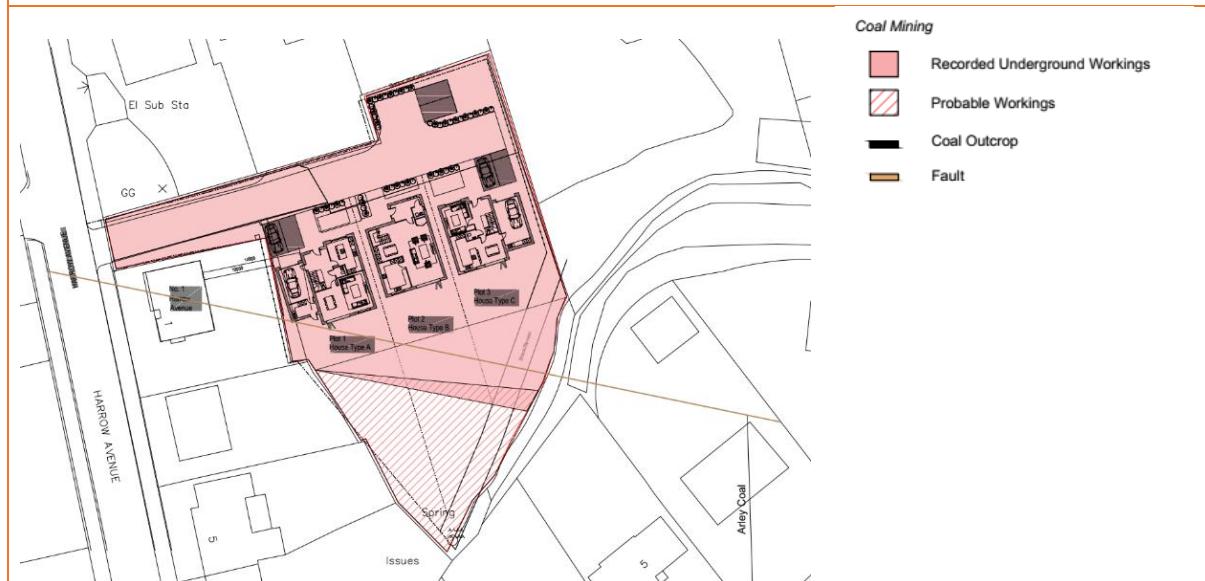
FIGURE 5.4 SNAPSHOT OF COAL MINING ISSUES AND PROPOSED LAYOUT

Figure 5.4 shows that the shallow mine workings risk from the coal sub-crop does not affect the proposed structures.
