**ENGINEERING REPORT 8874**

**GREENGATE HILL FARM  
ASHWORTH ROAD  
ROCHDALE  
OL11 5UN**

**CLIENT: MR C CAMPBELL**

**11.04.2023 MP/CH**

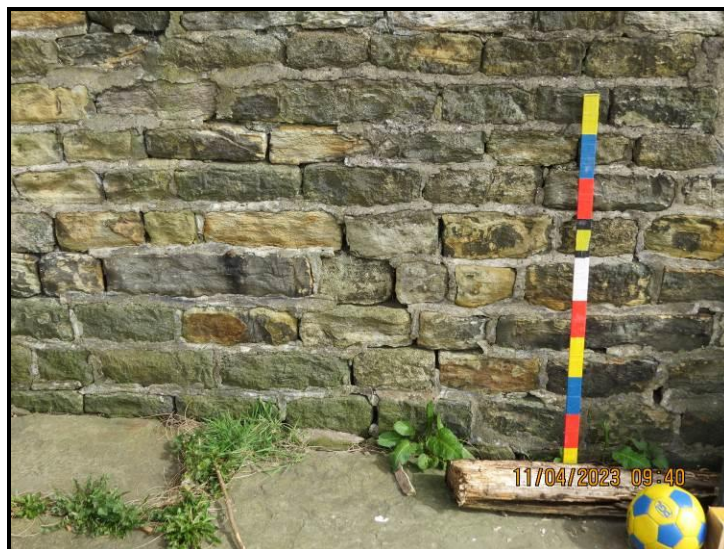
- 4.4 The ground level slopes towards the South Eastern aspect with an increase in height from the paviour to the gable in the order of 700mm. (Photograph 011).
- 4.5 The elevation is constructed in watershot coursing, the pointing is poor and there is evidence of some minor lateral movement in the lower coursing around chainage 4.5. (Photograph 015).

**Photograph 015 Minor lateral movement (historic)**

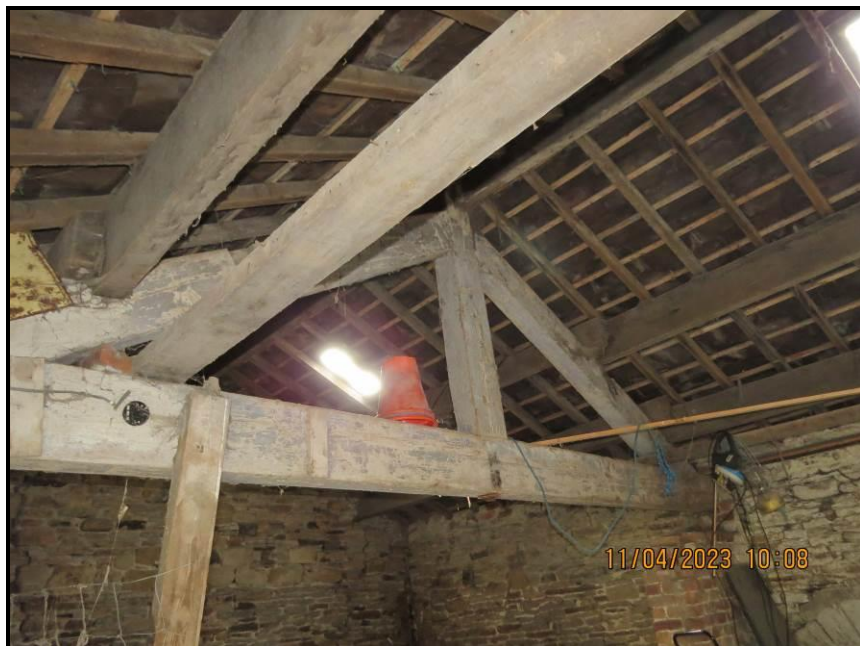
Photograph 061 King post truss

- 9.1 The roof is support on a single King post truss, the bottom tie in the order of 300mm x 75mm, the King post 200mm x 75mm and similar sized principal rafter.
- 9.2 The North Eastern flank wall on the main section (0 – 4.6 metres) is constructed in Crowthers common brick, completed with four number purlins spanning 6 metres, beneath 75mm x 50mm rafters. (Photograph 065).
- 9.3 On the inside face of the South Eastern gable vertical crazing is evident with joints widths circa 25mm – 50mm. (Photographs 062, 067).
- 9.4 There is no evidence of any lateral movement where the purlins seat into the gable wall, nor any inadequate bearing of the main truss and rafters. The horizontal profile of the purlins and rafters is good. (Photographs 058, 060, 061).

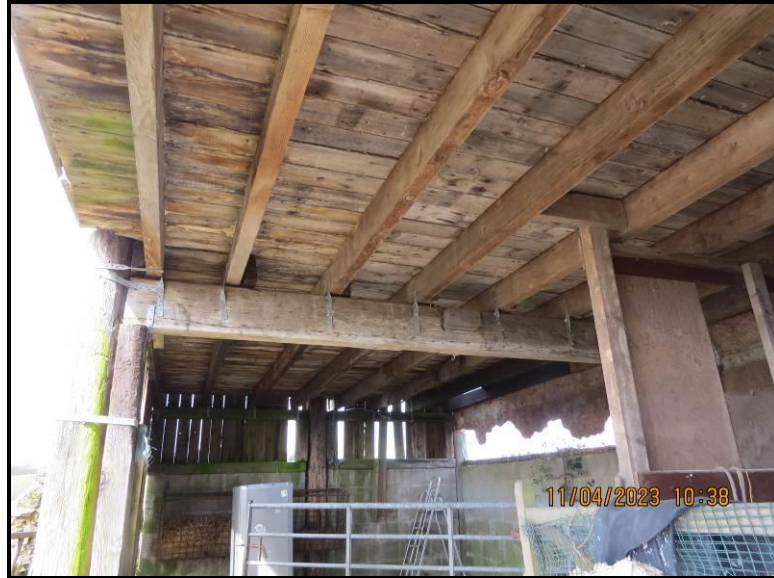
**Photograph 091 Main stanchion and first floor support**

- 11.5 The vertical alignment of the timber columns both longitudinally and laterally is good, the mid frontage column is supplemented with an additional 250mm x 250mm timber column supporting the main central floor beam spanning between the front and rear elevations, with galvanised joist hanger restraints to the main columns and the lateral floor beam. (Photographs 091, 091E).

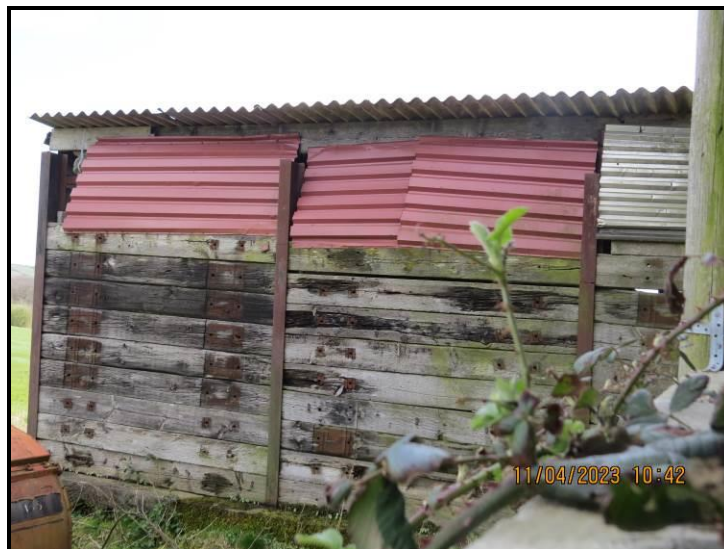
**Photograph 096 External rear elevation (East)**

- 12.6 Access to the external elevation was limited by storage and vegetation, on the North West corner adjoining the two storey barn, the two end bays incorporate ten deep whaling sections (former railway sleepers) and a profiled metal cladding. (Photograph 096).

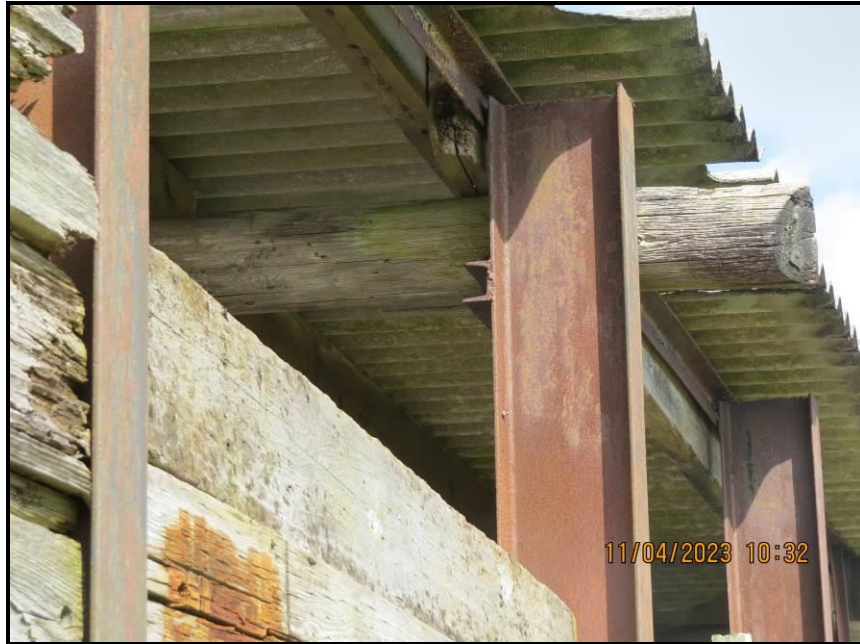
- 12.7 The South East flank (right hand from front) incorporates the whaling sections beneath the eaves opening, the typical stanchion detail is shown in photograph 087. (Photograph 086).

Photograph 087 Typical stanchion deformation

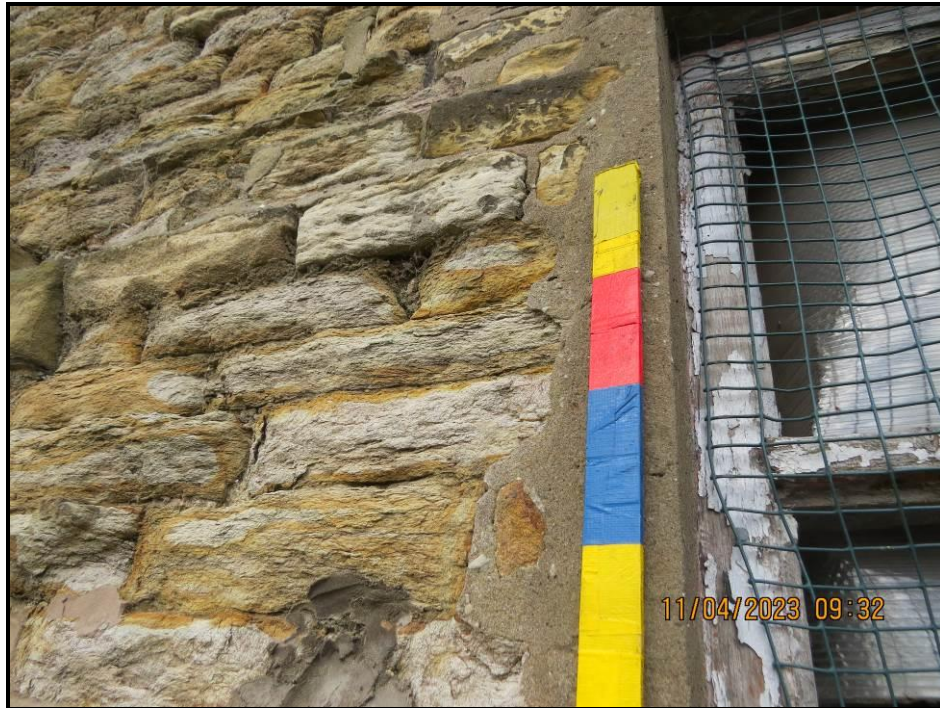
009 Weathering to stonework

- 10.7 Some weathering to the stonework is evident and may benefit from the use of an approved breathable water repellent. The repointing should be carried out in a Lime based mortar rather than cement based.

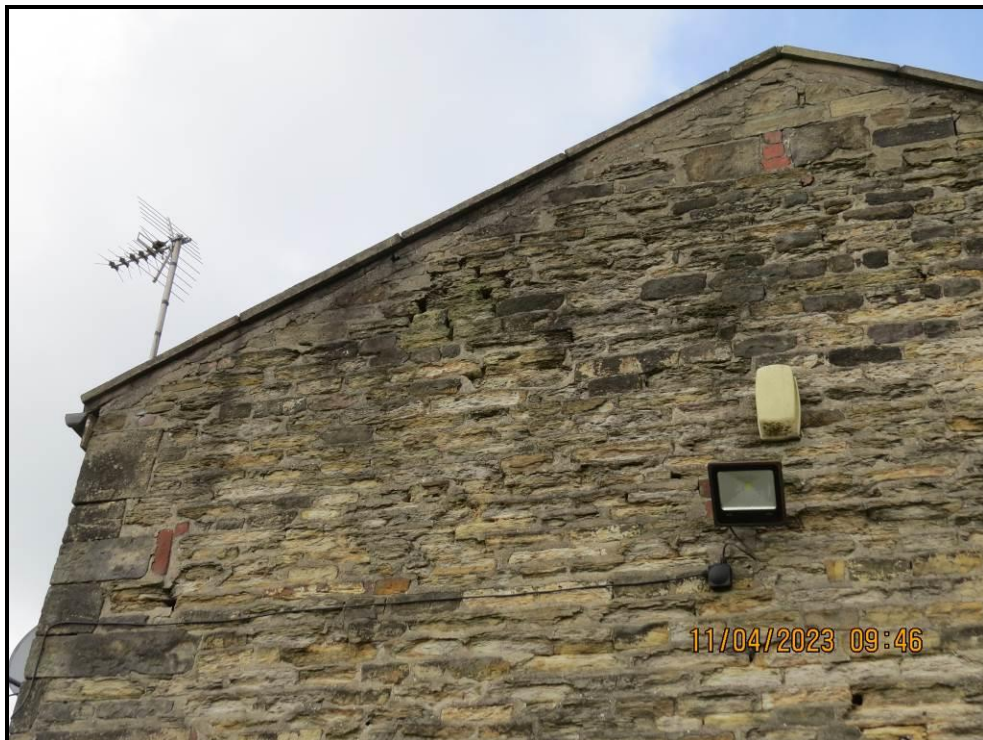
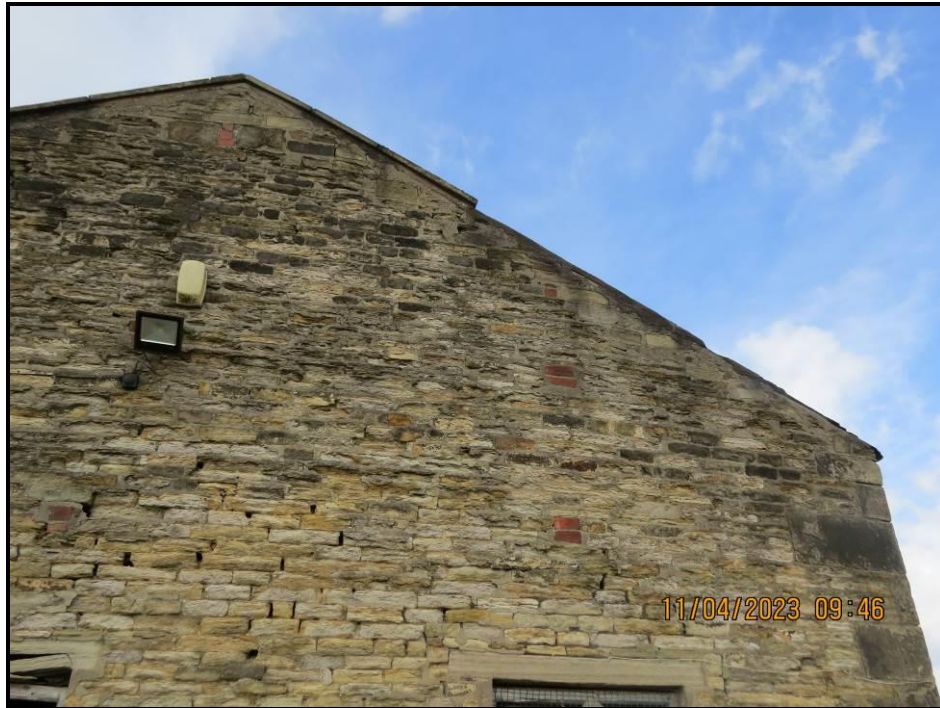
- 5.4 Two original windows (incorporating stone lintels and non-original pre cast stone cills) are evident between chainage 2 – 3 metres and chainage 5.5 – 6.5 metres. The left hand window lintel has failed, although there is only minor deviation to the bed coursing above.
- 5.5 Isolated losses of pointing are evident at mid-height, exacerbated by the weathering to the stonework. The alignment to the bed coursing shows minor variations. (Photograph 023).
- 5.6 The profile of the Northern window is reasonable. (Photograph 021).
- 5.7 In the upper pike construction, the weathering to the stonework is not as severe although some loss of pointing is evident in the upper left hand aspect. (Photographs 024, 025).

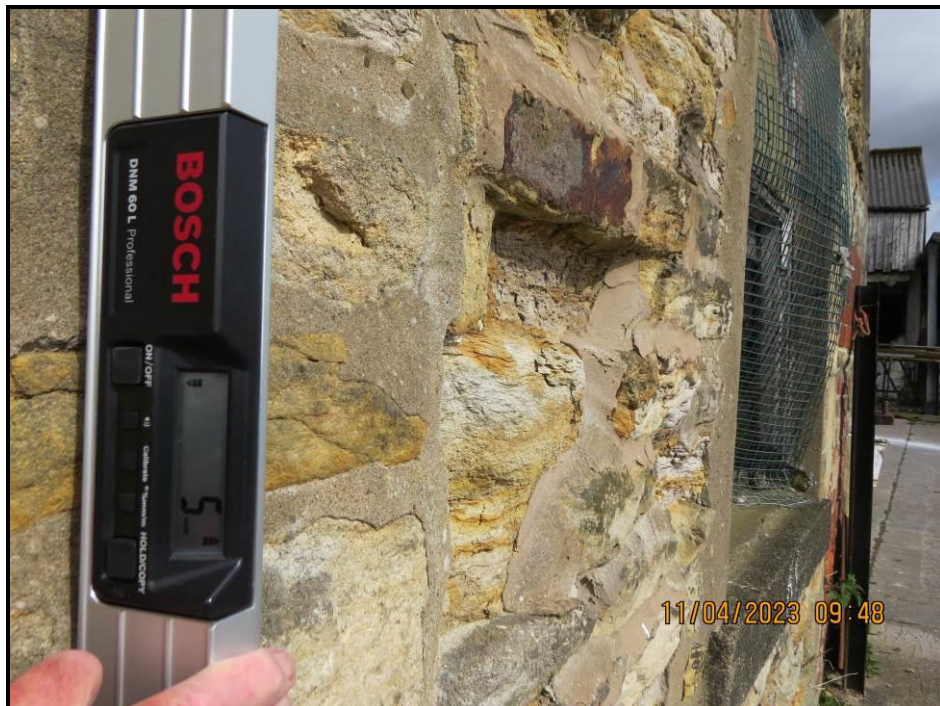
027 Loss of vertical alignment to gable, chainage 0

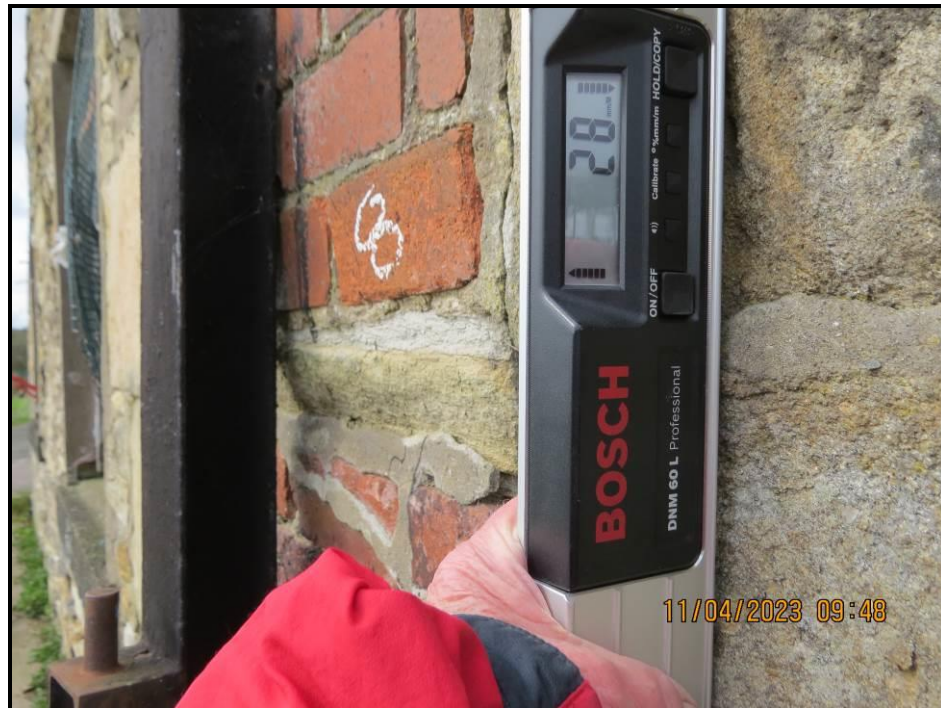
028 Loss of vertical alignment to gable, chainage 8.3 metres

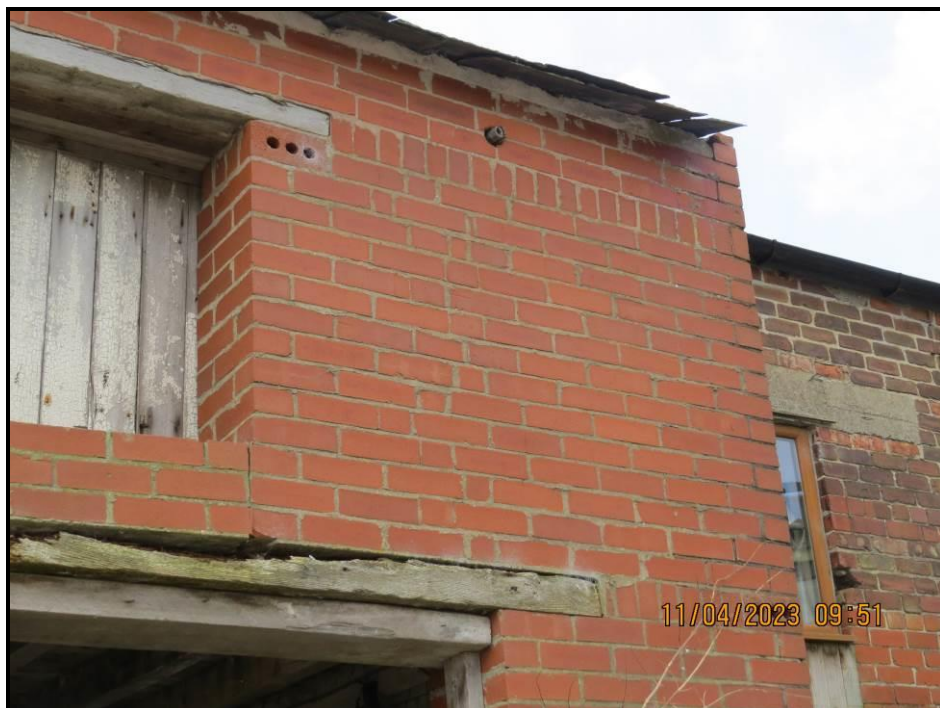
034 Satisfactory vertical alignment

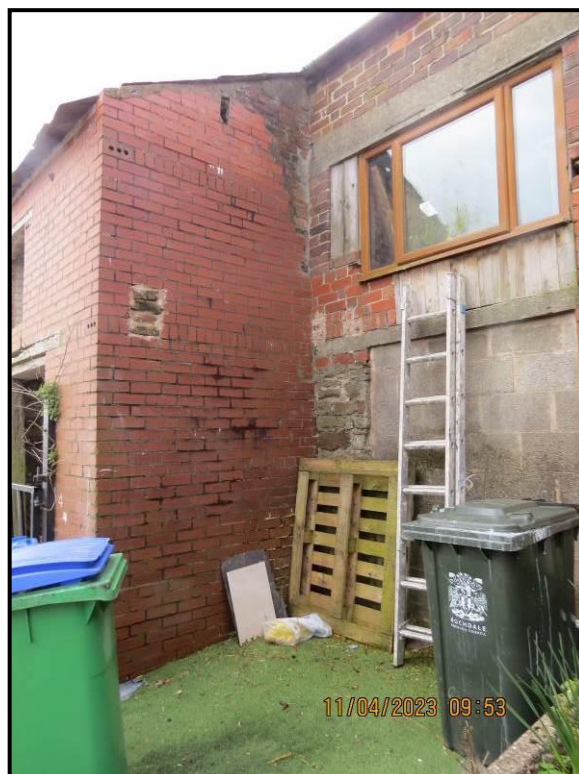
038 Satisfactory wall return

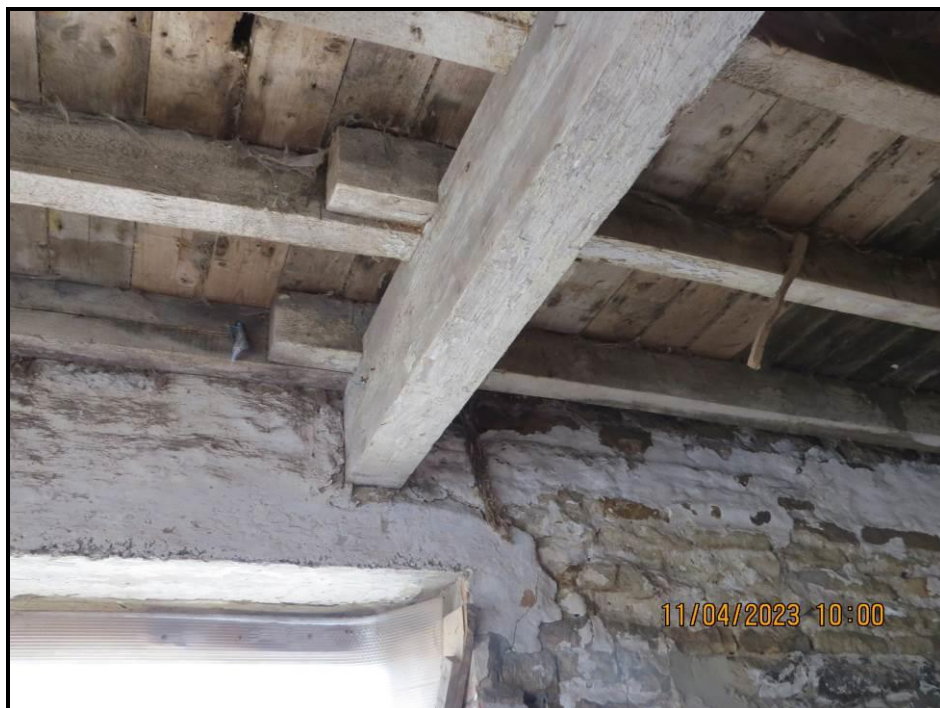
048 Satisfactory beam seating

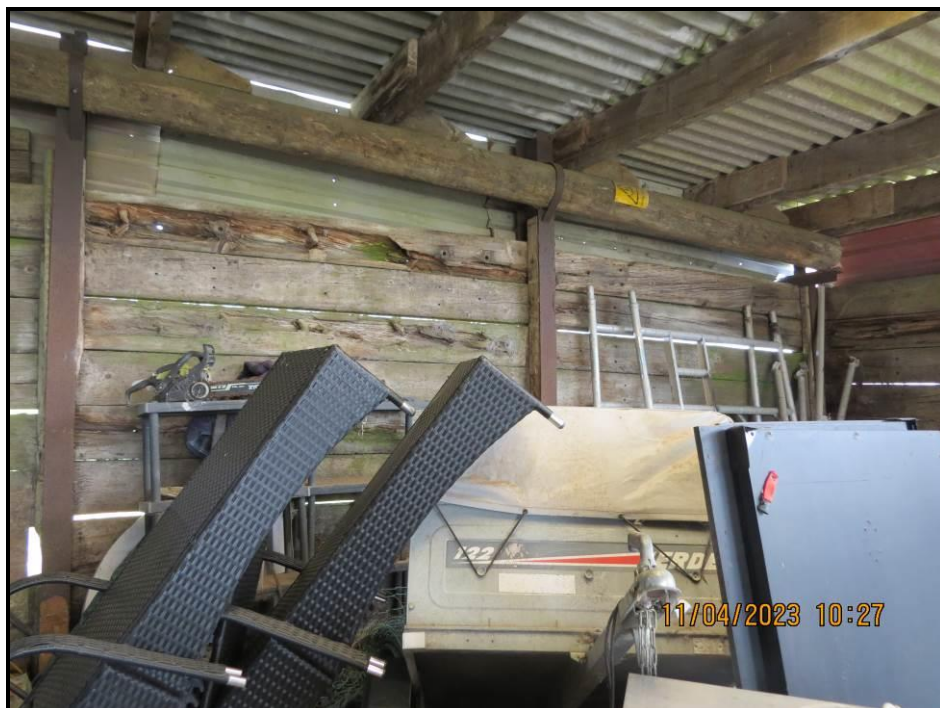
078 Rear wall (North West)

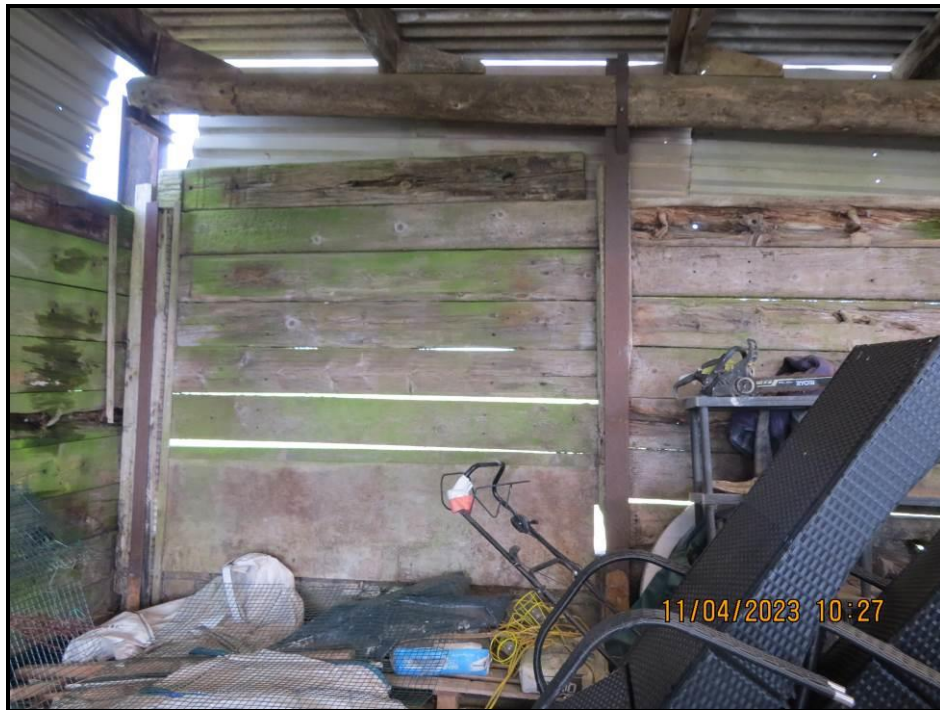
079 Rear wall (North West)

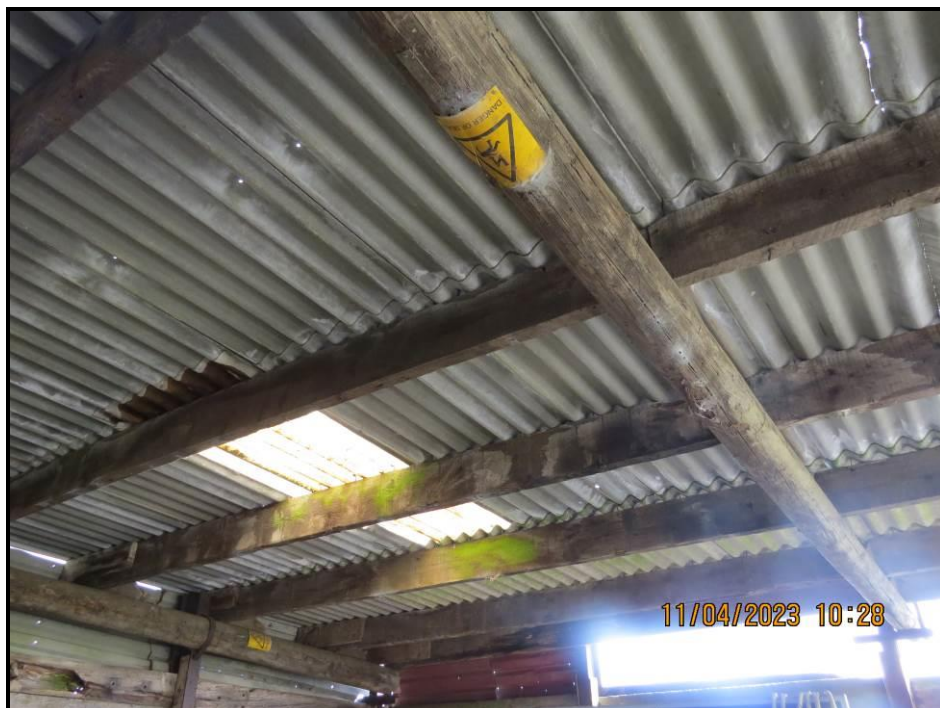
080 Main roof beam

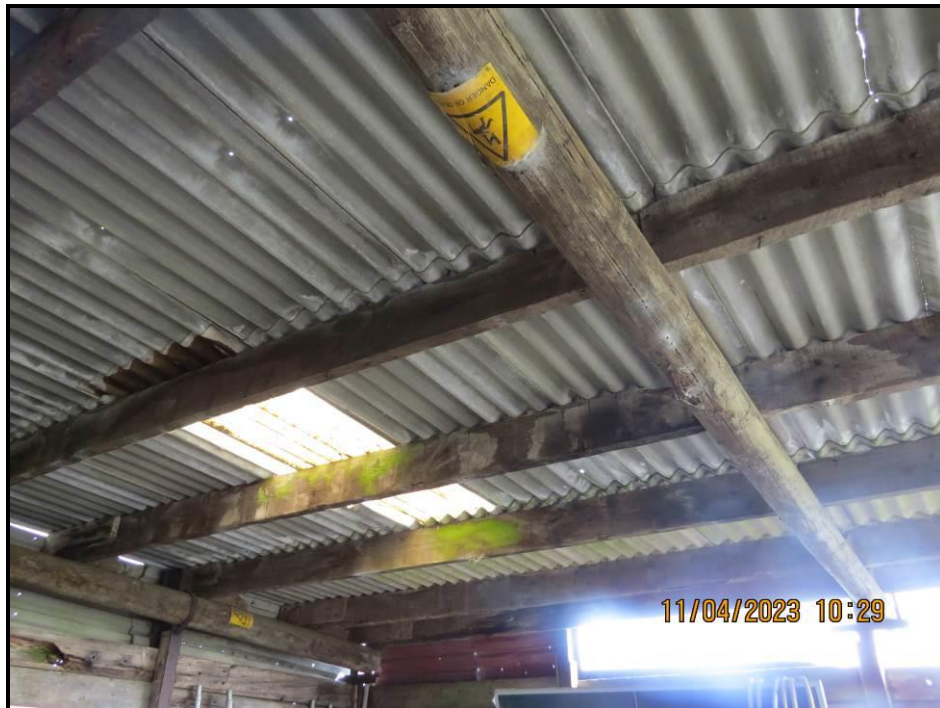
081 Main roof beam

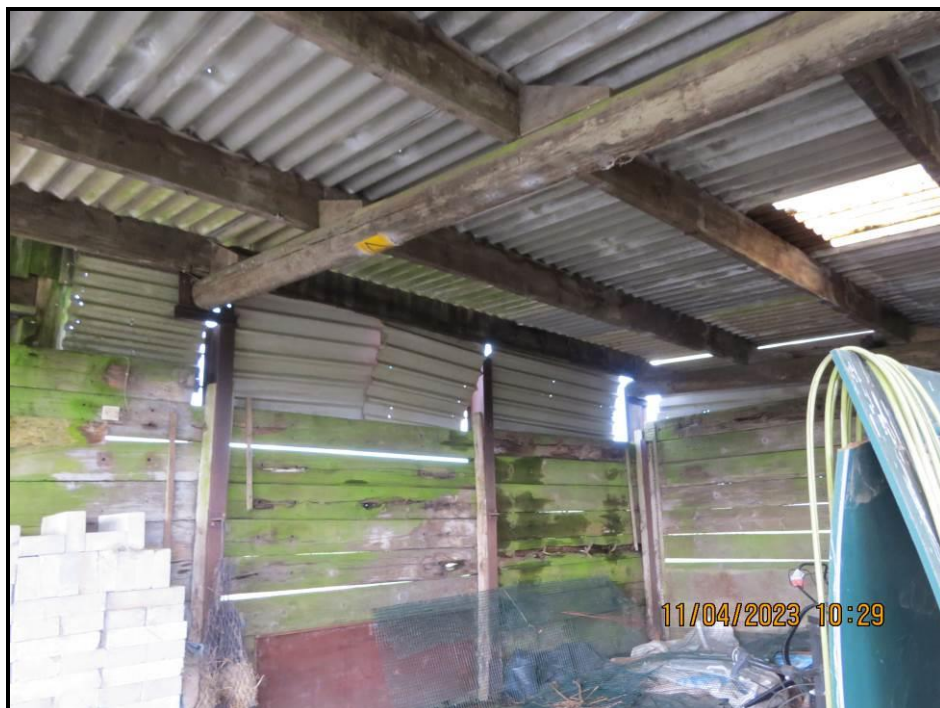
082 Ground floor gable to barn (East)

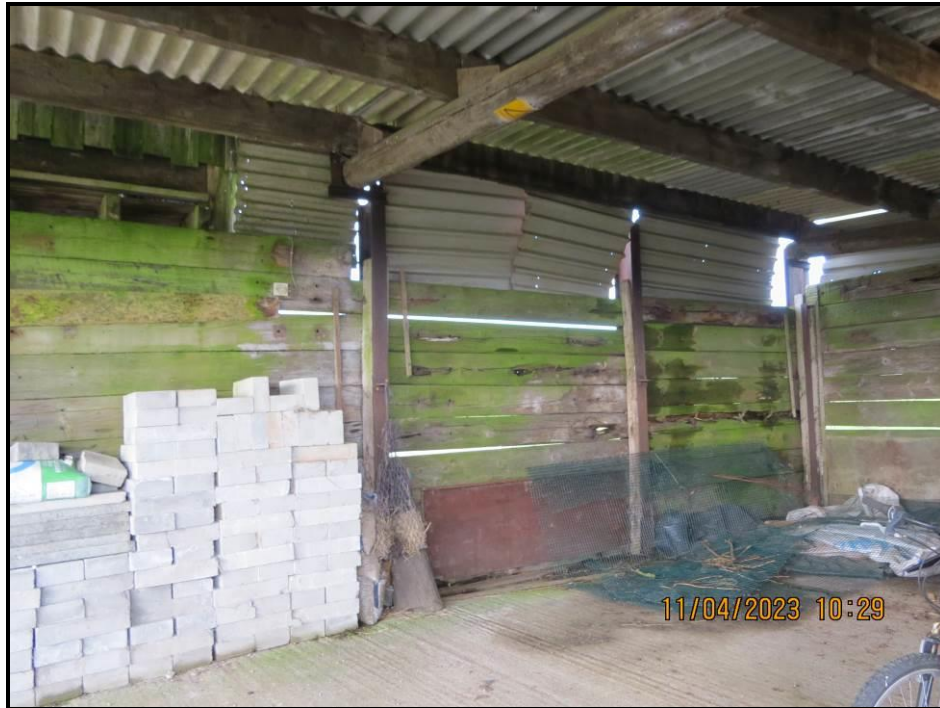
083 Ground floor gable to barn (West)

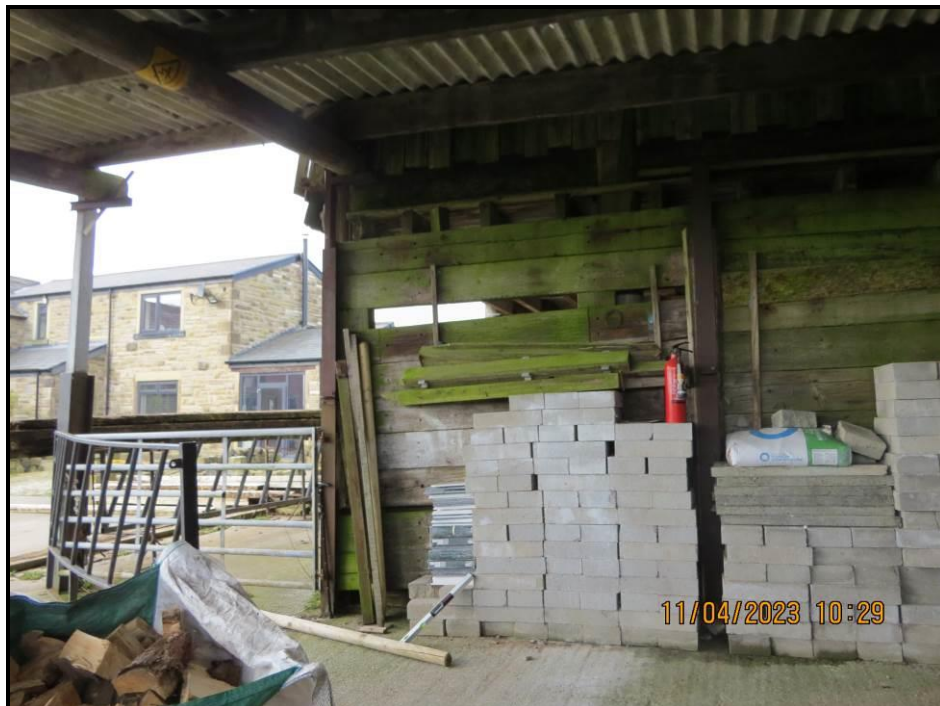
084 Ground floor gable to barn, chainage 0 – 3 metres

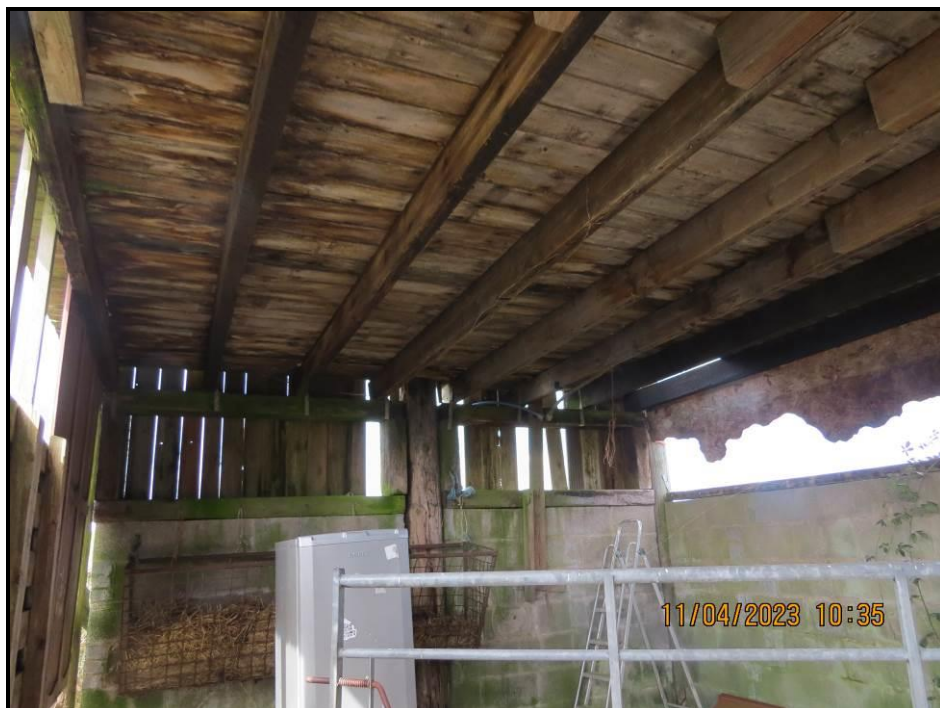
088 Shippon, ground floor looking South East – North West

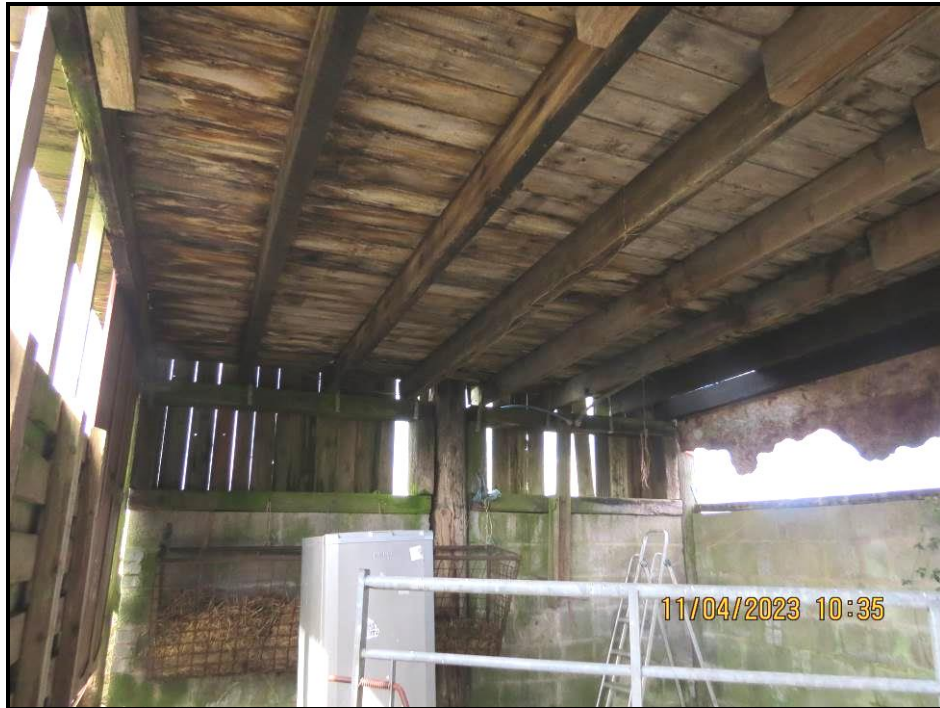
089 Shippon, ground floor looking South East – North West

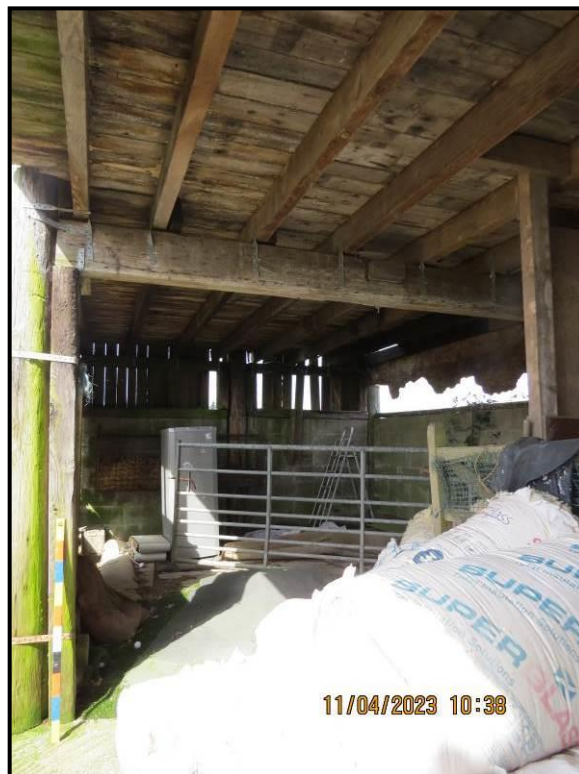
090 First floor support cross beam

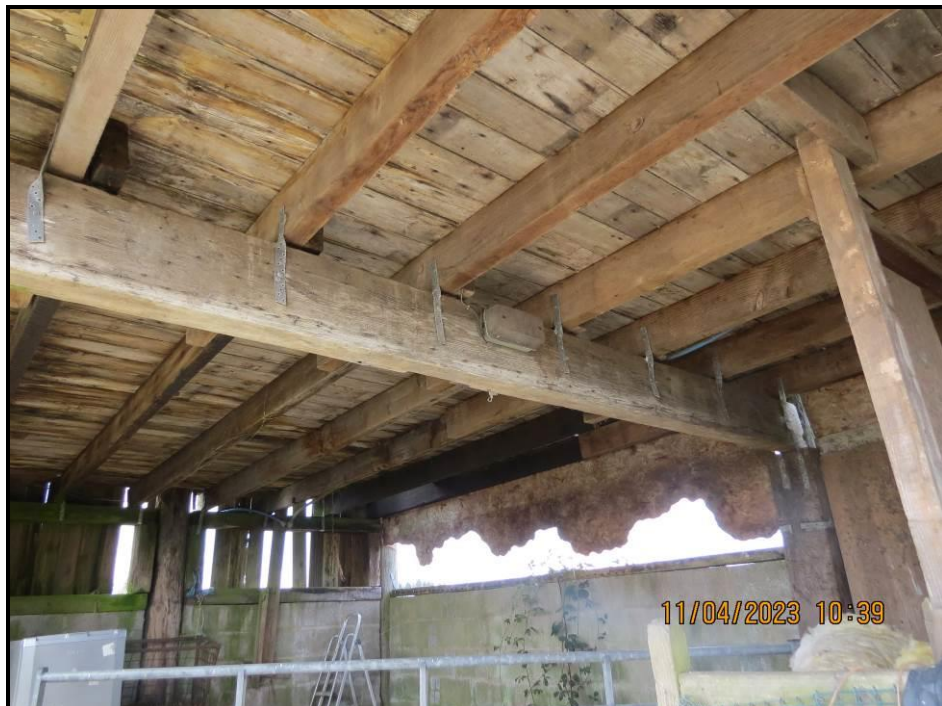
092 Cross beam support, rear wall

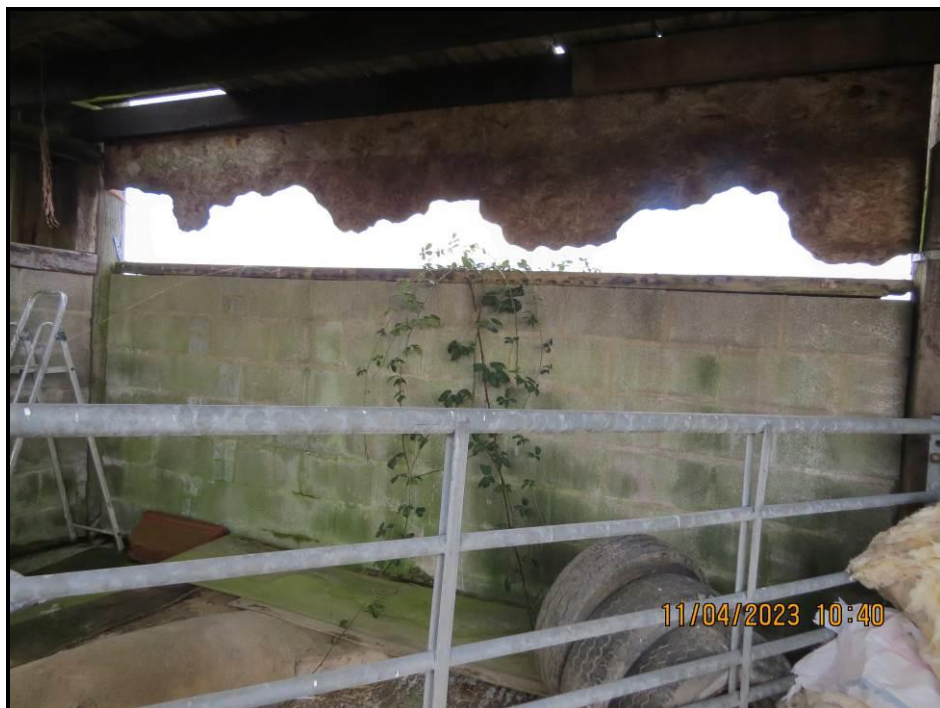
094 Blockwork plinth wall, rear elevation

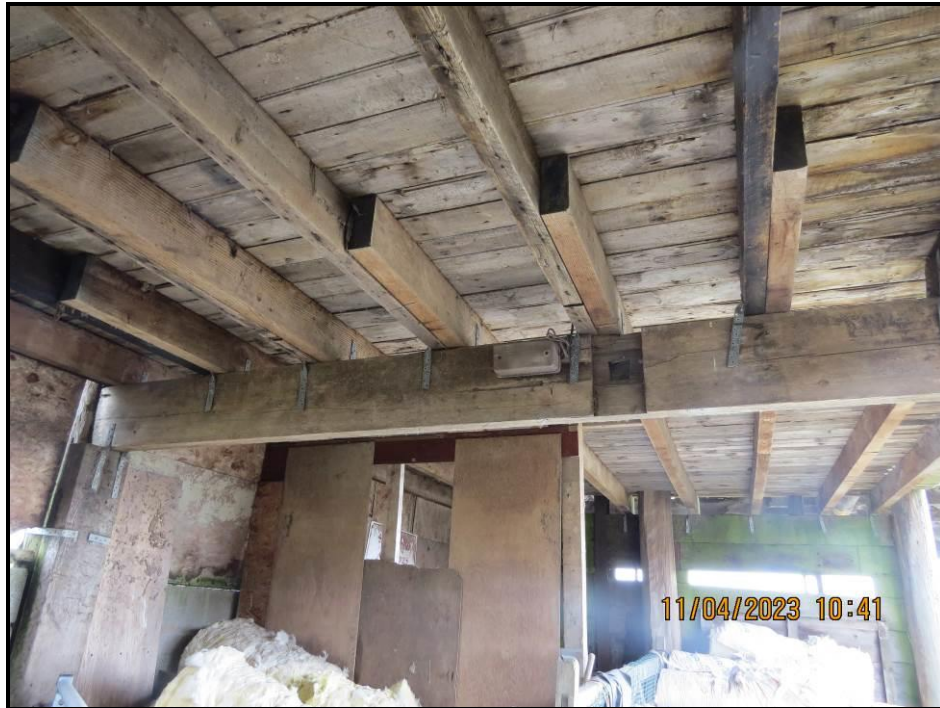
095 Floor beam and first floor looking North West – South East

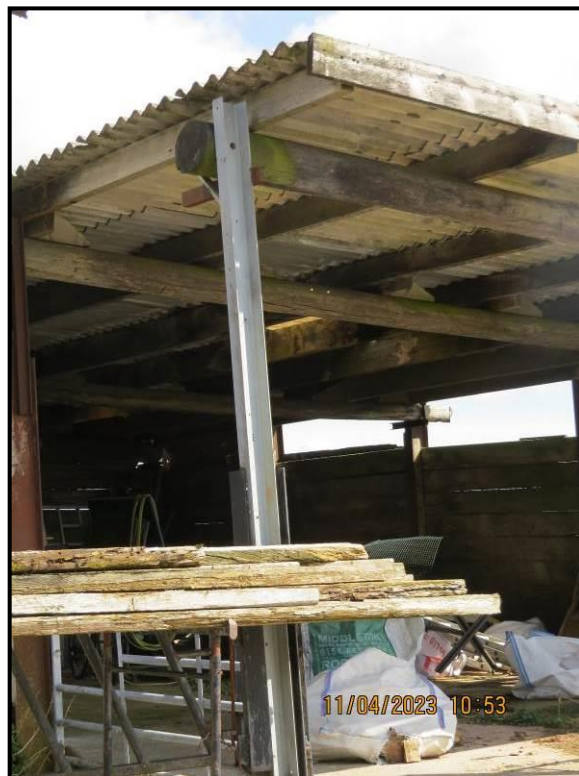
107 Irregular alignment to corner stanchion
