## Waterside House

Rochdale  
Heritage, Design and Access Statement

August 2023

Waterside House, Rochdale  
Condition Survey

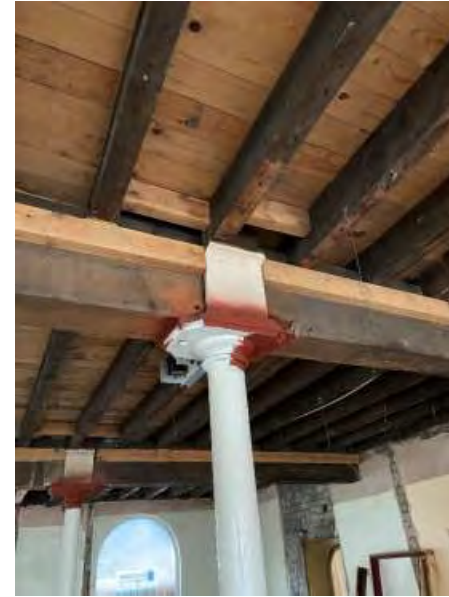
Photograph 34

On the Eastern side, the roof is supported by three lines of large timber trusses. These are Kingpost trusses with a steel rod acting as the Kingpost. Photograph 34.

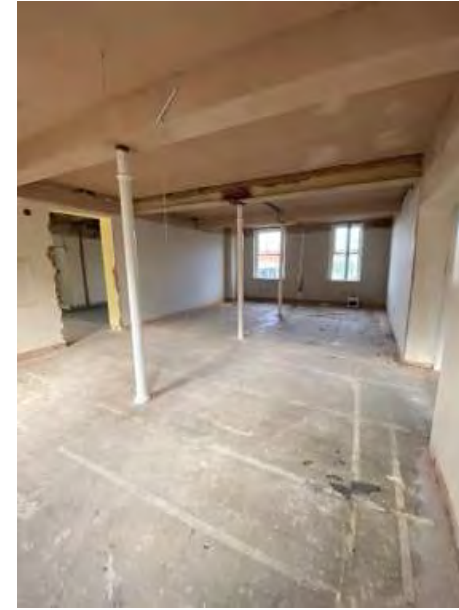
Photograph 50

The support to joists ends has been supplemented with additional timbers. This appears satisfactory. Photograph 50. These timbers may have also been provided to carry any Fireline boarding. No remedial action is required.

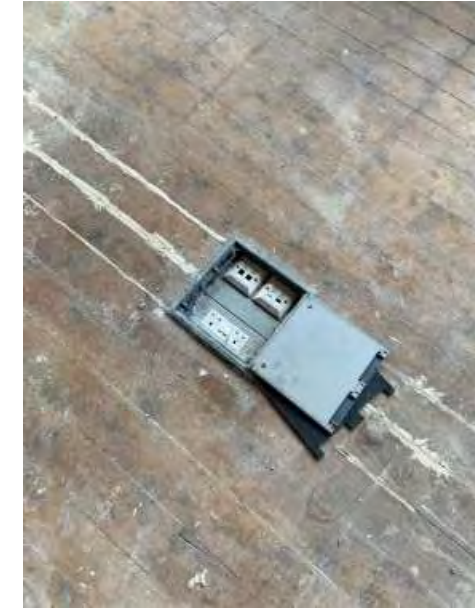
The ground floor is of similar nature to the first. Much of the front wall is covered with boarding and cannot be viewed. Photograph 53 is typical. The rear wall is also practically inaccessible due to large areas of stored material within the property. What was visible appears to be generally satisfactory.

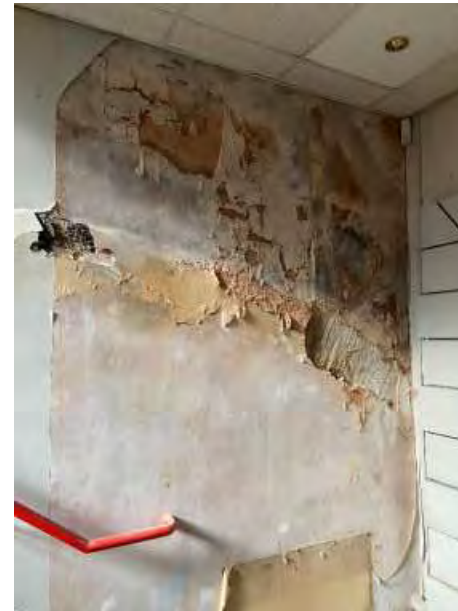
Photograph 51

At first floor on the line of the return elevation at the rear there is a full height crack. Again, this could not be seen externally. Photograph 51.

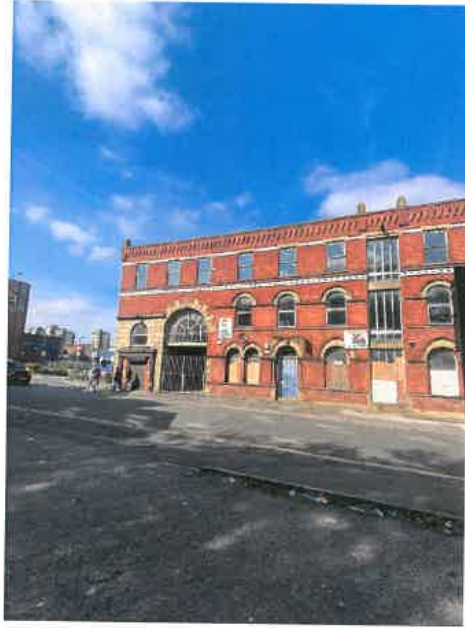
**2.02** The front (South) elevation is of three storey appearance and has a parapet wall at the head masking the pitch of the roof. Photograph 1 & 2.

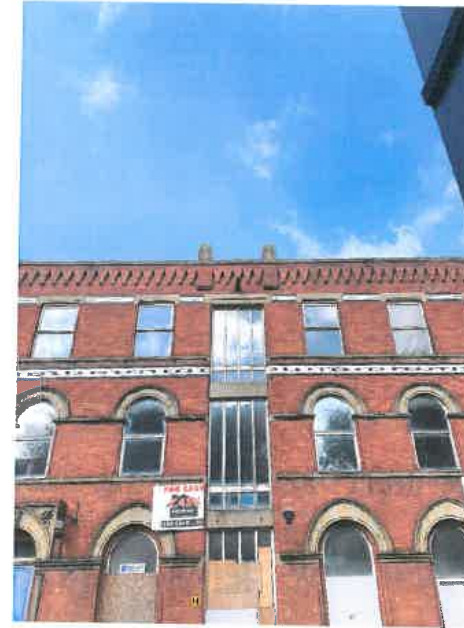
Photograph 5

Central in the elevation there is a full height window separated only by floors. The property was probably a former mill, and this would have been the loading bay areas. Photograph 5.

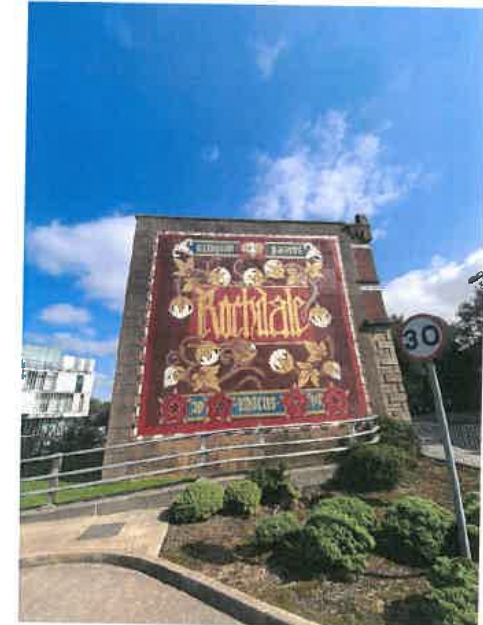
Photograph 6

**2.04** The left-hand side (West) elevation is a full height stone gable elevation that has a painted mural on the wall. Photograph 6.

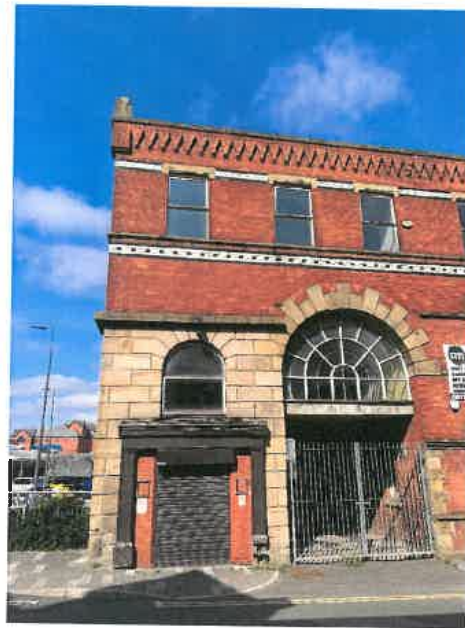
Photograph 3

To the left of this the elevation is of coursed stone at the lower level, photograph 3. To right the elevation is faced in brick with feature stone arched lintels, and brick plinth, photograph 4.

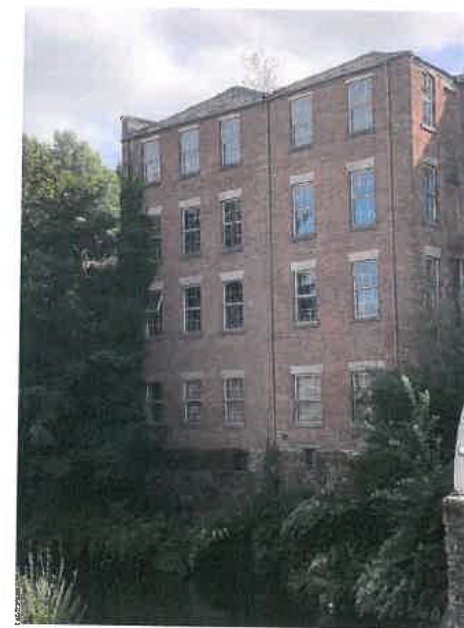
Photograph 7

**2.05** Much of the rear (North) elevation is also inaccessible. The main Eastern side of the property is sat on a stone retaining wall which is immediately adjacent to the river. There is no physical access to this area. Here the elevation is of four storey appearance. The cellar is fully exposed, photograph 7.

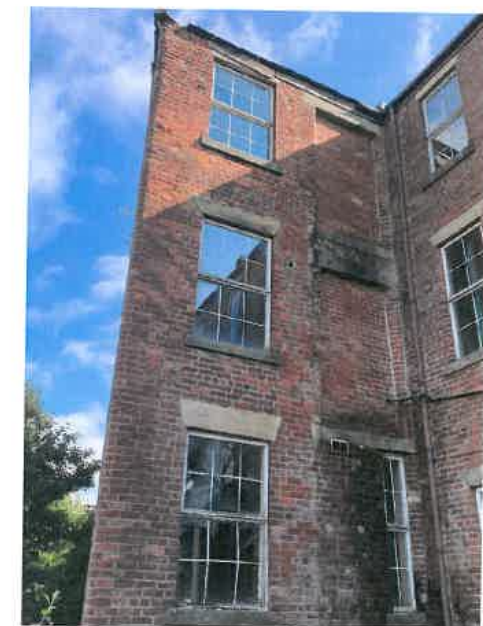
Photograph 8

**2.06** The rear elevation steps back towards the right-hand side and in the return elevation there are two window openings per floor, some of which have been infilled, photograph 8. There is external access to a basement area, but this is currently fenced off and inaccessible.

**2.07** In the remaining rear elevation up to the arch, there are two windows at each floor level. There are two further windows above the arch and at the far left is a full storey height window. Photographs 8, 9, 10 & 11.

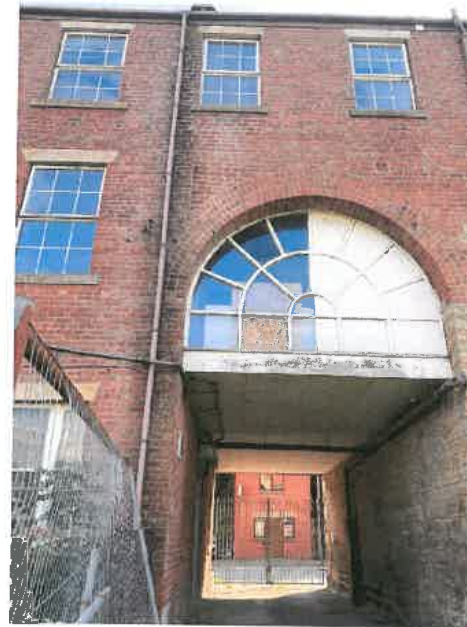
Photograph 10

On the rear elevation (North), there is cracking above the large rear arch. Photographs 10, 25 & 26.

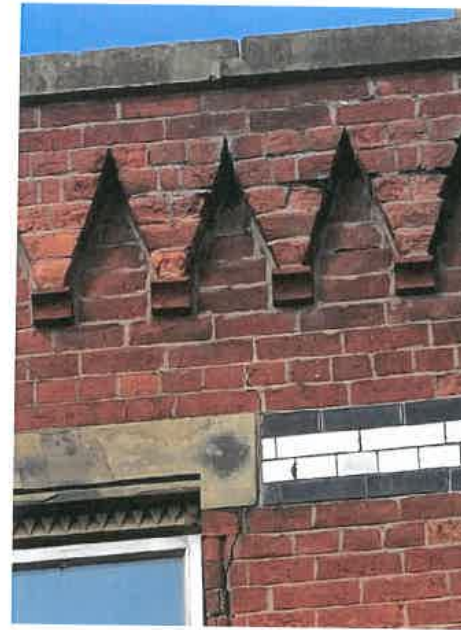
Photograph 13

On the front elevation to Water Street there is a large stone coping at roof level. Beneath this is feature brickwork. There are four feature stone monoliths on top of the wall. Photographs 13 & 14.

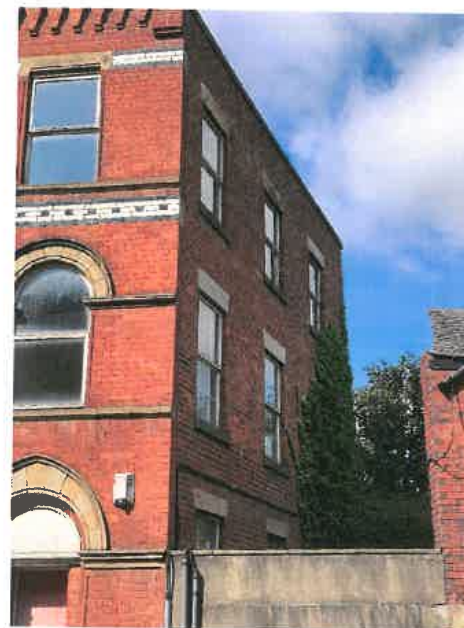
Photograph 12

**2.08** The right-hand, East, elevation is shown in photograph 12.

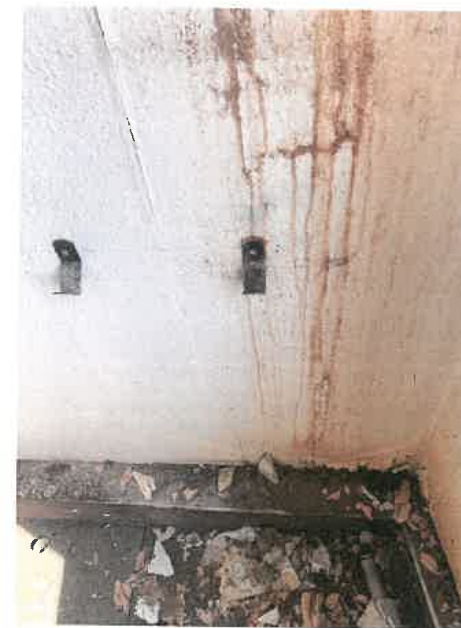
Photograph 15

A sandstone stone plinth at the base of the wall has perished and will need protection from further corrosion. Photograph 15.

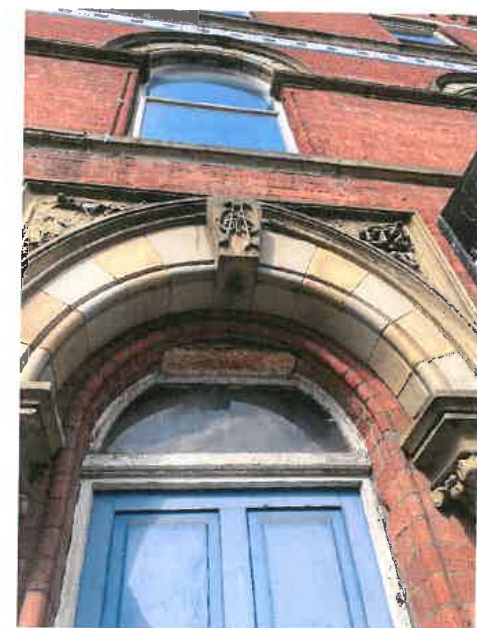
Photograph 16

East of the arch way there are two adjacent arch windows, followed by a door under a further arched lintel. This has an exposed steel plate which is beginning to rust and needs protecting to avoid further expansion and loss of masonry. Photograph 16.

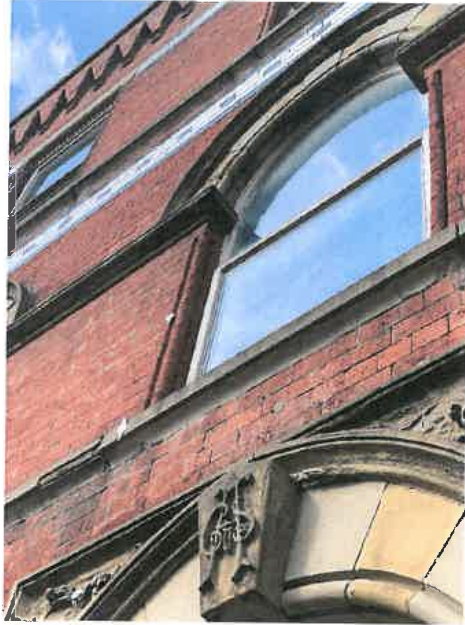
Photograph 17

Above the door there are two survey targets on the cill and jamb of the window over. These were probably part of a verticality check. Photograph 17. If any results are available from this, these should be obtained. The full extent of the verticality cannot be fully assessed from our simple visual survey, but our opinion is that the verticality is generally within acceptable tolerances.

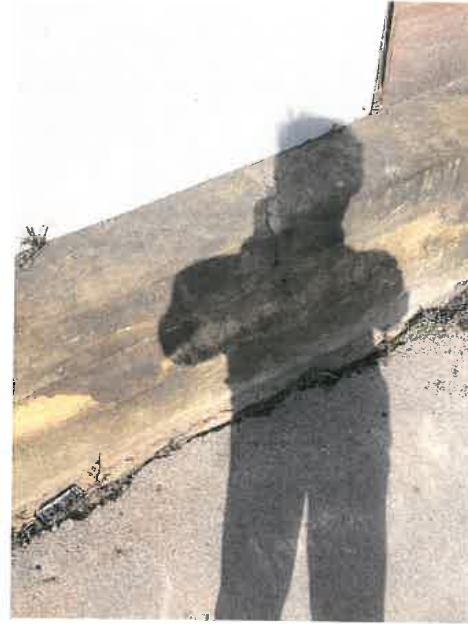
Photograph 18

The cill to the loading bay has split but this is not a structural concern. Photograph 18.

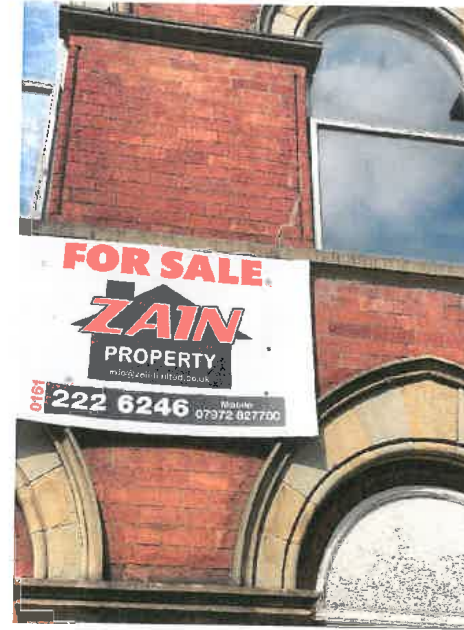
On the line of the next window there is another vertical crack which extends from the springing of the arch above up to the second-floor window cill and above. Adjacent to the second-floor window and directly above this is a further crack. Photograph 21 & 22.

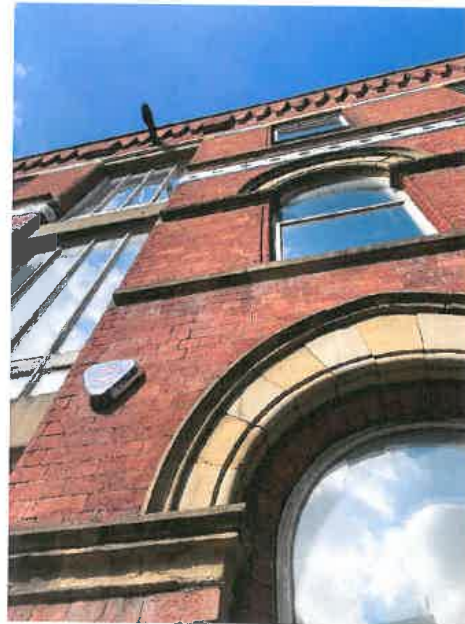
Beyond the loading bay window is a further arch window and to the left of this is the start of a vertical crack which extends practically the full height of the building. This has been patched in the past and has opened up. The recent movement is considered to be relatively minor. Photograph 19 & 20.

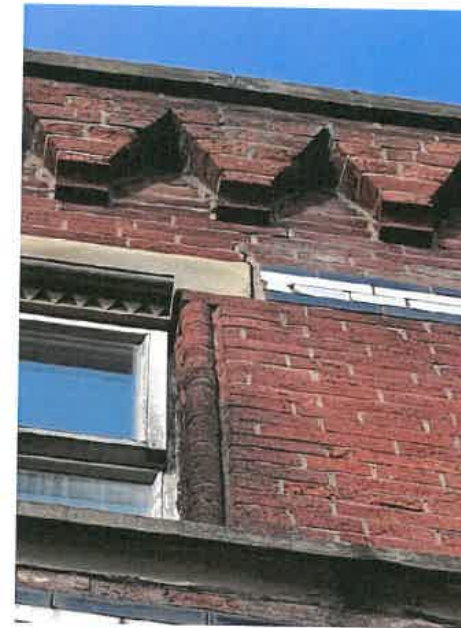
Photograph 23

Finally on the South elevation there is a door at ground floor level and two windows above. There are vertical cracks above the right-hand side of the two windows over. Photographs 23 & 24.

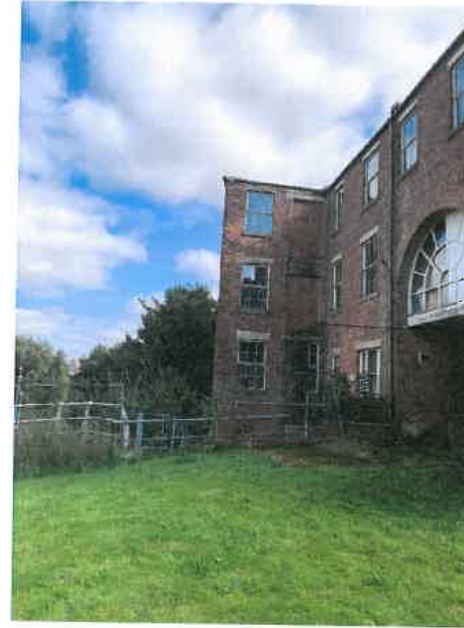
Photograph 29

Other sections of the rear elevation are difficult to assess as access is extremely limited. Photographs 27, 28 & 29.

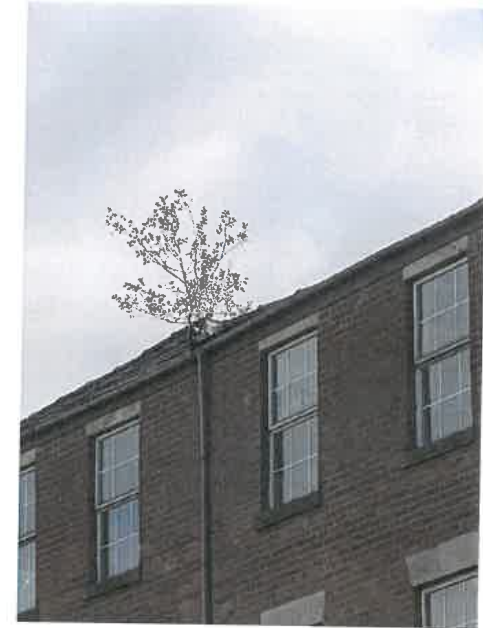
Photograph 30

We did notice that there was plant growth in the form of a small tree growing out of the main rear elevation above the river. Photograph 30. This will be difficult to remove, and the work will probably need to be carried out from within or with a scaffold extended out through the windows, cantilevered and counterbalanced internally.

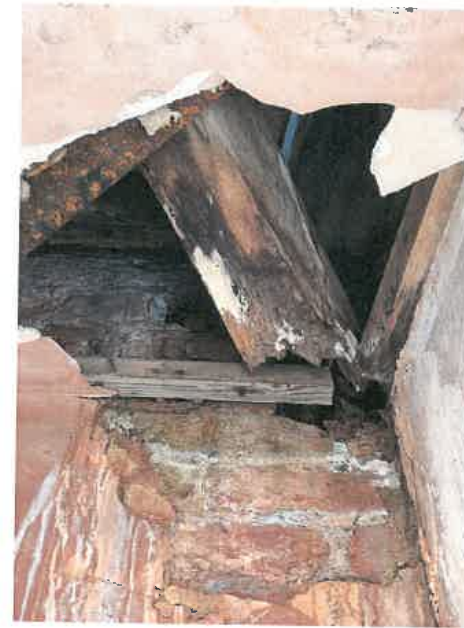
Photograph 31

Internally on the front right-hand corner there is rot in the timber hip. Photograph 31. There has clearly been water ingress at this point.
