**Structural Appraisal**

**Leaches Farm**

**Mr J Farrell**

**May 2023**

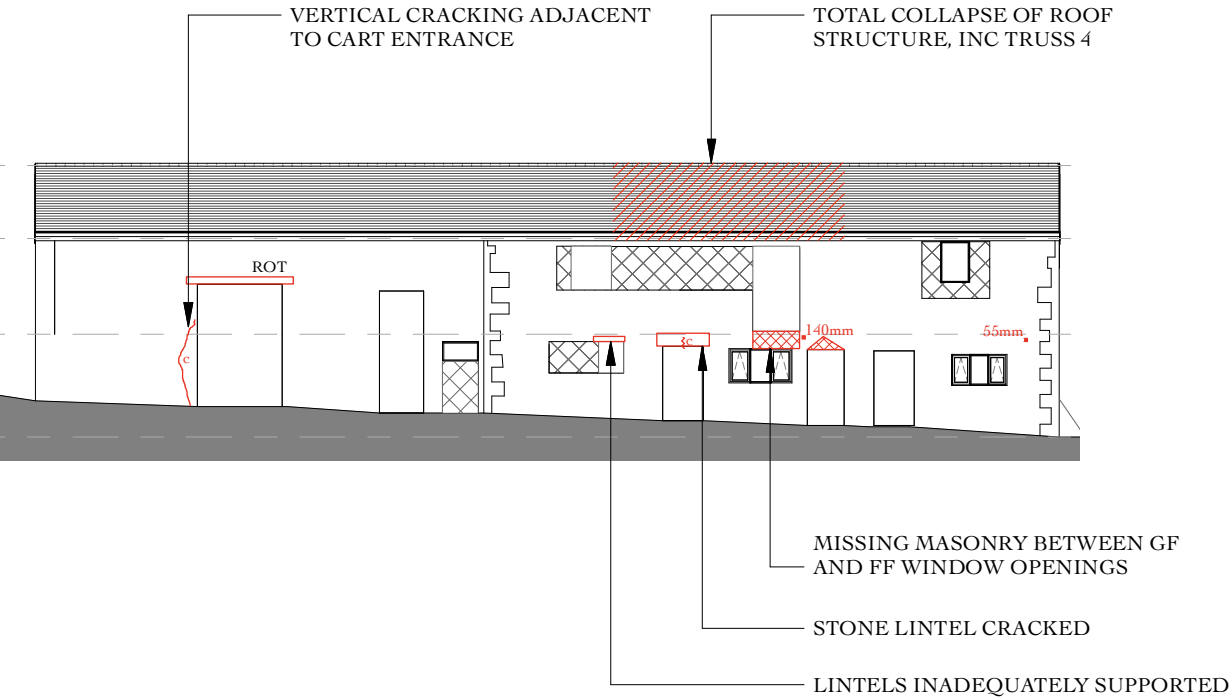
SOUTH ELEVATION

Localised repairs are required to the cart entrance in the south elevation. The vertical cracking up the western jamb should be remedied by stitching or localised rebuilding. The rotten timber lintel should be replaced and brickwork over consolidated. The other 2No isolated areas of missing masonry in the south elevation should be reinstated, any rotten timber lintels replaced and the cracked stone lintel should be repaired using stainless steel dowels.

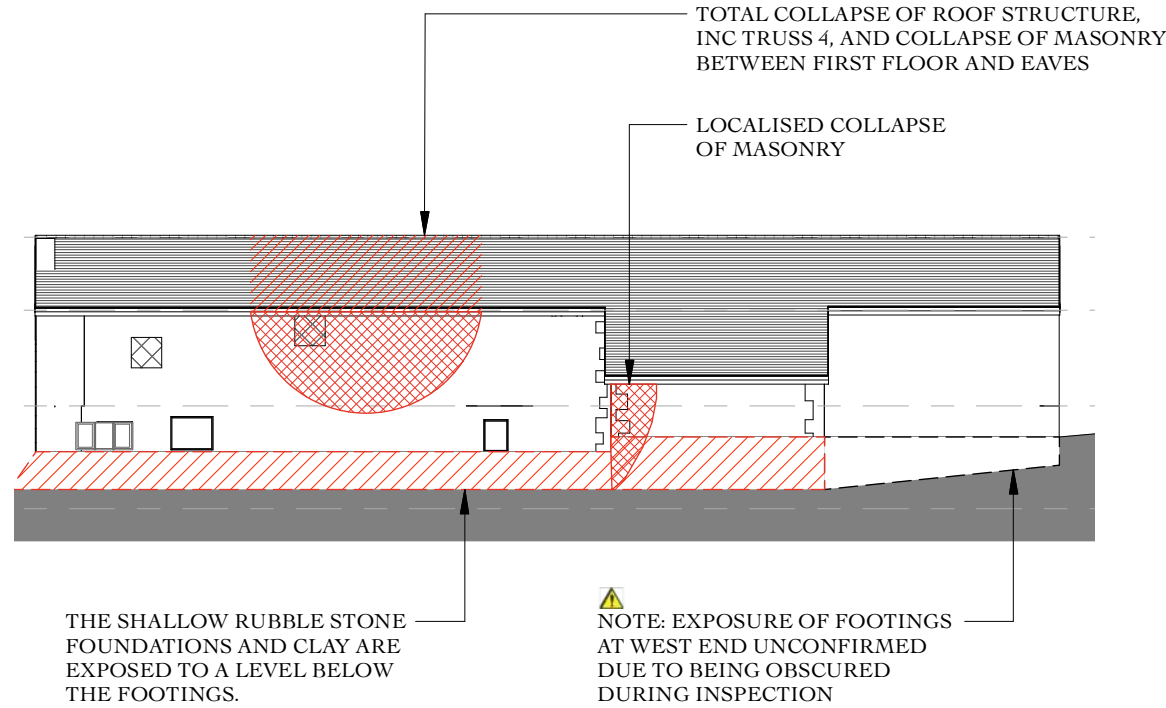
NORTH ELEVATION

The lean-to extension should be taken down and rebuilt on new concrete footings and the north elevation underpinned along its full length where foundations have been exposed.
