# Drainage Report

Bowlee Park Golf Range | Heywood Old Road

**Document Reference:** 062D22-DR/01

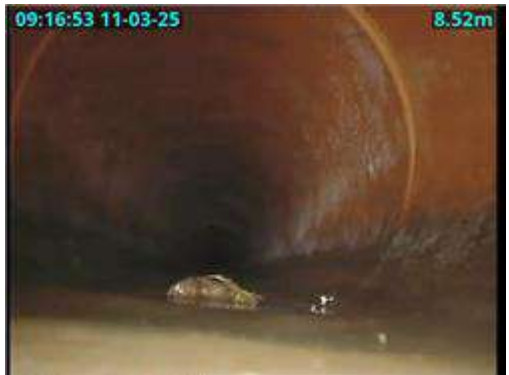
| Pos | Video Ref | Code | Description | Image |
|---|---|---|---|---|
| 08.52m | 0:00:24 | DER | Settled deposits coarse: 5%<br>Cross sectional area loss -<br>Severity 3 | Image Provided - Ref: 1_4<br> |

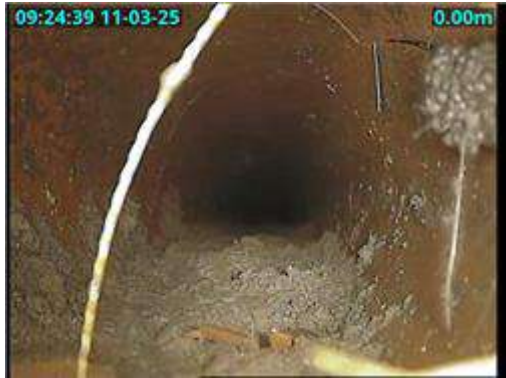
| Pos | Video Ref | Code | Description | Image |
|---|---|---|---|---|
| 00.00m | 0:00:00 | DES | Settled deposits fine: 10% Cross sectional area loss - Severity 3 | Image Provided - Ref: 2_1<br> |

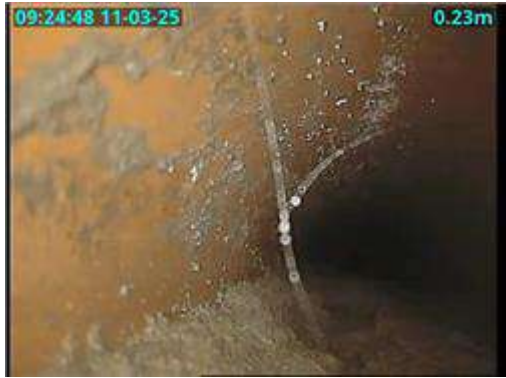
| Pos | Video Ref | Code | Description | Image |
|---|---|---|---|---|
| 00.23m | 0:00:12 | DES | Settled deposits fine: 25% Cross sectional area loss - Severity 3 | Image Provided - Ref: 2_3<br> |

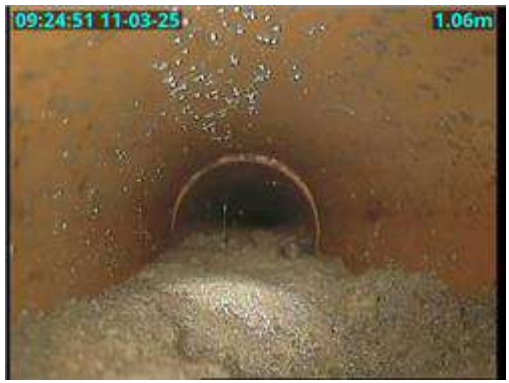
| Pos | Video Ref | Code | Description | Image |
|---|---|---|---|---|
| 01.06m | 0:00:15 | DES | Settled deposits fine: 45%<br>Cross sectional area loss -<br>Severity 3 | Image Provided - Ref: 2_4<br> |

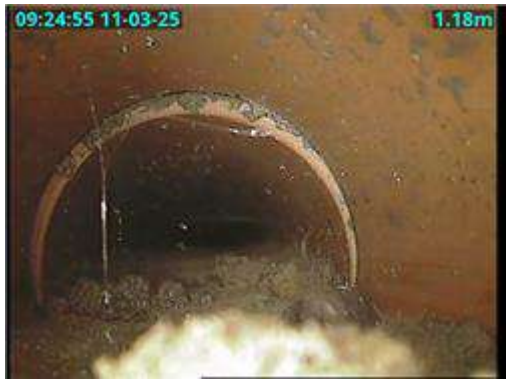
| Pos | Video Ref | Code | Description | Image |
|---|---|---|---|---|
| 01.20m | | SA | Survey abandoned<br>EOT. Unable to camera<br>further. Survey abandoned | Image Provided - Ref: 2_9999<br> |

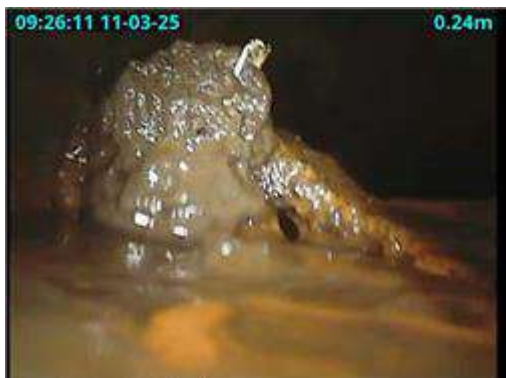
| Pos | Video Ref | Code | Description | Image |
|---|---|---|---|---|
| 00.24m | 0:00:05 | OB | Other obstacles: 25% Cross sectional area loss - Severity 3 | Image Provided - Ref: 3_2<br> |

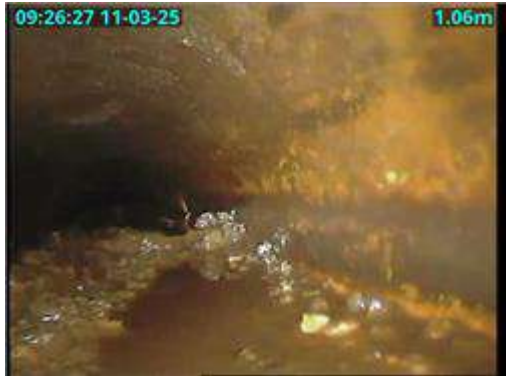
| Pos | Video Ref | Code | Description | Image |
|---|---|---|---|---|
| 01.06m | | SA | Survey abandoned EOT. Unable to camera further. Survey abandoned | <p>Image Provided - Ref: 3_9999</p> |

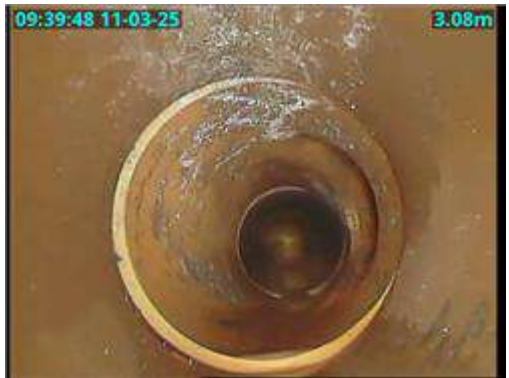
| Pos | Video Ref | Code | Description | Image |
|---|---|---|---|---|
| 03.08m | 0:00:22 | JDM | Joint displaced medium - Severity 3 | Image Provided - Ref: 5_5<br> |

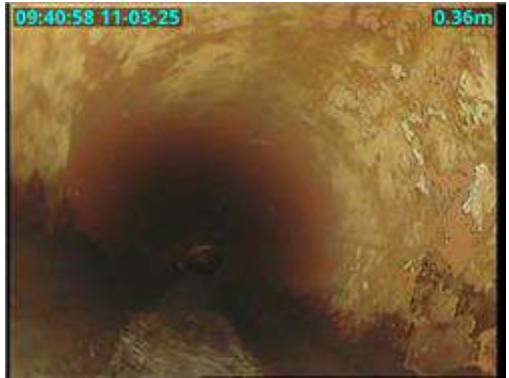
| Pos | Video Ref | Code | Description | Image |
|---|---|---|---|---|
| 00.36m | | S1 DEE | Attached deposits, encrustation 0.36m - 2.84m from 04 o'clock to 08 o'clock: 5% Cross sectional area loss - Severity 3 | <p>Image Provided - Ref: 6_1</p> |

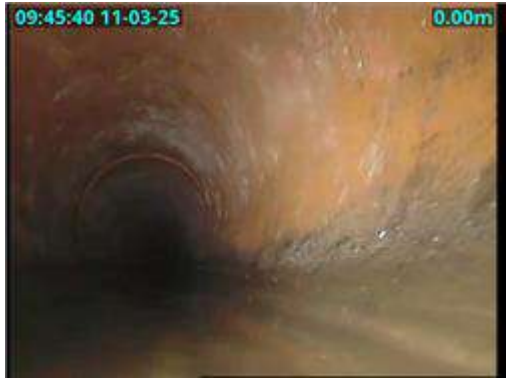
| Pos | Video Ref | Code | Description | Image |
|---|---|---|---|---|
| 00.00m | | S1 WL | Water level 0m - 8.51m: 10% Height/Diameter | Image Provided - Ref: 7_1<br> |

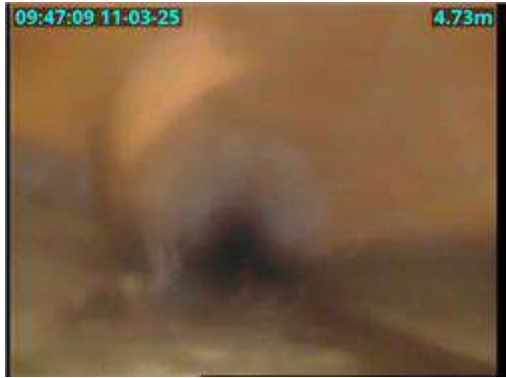
| Pos | Video Ref | Code | Description | Image |
|---|---|---|---|---|
| 04.73m | 0:01:32 | JN | Junction at 02 o'clock: 150mm Diameter | Image Provided - Ref: 7_3<br> |

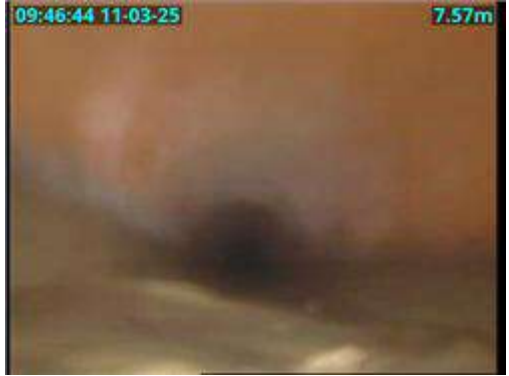
| Pos | Video Ref | Code | Description | Image |
|---|---|---|---|---|
| 07.57m | 0:01:08 | DES | Settled deposits fine: 15% Cross sectional area loss - Severity 3 | <p>Image Provided - Ref: 7_2</p> |

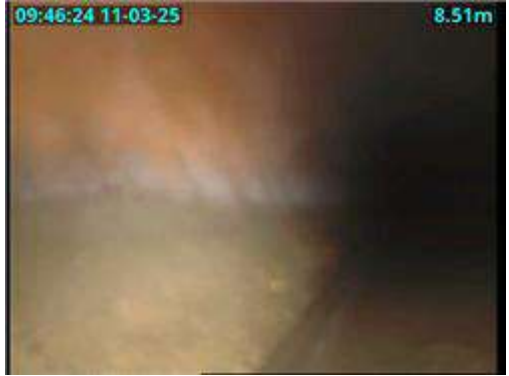
| Pos | Video Ref | Code | Description | Image |
|---|---|---|---|---|
| 08.51m | | SA | Survey abandoned EOT. Loss of leverage. Survey abandoned | <p>Image Provided - Ref: 7_9999</p> |

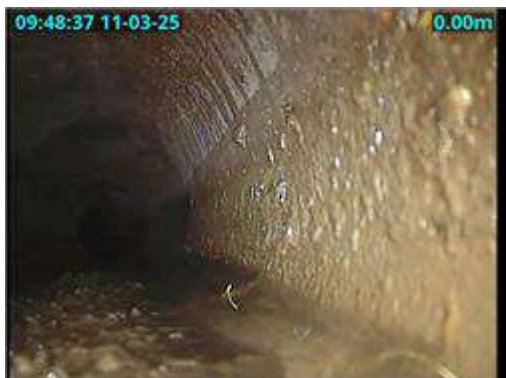
| Pos | Video Ref | Code | Description | Image |
|---|---|---|---|---|
| 00.00m | 0:00:00 | DER | Settled deposits coarse: 5%<br>Cross sectional area loss -<br>Severity 3 | Image Provided - Ref: 8_1<br> |

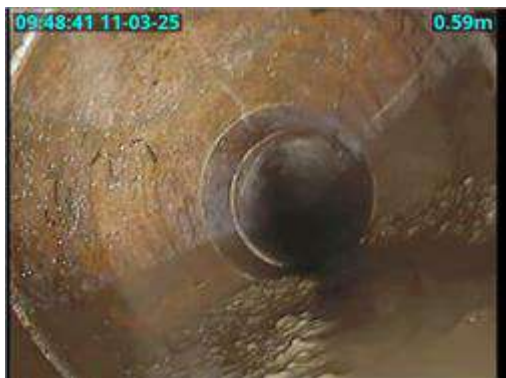
| Pos | Video Ref | Code | Description | Image |
|---|---|---|---|---|
| 00.65m | 0:00:07 | SC | Dimension of drain/sewer<br>changes: 100mm Diameter | Image Provided - Ref: 8_2<br> |

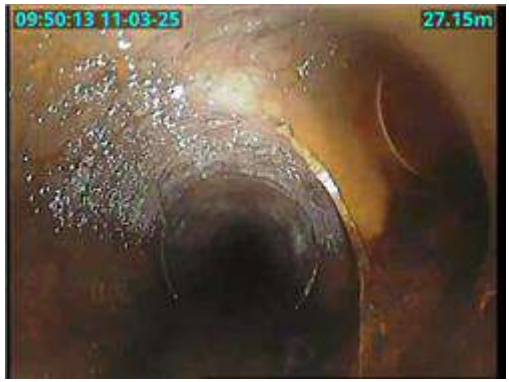
| Pos | Video Ref | Code | Description | Image |
|---|---|---|---|---|
| 27.20m | 0:01:39 | JN | Junction at 02 o'clock: 100mm Diameter | Image Provided - Ref: 8_9<br> |

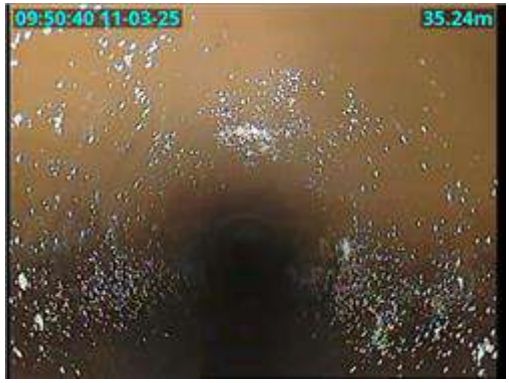
| Pos | Video Ref | Code | Description | Image |
|---|---|---|---|---|
| 33.00m | | SA | Survey abandoned<br>EOT. Loss of leverage.<br>Overlap on R11 | Image Provided - Ref: 8_9999<br> |

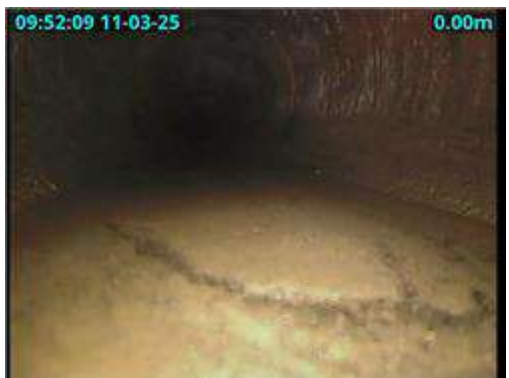
| Pos | Video Ref | Code | Description | Image |
|---|---|---|---|---|
| 00.00m | | S1 WL | Water level 0m - 8.7m: 5% Height/Diameter | <p>Image Provided - Ref: 9_1</p> |

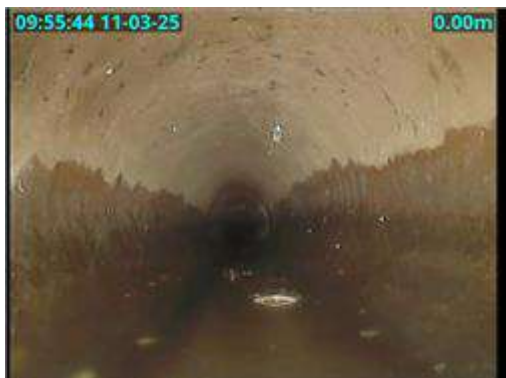
| Pos | Video Ref | Code | Description | Image |
|---|---|---|---|---|
| 00.00m | 0:00:00 | S1 WL | Water level 0m - 11.24m: 5% Height/Diameter | Image Provided - Ref: 10_1<br> |

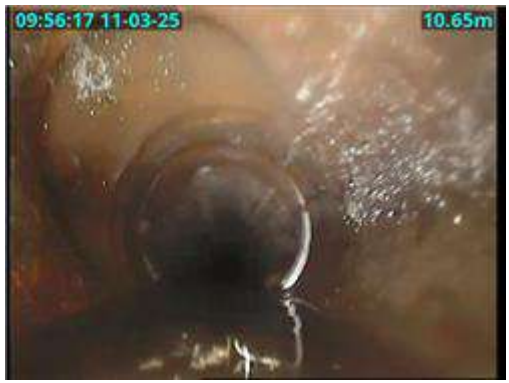
| Pos | Video Ref | Code | Description | Image |
|---|---|---|---|---|
| 10.65m | 0:00:36 | JN | Junction at 11 o'clock: 100mm Diameter | <p>Image Provided - Ref: 10_4</p> |

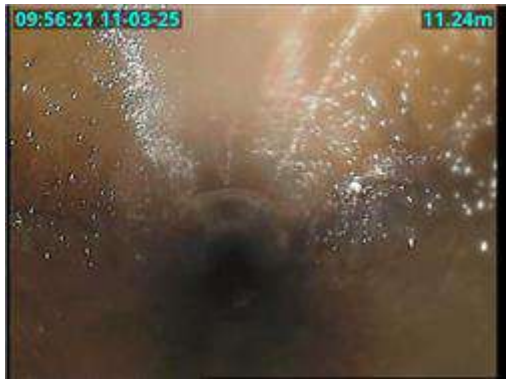
| Pos | Video Ref | Code | Description | Image |
|---|---|---|---|---|
| 11.25m | | SA | Survey abandoned<br>Overlap Met | <p>Image Provided - Ref: 10_9999</p> |

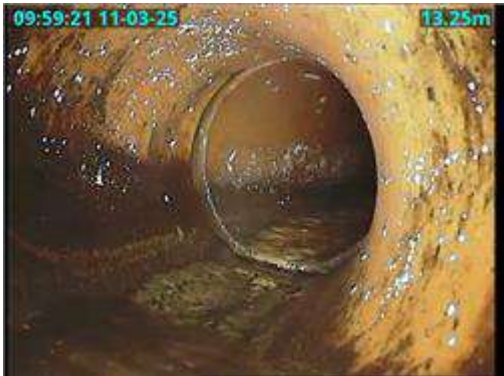
| Pos | Video Ref | Code | Description | Image |
|---|---|---|---|---|
| 13.25m | 0:00:45 | LRQ | Line of drain/sewer deviates right [quarter] | <p>Image Provided - Ref: 11_4</p> |

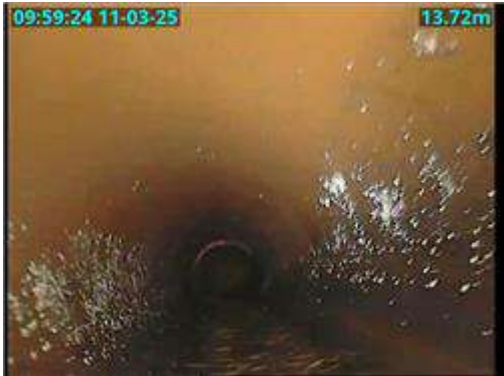
| Pos | Video Ref | Code | Description | Image |
|---|---|---|---|---|
| 13.72m | 0:00:48 | DEE | Attached deposits, encrustation from 04 o'clock to 08 o'clock: 5% Cross sectional area loss - Severity 3 | <p>Image Provided - Ref: 11_5</p> |

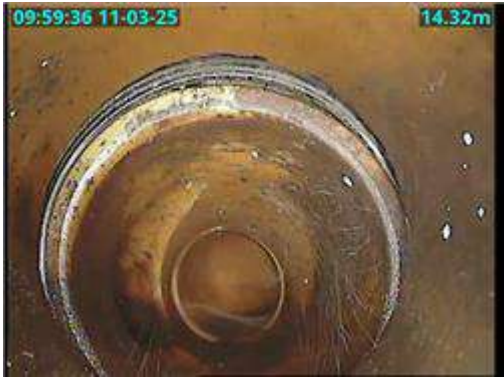
| Pos | Video Ref | Code | Description | Image |
|---|---|---|---|---|
| 14.32m | 0:01:00 | JDM | Joint displaced medium - Severity 3 | <p>Image Provided - Ref: 11_6</p> |

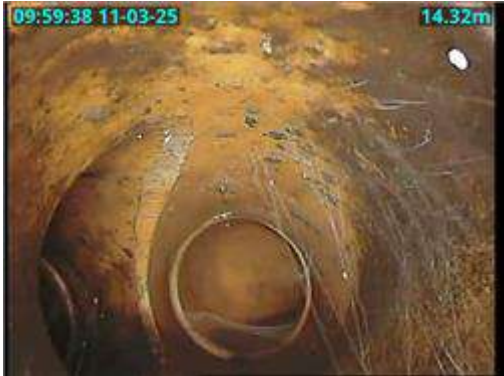
| Pos | Video Ref | Code | Description | Image |
|---|---|---|---|---|
| 14.40m | 0:01:02 | JN | Junction at 09 o'clock: 100mm Diameter | <p>Image Provided - Ref: 11_7</p> |

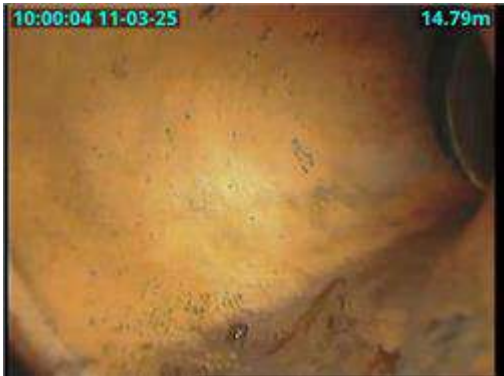
| Pos | Video Ref | Code | Description | Image |
|---|---|---|---|---|
| 14.79m | 0:01:28 | LRQ | Line of drain/sewer deviates right [quarter] | <p>Image Provided - Ref: 11_8</p> |

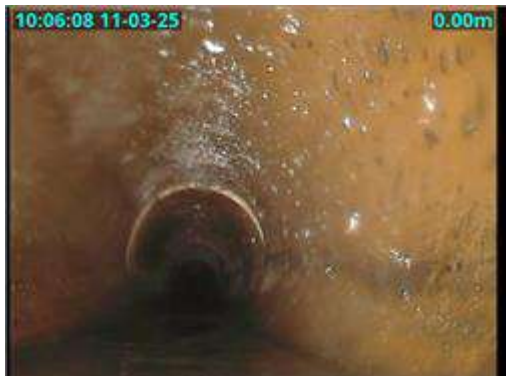
| Pos | Video Ref | Code | Description | Image |
|---|---|---|---|---|
| 00.00m | | S1 WL | Water level 0m - 0m: 5% Height/Diameter | <p>Image Provided - Ref: 12_1</p> |

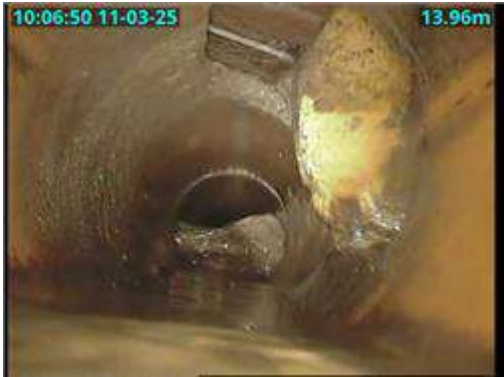
| Pos | Video Ref | Code | Description | Image |
|---|---|---|---|---|
| 13.96m | 0:00:46 | H | Hole in drain/sewer at 12 o'clock - Severity 4 | <p>Image Provided - Ref: 12_6</p> |

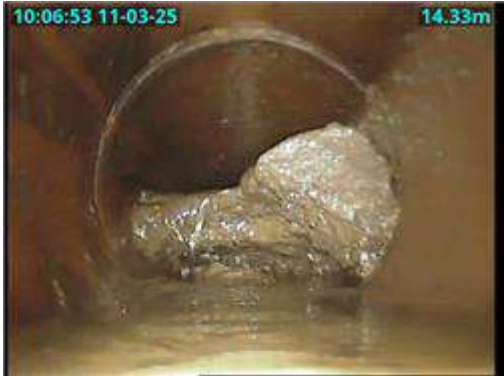
| Pos | Video Ref | Code | Description | Image |
|---|---|---|---|---|
| 13.96m | 0:00:49 | DER | Settled deposits coarse: 35% Cross sectional area loss - Severity 3 | <p>Image Provided - Ref: 12_7</p> |

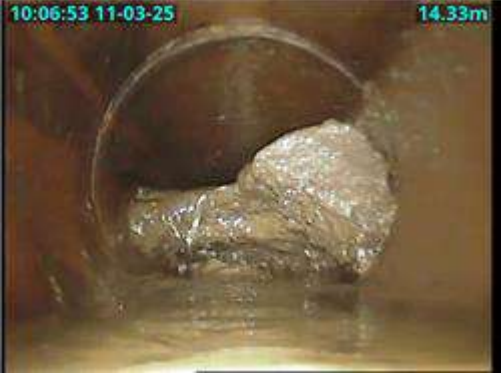
| Pos | Video Ref | Code | Description | Image |
|---|---|---|---|---|
| 14.00m | | SA | Survey abandoned<br>EOT. Unable to camera further | <p>Image Provided - Ref: 12_9999</p> <p>10:06:53 11-03-25 14.33m</p> |

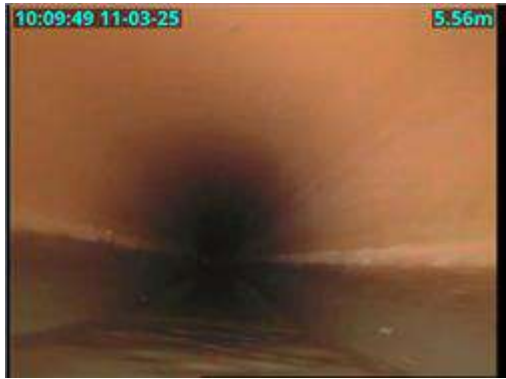
| Pos | Video Ref | Code | Description | Image |
|---|---|---|---|---|
| 05.56m | 0:00:24 | WL | Water level: 10%<br>Height/Diameter | <p>Image Provided - Ref: 13_2</p> |

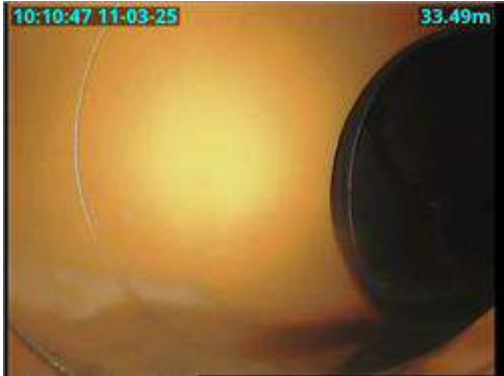
| Pos | Video Ref | Code | Description | Image |
|---|---|---|---|---|
| 33.49m | 0:01:22 | LRQ | Line of drain/sewer deviates right [quarter] | <p>Image Provided - Ref: 13_7</p> |

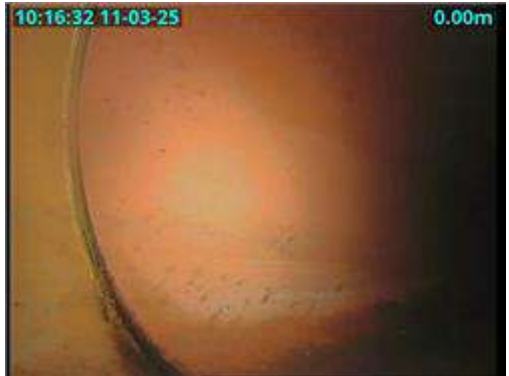
| Pos | Video Ref | Code | Description | Image |
|---|---|---|---|---|
| 00.00m | 0:00:00 | LRQ | Line of drain/sewer deviates right [quarter] | <p>Image Provided - Ref: 14_1</p> |

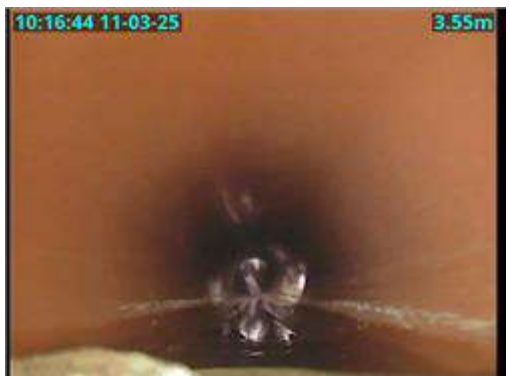
| Pos | Video Ref | Code | Description | Image |
|---|---|---|---|---|
| 03.55m | 0:00:16 | S1 WL | Water level 3.55m - 6.62m: 5% Height/Diameter | <p>Image Provided - Ref: 14_3</p> |

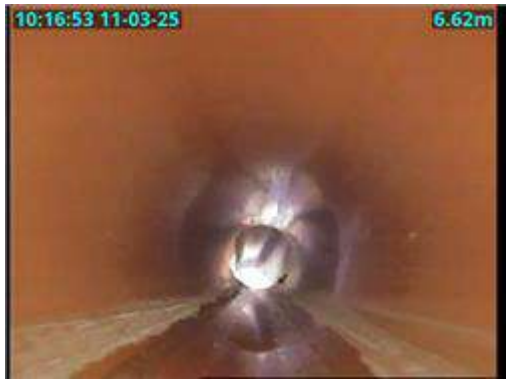
| Pos | Video Ref | Code | Description | Image |
|---|---|---|---|---|
| 06.62m | 0:00:24 | LUQ | Line of drain/sewer deviates up [quarter] | <p>Image Provided - Ref: 14_5</p> <p>10:16:53 11-03-25 6.62m</p> |

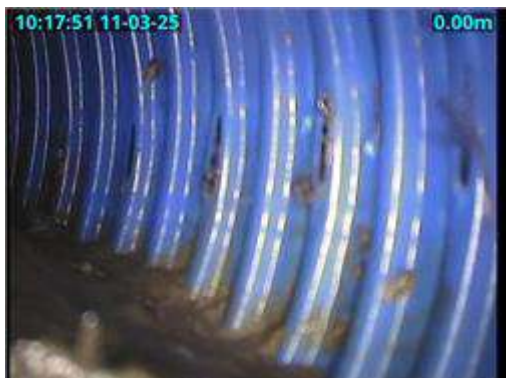
| Pos | Video Ref | Code | Description | Image |
|---|---|---|---|---|
| 00.00m | 0:00:00 | LLH | Line of drain/sewer deviates left [half] | <p>Image Provided - Ref: 15_1</p> |

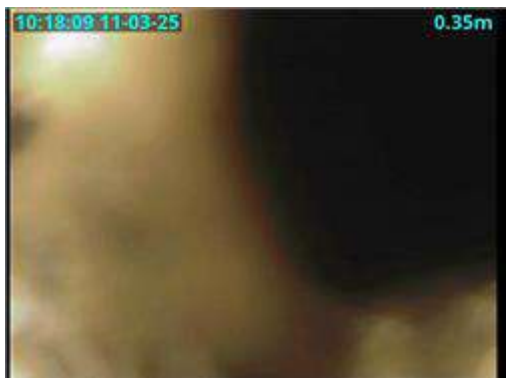
| Pos | Video Ref | Code | Description | Image |
|---|---|---|---|---|
| 00.00m | | SA | Survey abandoned EOT. Unable to camera further. Survey abandoned | <p>Image Provided - Ref: 15_9999</p> |

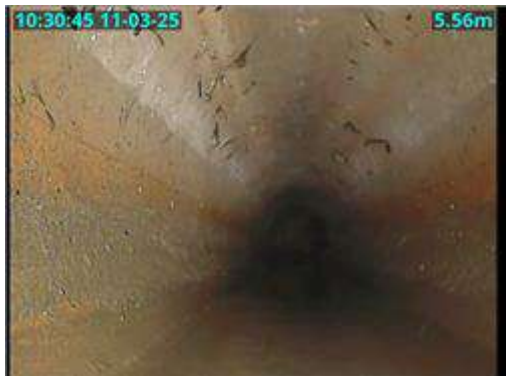
| Pos | Video Ref | Code | Description | Image |
|---|---|---|---|---|
| 05.56m | 0:00:21 | S1 WL | Water level 5.56m - 7.6m: 10% Height/Diameter | <p>Image Provided - Ref: 16_2</p> |

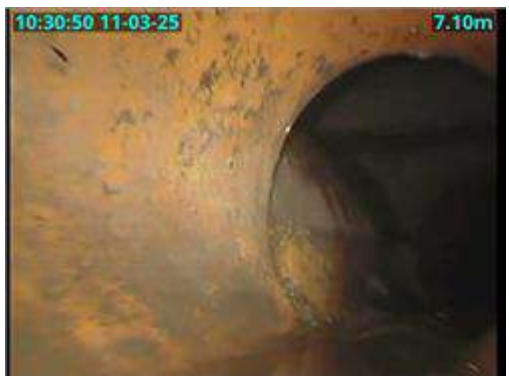
| Pos | Video Ref | Code | Description | Image |
|---|---|---|---|---|
| 07.10m | 0:00:26 | LRQ | Line of drain/sewer deviates right [quarter] | <p>Image Provided - Ref: 16_3</p> |

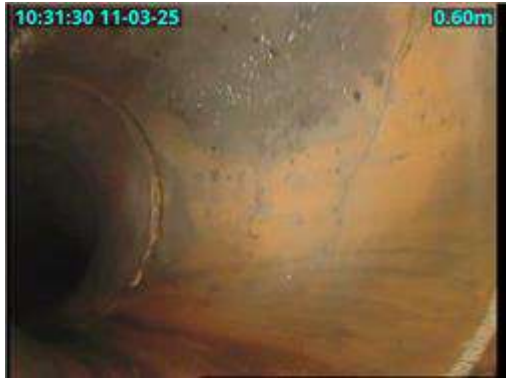
| Pos | Video Ref | Code | Description | Image |
|---|---|---|---|---|
| 00.60m | | LLQ | Line of drain/sewer deviates left [quarter] | <p>Image Provided - Ref: 17_1</p> |

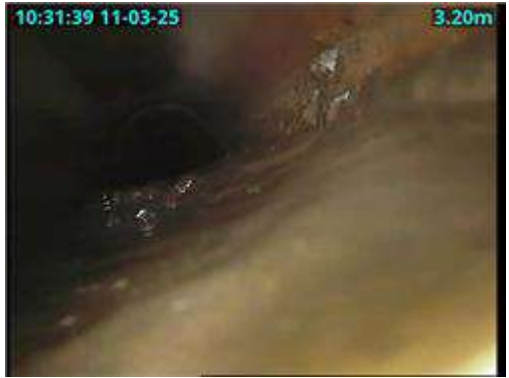
| Pos | Video Ref | Code | Description | Image |
|---|---|---|---|---|
| 03.20m | 0:00:16 | S1 WL | Water level 3.2m - 17.3m: 20%<br>Height/Diameter | <p>Image Provided - Ref: 17_3</p> |

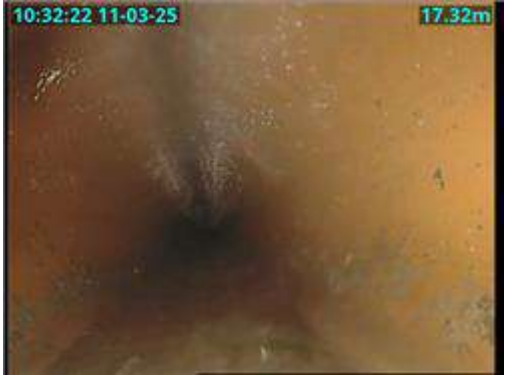
| Pos | Video Ref | Code | Description | Image |
|---|---|---|---|---|
| 17.32m | | SA | Survey abandoned EOT. Unable to camera further. | <p>Image Provided - Ref: 17_9999</p> |

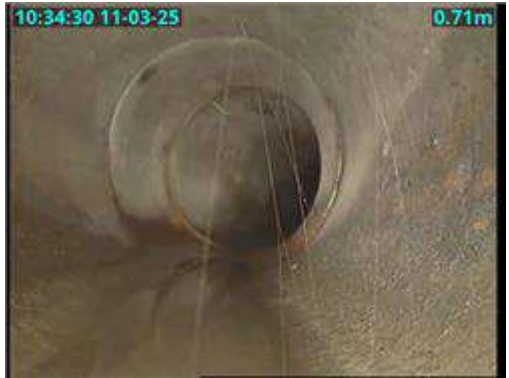
| Pos | Video Ref | Code | Description | Image |
|---|---|---|---|---|
| 00.80m | | LRQ | Line of drain/sewer deviates right [quarter] | <p>Image Provided - Ref: 18_1</p> |

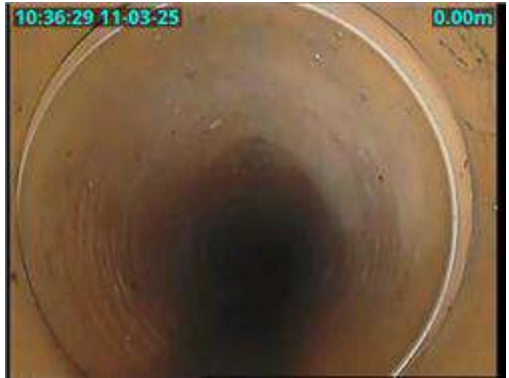
| Pos | Video Ref | Code | Description | Image |
|---|---|---|---|---|
| 00.00m | | JDM | Joint displaced medium - Severity 3 | <p>Image Provided - Ref: 19_1</p> |

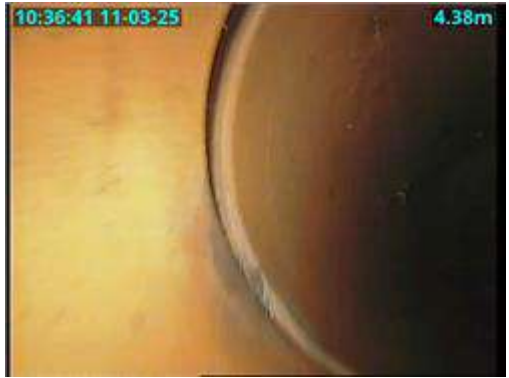
| Pos | Video Ref | Code | Description | Image |
|---|---|---|---|---|
| 04.38m | 0:00:17 | LRH | Line of drain/sewer deviates right [half] | <p>Image Provided - Ref: 19_3</p> |

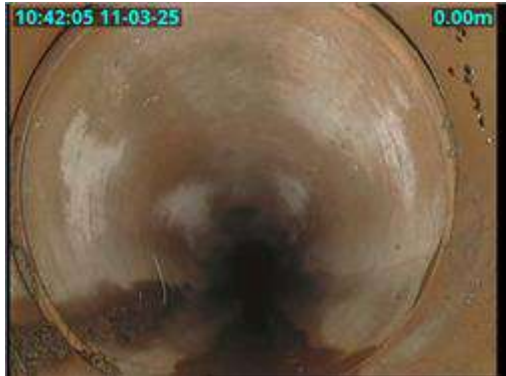
| Pos | Video Ref | Code | Description | Image |
|---|---|---|---|---|
| 00.00m | | JDM | Joint displaced medium - Severity 3 | <p>Image Provided - Ref: 20_1</p> |

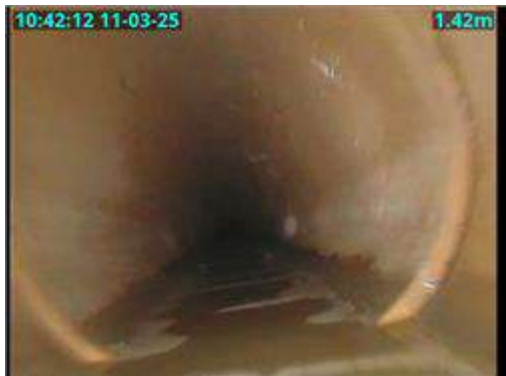
| Pos | Video Ref | Code | Description | Image |
|---|---|---|---|---|
| 01.42m | 0:00:10 | S1 WL | Water level 1.42m - 9.82m: 10% Height/Diameter | <p>Image Provided - Ref: 20_2</p> |

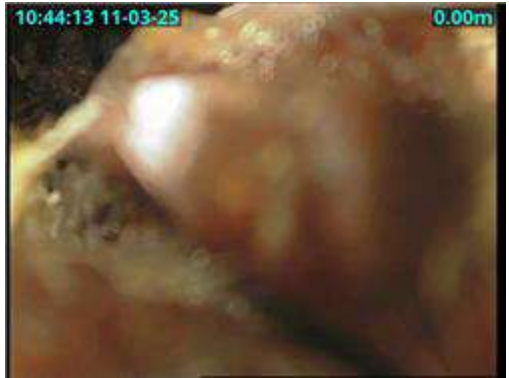
| Pos | Video Ref | Code | Description | Image |
|---|---|---|---|---|
| 00.00m | 0:00:03 | DES | Settled deposits fine: 20% Cross sectional area loss - Severity 3 | <p>Image Provided - Ref: 21_2</p> |

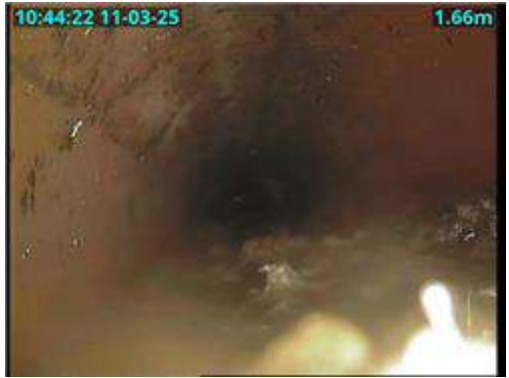
| Pos | Video Ref | Code | Description | Image |
|---|---|---|---|---|
| 01.70m | | SA | Survey abandoned EOT. Unable to camera further. Survey abandoned | <p>Image Provided - Ref: 21_9999</p> |

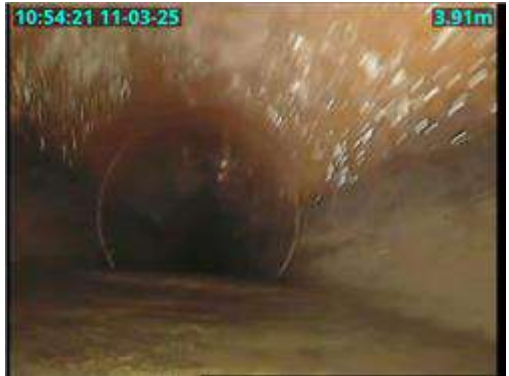
| Pos | Video Ref | Code | Description | Image |
|---|---|---|---|---|
| 03.91m | 0:00:13 | S1 WL | Water level 3.91m - 34.24m:<br>10% Height/Diameter | <p>Image Provided - Ref: 23_2</p> |

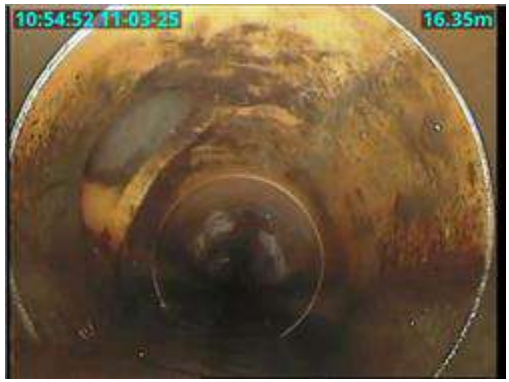
| Pos | Video Ref | Code | Description | Image |
|---|---|---|---|---|
| 16.35m | 0:00:44 | JN | Junction at 10 o'clock: 100mm Diameter | Image Provided - Ref: 23_5<br> |

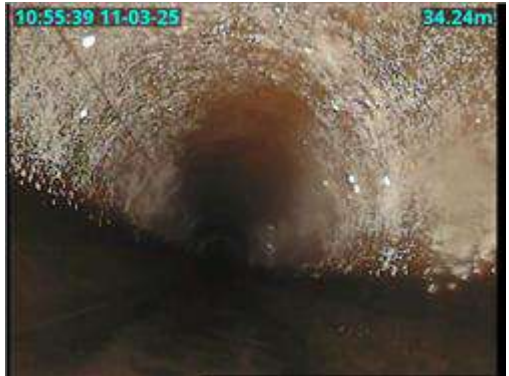
| Pos | Video Ref | Code | Description | Image |
|---|---|---|---|---|
| 34.24m | | SA | Survey abandoned EOT. Loss of leverage. Survey abandoned | <p>Image Provided - Ref: 23_9999</p> |

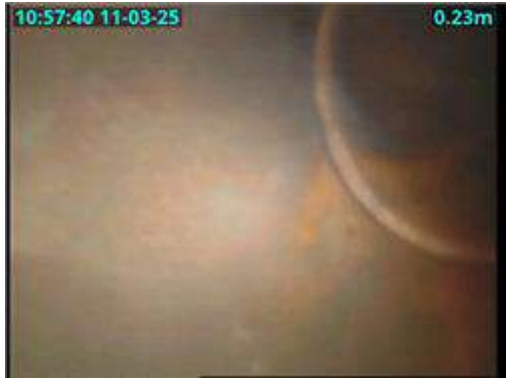
| Pos | Video Ref | Code | Description | Image |
|---|---|---|---|---|
| 00.23m | | LRH | Line of drain/sewer deviates right [half] | <p>Image Provided - Ref: 24_1</p> |

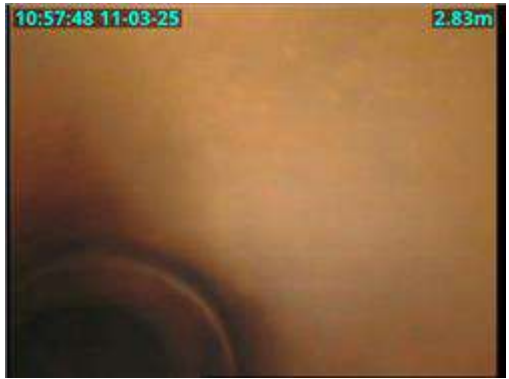
| Pos | Video Ref | Code | Description | Image |
|---|---|---|---|---|
| 02.83m | 0:00:15 | LLQ | Line of drain/sewer deviates left [quarter] | <p>Image Provided - Ref: 24_2</p> |

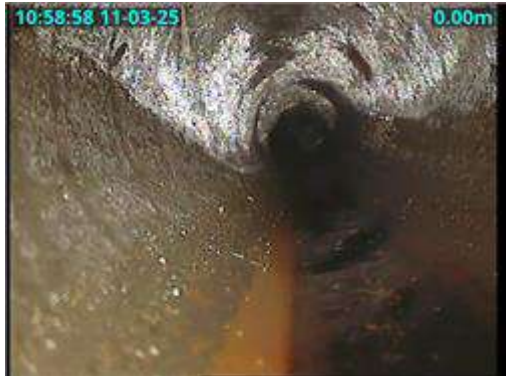
| Pos | Video Ref | Code | Description | Image |
|---|---|---|---|---|
| 00.00m | 0:00:00 | S1 WL | Water level 0m - 5.92m: 5% Height/Diameter | <p>Image Provided - Ref: 25_1</p> |

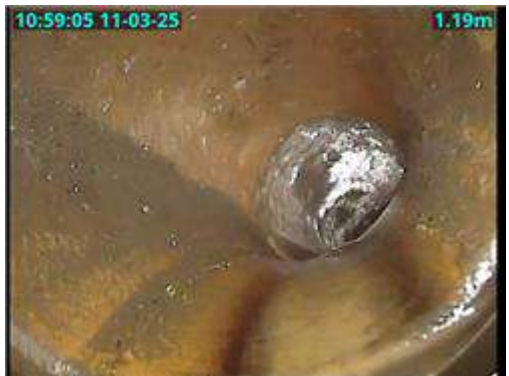
| Pos | Video Ref | Code | Description | Image |
|---|---|---|---|---|
| 01.19m | 0:00:10 | LRQ | Line of drain/sewer deviates right [quarter] | <p>Image Provided - Ref: 25_2</p> |

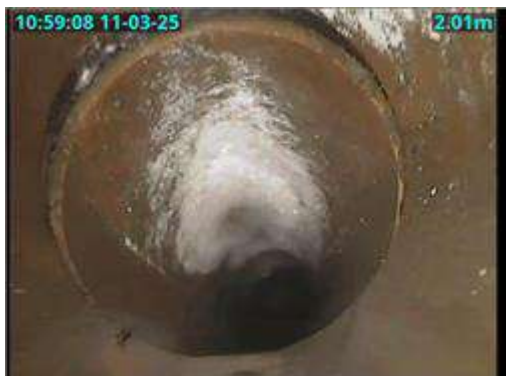
| Pos | Video Ref | Code | Description | Image |
|---|---|---|---|---|
| 02.01m | 0:00:13 | JDM | Joint displaced medium - Severity 3 | <p>Image Provided - Ref: 25_3</p> |

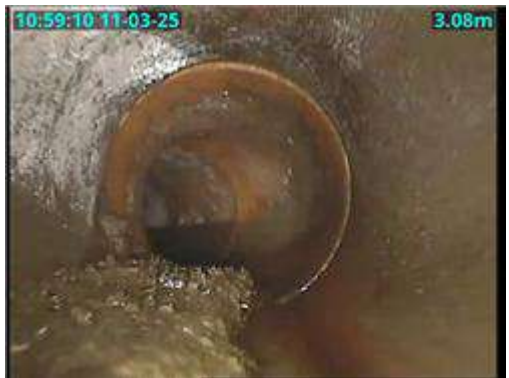
| Pos | Video Ref | Code | Description | Image |
|---|---|---|---|---|
| 03.08m | 0:00:15 | DES | Settled deposits fine: 10%<br>Cross sectional area loss -<br>Severity 3 | Image Provided - Ref: 25_4<br> |

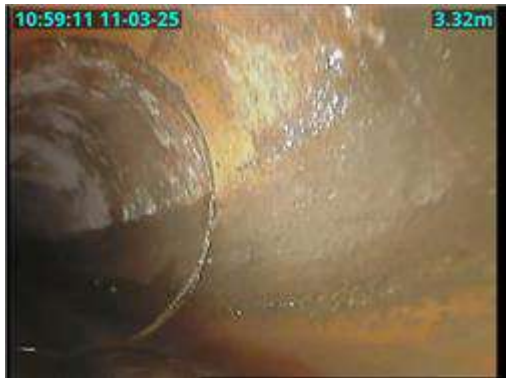
| Pos | Video Ref | Code | Description | Image |
|---|---|---|---|---|
| 03.32m | 0:00:16 | LLQ | Line of drain/sewer deviates<br>left [quarter] | Image Provided - Ref: 25_5<br> |
