**ENGINEERING REPORT 9179**

**ROBINSONS EQUESTRIAN CENTRE  
HARWOOD FIELD FARM  
CASTLE HILL ROAD  
BURY  
BL9 6UL**

**CLIENT: STEPHEN ROBINSON**

**24.11.2023 MP/CH**

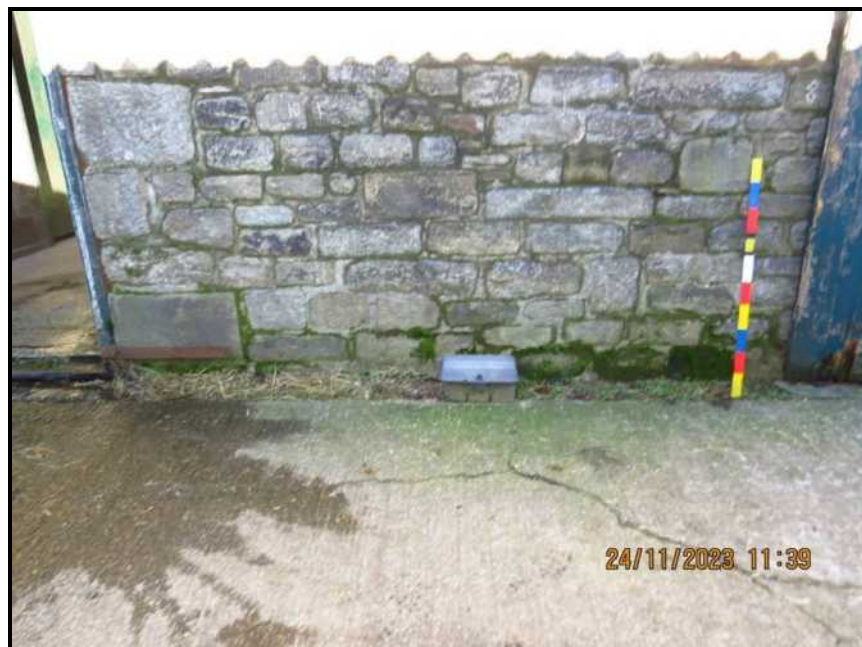
**Photograph 032 Plinth wall, chainage 10 – 7 metres**

- 3.5 The vertical alignment of the right hand door reveal (chainage 1.5 metres) is satisfactory. (Photograph 038).
- 3.6 The sliding door covers the main wall section between chainage 4 – 5 metres but overall vertical profile on either side of the doorway is satisfactory with good vertical alignment and satisfactory horizontal coursing. (Photographs 036, 037).
- 3.7 The adjoining stone panel (chainage 8 – 10 metres) is well pointing with satisfactory vertical alignment. (Photographs 032, 033, 034, 035).

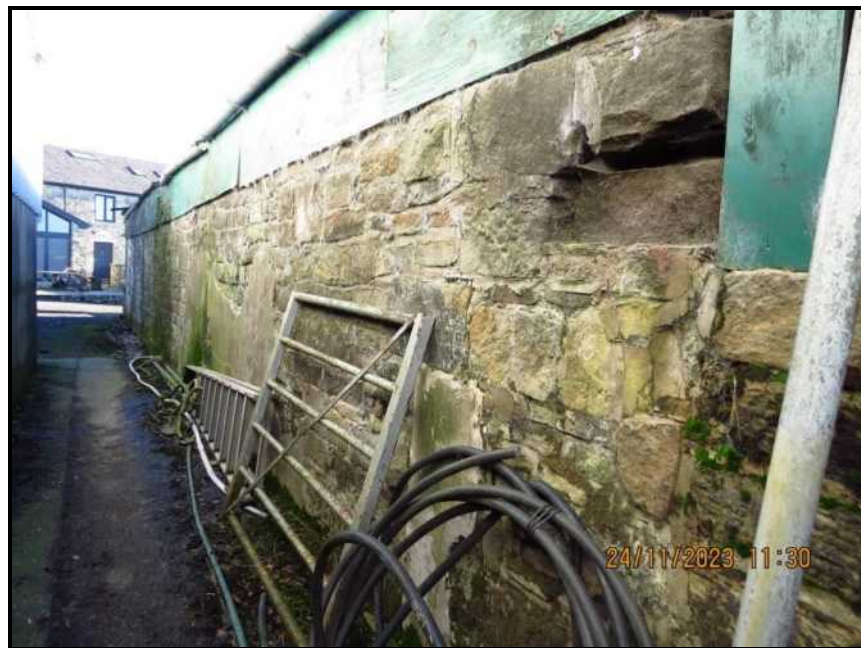
**Photograph 020 Rear elevation looking South East**

- 5.1 The North Eastern elevation extends for a length in the order of 15 metres in regular stone course of solid wall construction, a height in the order of 3 – 3.2 metres. (Photographs 012, 013, 014, 020).

- 5.3 The vertical alignment at chainage 7 metres is good with irregularities in the order of 7mm per metre.
- 5.4 The rear wall terminates with a vertical joint between the North Eastern section and the North Western section. (Photographs 019, 020).
- 5.5 Between chainage 8 – 12 metres the wall is completed with a 25mm rendered panel extending for a height between 1 – 1.2 metres and the rendering is generally in a satisfactory sound condition with good vertical alignment. (Photographs 015, 017, 018).

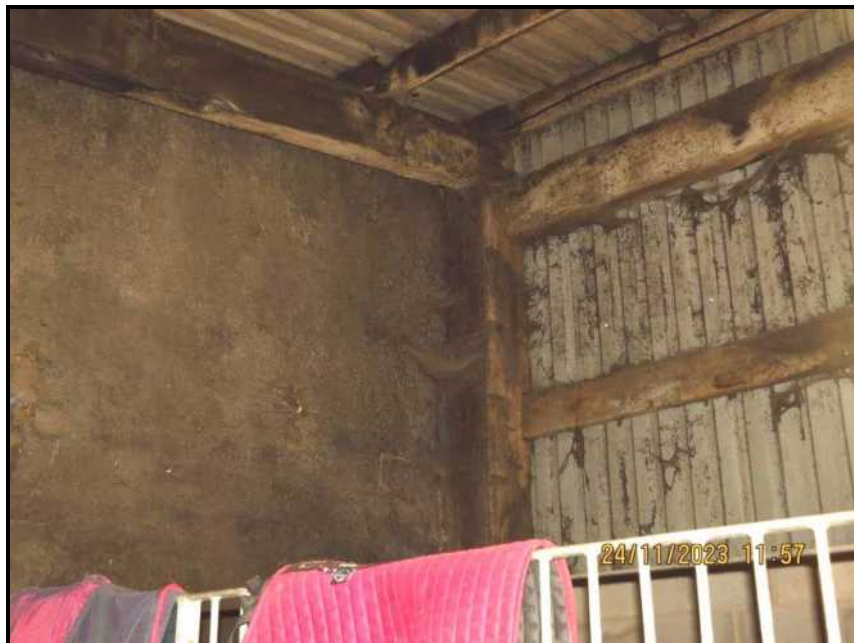
**Photograph 093 Outside of West wall**

- 6.1 The North Western half gabled wall currently acts as an internal party wall between stable units 1 and 2 to the East, and stable units 5 to 4 in the Western section (to be demolished).
- 6.2 The inspection of the Western outside face of the proposed gable elevation is limited with the existing usage (limited access).
- 6.3 The stone wall is completed with a flat cement render supporting the lateral purlin members, spanning from East to West towards the front elevation. (Photographs 093, 094 and photograph 090 towards the rear elevation).

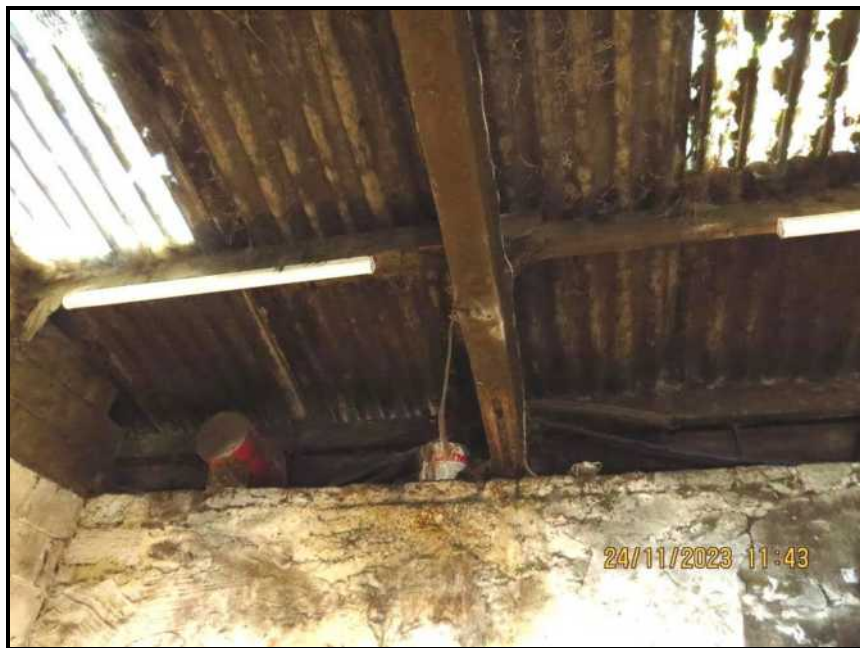
**Photograph 042 Rear wall rafter beam**

- 7.2 Stable No. 1 is sub-divided into three stalls adjoining the internal cross wall and the inside face of the Western half gable wall is completed with a random render finish. The render finish follows a satisfactory vertical profile, the wall supporting 400mm x 150mm rafters at wall plate level spanning from the rear elevation to the front elevation. The Eastern gable wall supports the lateral purlins spanning from East to West. (Photographs 040, 041, 042).

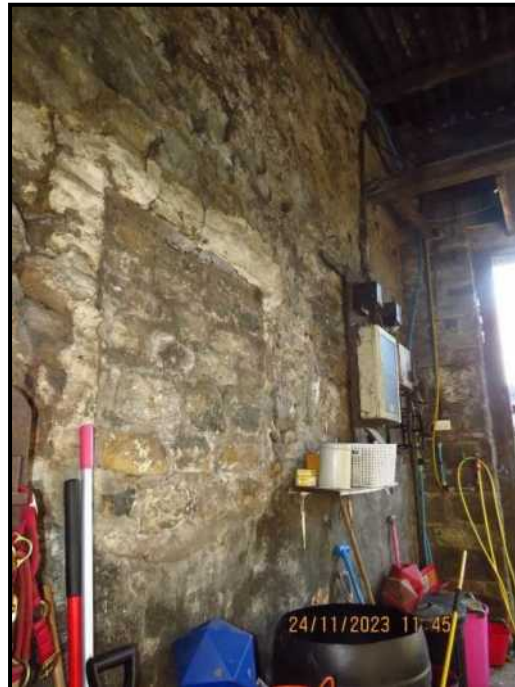
- 7.4 On the inside face of the gable elevation the infilled window opening as identified externally can be traced in the wall finishes with no evidence of any recent movement. (Photographs 053, 054, 055).

**Photograph 053 Former window, internal corner South/East**

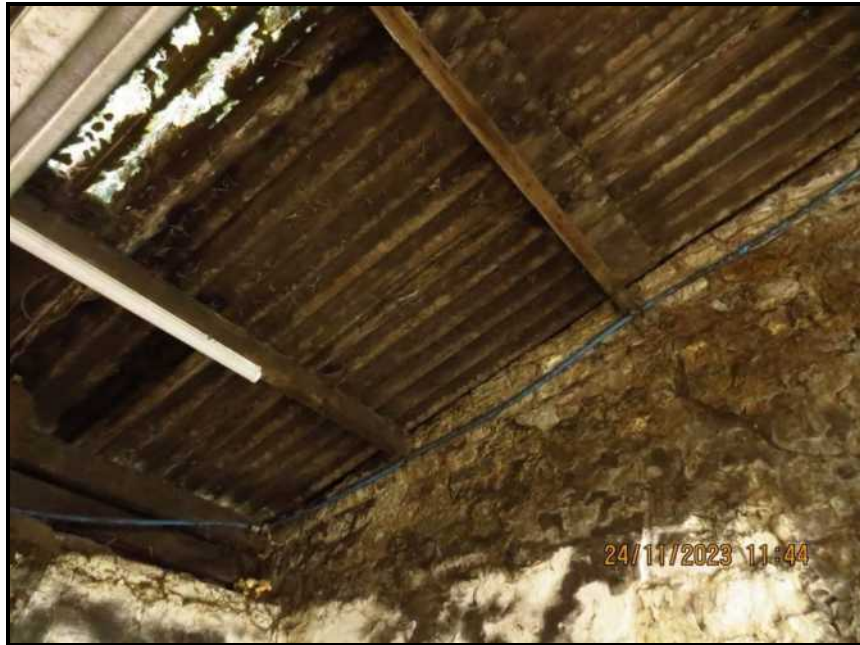
- 7.5 There are no signs of any separation where the purlins seat into the gable wall. (Photographs 045, 047, 50, 051).

(Photograph 045 Purlin seating Eastern gable

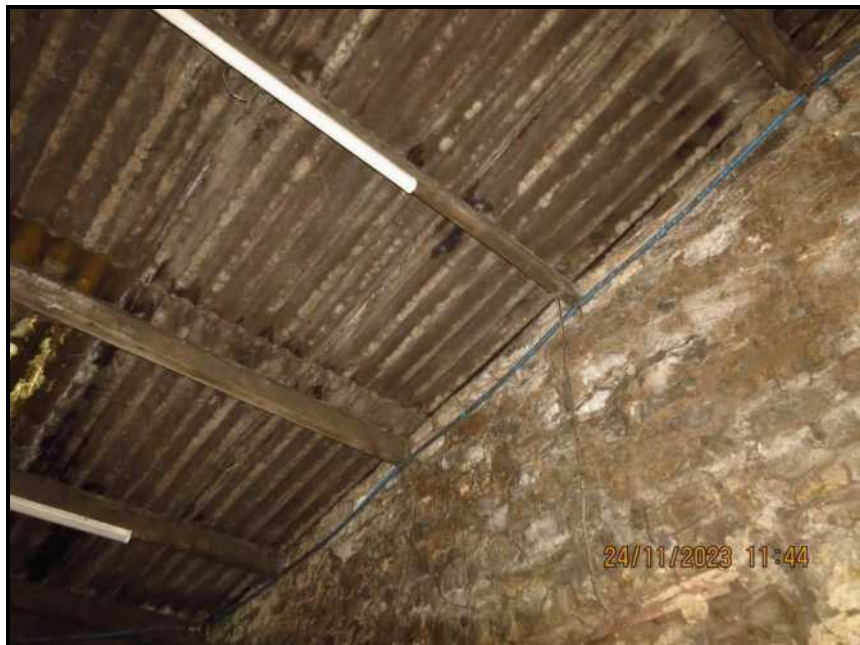
Photograph 050 Eastern gable roof support

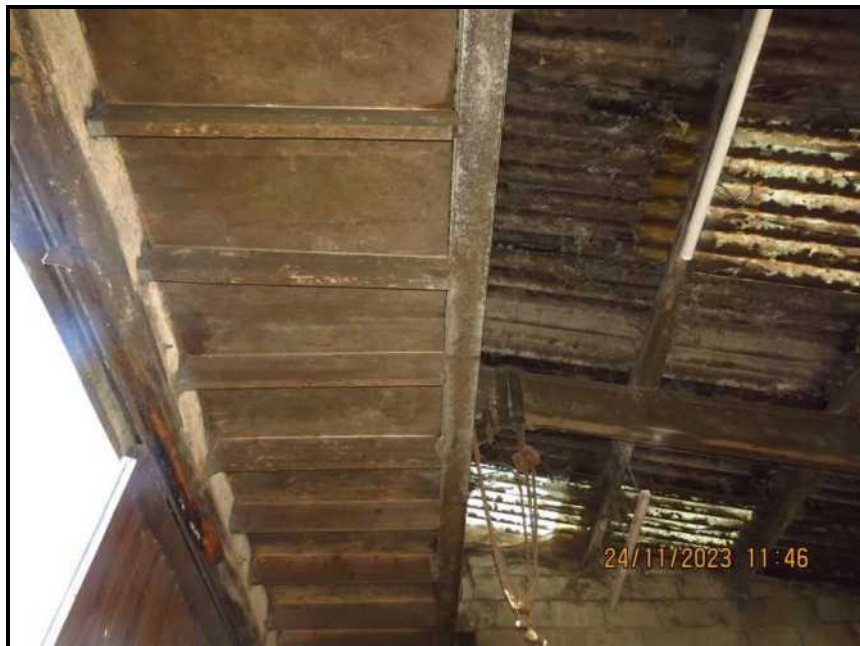
**Photograph 056 Front elevation supporting timber detail**

- 7.6 In the front stall the roof incorporates 300mm x 150mm joists spanning longitudinally onto a blockwork seating.
- 7.7 The vertical and horizontal alignment of the internal cross wall is good and the blockwork and pointing in very good condition.
- 7.8 Parallel to the front wall there are suspended beams supporting a timber platform between the gable and the internal cross wall. (Photographs 056, 057, 058).

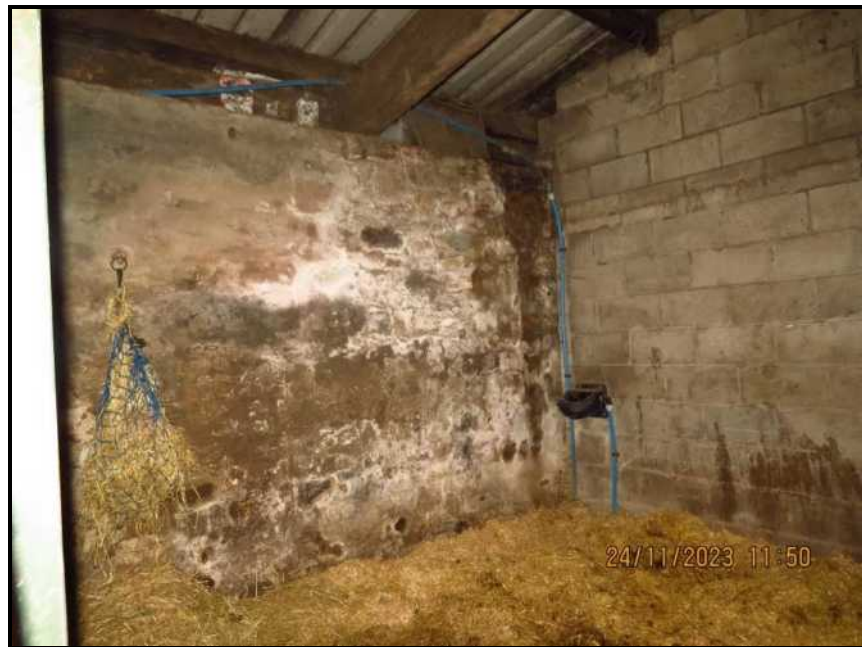
**Photograph 072 Rear wall and party wall North East corner**

- 7.10 Stable No. 2 incorporates two Tack Rooms with limited access to the rear walls. (Photographs 070, 071).
- 7.11 The rear wall of the original building is finished with a weathered and stained render finish, with a reasonable vertical alignment, with the internal party wall completed in satisfactory blockwork.
- 7.12 There are no signs of any separation where the blockwork cross wall adjoins the original rear and front elevations. (Photographs 072, 073, 074).

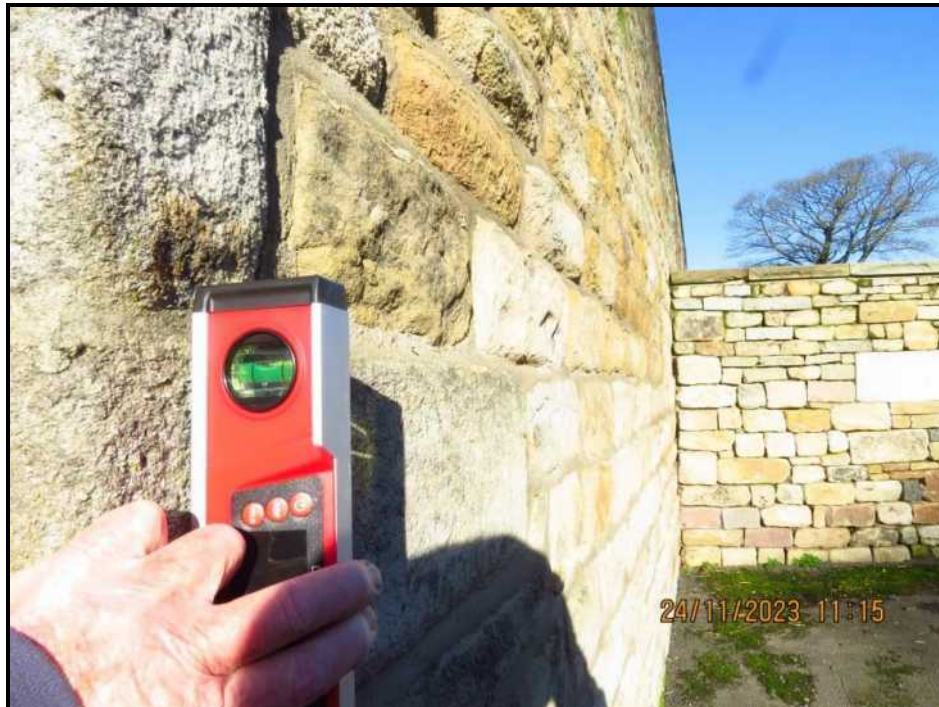
003 Satisfactory vertical alignment

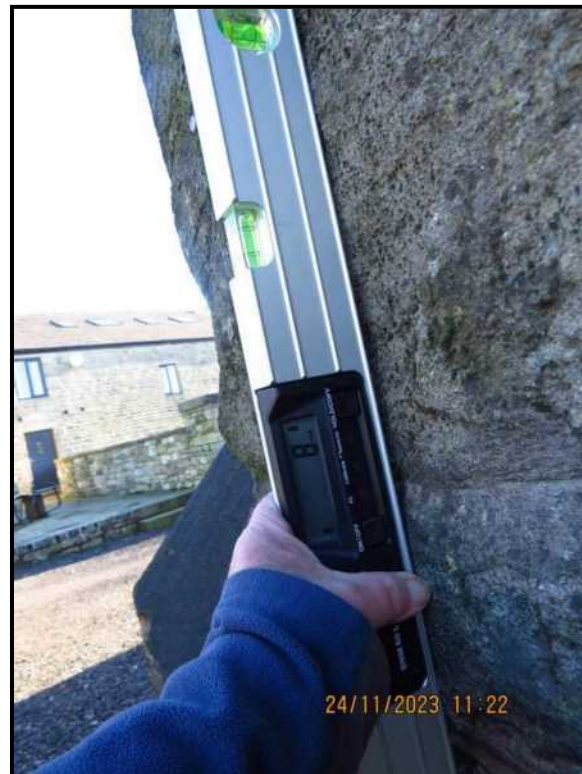
- 5.2 At chainage 0.5 metres the vertical alignment is in the order of 8mm per metre with a 7mm per metre at chainage 4 metres. (Photographs 010, 011).

010 Good vertical alignment 8mm per metre

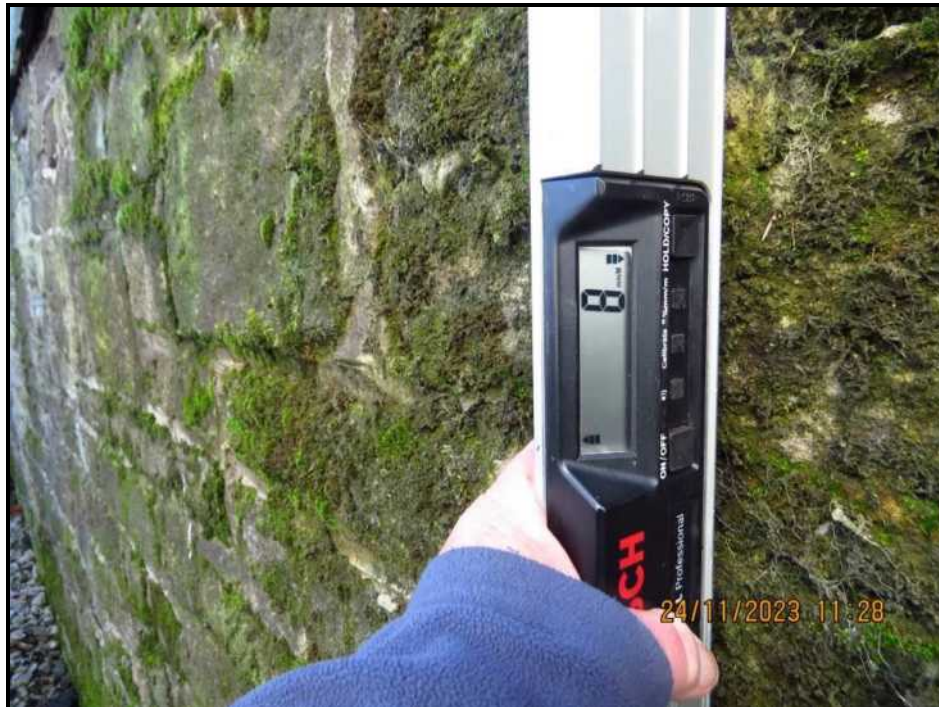
016 Satisfactory vertical alignment, chainage 12 metres

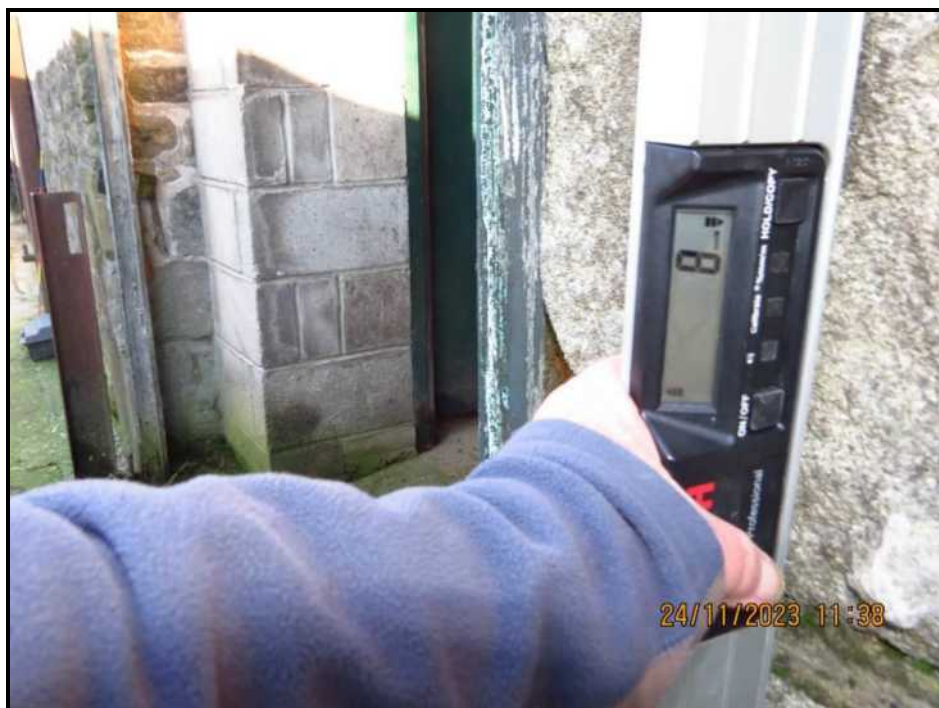
031 Good vertical alignment

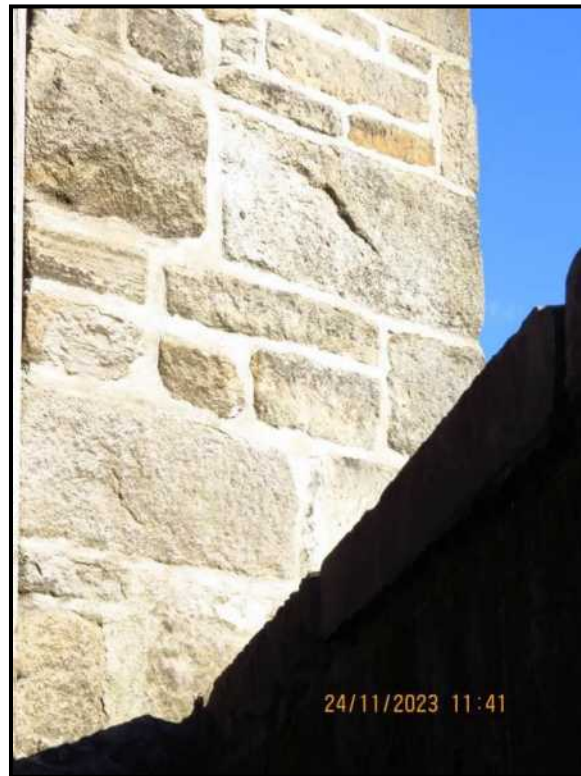
039 South Eastern corner, chainage 1.2 – 0 metres

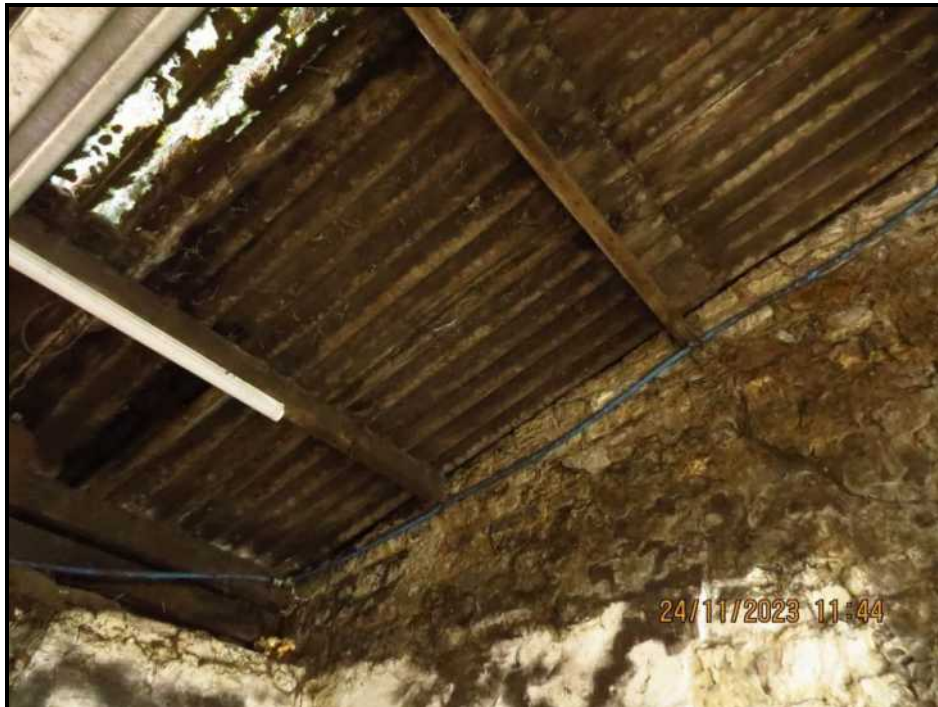
045 Purlin seating, Eastern gable

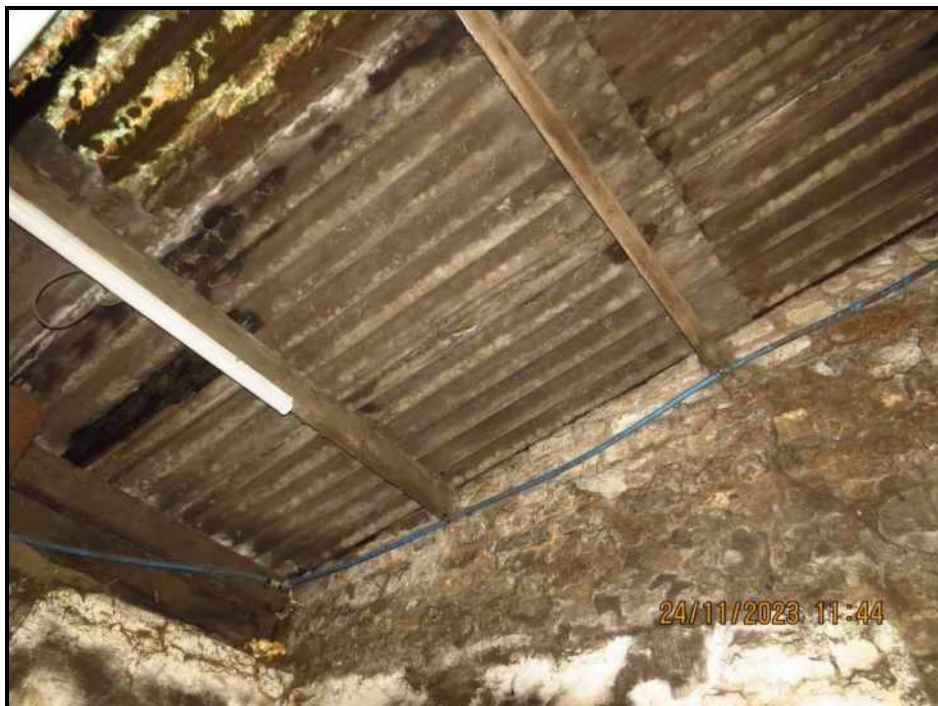
049 Eastern gable, roof support

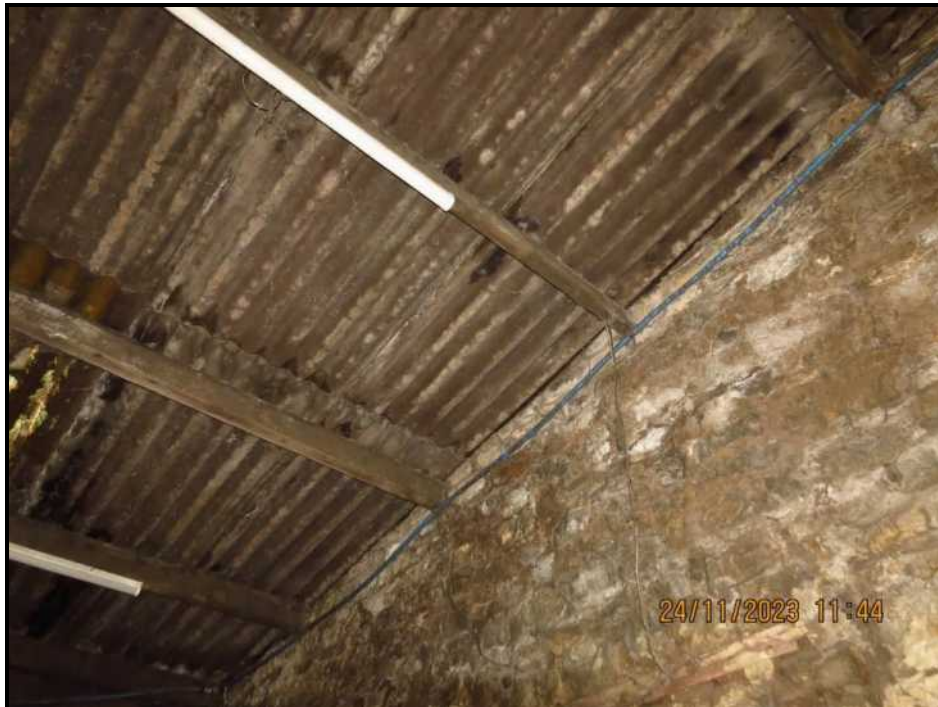
050 Eastern gable, roof support

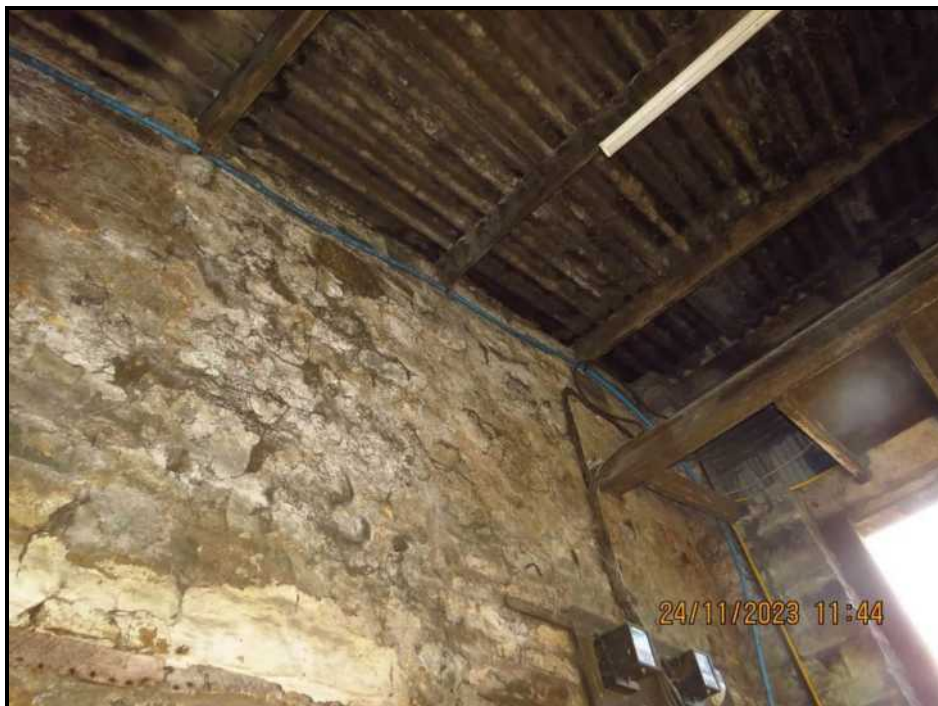
051 Eastern gable, front corner

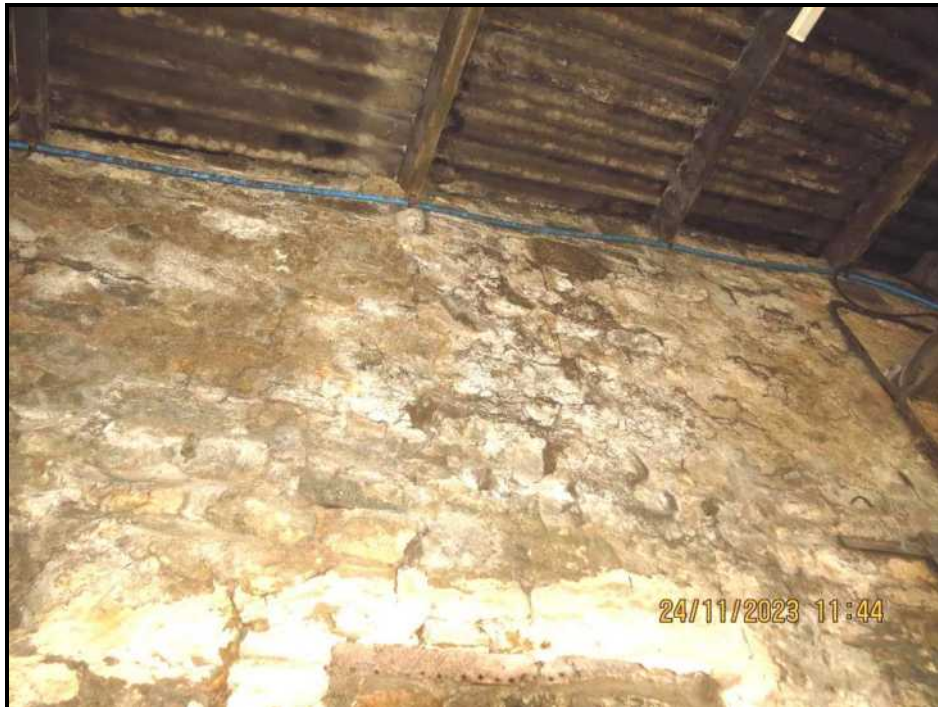
052 Upper wall, East

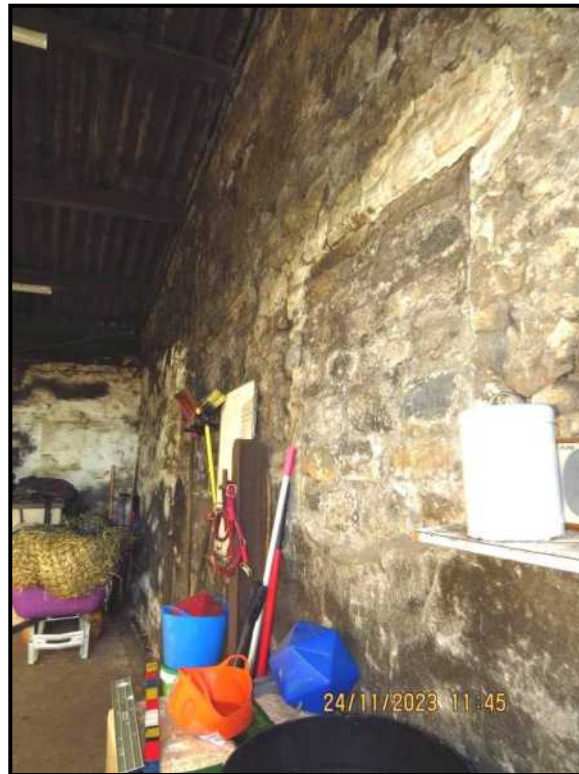
054 Gable elevation looking to rear

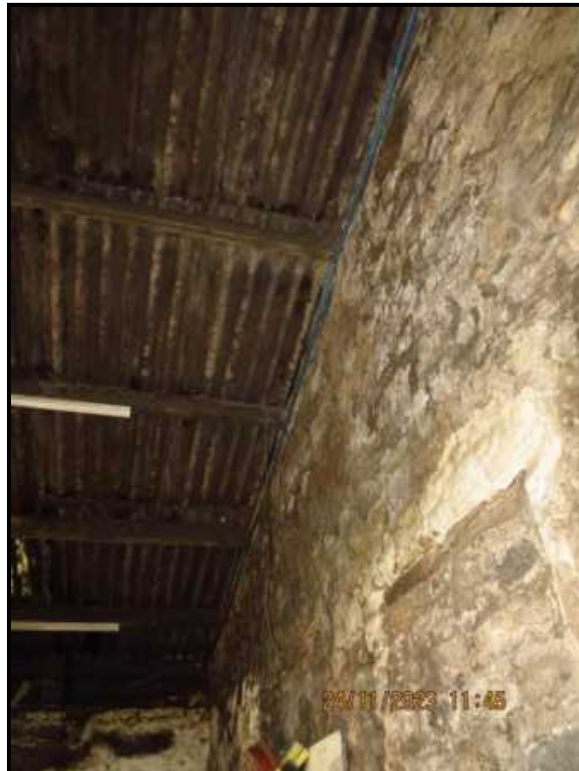
055 Gable elevation looking to rear

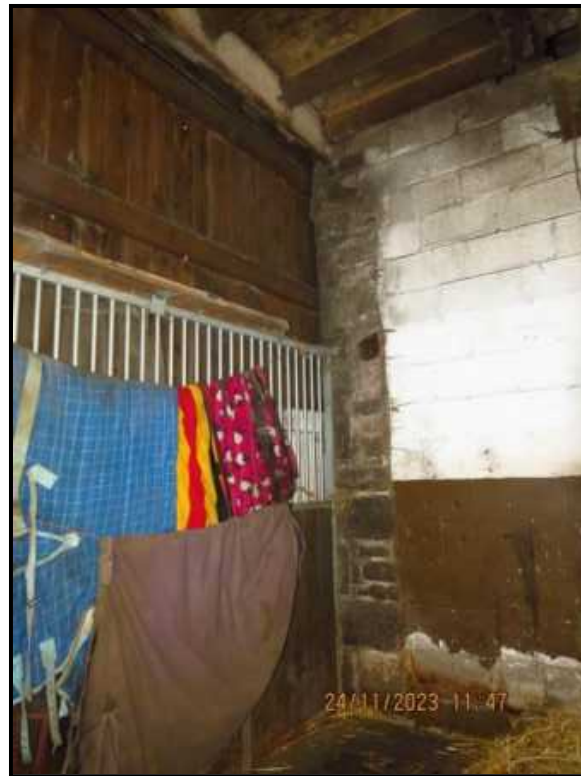
058 Front elevation and internal cross wall

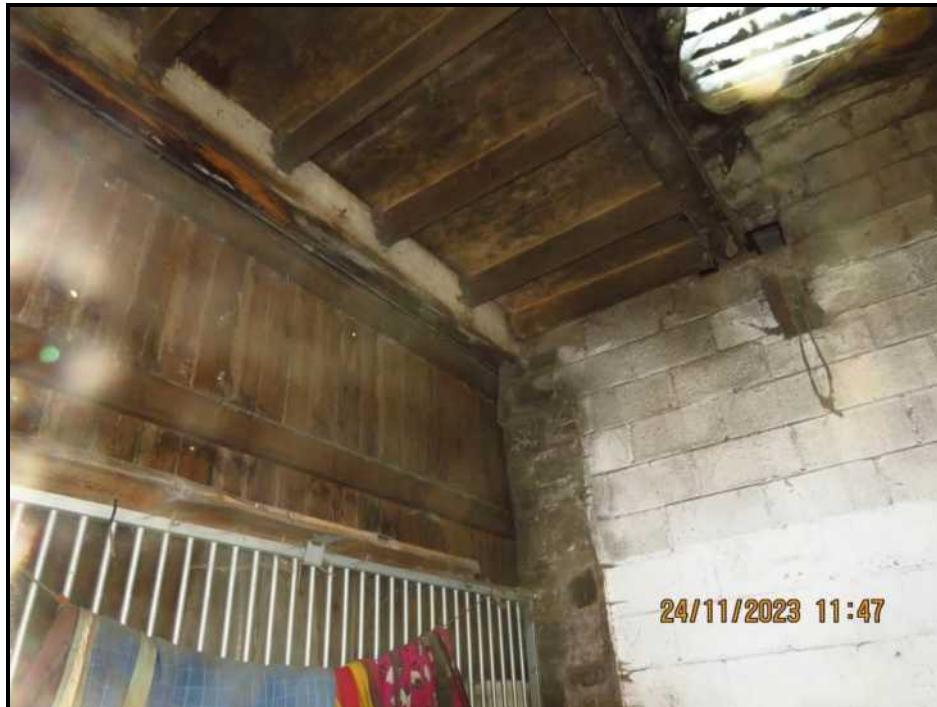
060 Front elevation, upper roof and cross wall

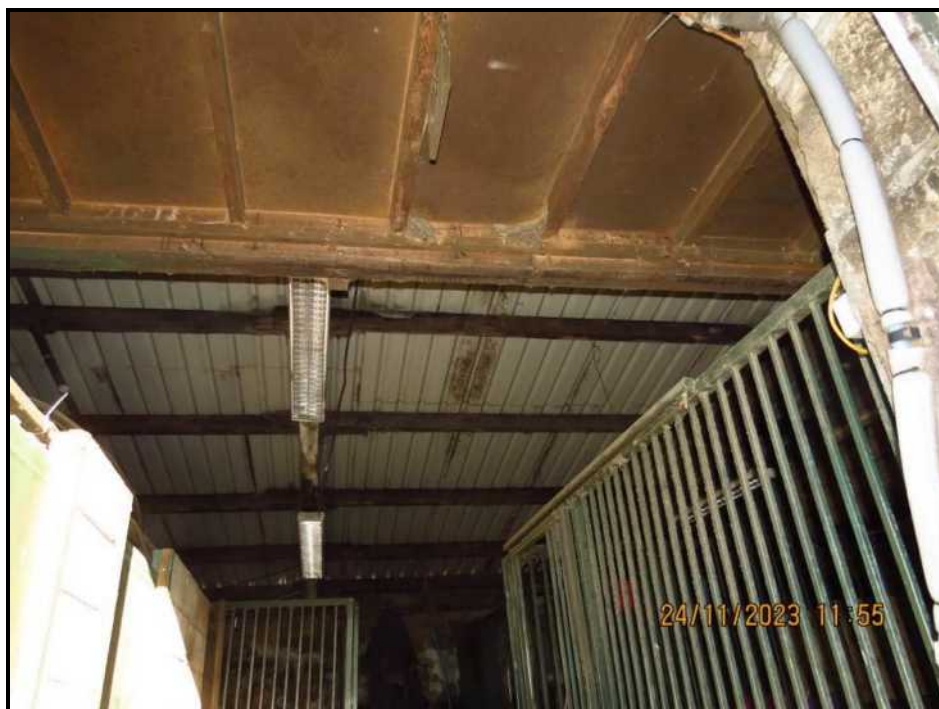
088 Roof, front elevation

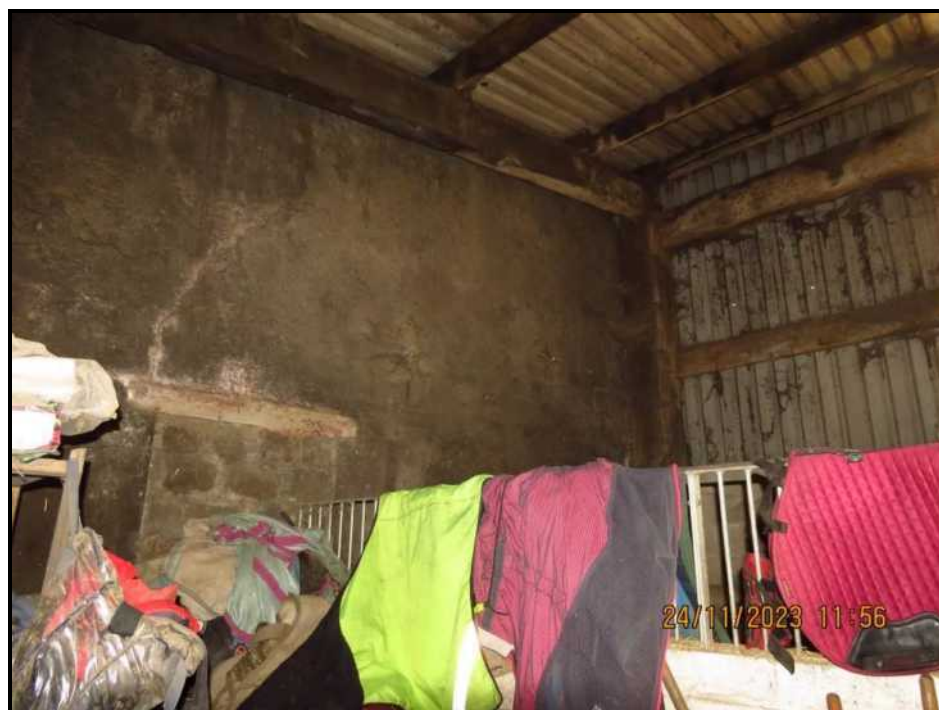
092 'Outside' of Western wall
