Preliminary Roost Assessment and Ecological Walkover

The Farmhouse, Littleborough

Reference: 81-315-R1-1

Date: June 2023

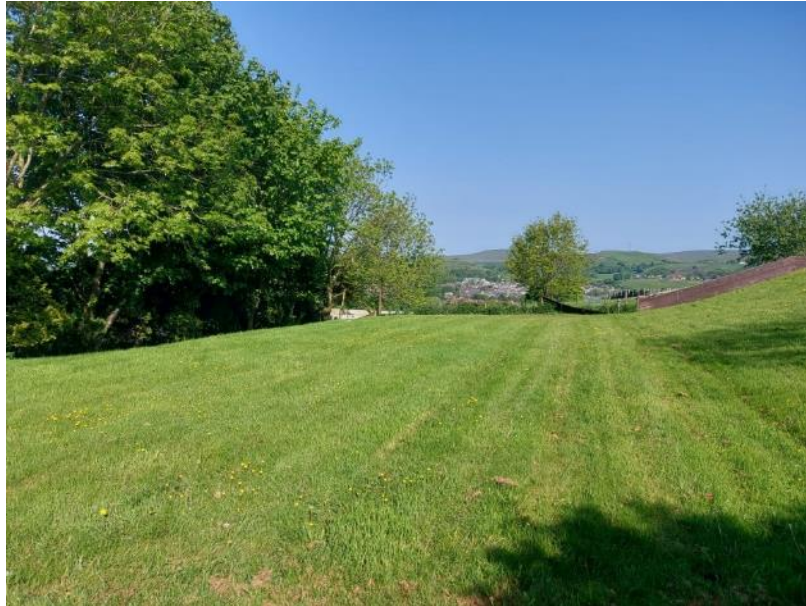
PLATE 17      SHOWING AMENITY GRASSLAND

The amenity grassland comprised a small area near the stable around the north-west and south-east extent of the site. The grassland was short and managed and comprised perennial rye-grass (*Lolium perenne*), ribwort plantain (*Plantago lanceolata*) and common daisy (*Bellis perennis*).

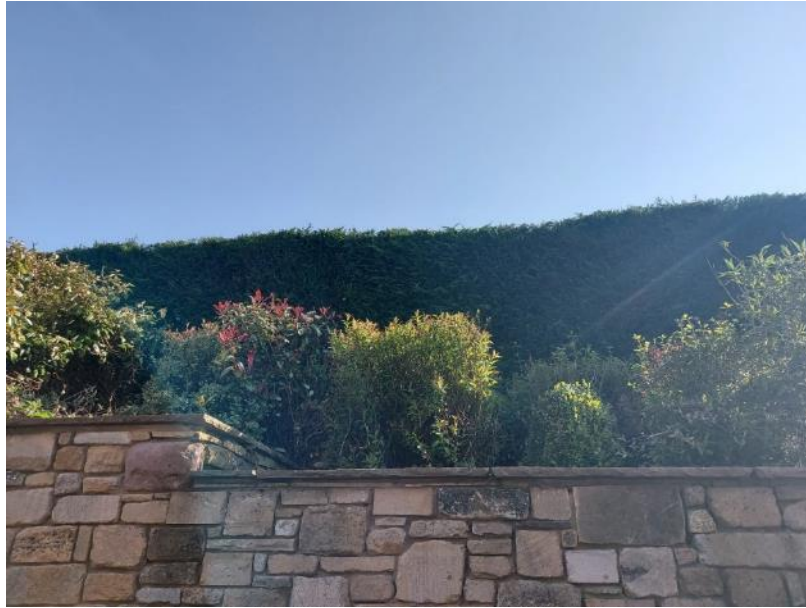
PLATE 19      SHOWING INTRODUCED SHRUB

Introduced shrub was present directly south of Building 3, and along the hedgerow opposite the north-east facing aspect of Building 1. Introduced shrub species included evergreen spindle (*Euonymus japonicus*), broad-leaved lavender (*Lavandula latifolia*), intermediate Lady's-mantle (*Alchemilla xanthochlora*), broad-leaved dock (*Rumex obtusifolius*) and garden privet (*Ligustrum ovalifolium*).

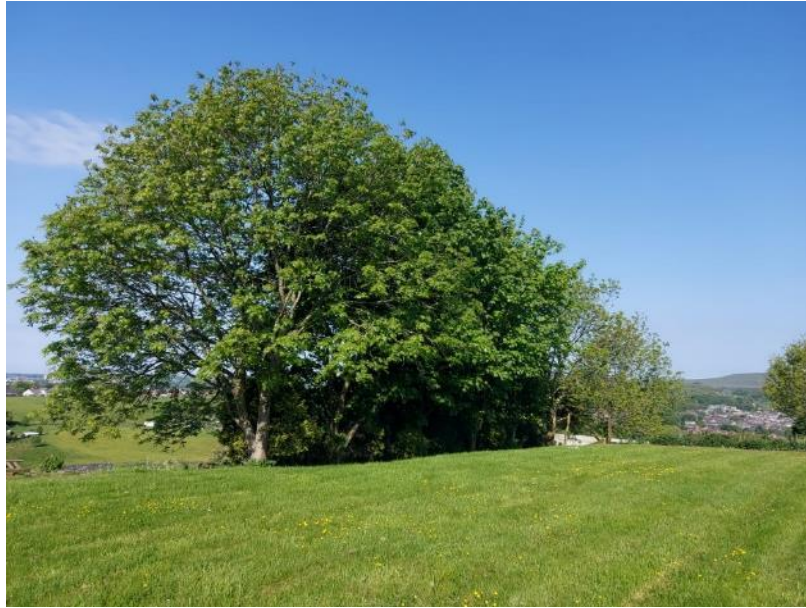
PLATE 21      SHOWING SCATTERED TREES

A number of scattered trees were located on site. Tree species comprised sycamore (*Acer pseudoplatanus*), Lawson cypress (*Chamaecyparis lawsoniana*), Hinoki cypress (*Chamaecyparis obtusa*), poplar (*Betula tremula*), and ash (*Fraxinus excelsior*). All trees were deemed as **Negligible** for bat potential as no features were identified.

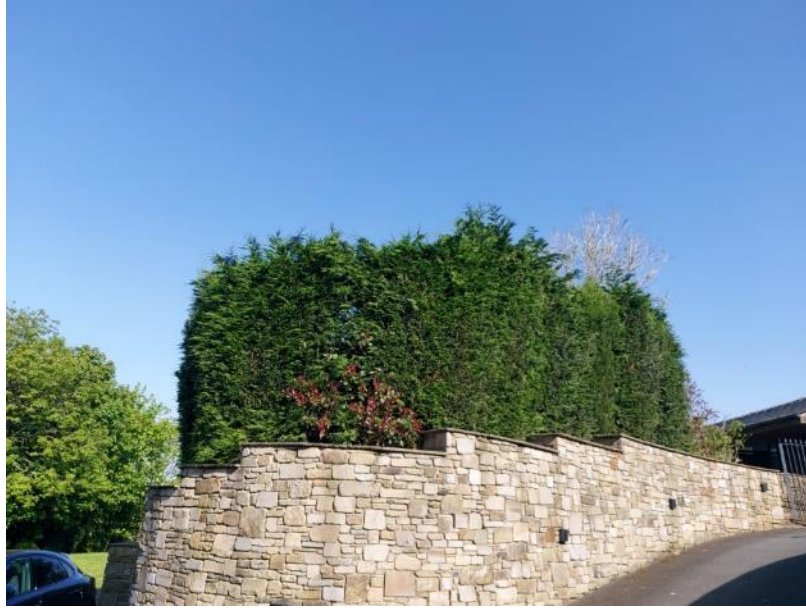
PLATE 24      SHOWING HEDGEROW

A number of hedgerow were present on site adjacent to Building 3, and along the north-east and south-east site boundaries. Hedgerows were comprised of Lawson cypress and hawthorn (*Crataegus monogyna*).

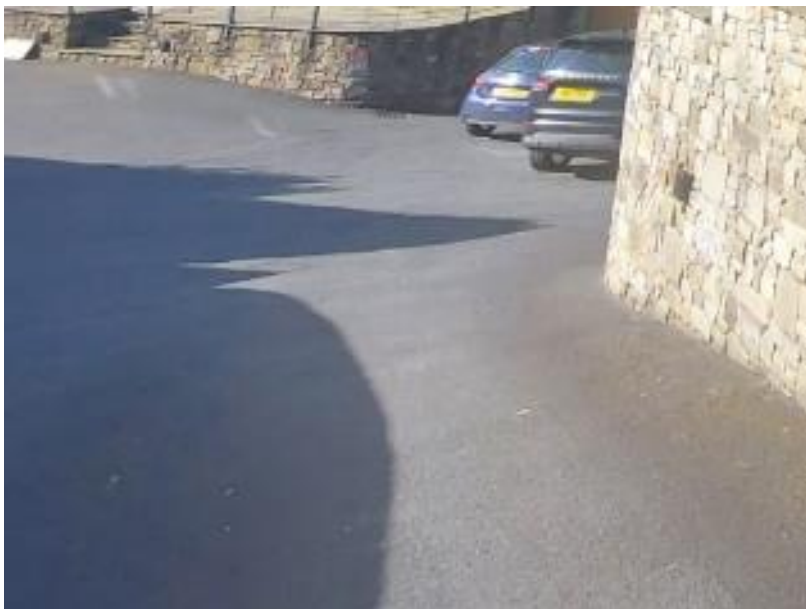
PLATE 25      SHOWING HARDSTANDING

The remainder of the site comprised an area of hardstanding used as car parking.
