# Post Arboricultural Impact Assessment

663 Bury Road  
Rochdale  
OL11 4 AX

Post impact assessment of a residential property and its landscaping

**Treestyle Consultancy Ltd**

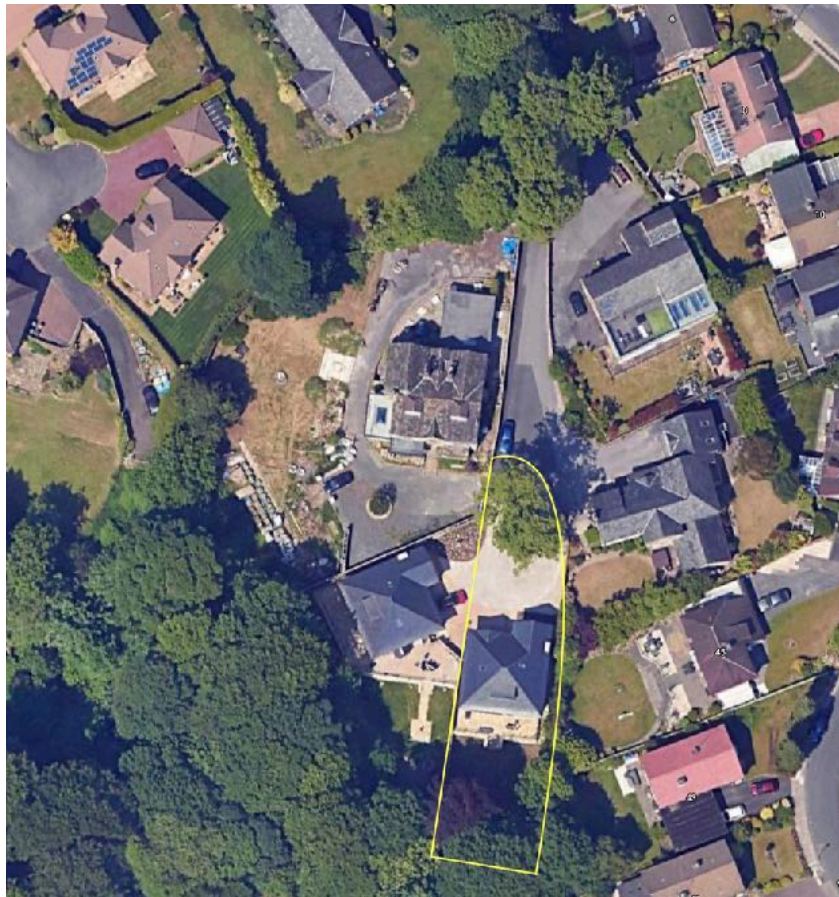
- 1.5 663 Bury Road is located in the leafy residential area of Rochdale. This newly developed housing estate is still undergoing construction with neighbouring properties still to be completed. These houses and their gardens back on to a woodland seen below. There is shared access to the two properties where a raised circular feature at the front (north) houses two mature trees. Access to the rear garden is gained along the eastern boundary.
- 1.5.1 Generally the green infrastructure presents good visual amenity value due to its location, it also creates screening and wildlife benefits.
- 5.5.2 Generally high occupancy targets being residential properties and their associated gardens.
