# ARBORICULTURAL IMPACT ASSESSMENT AT A VAN STORAGE FACILITY, JOHN MILNE AVENUE, ROCHDALE

Prepared for Lysander

**By A.T. Coombes Associates Ltd.**

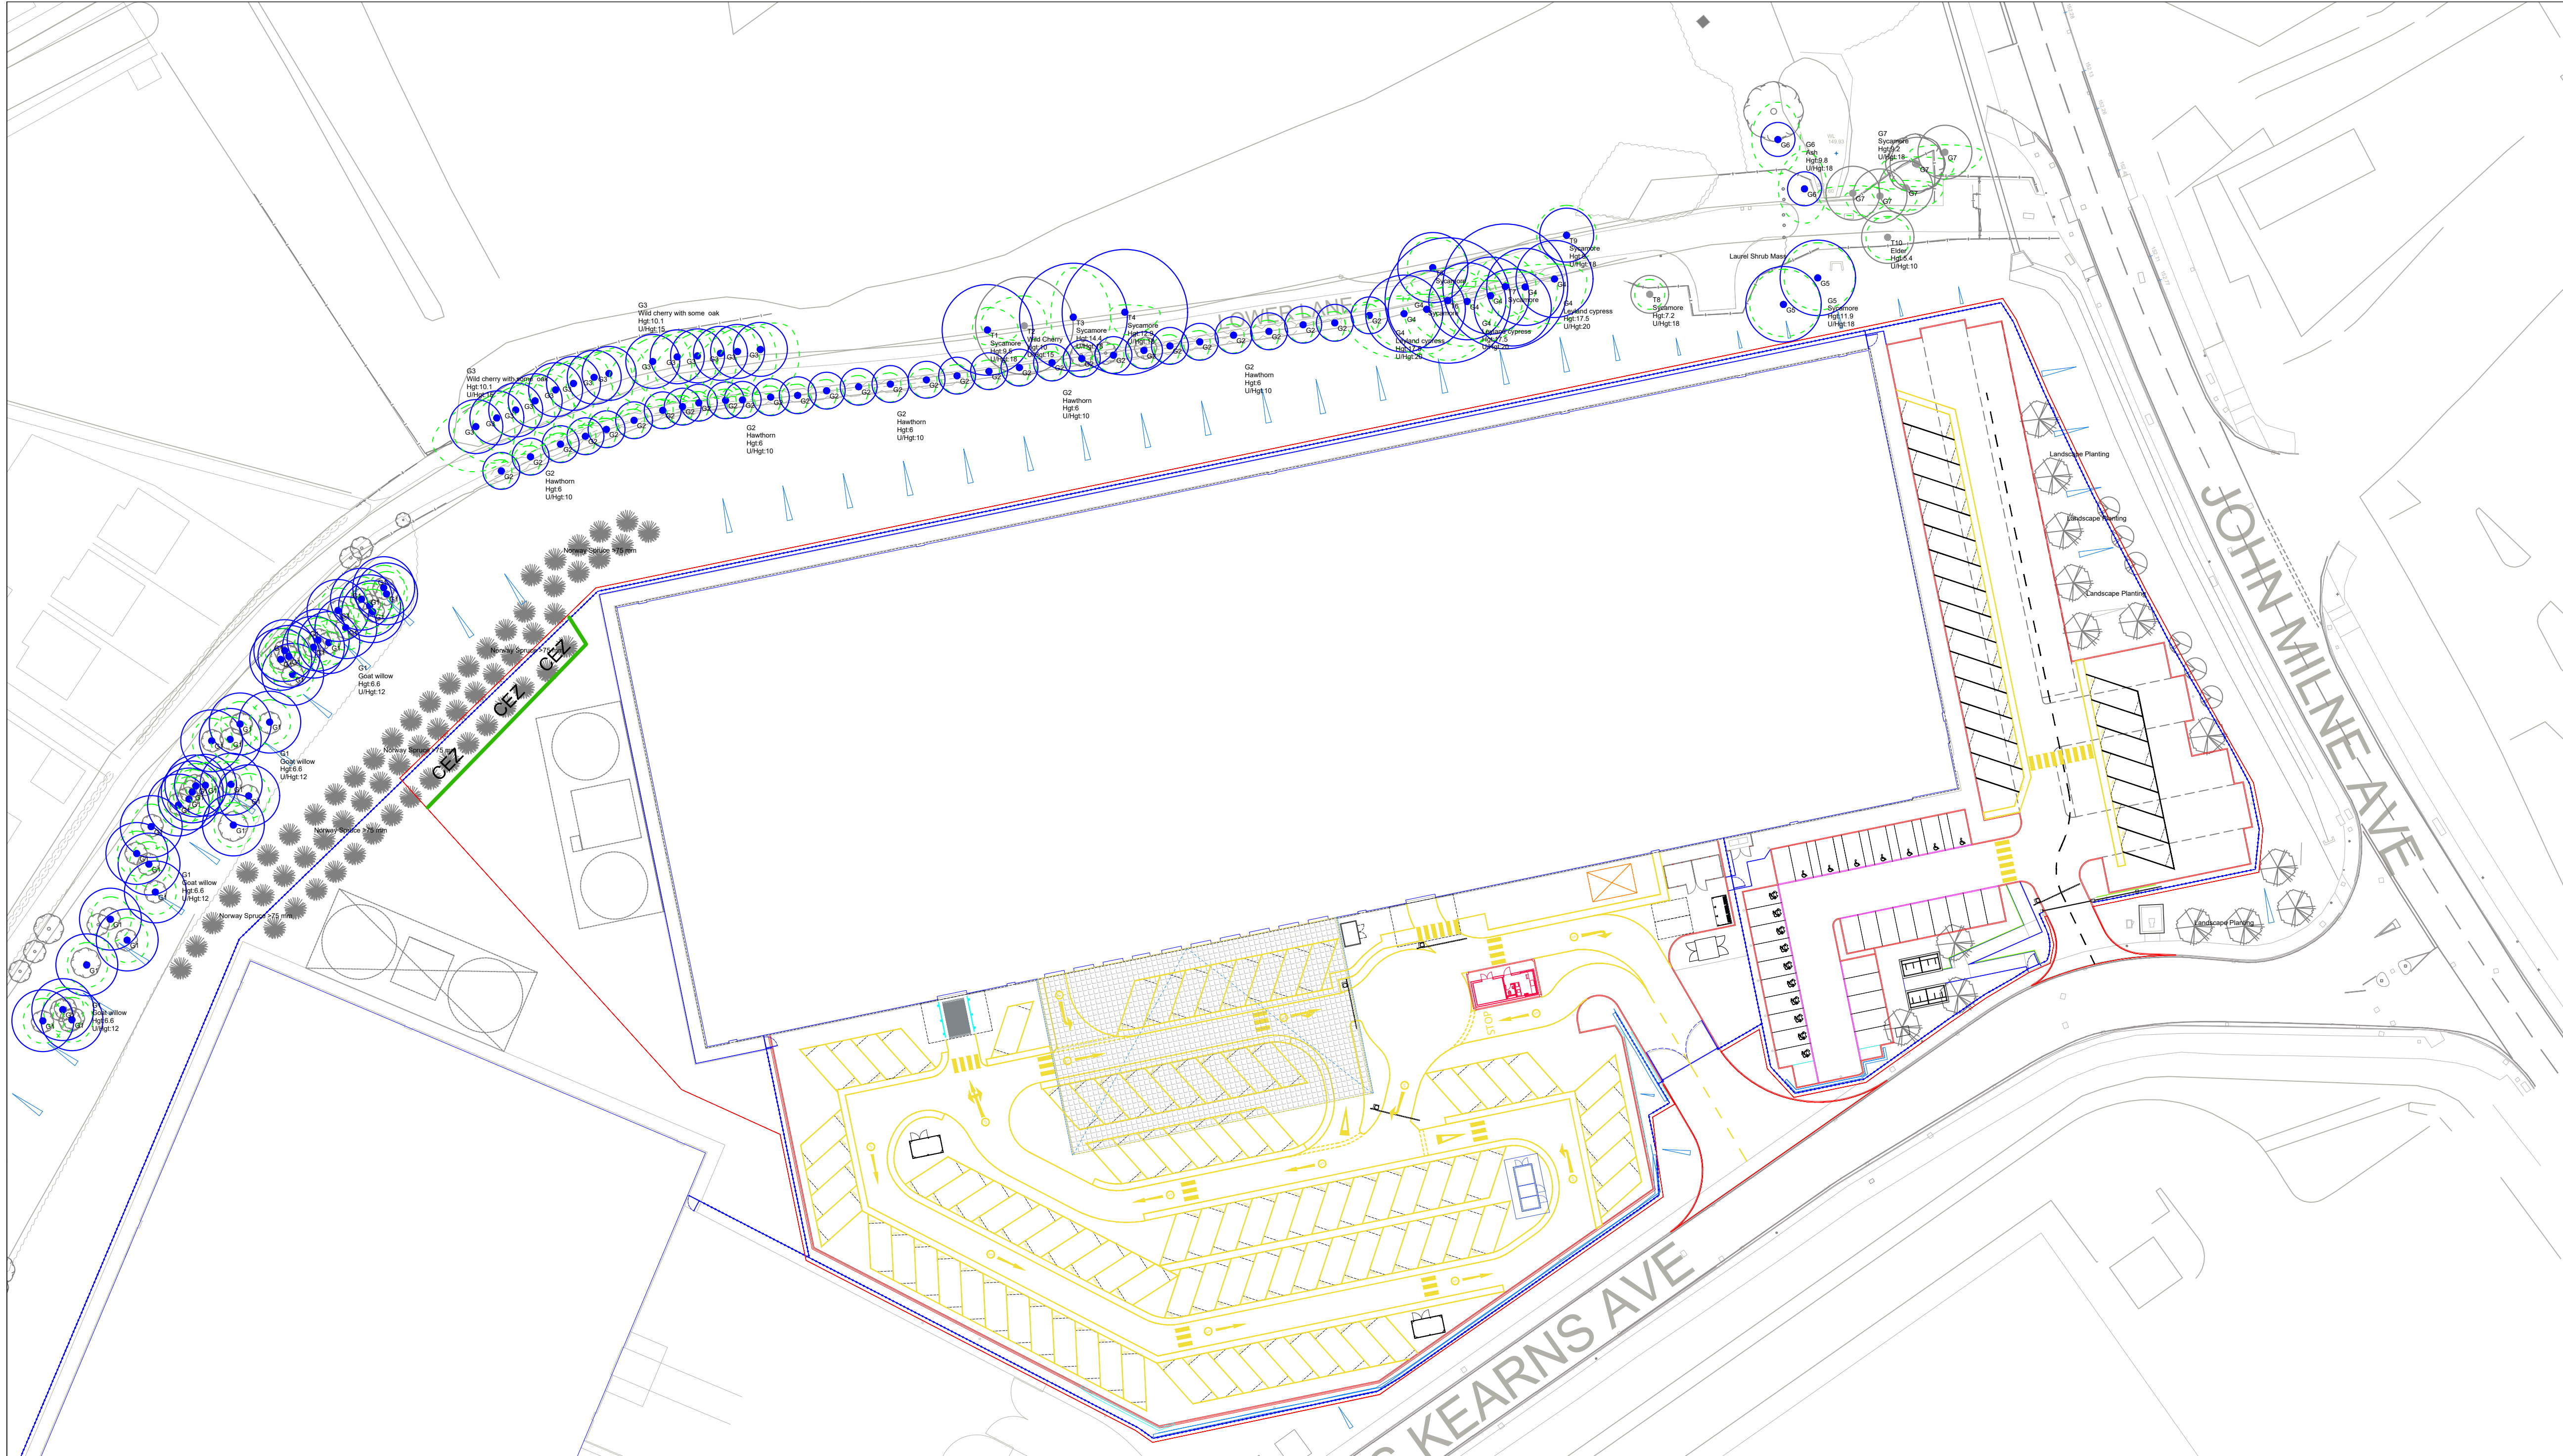
Drawing Title:  
**Appendix 4 - Tree Protection Plan**

- 3.1 Remaining trees will be protected by forming Construction Exclusion Zones (CEZ) as shown on Appendix 4 the Tree Protection Plan (TPP).
- 3.2 Temporary barriers will be erected as shown by the thick green lines on the TPP to form the Construction Exclusion Zone (CEZ). The barriers will consist of 2m tall welded mesh panels (Heras) supported on rubber or concrete feet. The fence panels should be joined together using a minimum of two anti-tamper couplers installed so they can be removed from the inside of the fence. The distance between couplers should be at least 1m and be uniform throughout the fence.
