# LYONS STONEMASONRY

## Stone survey report

Edgar Wood Trough

Heywood Old Rd

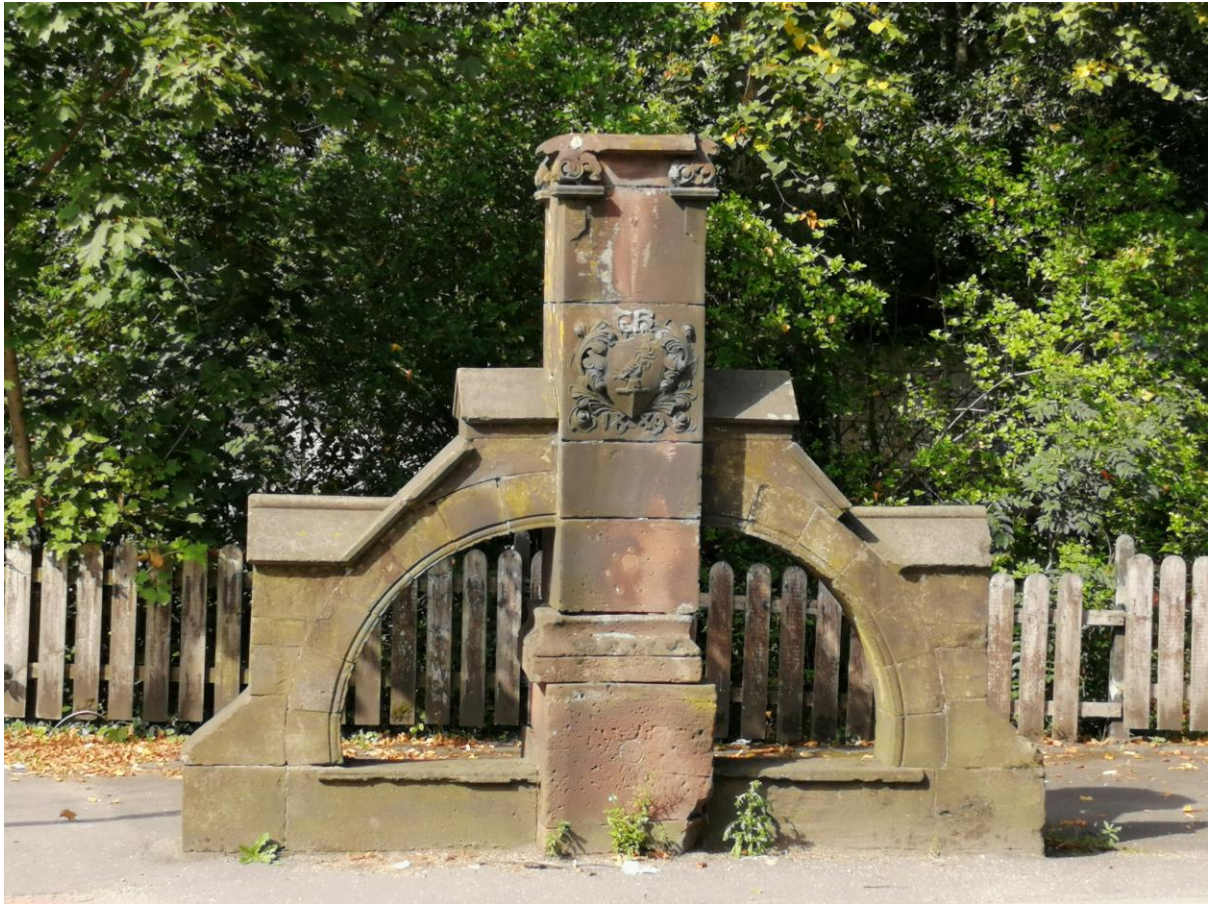
The existing structure is in reasonable condition. There is evidence that the structure has suffered impact damage from possibly vehicles. There is an outward lean too the structure of approx 80mm. The central shaft of the structure has rotated possibly due to impact.

The majority of the stones have small sections of stone missing which are not structural, there is only one number stone that requires replacing in full due to the structural integrity of the unit. One number stone requires indenting due to the location becoming a water trap.
