21314

BRANCH ROAD FARM, BRANCH ROAD  
LITTLEBOROUGH – OL15 0AB

Revised: 24<sup>th</sup> June 2022

# REPORT ON STRUCTURE

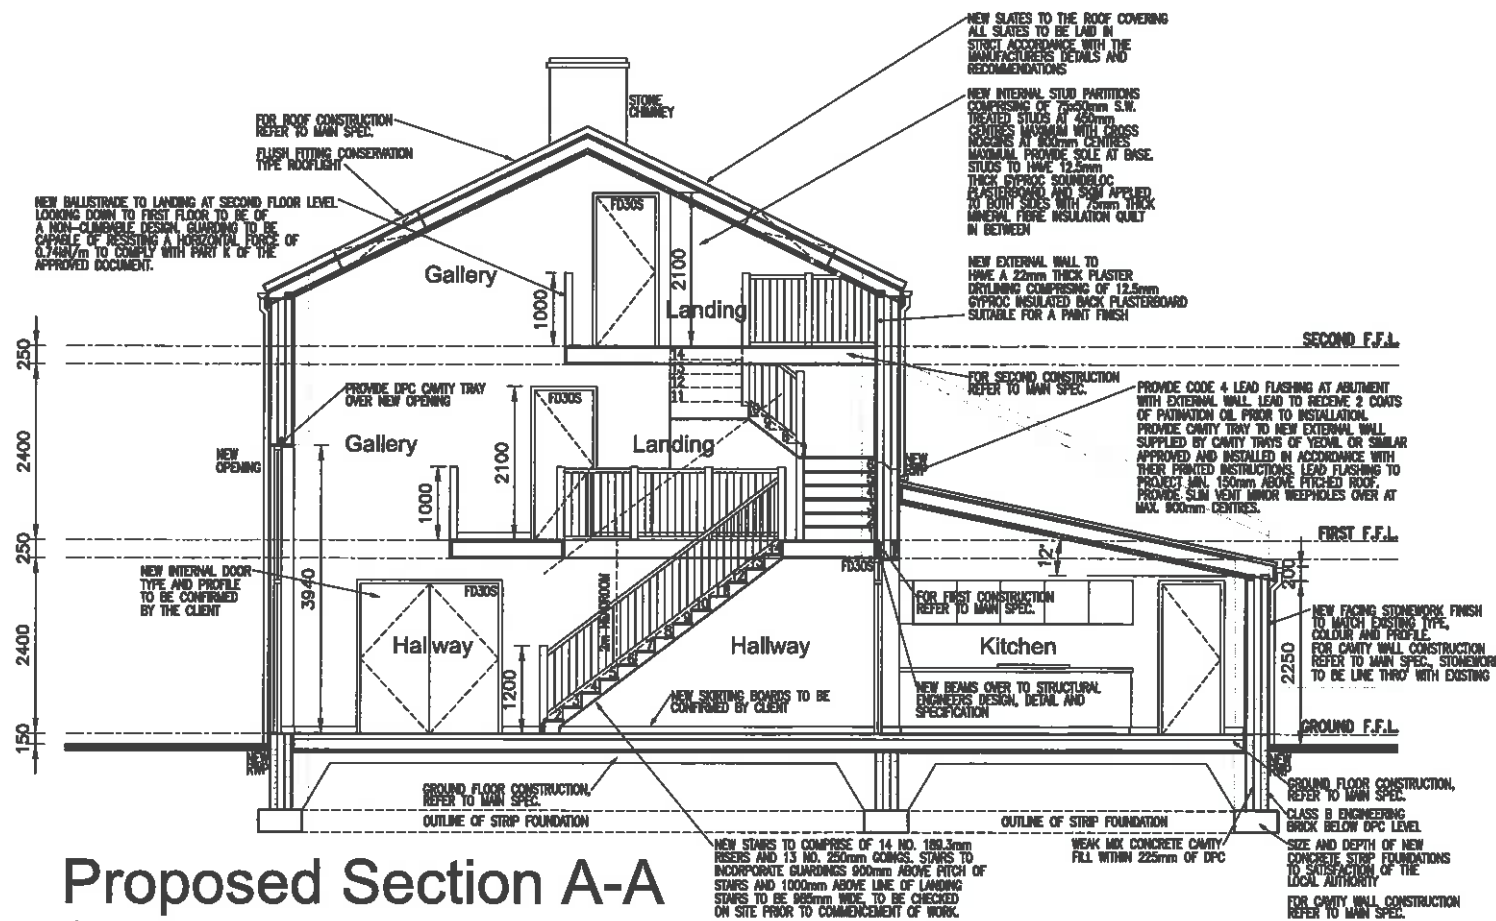
Proposed Section A-A

NEW BEAMS INDICATED TO BE ENCASED IN 15mm THICK FIRELINE BOARD TO PROVIDE 1 HOUR FIRE RESISTANCE. ALL SUPPLIED BY BRITISH GYPSUM AND INSTALLED IN ACCORDANCE WITH THEIR PRINTED INSTRUCTIONS. ALL JOINTS TO BE TAPED AND PLASTERBOARD TO HAVE A SOW FINISH. ALL NEW BEAMS TO BE BOLTED TOGETHER, TO BE CONFIRMED BY STRUCTURAL ENGINEER.

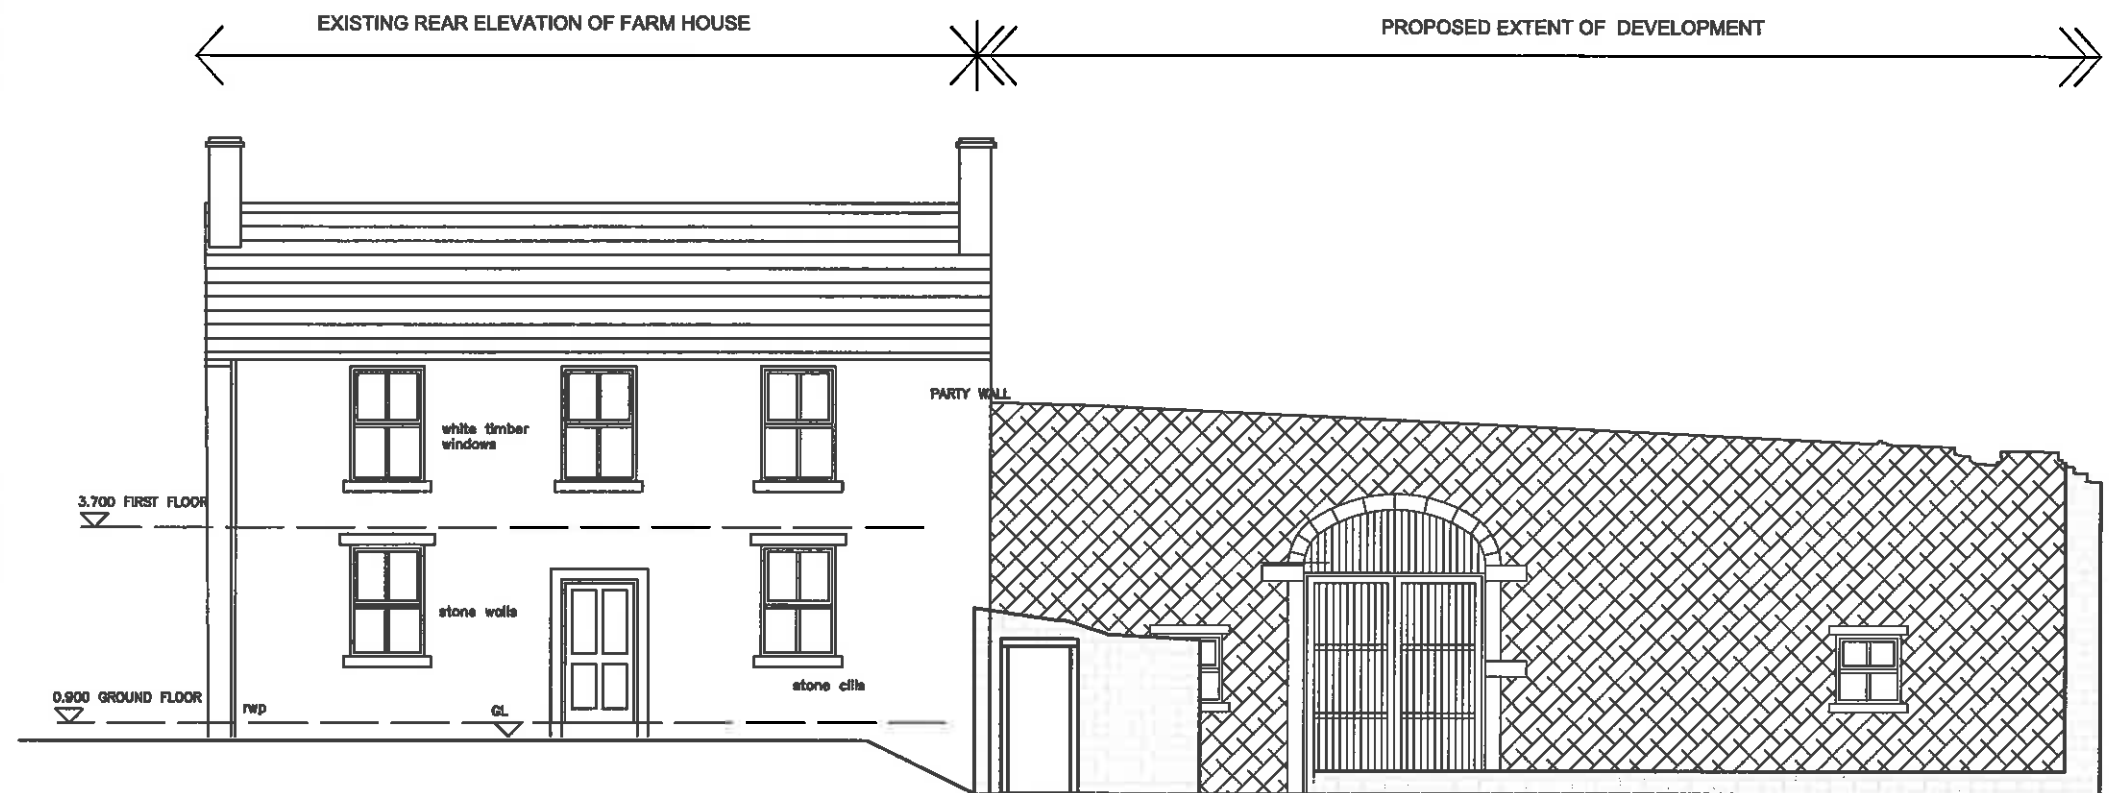
EXISTING REAR ELEVATION @ TIME OF SURVEY

- 4.01** We believe the collapse of the left-hand side and the rear elevation was inevitable given the condition of the walls and the poor quality of the inner leaf matrix and the loose rubble fill. See photographs 15 & 16. The loss of lateral restraint due to the removal of the roof was also a contributing factor.
