Validation Report  
Land off Don Street, Middleton

Reference: 14-554-R8-2  
Date: November 2024

# REMEDIATION AND ENABLING WORKS VALIDATION

Land off Don Street  
Middleton  
Greater Manchester  
M24 2DB

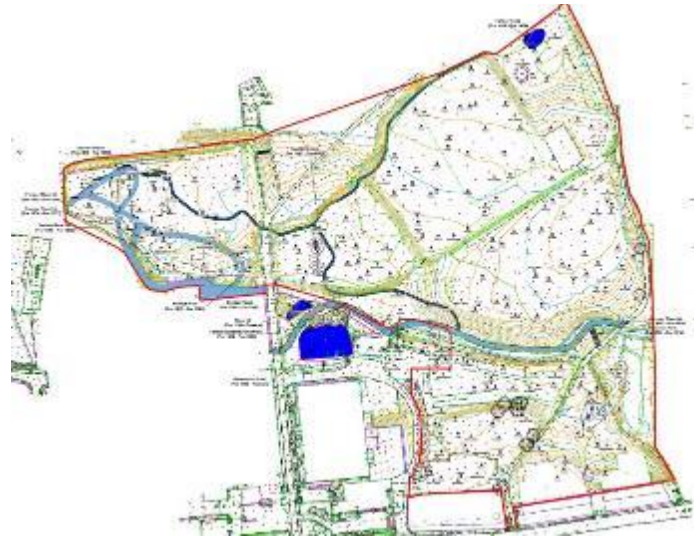
**FIGURE 4.4 LOCATION OF IDENTIFIED INFILLED PONDS, STREAMS AND RIVERS**

Within Phase 1 a former stream and historical River Irk layout is present through much of the south and west of the parcel. E3P maintained part time supervision during turnover in this parcel, no soft alluvial deposits or geotechnically unsuitable material resembling historic river or stream deposits was noted, as such, it is assumed this was grubbed out prior to the construction of the former Rex Mill. No further works were required in this area.

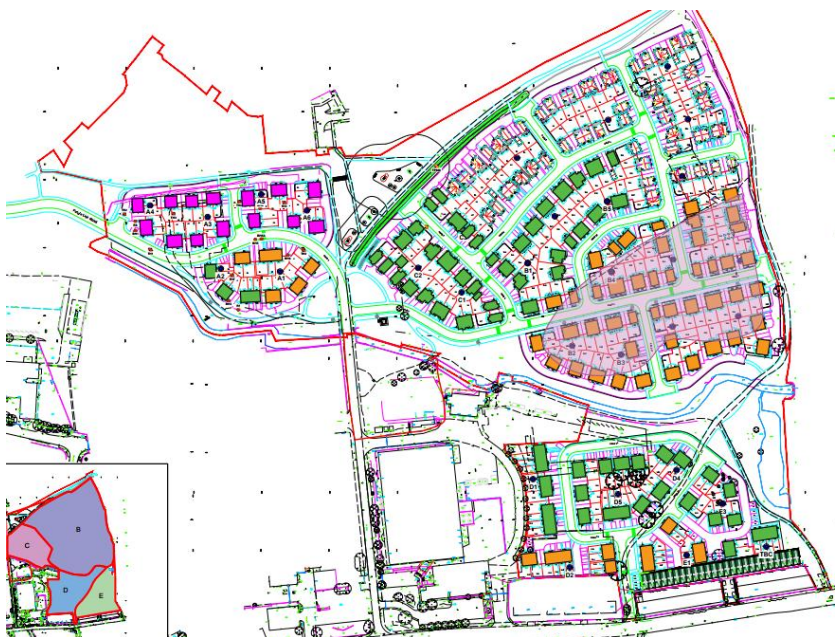
FIGURE 4.5 – GROUND GAS LOCATION AND ZONING PLAN

A snapshot showing the location of post remediation monitoring wells, and ground gas zoning plan within completed phases is given as Figure 4.5 below and Drawing 14-554-036 in Appendix III.

Further monitoring within the remaining area of Parcel B.
