**Project****Project Name:** 2023-07-20641 Kellen Homes Castleton Manchester OL11 3BX**Project Date:** 07/08/2023**Inspection Standard:** MSCC5 Sewers & Drainage GB (SRM5 Scoring)

## Section Inspection - 03/08/2023 - MH2X

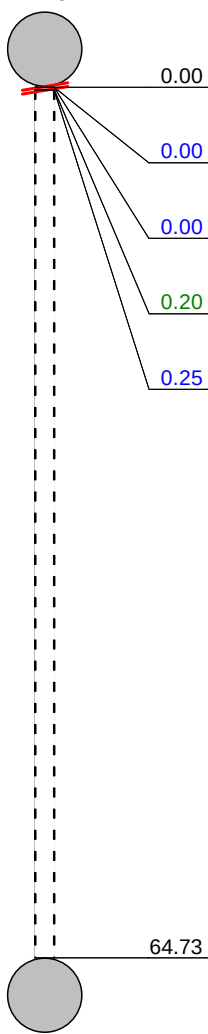
<table><tr> <td>0.00</td><td>MH</td><td>Start node, manhole, reference: MH3</td><td>00:00:00</td><td></td><td></td><td></td></tr><tr> <td>0.00</td><td>REM</td><td>General remark: picture dark due to black walls</td><td></td><td></td><td></td><td></td></tr><tr> <td>0.00</td><td>WL</td><td>Water level, 20% of the vertical dimension</td><td>00:00:19</td><td></td><td></td><td></td></tr><tr> <td>0.20</td><td>DES</td><td>Settled deposits, fine, 20% cross-sectional area loss</td><td>00:00:40</td><td>MH2X_15<br/>2bb695-15<br/>d6-46df-97</td><td></td><td>4</td></tr><tr> <td>0.25</td><td>SA</td><td>Survey abandoned: unable to pass</td><td>00:00:40</td><td></td><td></td><td></td></tr></table>

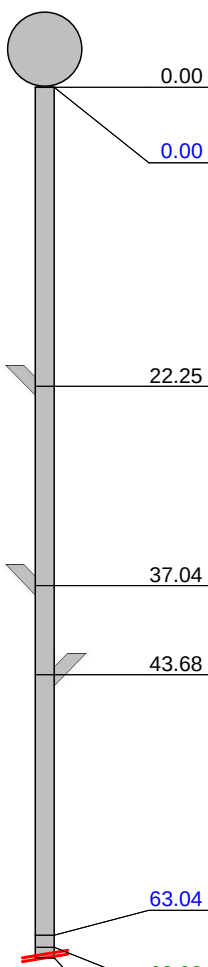
| Scale: 1:561 | Position [m] | Code | Observation | MPEG | Photo | Grade |
|---|---|---|---|---|---|---|
| Depth: 5.50 m<br>MH2 | | | | | | |

| Scale: 1:561 | Position [m] | Code | Observation | MPEG | Photo | Grade |
|---|---|---|---|---|---|---|
| | 0.00 | MH | Start node, manhole, reference: MH2 | 00:00:00 | | |
| | 0.00 | WL | Water level, 5% of the vertical dimension: flowing | | | |
| | 22.25 | CN | Connection other than junction at 02 o'clock, 255mm dia | 00:01:46 | MH2X_0ce<br>11f09-7e9<br>3-46ff-b01 | |
| | 37.04 | CN | Connection other than junction at 03 o'clock, 225mm dia | 00:02:51 | MH2X_ed<br>12cab5-16<br>6a-4e04-9 | |
| | 43.68 | CN | Connection other than junction at 08 o'clock, 225mm dia | 00:03:27 | | |
| | 63.04 | WL | Water level, 20% of the vertical dimension | 00:05:02 | | |

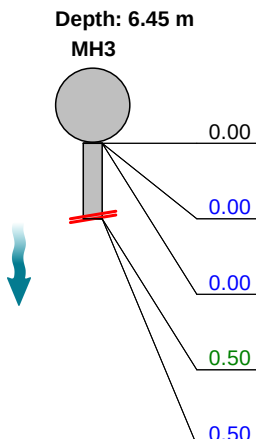
| Scale: | 1:50 | Position [m] | Code | Observation | MPEG | Photo | Grade |
|---|---|---|---|---|---|---|---|
| | | 0.00 | MH | Start node, manhole, reference: MH3 | 00:00:00 | | |
| | | 0.00 | REM | General remark: Picture dark due to black walls | | | |
